**NATIONAL TRANSPORTATION SAFETY BOARD
OFFICE OF HIGHWAY SAFETY
WASHINGTON, D.C.**

**SURVIVAL FACTORS GROUP CHAIRMAN'S
FACTUAL REPORT**

NTSB #: **HWY18MH005**

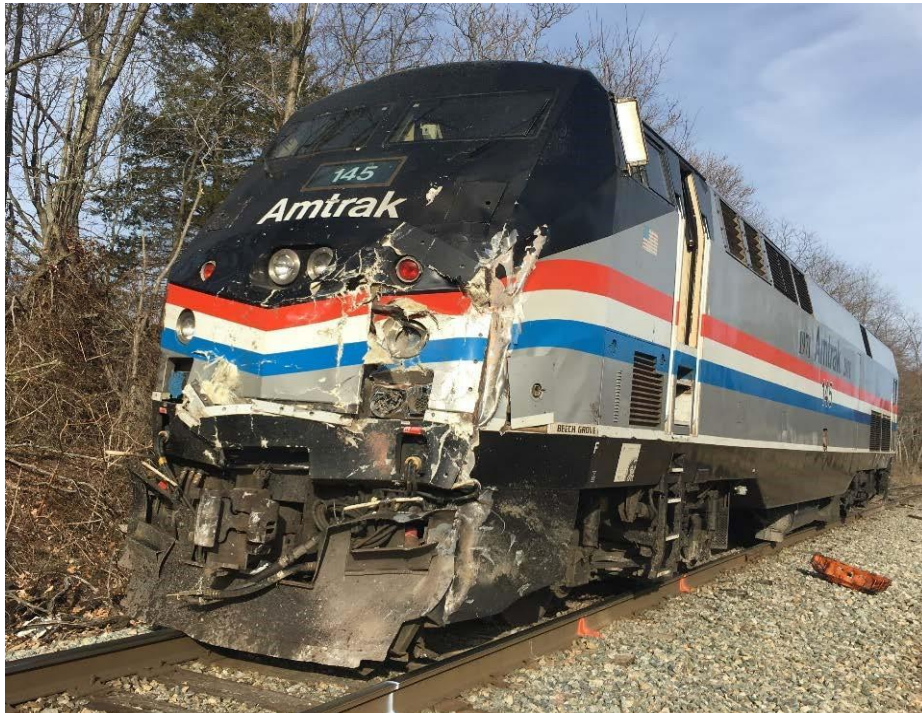
The lead locomotive was a 2001 General Electric Diesel Electric locomotive. At the time of the collision, the lead locomotive was occupied by three on-duty Amtrak employees that included; the locomotive engineer, the road foreman of engines, and a locomotive technician and a United States Capitol police officer. Because of the collision with the trash truck, the lead locomotive sustained extensive damage to the area comprising the knuckle and the pilot; extending upward towards the front windshield. The locomotive's interior did not sustain any damage in the collision. The first axle of the locomotive derailed in the crash. **(Photo 1).**

Photo #1: FBI photo showing exterior damage to lead locomotive.

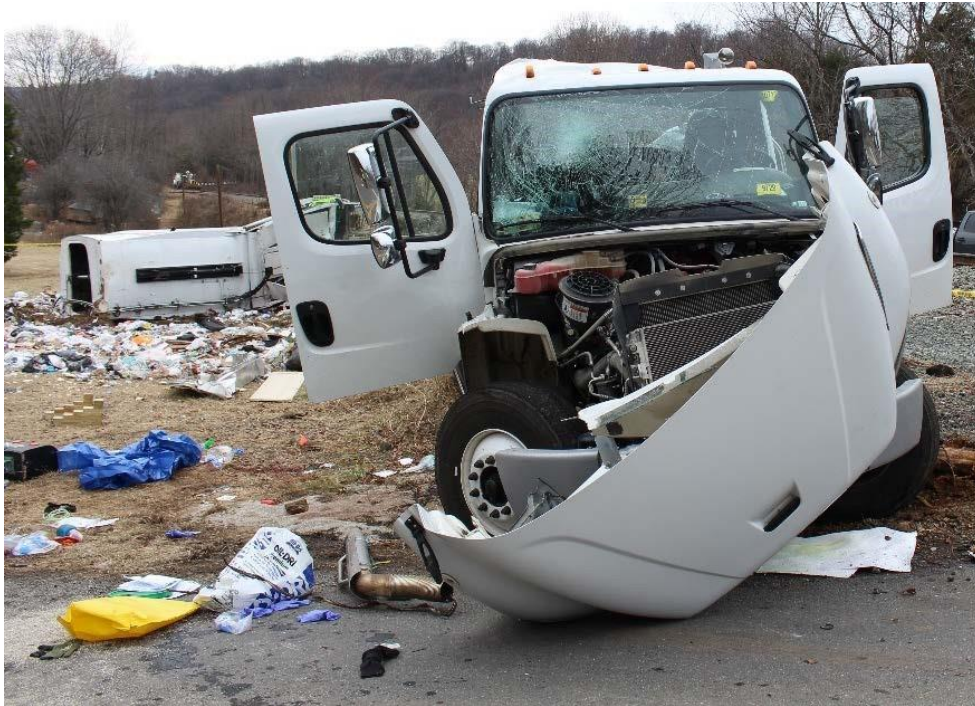
mailboxes and support posts; the hopper was torn from the main body of the truck. During the separation of the hopper from the truck, the truck frame experienced significant twisting and the loss of structural integrity to the truck cab.² (Photo 2)

Photo #2: Exterior front view of truck and the detached Hopper in background

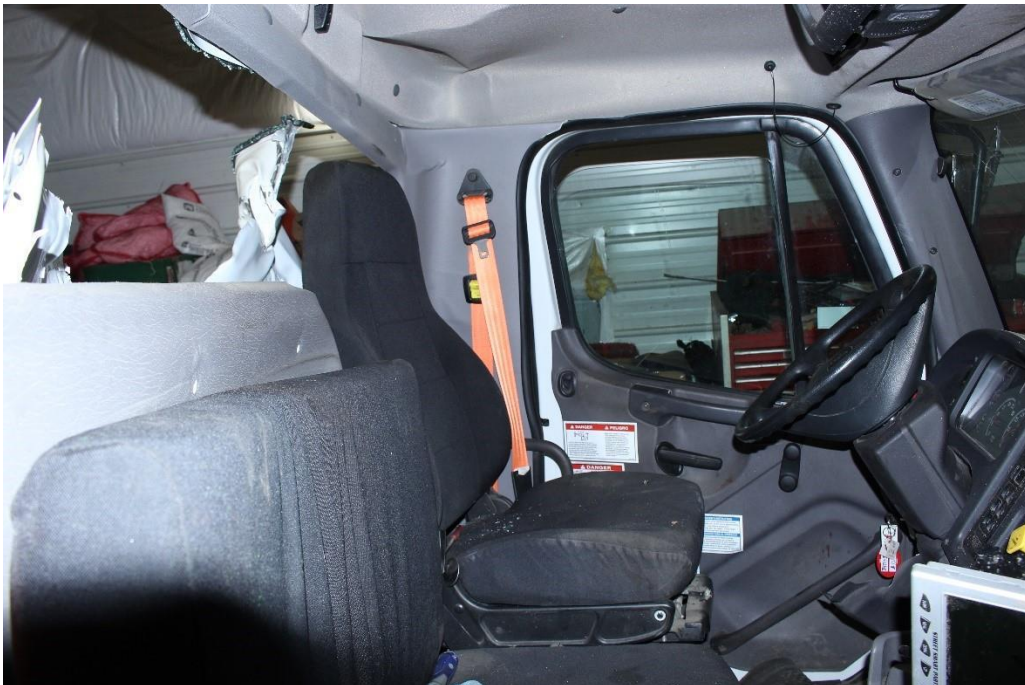
The overall interior damage sustained by the truck was documented. The overall height of the roof in the undamaged area, measured from the cab floor is 60 inches. In several locations, the structural integrity of the roof had been compromised and the interior height was decreased to

41 inches at its lowest point in the truck cab. Directly in front of the steering column, the floor of the truck had been deformed and deflected upwards into the passenger compartment by 4 inches.

Photo #3: Interior of truck cab showing seat positions and rear window damage.

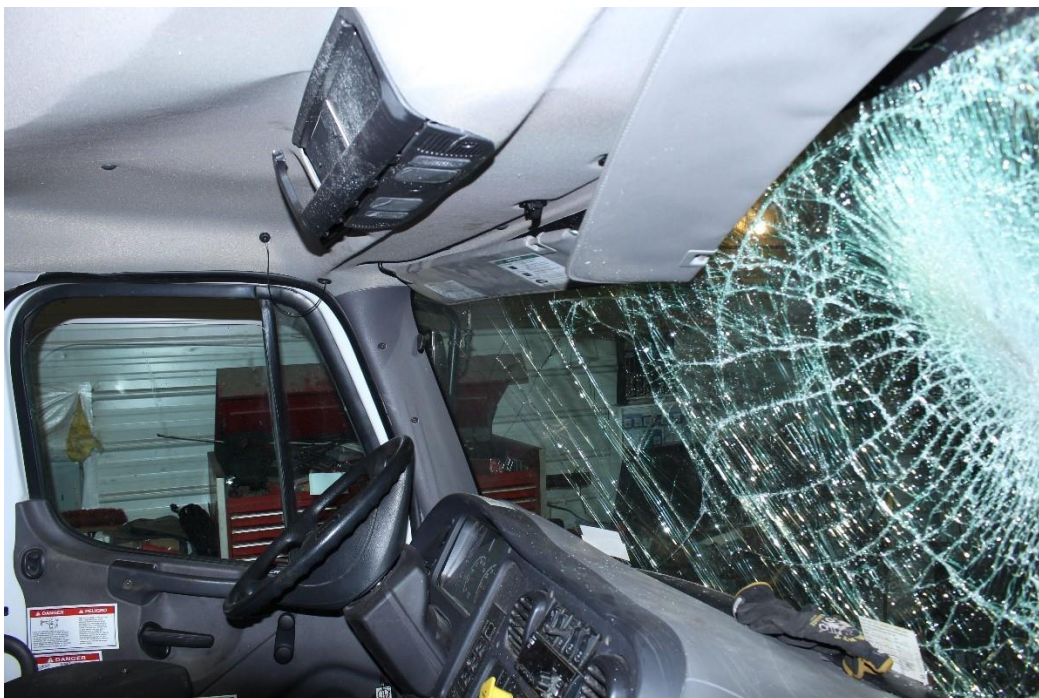
The interior cab design of the Freightliner provides seating for the driver as well as two passengers on a bench seat. All seating positions, in the trash truck, are equipped with seatbelts; lap and shoulder belts for the driver and the right seat passenger and a lap belt for the middle seat occupant. A post-crash examination of the seatbelts revealed no evidence of use by the truck occupants. The driver's seatbelt and the right passenger seatbelt were found locked in the stowed position. The seatbelt designated for the middle occupant was found under the displaced bench seat and entangled around the bottom of the driver's seat that shifted during the crash. The post-crash examination revealed that the occupant located in the right seat adjacent to the passenger door, had struck the front windshield with his head causing extensive damage to the windshield glass.

Photo #4: Interior of truck cab showing head strike to windshield by passenger.
