**SURVIVAL FACTORS GROUP CHAIRMAN'S
FACTUAL REPORT**

Biloxi, Mississippi

HWY17MH010

**NATIONAL TRANSPORTATION SAFETY BOARD
OFFICE OF HIGHWAY SAFETY
WASHINGTON, D.C.**

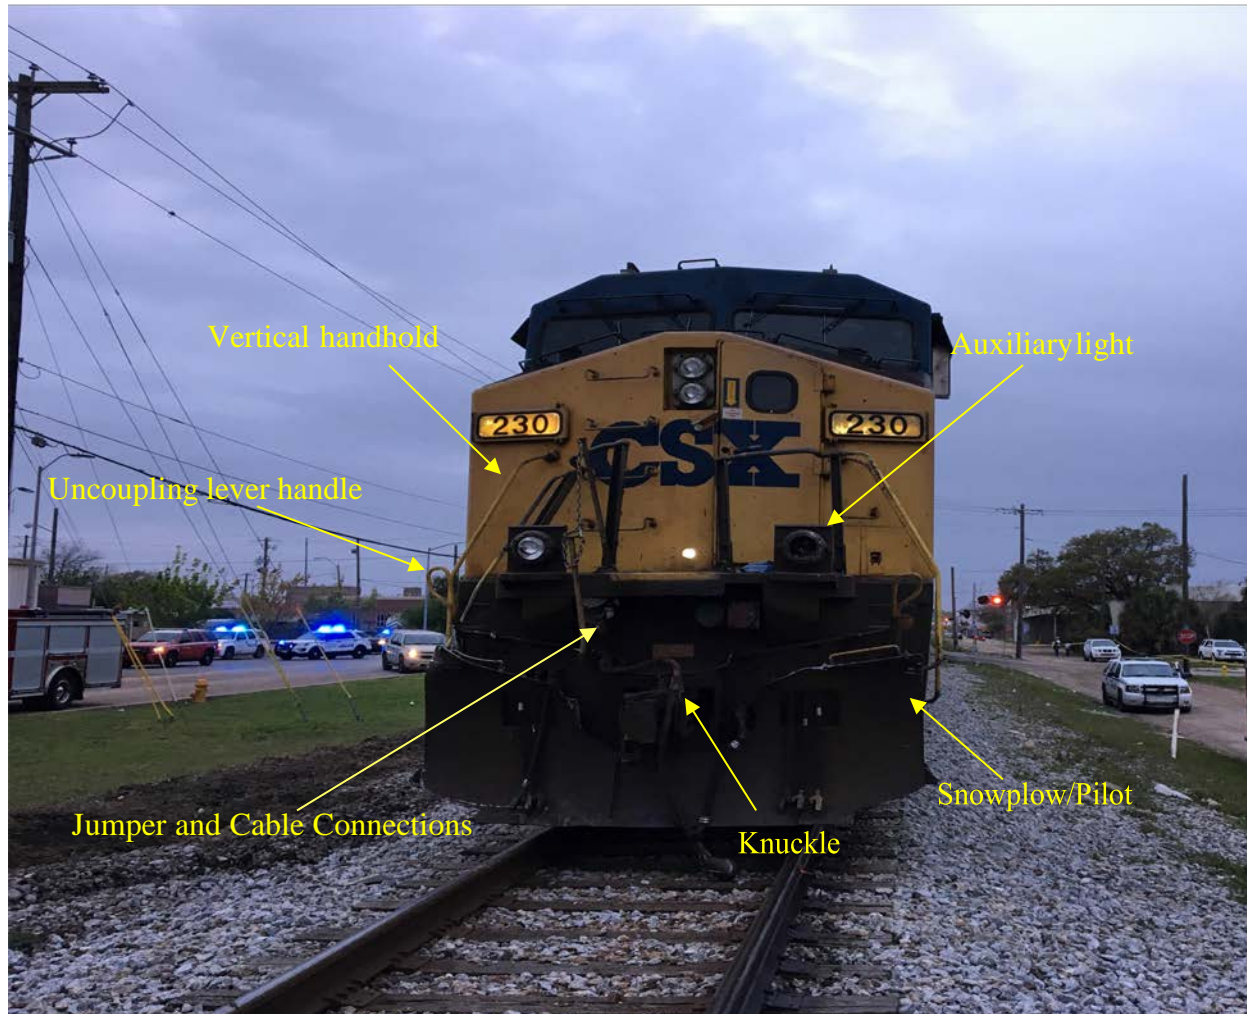
Photo #1: Lead locomotive and contact areas with motorcoach.

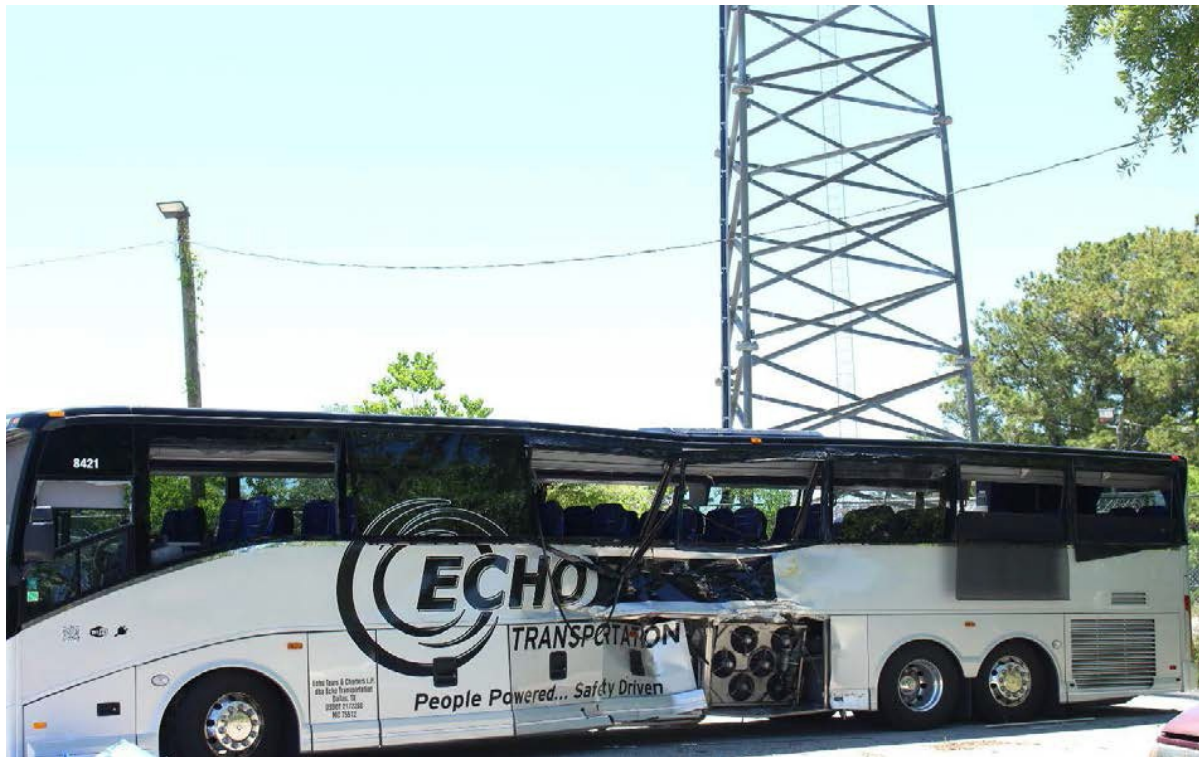
The motorcoach sustained extensive damage to the left side resulting from the impact with the train. As shown in **Photo #2**, the damage extended from the lower luggage compartments to the top of the metal frame for windows #3, 4 and 5 on this side. Evidence of intrusion into the motorcoach was located at seat row #5 on the left side and extended to just behind seat row #8. (See Vehicle Factors Group Chairman's report for further information.)

Photo #2: Exterior left side of the motorcoach

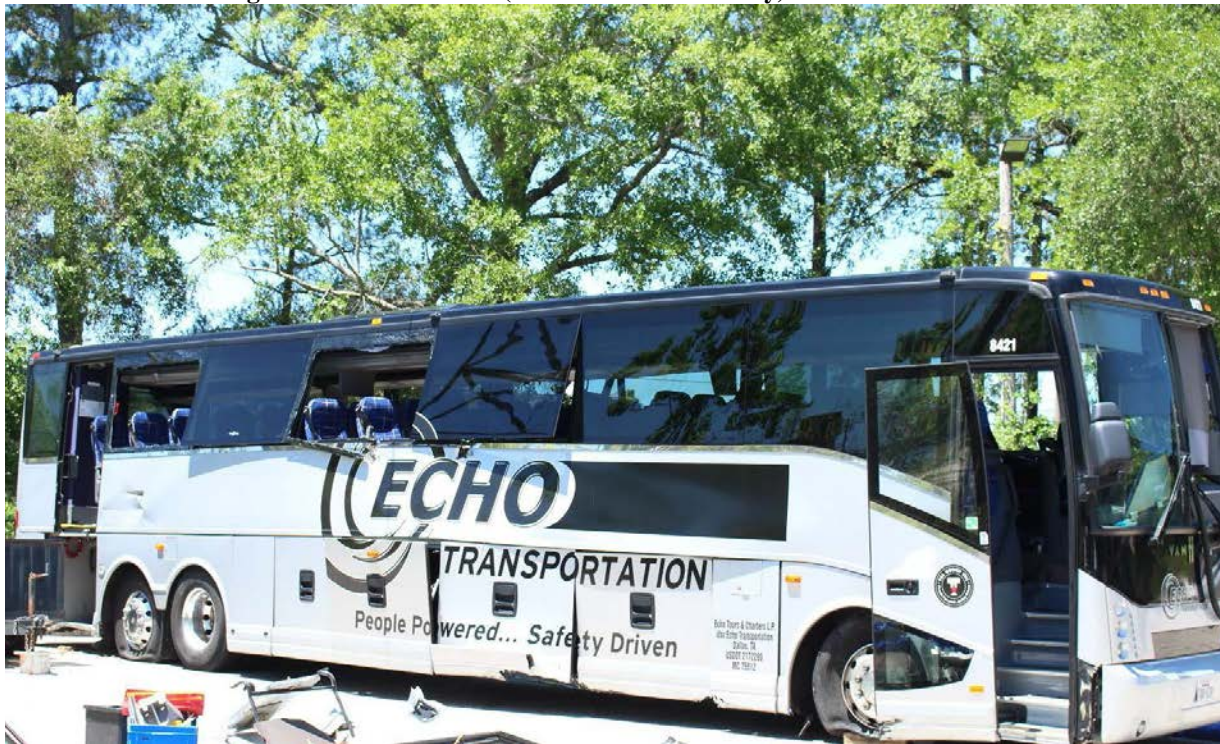
The motorcoach sustained minor damage to the right side in the collision. The damage, located just in front of the rear exit door resulted from the impact with the crossing gate. The rest of the damage was caused by the intervention of the first responders. The rear exit door was forcibly removed by the fire department after it was determined that the door was locked and prevented the necessary secondary access. Initially, access to the interior of the motorcoach was gained by breaking out the windows on the right side. Additional access was gained by cutting and prying the windows away from the motorcoach frame. **Photo #3** shows the damage sustained by the motorcoach to the right side.

Photo #3: Exterior right side of motorcoach (with rear door cut away)

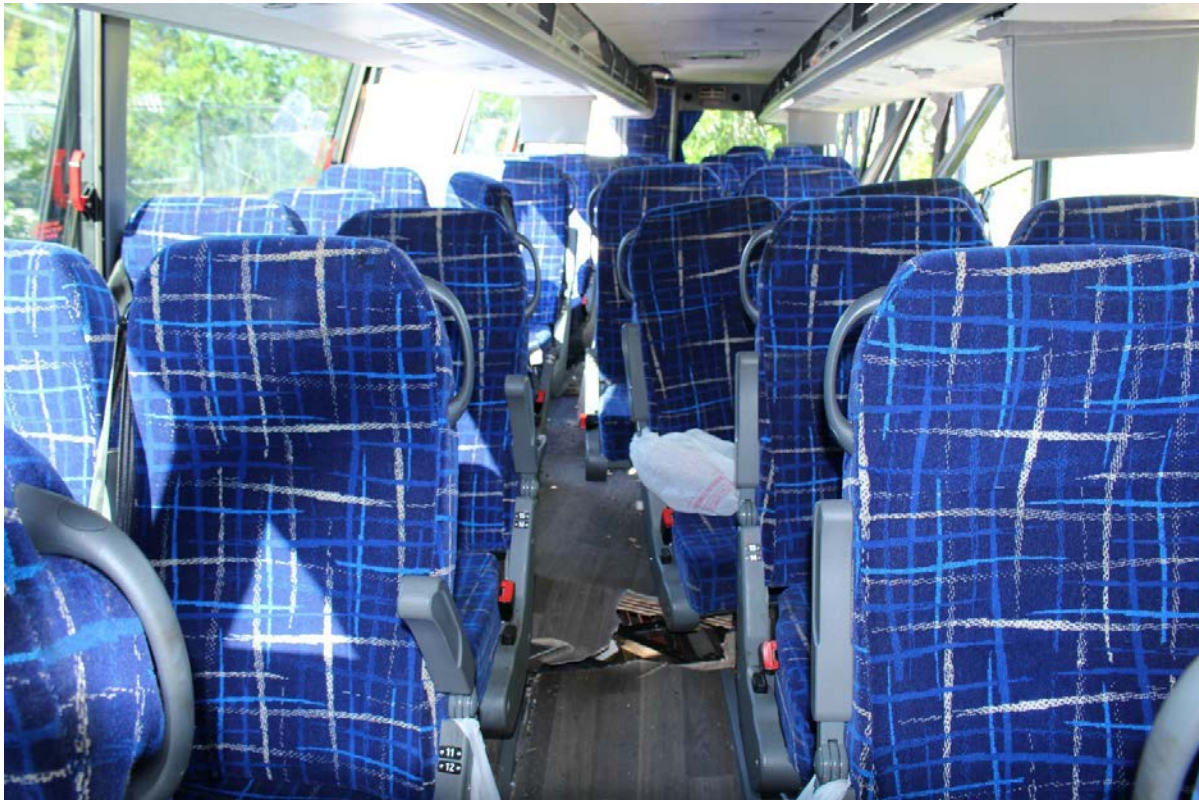
The seats were numbered starting from the front left side window seat and goes from right to left across each row. Damage to the interior of the motorcoach was extensive. The area of impact with the train started at the fifth row of seats on the left side and extended rearward behind the eighth row of seats. In this area, there was extensive sidewall intrusion that reduced the overall interior width of the motor coach from 8 feet to 6 feet 8 inches, sidewall to sidewall. The upper panel of the windows at the driver's position shattered during impact as well as Window #1, #3, #4, and #6 on the left side. Windows #2 and #5, on the left side, suffered damage to the frame that shifted the windows, but the glass pane remained intact. Window #7, on the left side was removed during extrication operations. Because of the impact with the train, the overall occupant space available in the aisle-way decreased from 17 inches to 8 inches at the point of impact between rows 5-8. **Photo #4** shows the interior damage of the motorcoach at the point of maximum intrusion and deformation.

Photo #4: Interior damage to motorcoach

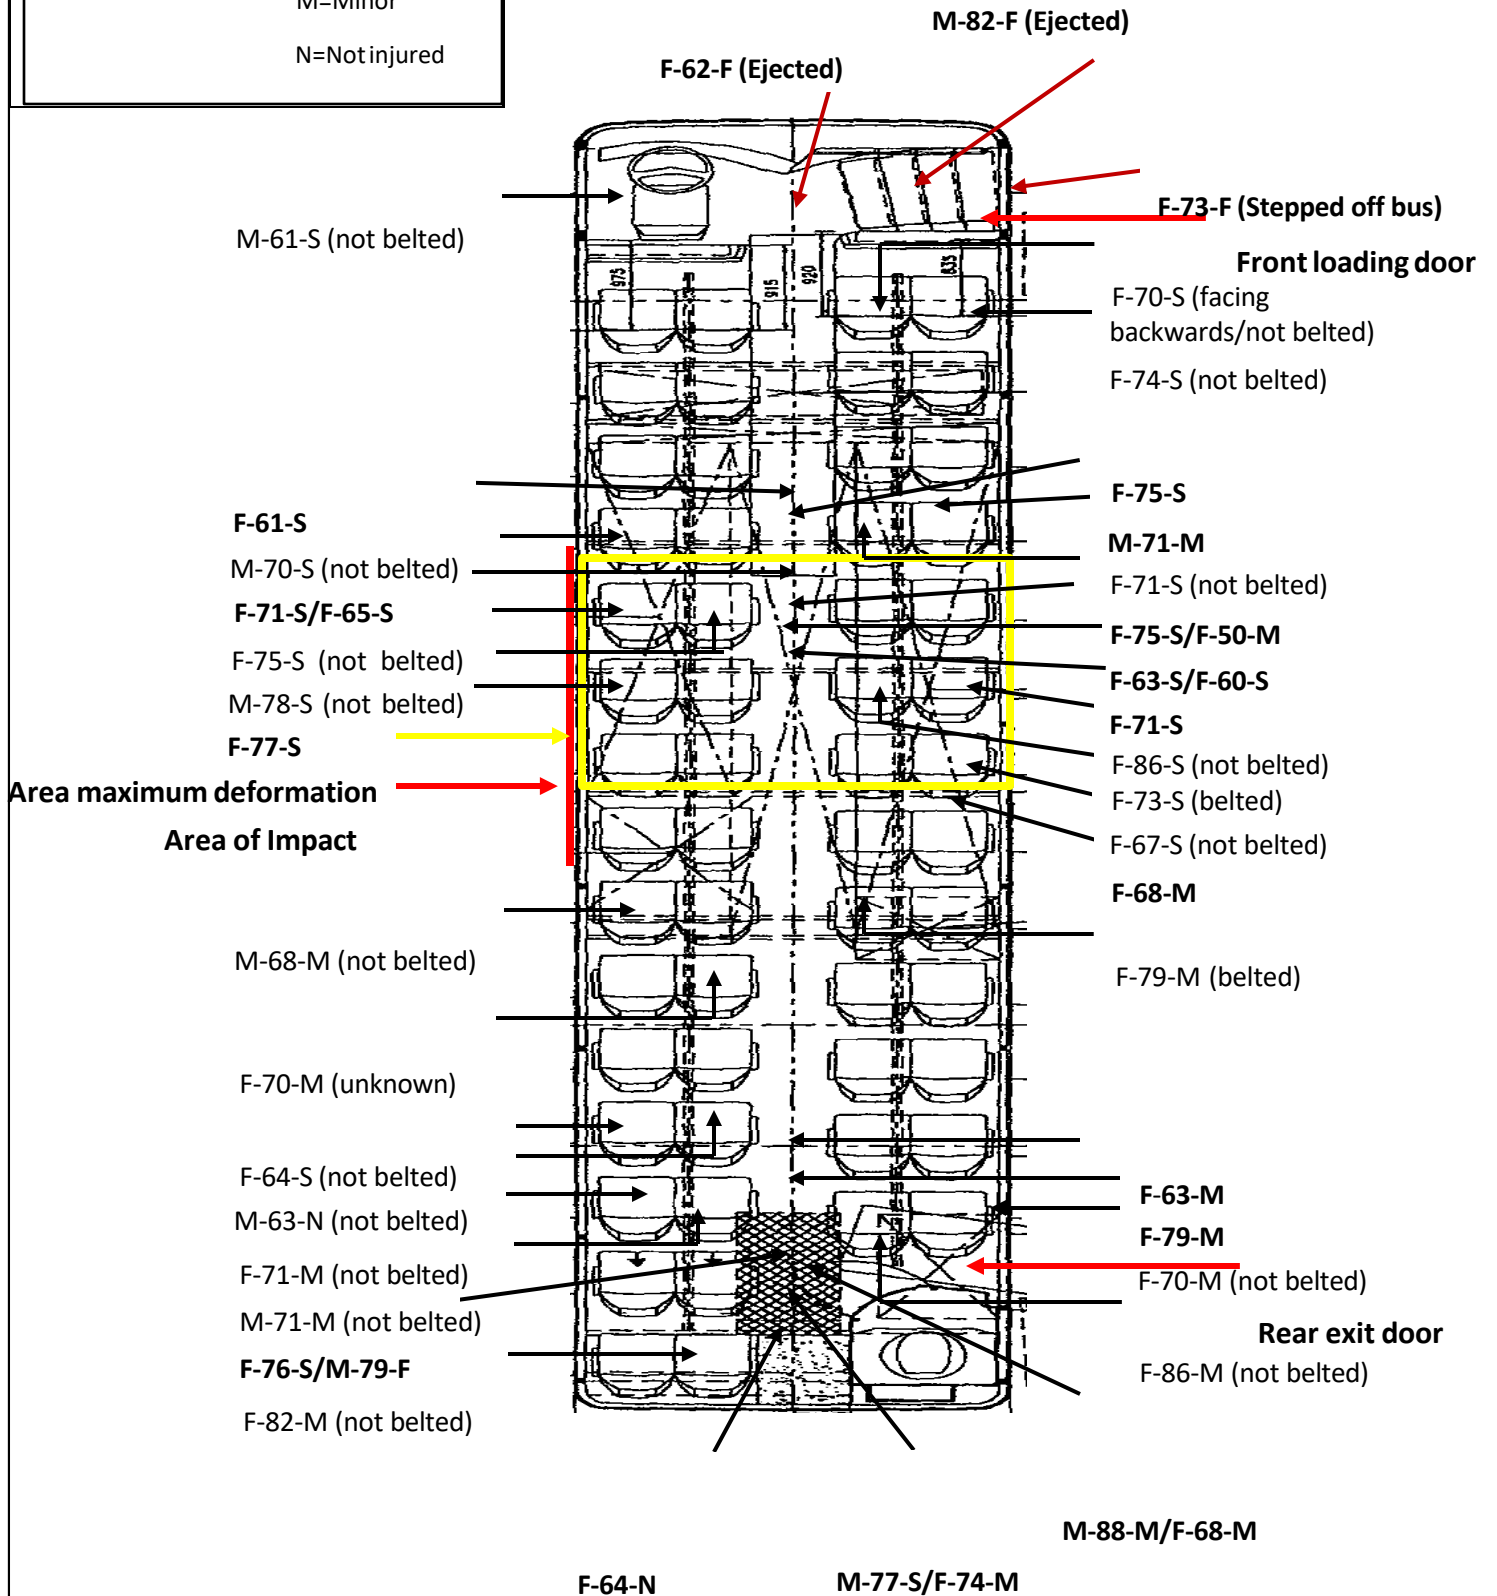
The inward-facing Drive-cam camera showed three of the passengers attempting to exit the motorcoach at the time of impact. One passenger had just stepped down from the front loading-door when the train collided with the motor coach. The passenger was knocked down by the motorcoach and along with two other passengers who were ejected out the front-loading door; was run over by the motorcoach and the freight train.² Two of the passengers were pronounced on the scene and turned over to the Harrison County Coroner's Office. The third died in the hospital. A fourth passenger, who was standing in the rear of the motorcoach during the crash, was pronounced dead on the scene and turned over to the Harrison County Coroner's Office. **Figure 1** shows the schematic of the motorcoach, occupant location at time of impact and injury.

*Standing Passengers in bold text
Figure 1

Most of the seated occupants sustained minor injuries. This was regardless of their use of seatbelts. The occupants seated in the impact area sustained more injury than those seated outside of that area. The occupant of seat #24 sustained injuries to her lower extremities and the occupant of seat #23 sustained compression injuries resulting from the floor buckling and the opening of the void space beneath those seats. The passengers standing in the aisle-way adjacent to rows 4 and 5 located in the impact area, sustained severe injury resulting from the deformation of the interior structure, floor, and seating. Fourteen occupants, standing at the time of the impact, sustained serious to fatal injuries from the impact or from impact with the interior structure of the motorcoach.

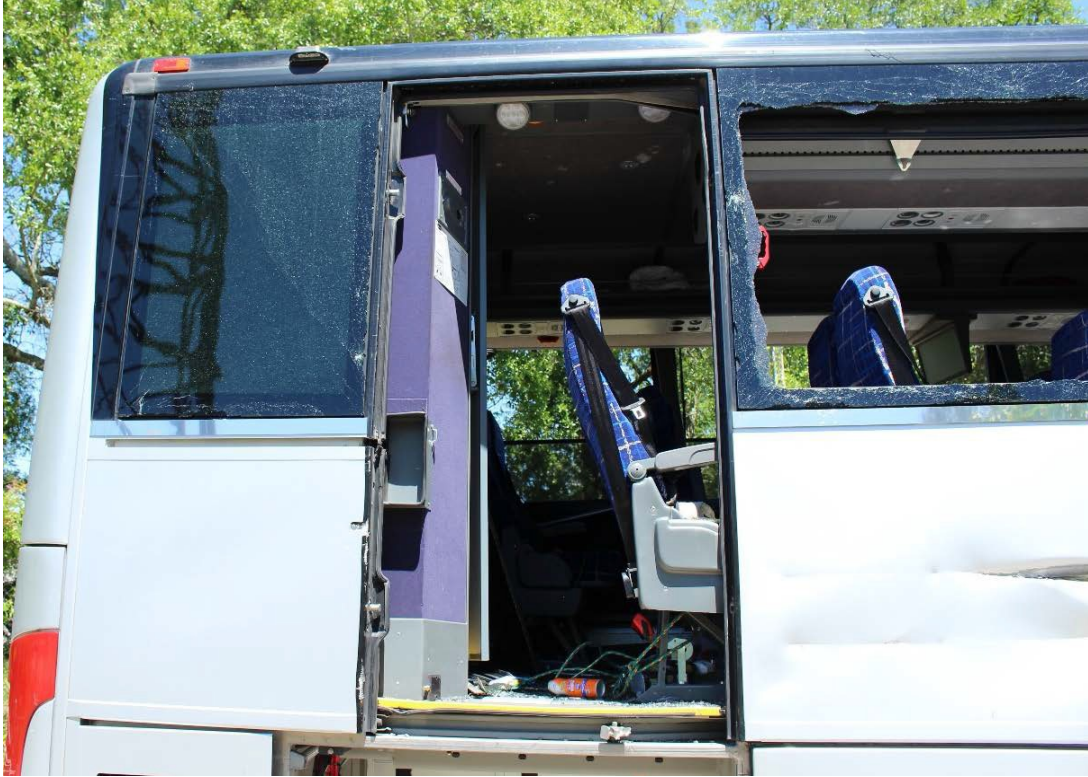
Echo Transportation did not configure the rear exit door of the crash motorcoach for wheelchair access. The rear door is marked and could have been used to evacuate passengers after the crash and to provide needed access for first responders to the interior of the motorcoach. One of the first rescuers on the scene attempted to open the rear door from the interior of the motorcoach but was unsuccessful. The first responders did attempt to enter the motorcoach through the rear door from the exterior but found it locked. This resulted in the need for the first responders to cut away the door which delayed both the first responders access to the interior of the motorcoach and the evacuation of the passengers. Locking the rear door from the exterior does not adversely affect the use of the door during an emergency from the interior. Operating the door from the interior disengages the lock and allows the occupants to exit the motorcoach. The door handle, which was found attached to the rear wall of the lavatory, is required to open the rear exit from the interior.

Photo #5: Exterior view of crash motorcoach rear exit door (not configured for ADA/wheelchair use)

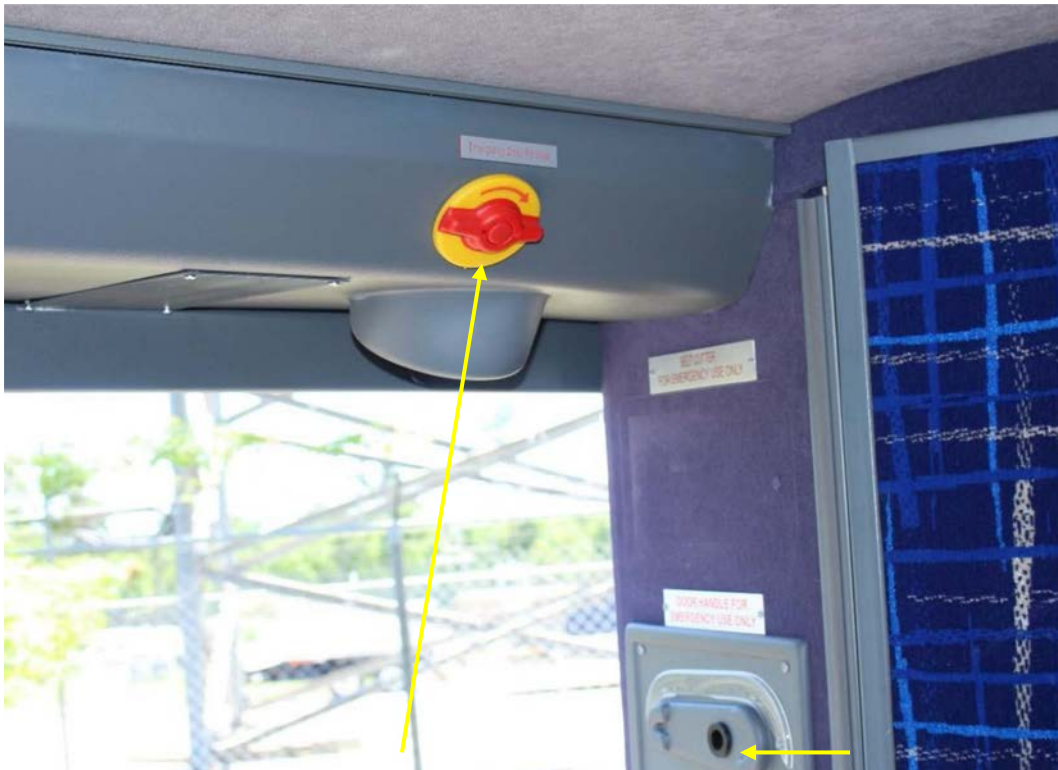
Photo #6: Interior view of rear exit door

Emergency door release

Location for emergency door handle

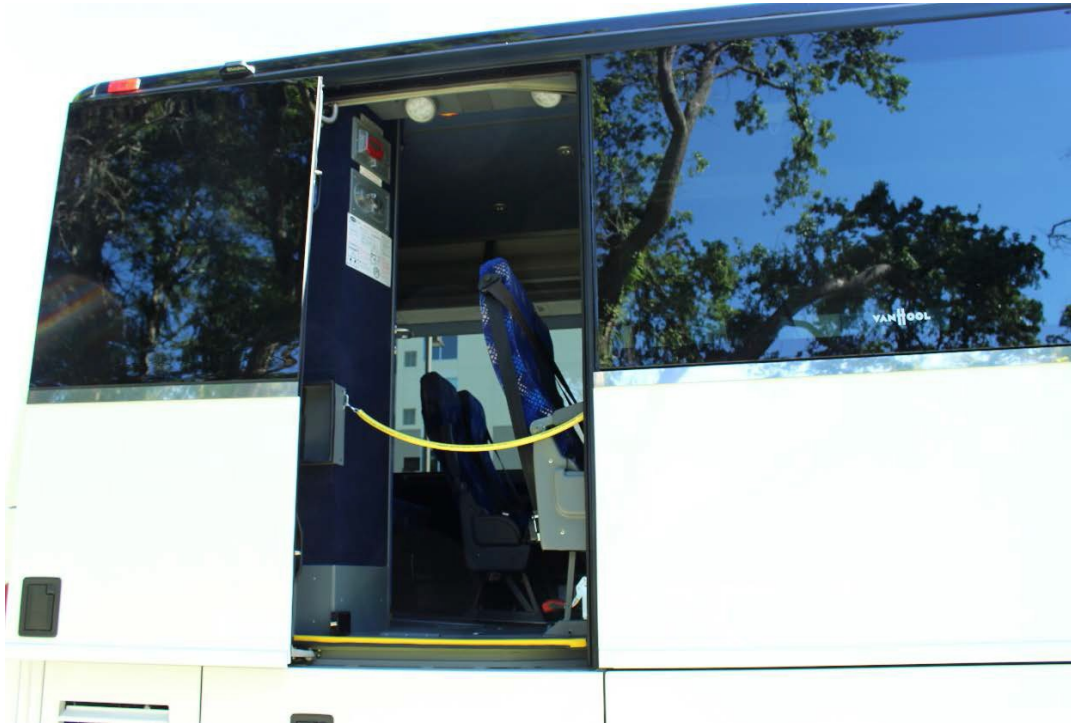
Photo #7: Exemplar motorcoach rear exit door (also not configured for ADA/wheelchair use)

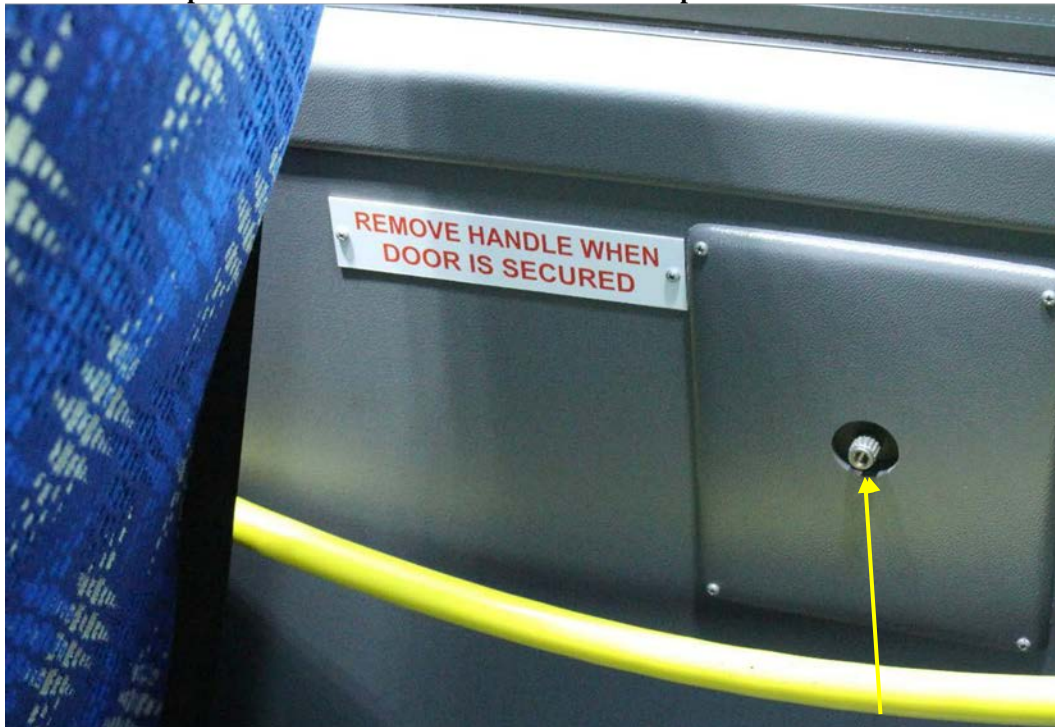
Photo #8: Exemplar motorcoach interior view of rear door panel.

Emergency handle placement

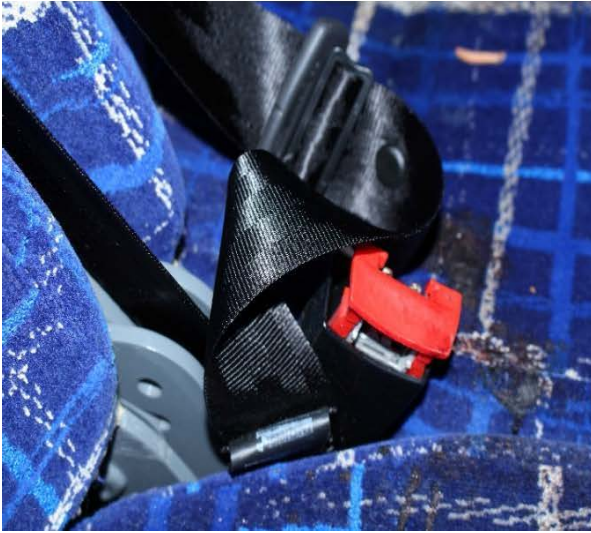
During the post-crash examination, twenty-seven seatbelt buckles were found to have a design flaw. The seatbelt buckle assembly is comprised of a hard, plastic covering that is designed to prevent the exposure of the internal locking mechanism to debris or to damage caused by other external forces that would prevent the buckle from functioning. In all twenty-seven of the seatbelt buckles, the hard, plastic covering has slipped downward, and the internal locking mechanism was exposed to the environment. In several seat positions, the exposed internal locking mechanism sustained damage when the adjacent seat-pan shifted during the crash and impacted the buckle's internal mechanism. One buckle, not located in the impact area, was found to be inoperative. The seatbelt buckle would release when pressure was exerted on the seatbelt. Four of these seatbelt buckles also showed signs of rescue damage. At the location of two occupied seats, the buckles were found taped up and not readily available for use. Subsequent investigation revealed that one of the seatbelt buckles was taped up by a passenger on this trip when the seat occupant complained of the buckle rubbing against her. The second seatbelt buckle was taped by an unknown individual prior to the crash.

The Director of Technical Services for ABC Companies, the authorized U.S. distributor for Van Hool motor coaches reported that the manufacturer was aware of the defect in the buckle portion of the seatbelt assembly. Van Hool is currently working to either re-engineer the buckle or find a new supplier for the seatbelts. The ABC Companies representative advised that ABC has been replacing the defective buckles upon notification by their customers. Pre-notification to customers is not being performed by either Van Hool or its U.S. distributor, ABC Companies.

Photo #9: Defective buckle

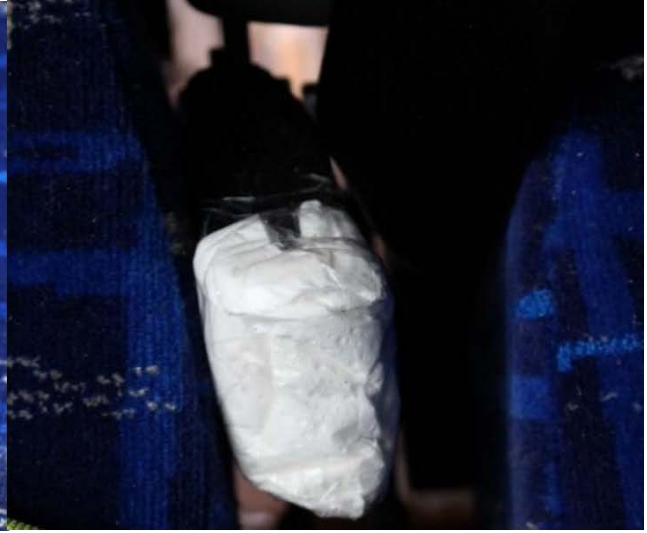
Photo #10: Defective buckle taped prior
