NATIONAL TRANSPORTATION SAFETY BOARD

Group Chairman's Factual Report

SURVIVAL FACTORS

DCA16FA013

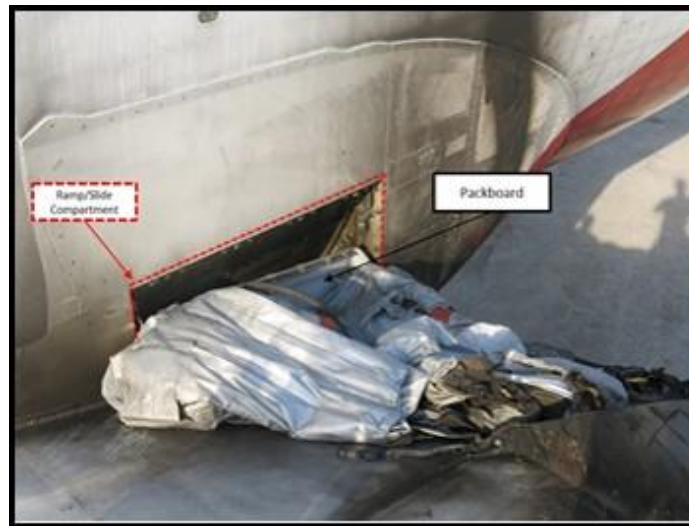
The left side overwing exit was opened by a passenger during the evacuation. Although the ramp/slide reportedly deployed and inflated properly, no passengers evacuated through the left OWE due to a flight attendant blocking the exit. The bottom portion of the ramp/slide was destroyed by the fire. The ramp/slide compartment door was found open with the top portion of the ramp/slide and packboard attached (photograph 3).

Photograph 3 – Left ramp/slide compartment with top portion of the ramp/slide and packboard.

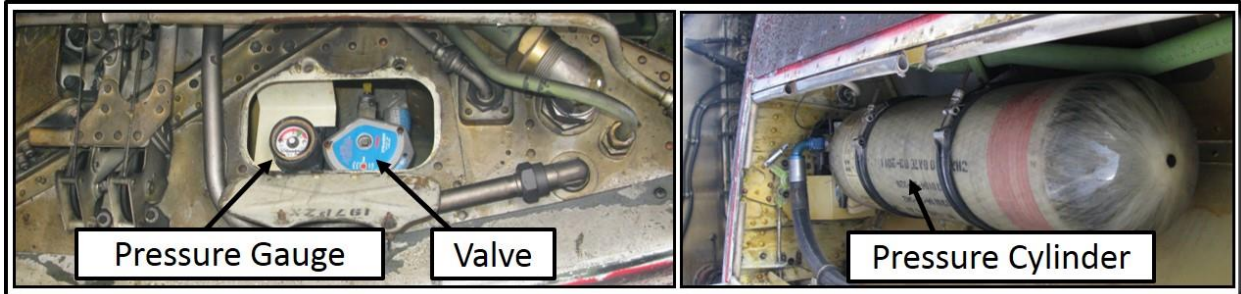
The ramp/slide's reservoir assembly (consisting of a regulator valve, pressure gauge and pressure cylinder) was found attached in its brackets located below the left wing in the aft wing/body fairing (photograph 4). The regulator valve and pressure gauge can be viewed through the forward side of the wing/body fairing bulkhead, while the reservoir assembly is located aft of the bulkhead. No damage was found to the inflation actuation rod, bellcrank, and cylinder firing cable. The ramp/slide cylinder pressure gauge showed zero pressure in the cylinder and the cable trigger was pulled free from the cylinder regulator valve. No anomalies were identified with the overwing escape ramp/slide pack release and deployment mechanisms.

Photograph 4 – Left reservoir assembly.

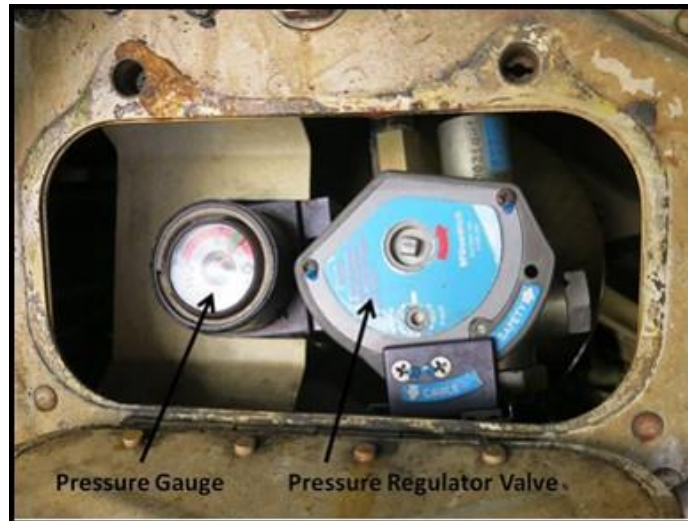
The reservoir assembly was found attached in its brackets located in a compartment below the right wing in the aft wing/body fairing. The inflation cylinder pressure gage indicated the cylinder was fully charged (photograph 5). The firing cable was not pulled from the inflation cylinder regulator valve (photograph 6). The regulator safety pin was found properly stowed within the pin pocket.

Photograph 5 – Pressure gauge and reservoir valve.

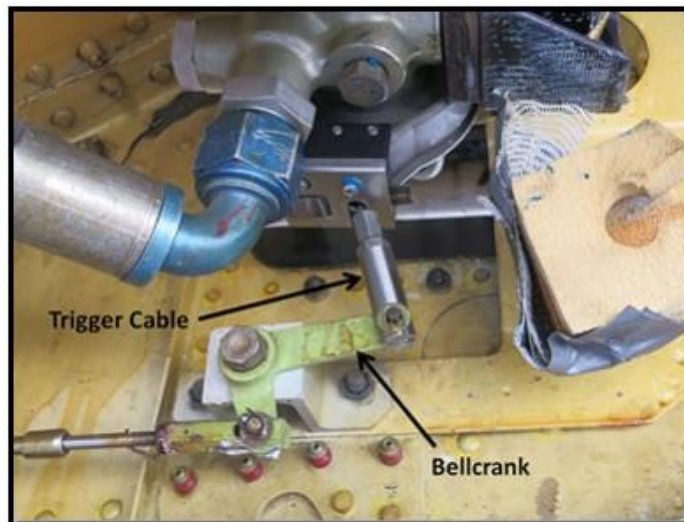
Photograph 6 - Reservoir assembly bellcrank and trigger cable.

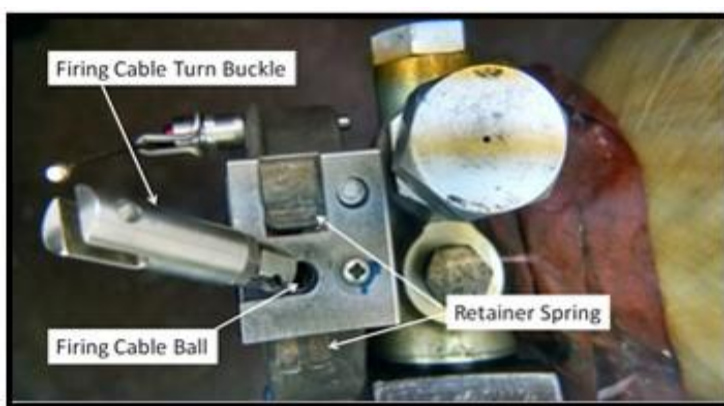
Preliminary examination of the regulator valve assembly (photograph 7) noted that the hole of the Pull Force Increase Mechanism (PFIM) retainer spring (photograph 8) was not aligned with the hole of the PFIM housing. It was also noted that the retainer spring and firing cable ball were unable to move freely.

Photograph 7 – Regulator valve assembly.

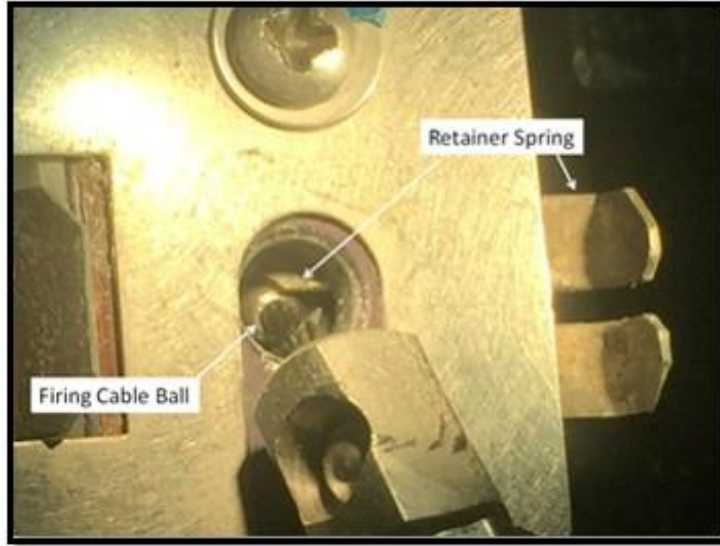
Photograph 8 – Positions of retainer spring and firing cable ball.

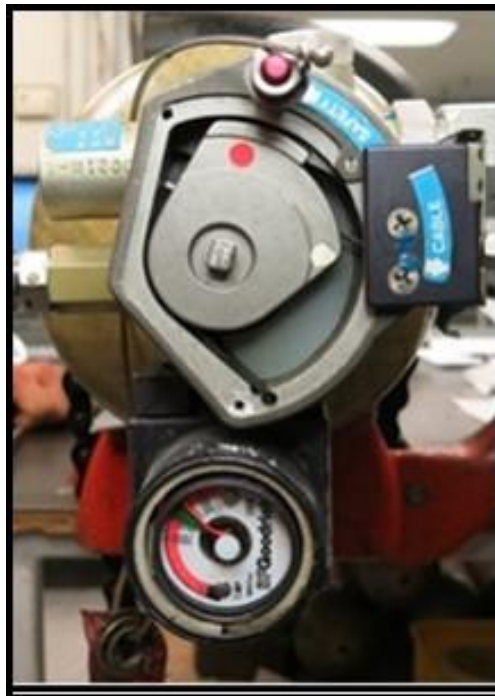
The reservoir was placed in a belt vise and the regulator trigger housing cover was removed (photograph 9). Although some minor corrosion was noted on the screws, no anomalies were noted on the trigger mechanism components.

Photograph 9 – Regulator valve with cover plate removed.

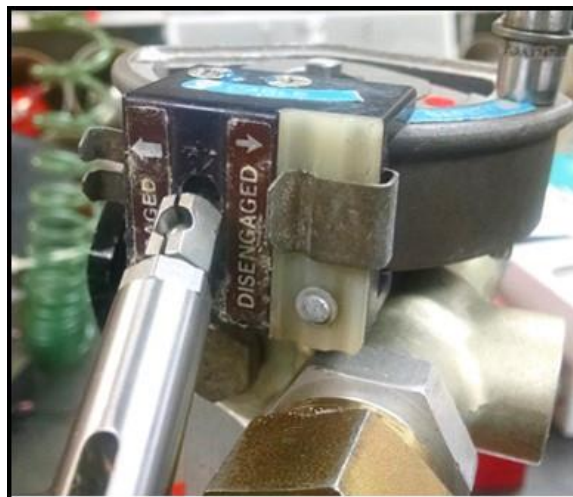
The pressure gauge was removed to allow better visibility of the ball and ball seat. The alignment of the PFIM retainer spring hole was confirmed to be out of alignment with the hole of the PFIM housing (photograph 8). Subsequently, the PFIM safety was removed to allow for further examination. The retainer spring was moved from the “ENGAGED” to “DISENGAGED” position to allow the firing cable ball to pass through freely (photograph 12). This allowed for actuation of the valve trigger mechanism without interference by the PFIM. The result of this test was a pull force of 25 lbf.

Photograph 12 - PFIM “ENGAGED” / “DISENGAGED” indication.

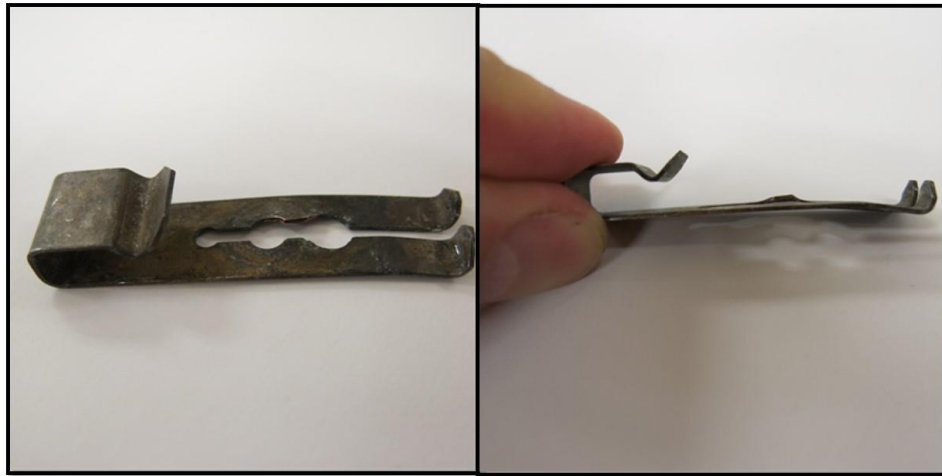
The PFIM was disassembled and removed from the valve body allowing access to the retainer spring. Examination of the retainer spring noted surface corrosion and deformation around the small “ENGAGED” hole (photographs 13). Witness marks were also noted around the “ENGAGED” hole.

Photograph 13 – Top and side view of the retainer spring.

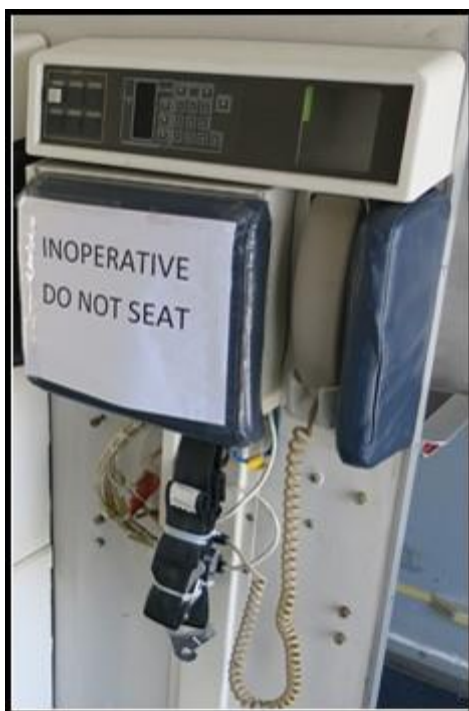
Photograph 16 – Inoperative 1R jumpseat.
