**NATIONAL TRANSPORTATION SAFETY BOARD**

**Group Chairman's Factual Report**

**SURVIVAL FACTORS**

**DCA17FA076**

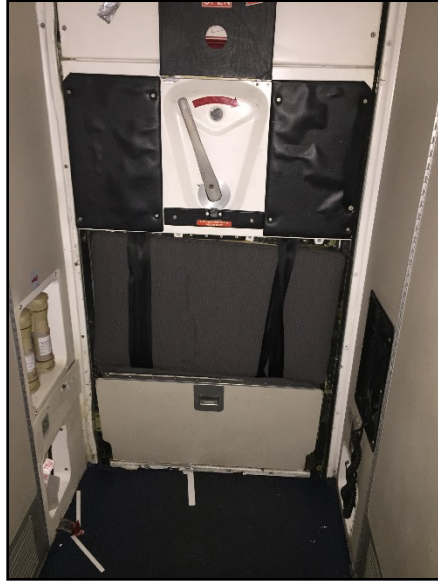
F/A B reported that the tailcone emergency exit (photograph 1) was temporarily restricted from opening during the evacuation when one of the two jumpseat lift latch seatbelt buckles became stuck under the door. Page 3-17 (G)(4) of the flight attendant manual stated, “*Stow jumpseat with seat belt/shoulder harness buckled*”. Photograph (2) was taken post-accident and shows the jumpseat in the down position with both right and left seatbelts unlatched.

**Photograph 1 – Tailcone emergency exit and jumpseat.**

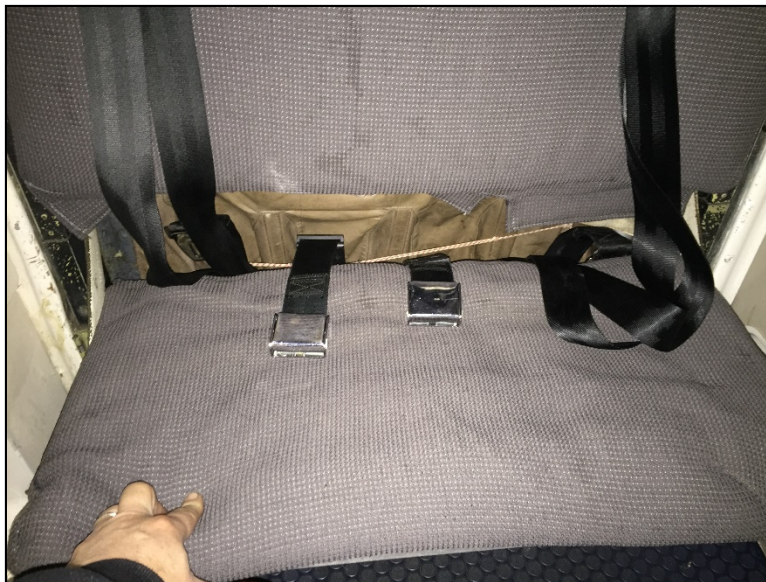
**Photograph 2 – Tailcone jumpseat with both seat belts unbuckled.**

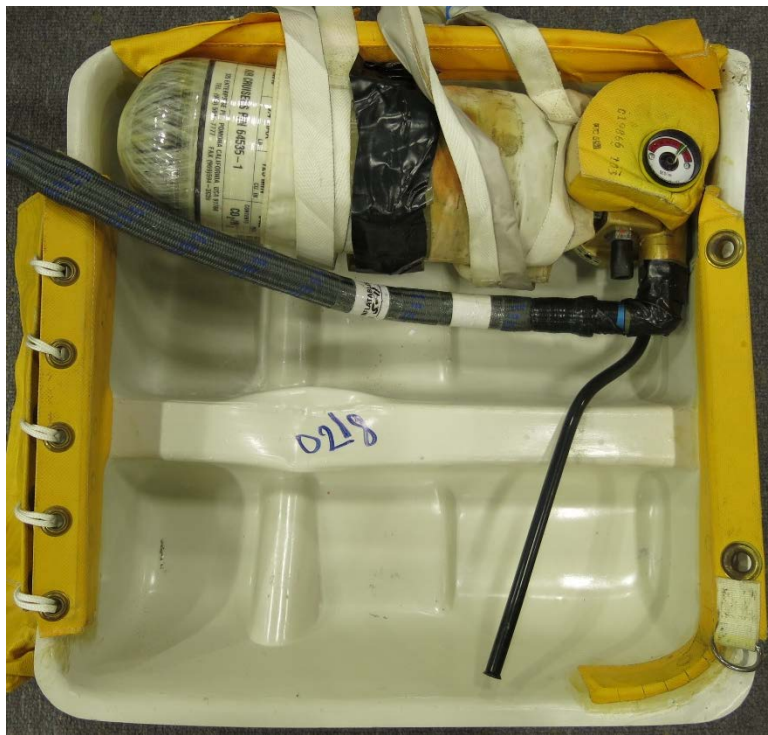
Members of the Survival Factors Group met at Zodiac Aerospace<sup>9</sup> in Wall Township, NJ on April 5, 2017 to conduct a teardown of the door 1R slide assembly. The 1R slide (part number D29982-107, serial number 0218) was manufactured by Air Cruisers in January of 1986.<sup>10</sup> The reservoir valve assembly (RVA part number D37013-121) located in the slide packboard was comprised of a reservoir and valve (photograph 3). Table 3 shows each component's part and serial number along with a part number for the RVA.

**Photograph 3 – Reservoir and valve assembly (RVA) in slide packboard.**

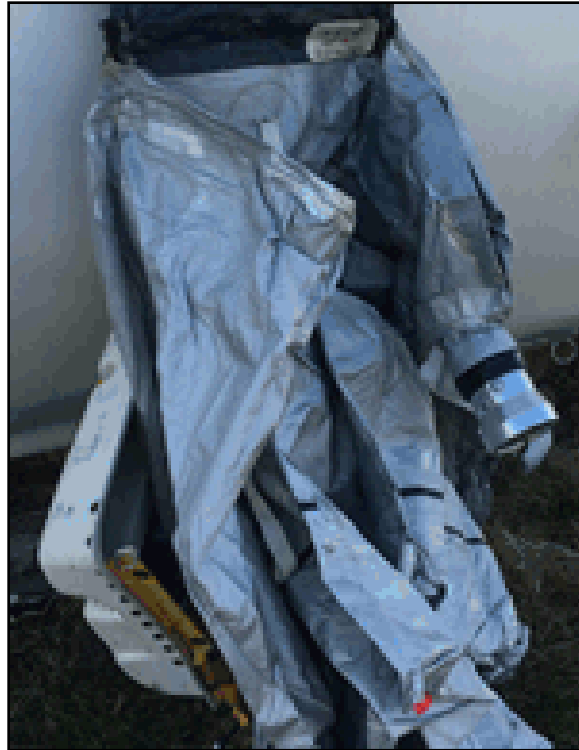
The slide had partially deployed during the evacuation (photograph 4) with no evidence of gas flow from the RVA into the slide.

**Photograph 4 – 1R door slide partially deployed.**

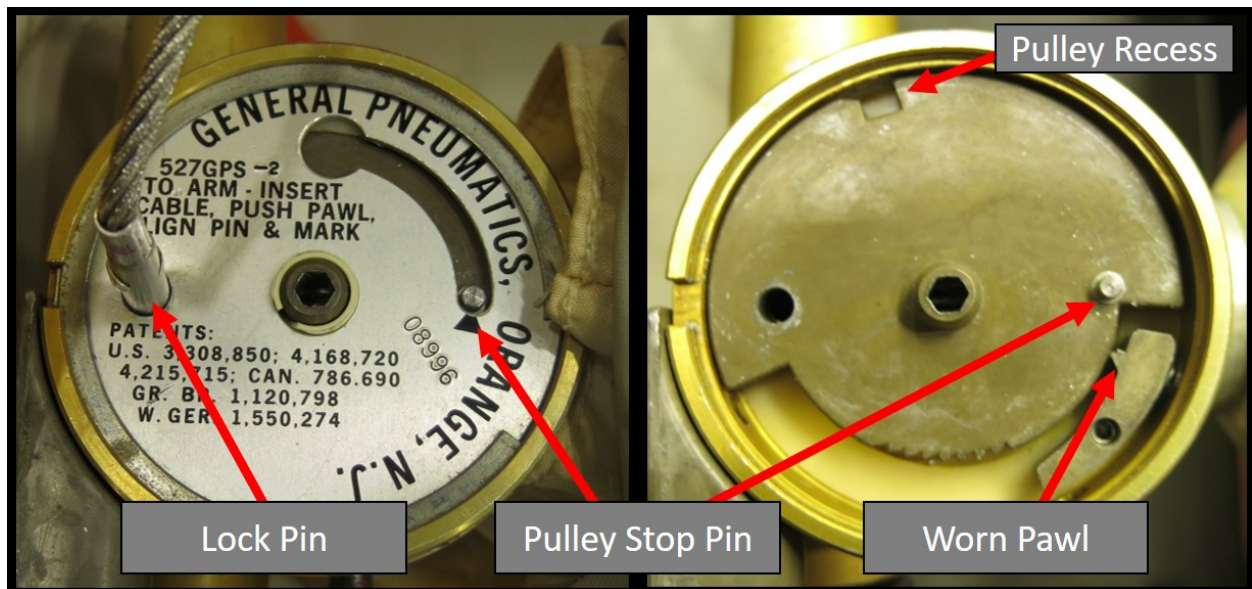
The RVA was inspected and found with a fully charged reservoir with the valve pulley in the closed position. The manual inflation release cable (pulled by the flight attendant during the evacuation) was located inside the shipping box. The cover plate on the valves internal mechanism was removed to reveal the pulley, pulley recess, lock pin and pawl<sup>11</sup> (photograph 5).

<sup>11</sup> The pawl was worn but maintained its ratchet function to keep the valve closed.

**Photograph 5 – Valve assembly before and after removal of cover plate.**

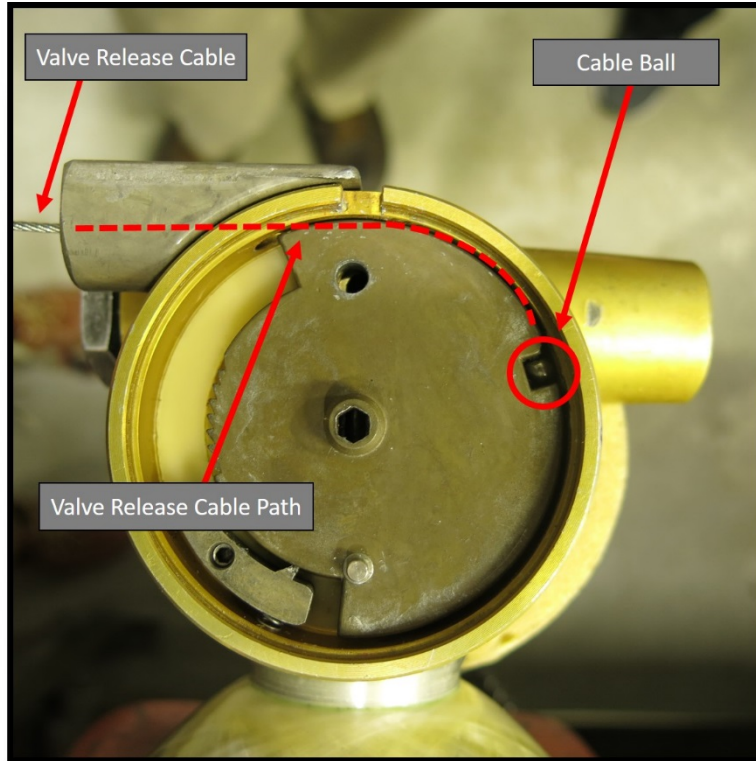
The valve was re-assembled, and the valve release cable was installed (photograph 6) by rotating the pulley to the 'valve open' position, inserting the cable ball end of the cable into the pulley recess, and then rotating the pulley back to the 'valve closed' position.

**Photograph 6 – Valve release cable installed.**

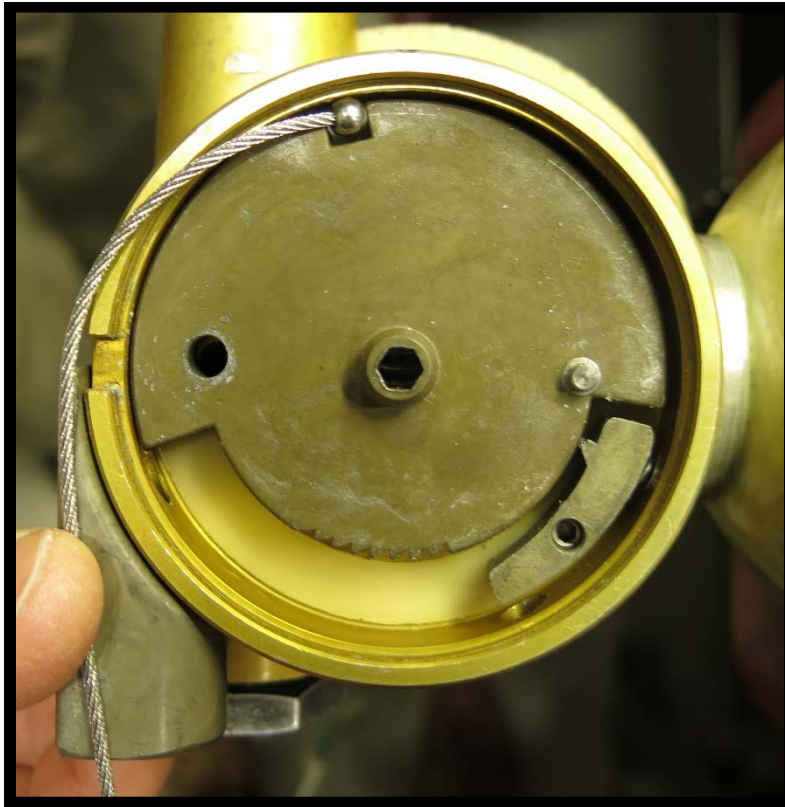
The RVA was removed from the slide. The inflation valve was disassembled to simulate the potential for incorrectly installing the valve release cable assembly. The investigation revealed that the cable ball could be retained inside the housing without actually engaging the pulley recess.

The ball end of the cable was noted to have a permanent ‘set’ or bend which conformed to the circumference of the pulley (photograph 7).

**Photograph 7 – Permanent set to valve release cable.**

Zodiac Aerospace made modifications to the CMM valve testing procedures to ensure the cable ball is retained in the pulley recess in revision #29, dated July 14, 2017. Attachment 3 shows the CMM revision. The CMM was revised on page 711 (D) (5) to read, *Ensure valve is in the fully open position. Install ball end valve release cable (50B, 50D, 50F, 50I, 50J, IPL Figure 1; 50A 50B, 50C, IPL Figure 2) into pulley and cable adapter (260) until it is ~~pulled~~ fully inserted into pulley.* Page 711 (D)(6) adds *Verify that the valve release cable is pulled into the pulley housing as the pulley is rotated to the valve closed position.* (D)(7) is replaced with *Gently pull or tug on the valve release cable. Looking closely around the gaps in the valve cover assembly on the inflation valve, verify that there is slight movement of the pulley and the lock pin due to the movement of the valve release cable. The valve release cable should not pull free of the inflation valve assembly. If the valve release cable can withdraw from the valve assembly, either the lock pin is not fully engaged or the inflation cable was not fully inserted into the pulley during the arming procedure. Repeat steps (5) and (6) to resolve unacceptable cable movement.*

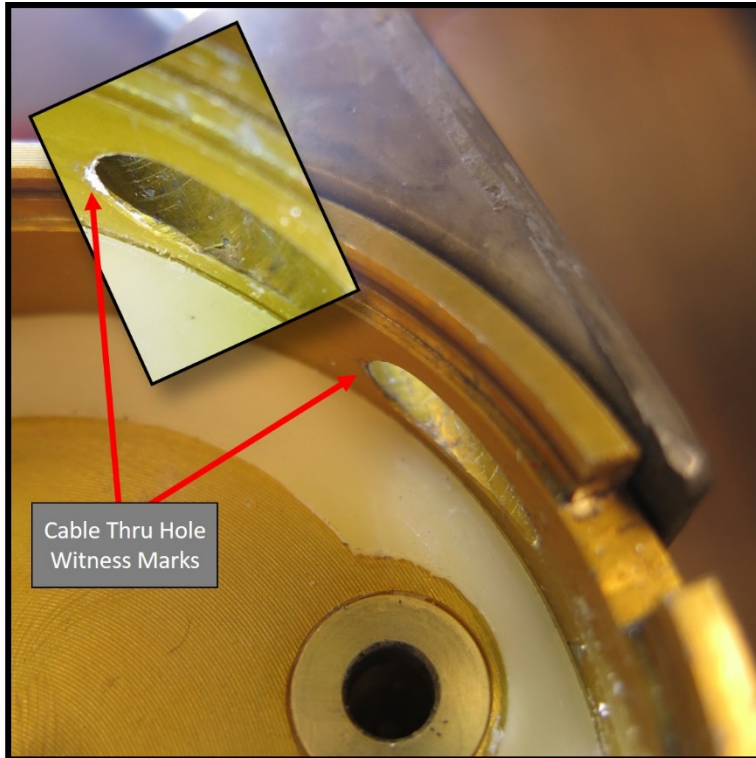
Witness marks were found inside the pulley housing around the cable thru hole. This area would normally not be subjected to chafing during normal valve operation (photograph 8). The location was observed to be a potential “catch” point with the cable ball if the valve release cable was not properly installed into the valve pulley.

**Photograph 8 – Cable thru hole witness marks.**

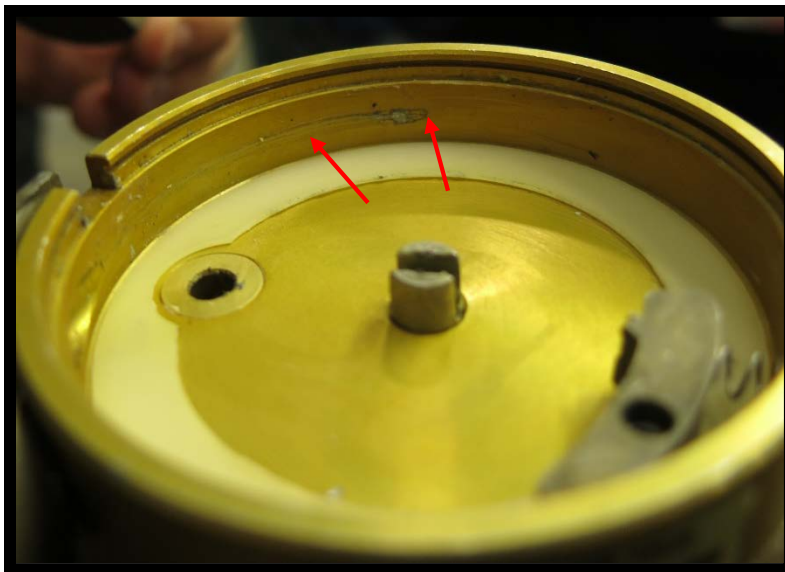
Witness marks were found inside the pulley housing consistent with normal travel of the cable ball along the housing circumference (photograph 9).

**Photograph 9 – Witness marks along normal path of the valve release cable ball.**
