**SURVIVAL FACTORS GROUP CHAIRMAN'S
FACTUAL REPORT**

HWY17MH009

**NATIONAL TRANSPORTATION SAFETY BOARD
OFFICE OF HIGHWAY SAFETY
WASHINGTON, D.C.**

Location: 300 block of Talley Road, Chattanooga, Hamilton County, Tennessee
Vehicle #1: 2008 Thomas Built School Bus
Operator #1: Durham School Services LP of Warrenville, IL
Date: November 21, 2016
Time: Approximately 03:20 p.m. Eastern Standard Time (EST)
NTSB #: **HWY17MH009**

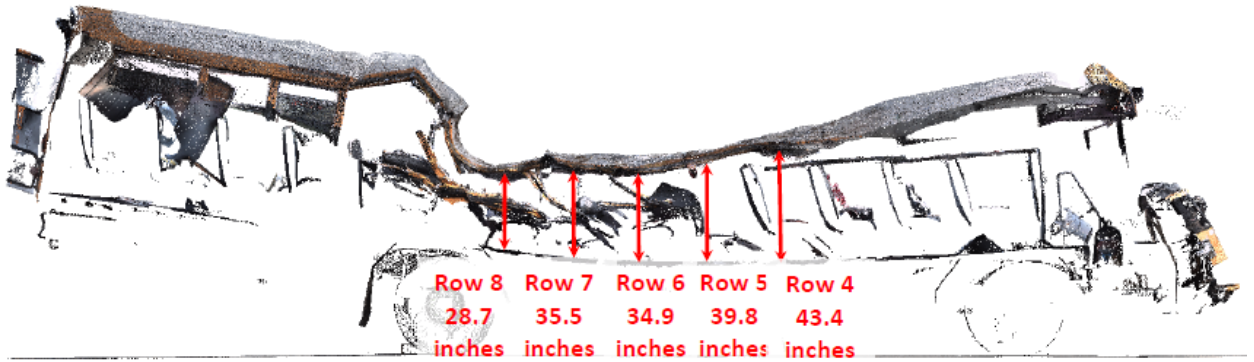
Figure 1: Longitudinal Cross-Section of the School Bus Laser Scan

The data points of the slice were used to approximate the distance between the floor of the bus and the lowest portion of the roof in the vicinity of passenger seat rows 4 through 8 of the passenger side, as shown in Figure 1.

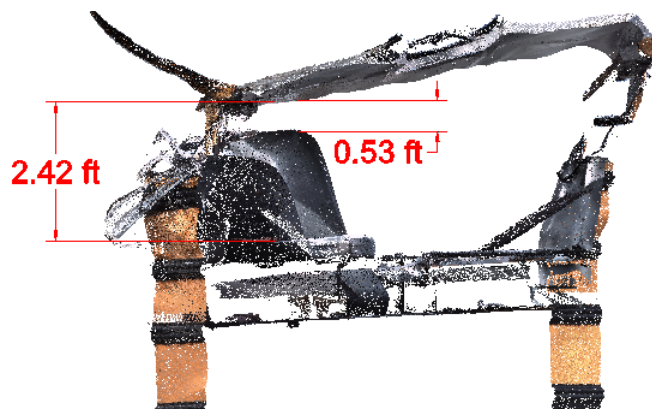
Figure 2: Lateral Cross-Section of the School Bus Laser Scan at Passenger Seat Row 4

Figures 2 through 5 shown below, illustrate lateral cross sections of the bus at the location of the passenger side seatbacks for rows 4, 5, 6, and 7 respectively. The slices were 4 inches thick. The dimensions from the top of the seatpan cushion to the lowest points of the roof crush were estimated as shown in the figures.
