**SURVIVAL FACTORS GROUP CHAIRMAN'S
FACTUAL REPORT**

HWY17MH015

**NATIONAL TRANSPORTATION SAFETY BOARD
OFFICE OF HIGHWAY SAFETY
WASHINGTON, D.C.**

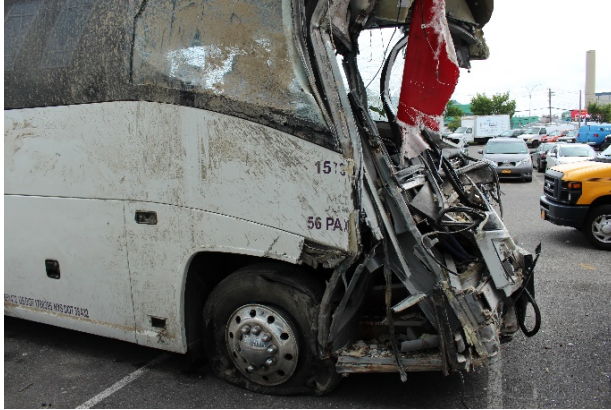
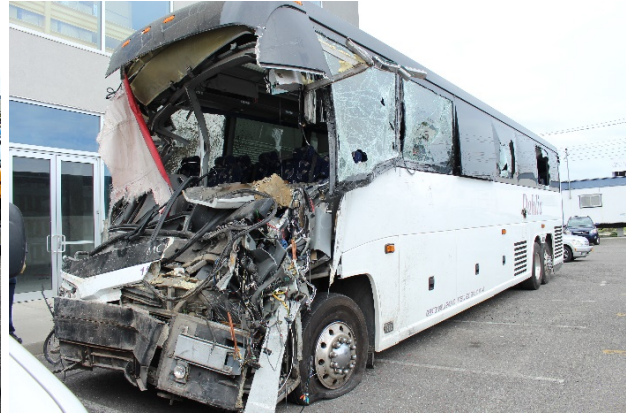
Figure 1: Right Front View of the Motorcoach Figure 2: Left Front View of the Motorcoach

The motorcoach was severely damaged at the front end, with the entire front portion of the motorcoach forward of the front tires destroyed. The middle area of the coach (just above the wheels) was crushed aft with the dashboard structure pushed aft to the aft loading door frame and the first passenger windows. The forward door frame was crushed aft such that the lower portion and stairwell were partially intact, the middle and upper portion were in contact with the aft door frame, and there was no space to enter the motorcoach. There were large areas with blood and tissue residue at the exterior right front corner of the motorcoach and in the stairwell. The center section of the front structure was crushed aft to the position of the spare tire, which was also displaced some distance aft. The windshield and driver window were destroyed, and the vertical support structure aft of the driver window cut away by responders.

The first and second passenger windows on the driver side, and the first passenger window on the passenger side were broken from impact. The first passenger windows on both sides had deformed window frames and the outer class missing and the inner glass shattered. The 4th and

6th window frames on the driver side were also broken, with the 4th window, both inner and outer panes broken out (and used as an access point for responders). Figure 1 provides a view of the right front portion of the motorcoach, illustrating the damage to the front and to the loading door. Figure 2 provides a view of the left front and left side of the motorcoach, illustrating damage to the front and to the windows along the left side.

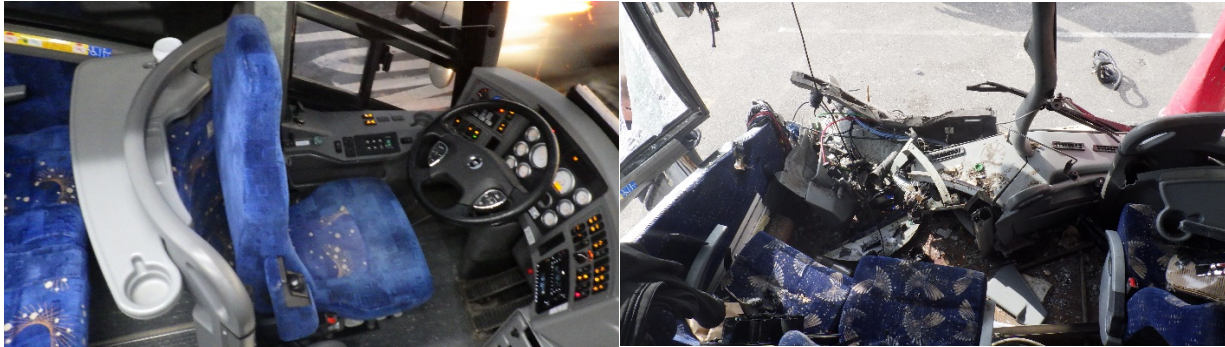
Figure 3: Driver Area of Exemplar Motorcoach Figure 4: Driver Area of Accident Motorcoach

The frontal impact crushed the front of the motorcoach and the entire driver seat was displaced rearward and separated from the floor at the interface to the adjustable seat rails. The driver seat impacted the privacy divider. Both the driver seat and the driver side privacy divider were found approximately in the middle of the passenger cabin of the motorcoach. The front row seat on the driver side was positioned by design with an offset about 11 inches aft of the passenger side. Figure 3 provides a view of the driver seat area of an exemplar motorcoach. Figure 4 provides a view of the driver seat area of the accident motorcoach. The steering wheel hub is visible just forward of the front row of left side passenger seats. The driver seat and left side privacy panel are missing from the view, as noted above. Figure 4 also shows the inboard portion of the right side privacy panel, which is in contact with the front row of right side passenger seats.

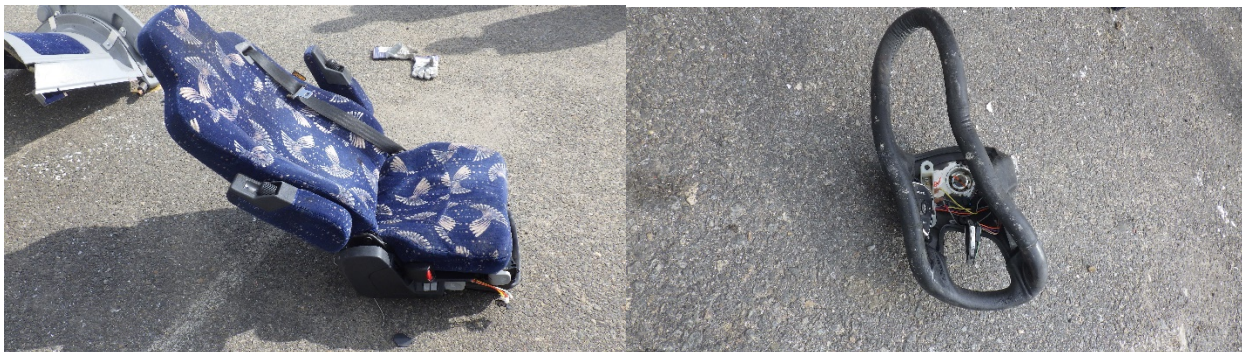
Figure 5 Driver Seat

Figure 5 shows the driver seat after removal from the interior of the motorcoach. The backrest was deformed aft. Inspection of the driver seatbelt indicated no evidence that it was worn at the time of the crash. Figure 6 shows a view of the steering wheel, which was cut from the steering column by responders. The wheel was crushed as shown in Figure 6.

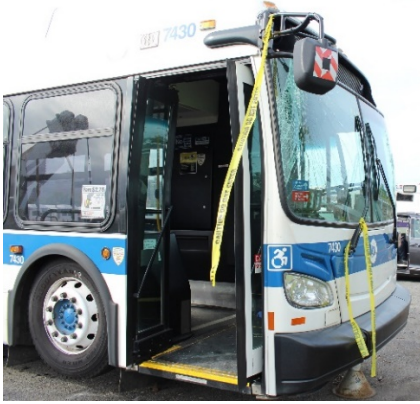
Figure 7: Right Front of the Transit Bus

The front of the transit bus exhibit little damage other than a broken but intact right side windshield pane as shown in Figure 7. The right side of the bus, forward of the rear axle, was not damaged. The rear of the bus aft of the rear axle was crushed forward, with the aft windows on broken but with the glass remaining in place. The deformation at the rear from the impact was more severe on the lower half of the bus. The aft side panels were partially dislodged and damaged, as shown in Figure 8.

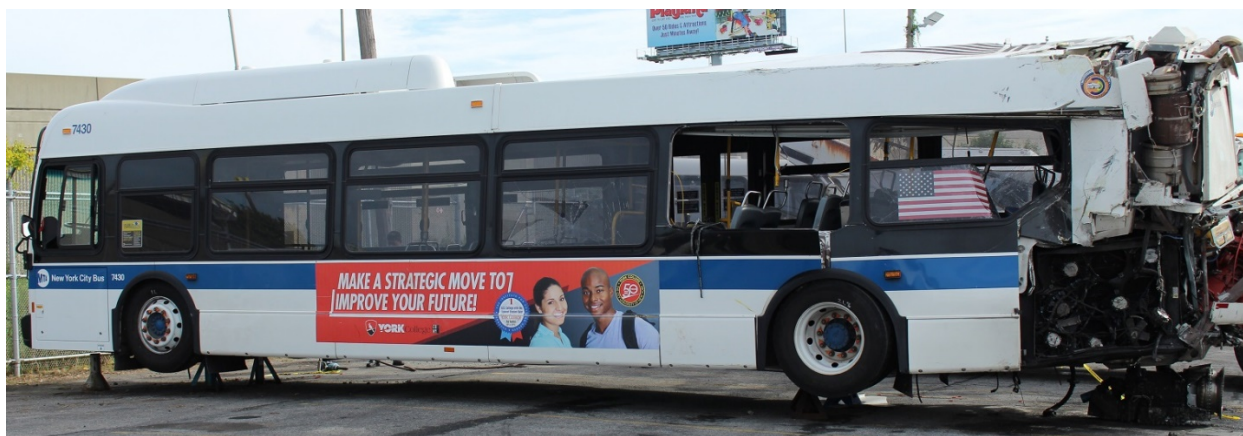
Figure 9: Left Side View of the Transit Bus

The forward half of the left side of the transit bus was not damaged, as shown in Figure 9. The rear half had damage to the windows and extensive damage aft of the passenger windows. The side panels extending from the roof to the bottom of the bus were damaged or displaced, as also shown in Figure 9.

There was a driver window followed by six passenger windows on the left (driver) side of the bus. The first through third windows were intact. The fourth window glass was broken but remained. The entire fifth window was missing, and the frame was displaced and there was extensive damage to sidewall. The sixth window had the lower portion of the window smashed and bowed inward, and the upper portion of the window was missing. There was extensive deformation and intrusion at this location, which was at the point of impact with motorcoach.

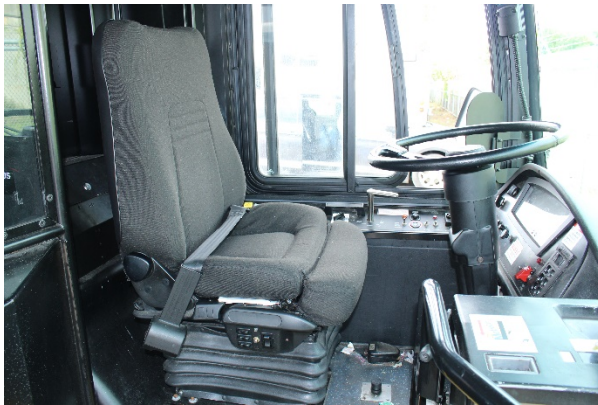
Figure 11: Transit Bus Driver Seat Area

The driver seat compartment was not damaged. The driver seat was a suspended seat with a two point lapbelt. The lapbelt was found buckled in place, as shown in figure 11. Behind the driver's compartment was an electronics cabinet, which contained equipment for the video camera system and other electronics, as shown in figure 12 with the door of the cabinet open.

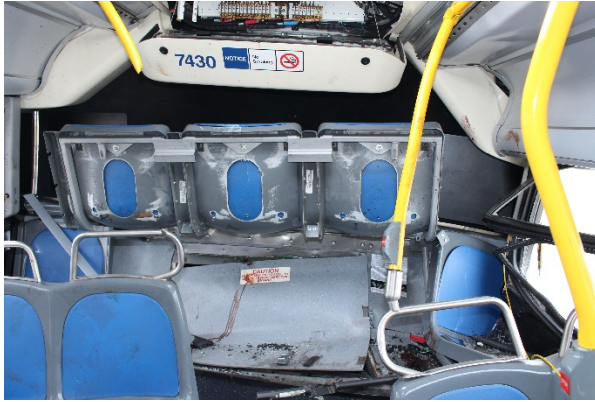
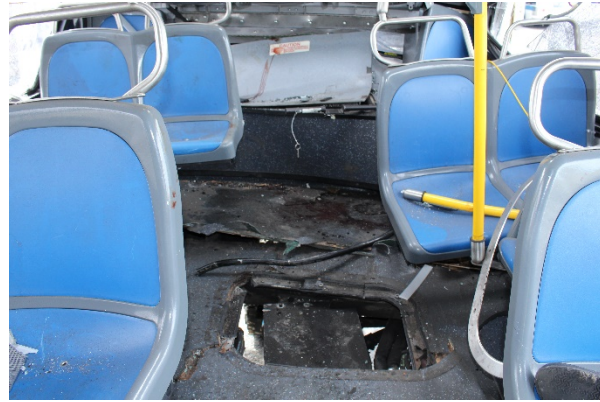
Figure 15: Rear Seat Row of the Transit Bus Figure 16: Floor and Rear Seats of the Transit Bus

The last row of 5 seats had the driver side window seat frame fractured from being shifted to the right and slightly upward, due to the left rear corner of bus intruding into occupant space at this location. The set of 3 seats in the center (32, 33, 34) was found in the raised position, and contained biological material (blood) located on the under sides of the seats. The access panel to engine compartment was partially open and torn away, with the metal deformed and bolts fractured. The inspection panel in the floor was missing the cover. Figures 15 and 16 provide views of the seats and floor at the rear of the bus.
