**SURVIVAL FACTORS PHOTOGRAPHS**

**Chattanooga, TN**

**HWY17MH009**

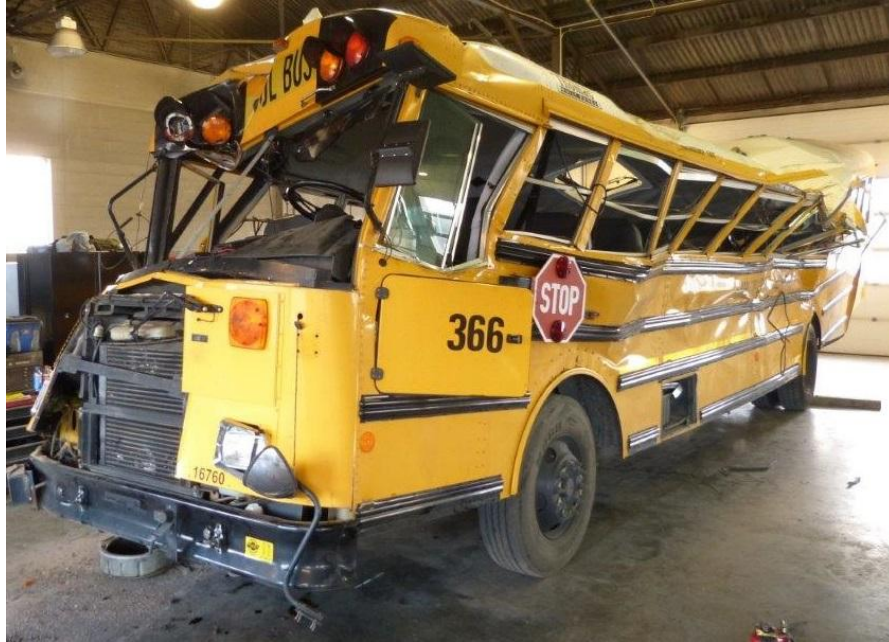
SF Photograph 1 shows a left front view of the school bus. Severe damage to the right front corner, front, and left side of the bus is visible. The roof is visibly crushed downward and to the left side of the bus, with the most severe crush shown at the middle region of the bus.

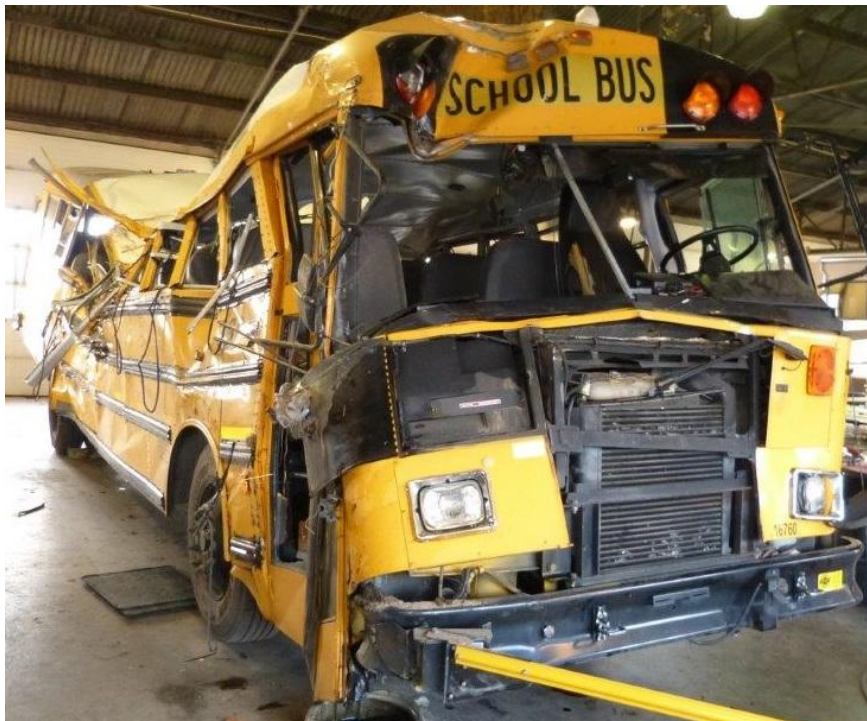
SF Photograph 2 shows a right front view of the school bus. Severe damage is visible at the front and right side of the bus. The front roof portion of the bus exhibits a semi-circular indentation at a roughly 45 degree angle, just to the right of the centerline of the bus. The roof is visually crushed downward, with the most severe crush at the middle of the region of the bus.

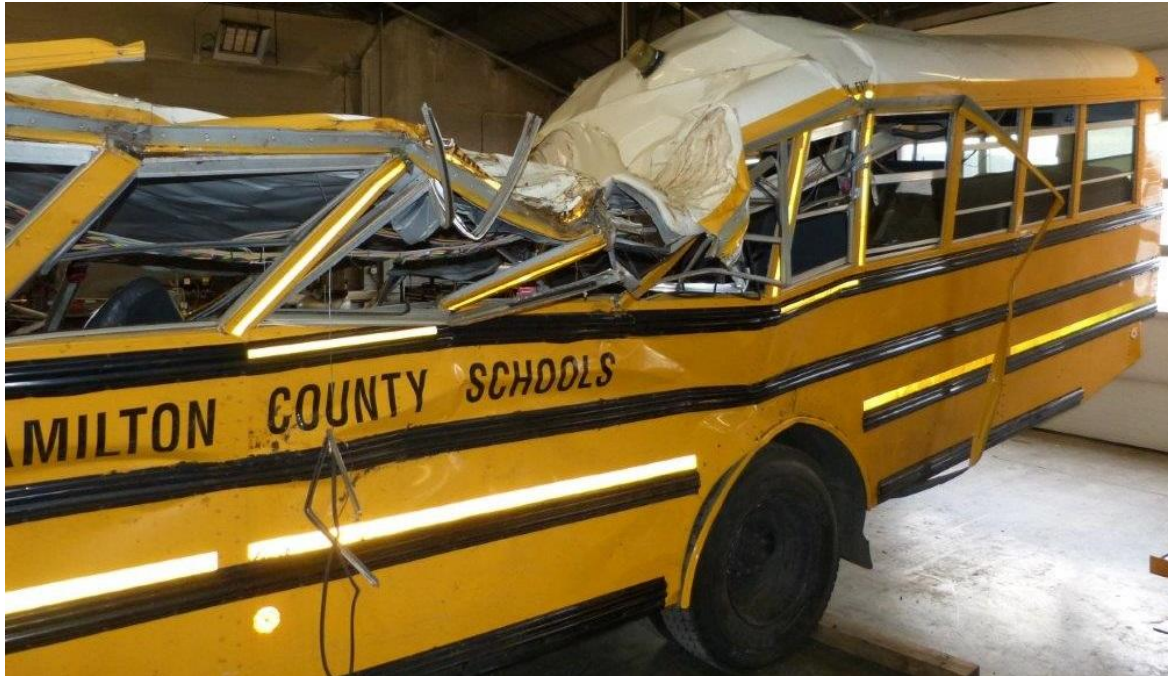
SF Photograph 3 shows a left rear view of the school bus. Severe damage to the upper portion of the middle of the bus is visible. The roof is crushed downward in the region forward of the rear axle. The passenger window frames forward of the rear axle are crushed. The portion of the bus aft of the rear wheels exhibits minor damage.

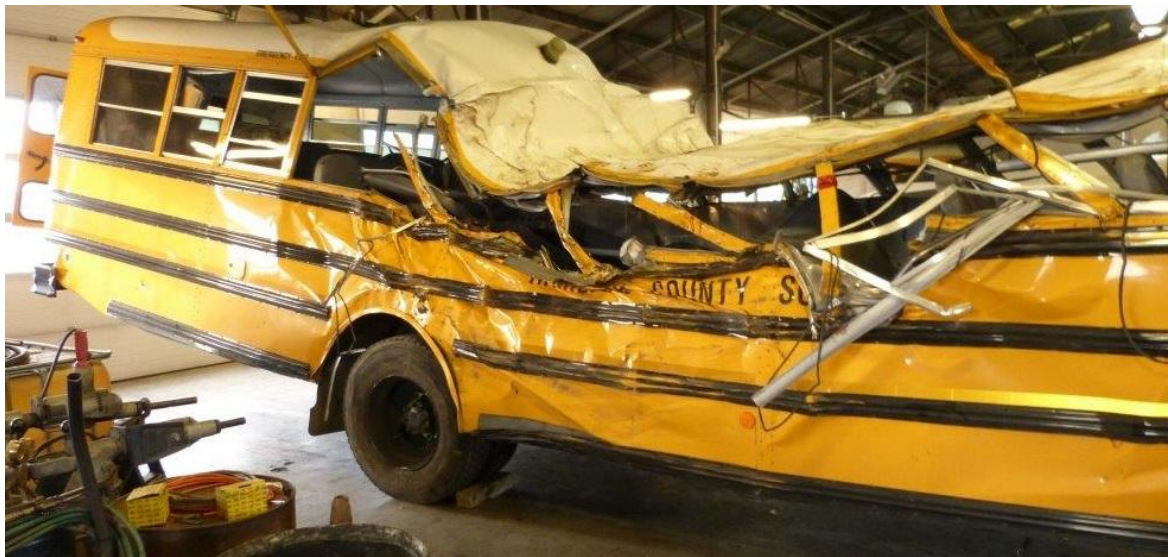
SF Photograph 4 shows a right rear view of the school bus. Severe damage to the upper portion of the middle of the bus is visible. The roof is crushed downward in the region above and forward of the rear axle. The crush is most severe just forward of the rear axle and decreases further forward. The passenger window frames above and forward of the rear axle are crushed. The portion of the bus aft of the rear wheels exhibits minor damage.

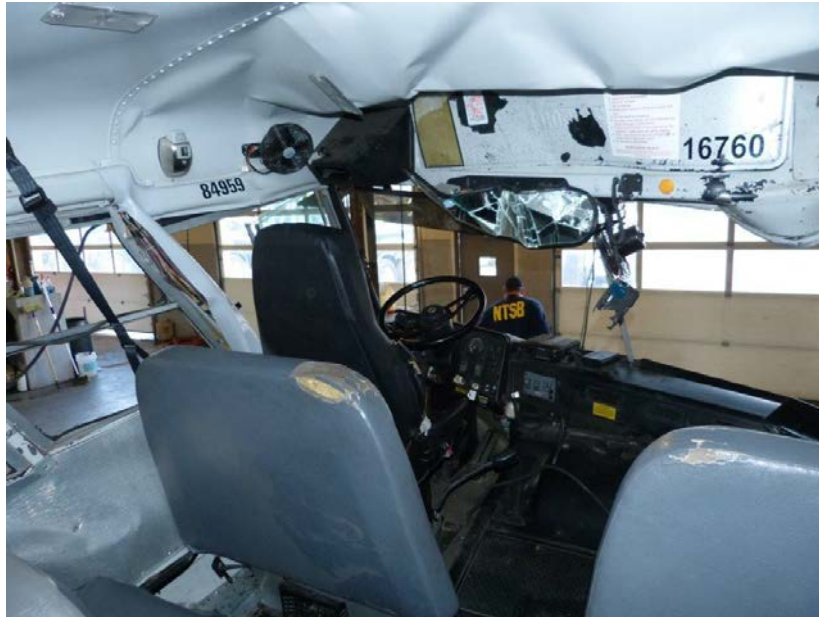
SF Photograph 5 shows the driver compartment of the school bus. The perspective of the view is from aft of the loading area. Deformation of the roof above the driver seat is visible, as well as damage to the left sidewall of the bus. The windshield is missing and the rear view mirror at the upper-center of the bus is visible and damaged. The partition just aft of the driver seat and part of the partition aft of the loading door are visible. The driver seat, steering wheel, and portions of the dashboard are visible.

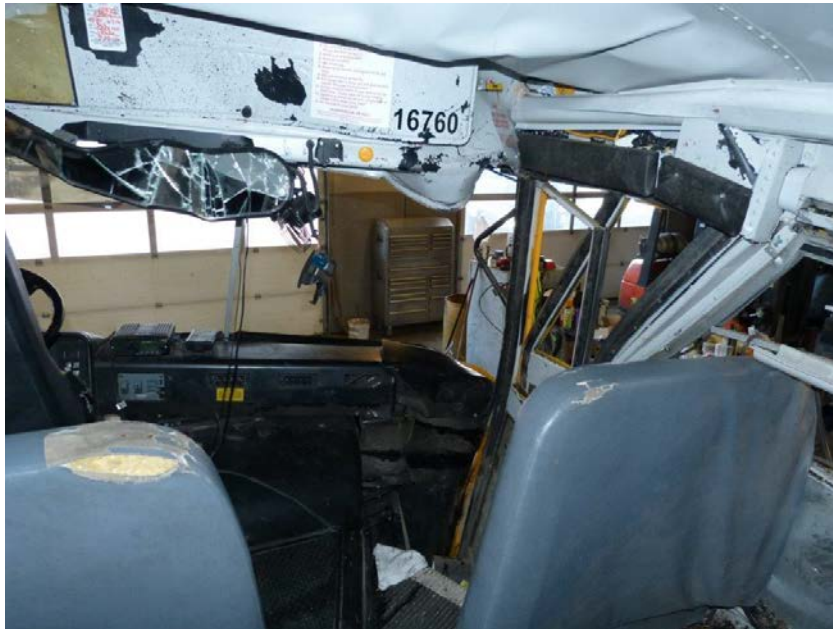
SF Photograph 6 shows a view of the loading area at the front of the school bus. The perspective of the view is from aft of the driver seat. The windshield is missing and the rear view mirror at the upper-center of the bus is visible and damaged. The partition just aft of the loading area and part of the partition aft of the driver seat are visible. The right side of the dashboard, a portion of the loading area and loading door are visible. The loading door exhibits severe damage.

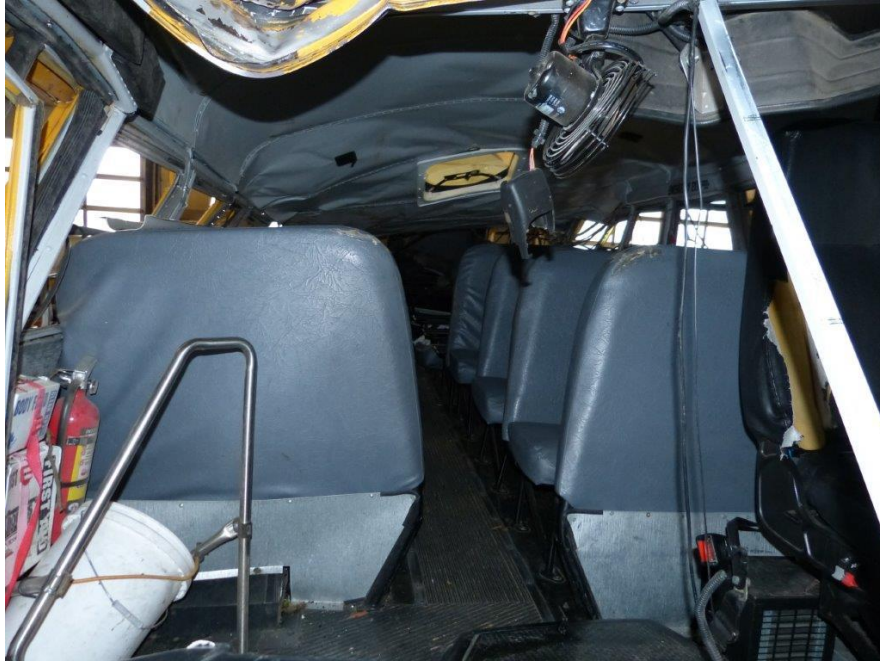
SF Photograph 7 shows a view of forward portion of the passenger compartment of the school bus. The perspective of the view is from the front of the bus looking inward. A portion of the loading area, including a railing and a portion of the driver seat are visible. The front partitions and portions of the front passenger seats and aisle way are visible. The roof is crushed downward, with the most severe crush at the middle of the bus.

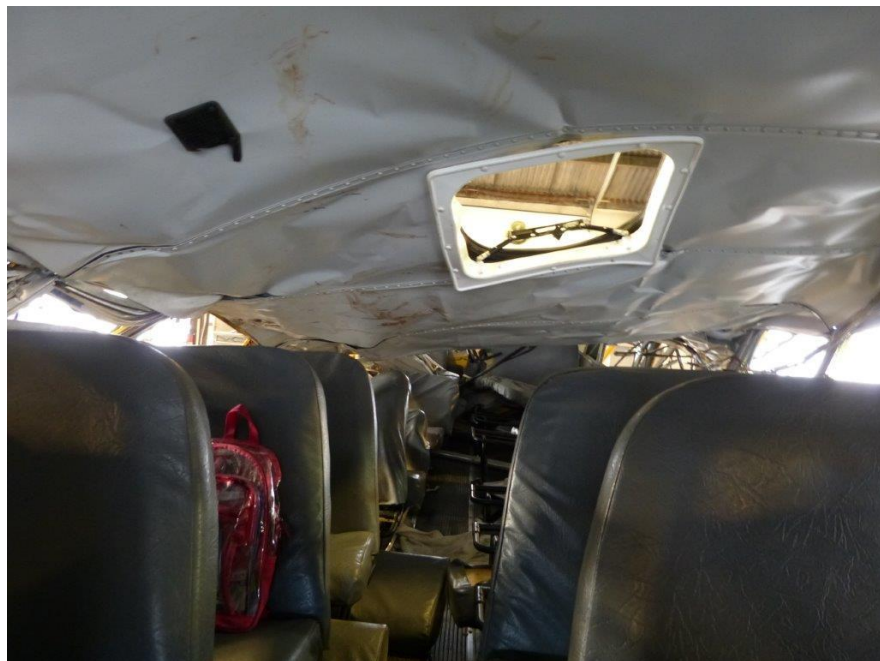
SF Photograph 8 shows a view of the middle-forward portion of the passenger compartment of the school bus. The view is from the front seats looking aft. Portions of the passenger seats and aisle are visible. Portions of damaged seats are displaced into the aisle, and the crushed roof extending to the level of the seatbacks is visible. At least one seatback is visibly deformed downward.

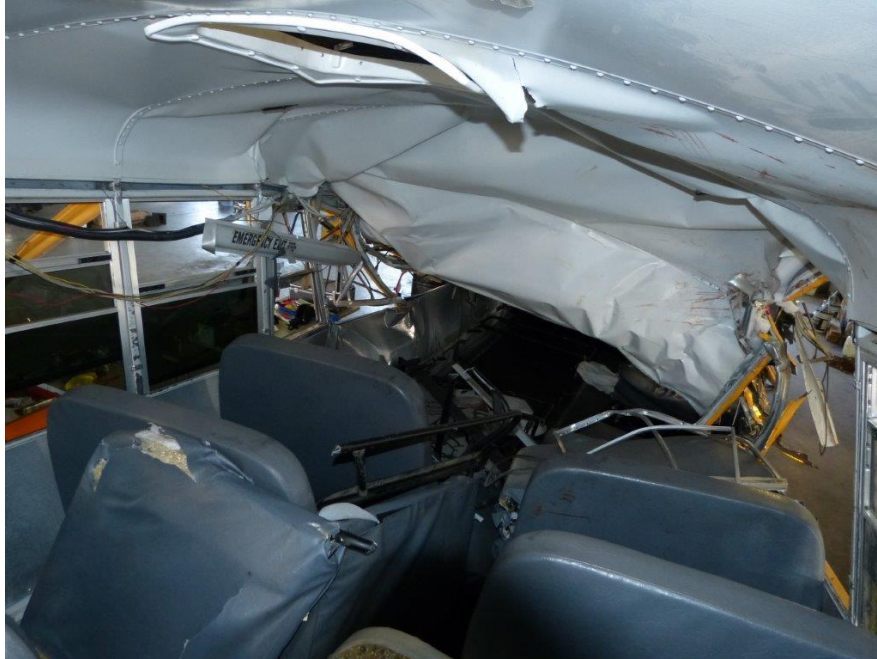
SF Photograph 9 shows a view of the middle-rear portion of the passenger compartment of the school bus. The view is from the back of the bus looking forward. Portions of passenger seats, with some displaced and damaged are visible. The roof is crushed downward in the middle portion of the bus. Portions of the right side window frames are broken away, and window glass from both sides is broken out.

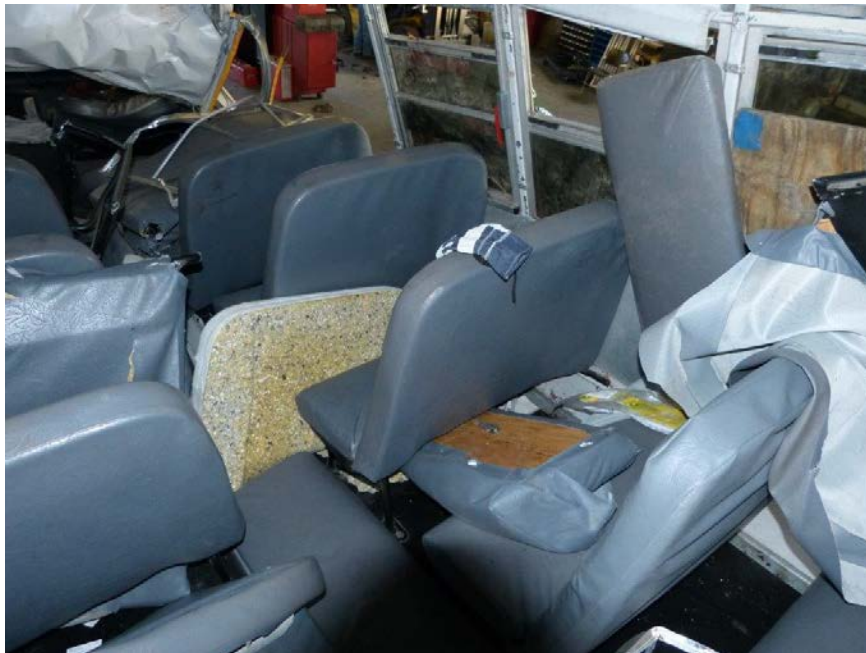
SF Photograph 10 shows a view of the rear portion of the passenger compartment of the school bus. The view is from the back-left side of the bus looking forward and to the right. Several rows of seats are visible with some damaged and some portions of seats displaced. Other debris is visible; a portion of the crushed roof, and damaged window frames are visible.
