**NATIONAL TRANSPORTATION SAFETY BOARD  
OFFICE OF HIGHWAY SAFETY  
WASHINGTON, D.C.**

**SURVIVAL FACTORS GROUP CHAIRMAN'S  
FACTUAL REPORT**

Vehicle #1: 2014 Tesla Model S P85D

NTSB #: **HWY18FH013**

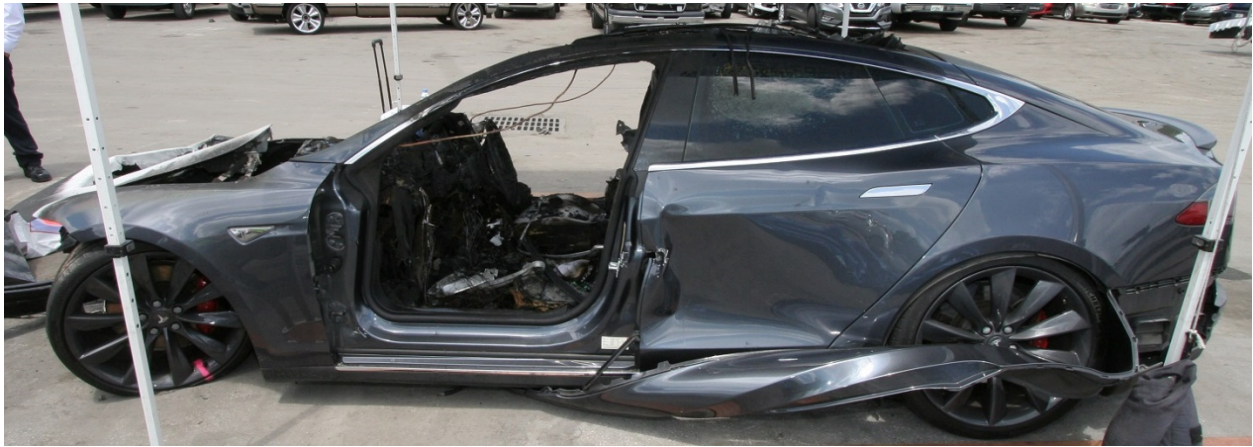
Figure 1. Left Side of Tesla

A general inspection of the vehicle was conducted on May 11, 2018 at Westway Towing, and a follow up inspection, focused on the vehicle traction battery, was conducted on June 7, 2018 also at Westway Towing. The Tesla was destroyed and several major components of the vehicle were separated and found loaded on a wooden palate or in a debris pile stored near the vehicle. The largest portion of the vehicle consisted of the chassis, left wheels, body and interior, as shown in Figure 1.

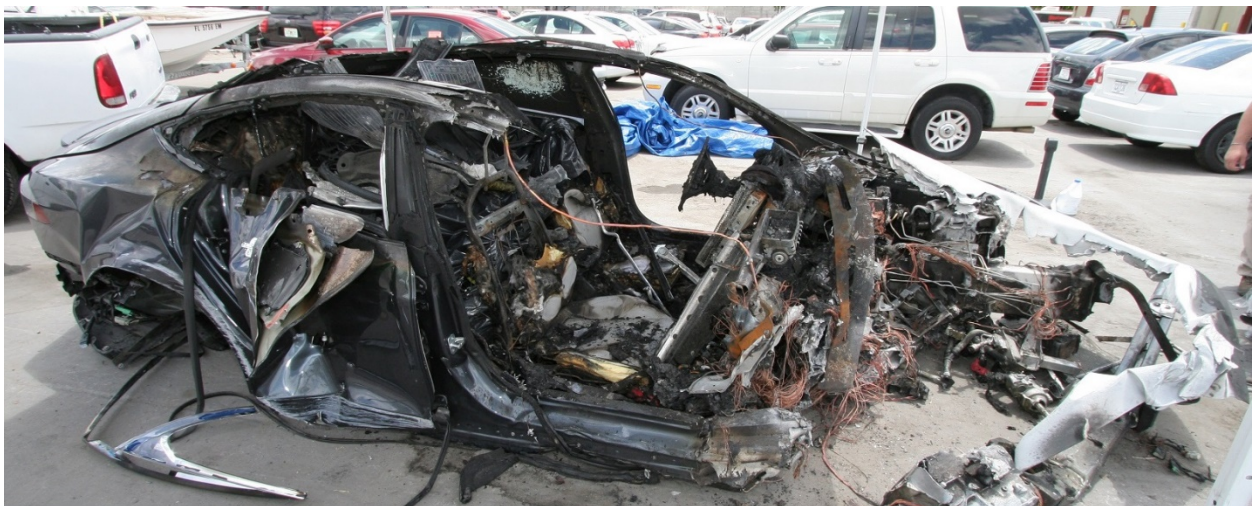
Figure 2. Right Side of Tesla

Both right side wheels and some suspension components, the entire traction battery pack, both front doors, right front fender, front electric drive motor, hood, and front of the car were displaced from the body, as shown in Figure 2.

There was extensive fire damage, which was most severe in the middle front portion of the passenger compartment. The outer paint on the sides and rear of the Tesla was intact, and the upper portions of the car exhibited thermal damage. The left front wheel was intact and the tire was flat. The left rear wheel was intact and the tire was inflated. The left side B-pillar exhibited damage consistent with rescue extrication operations. The left rear window glass was intact and fire damaged. The windshield and roof glass were broken out.

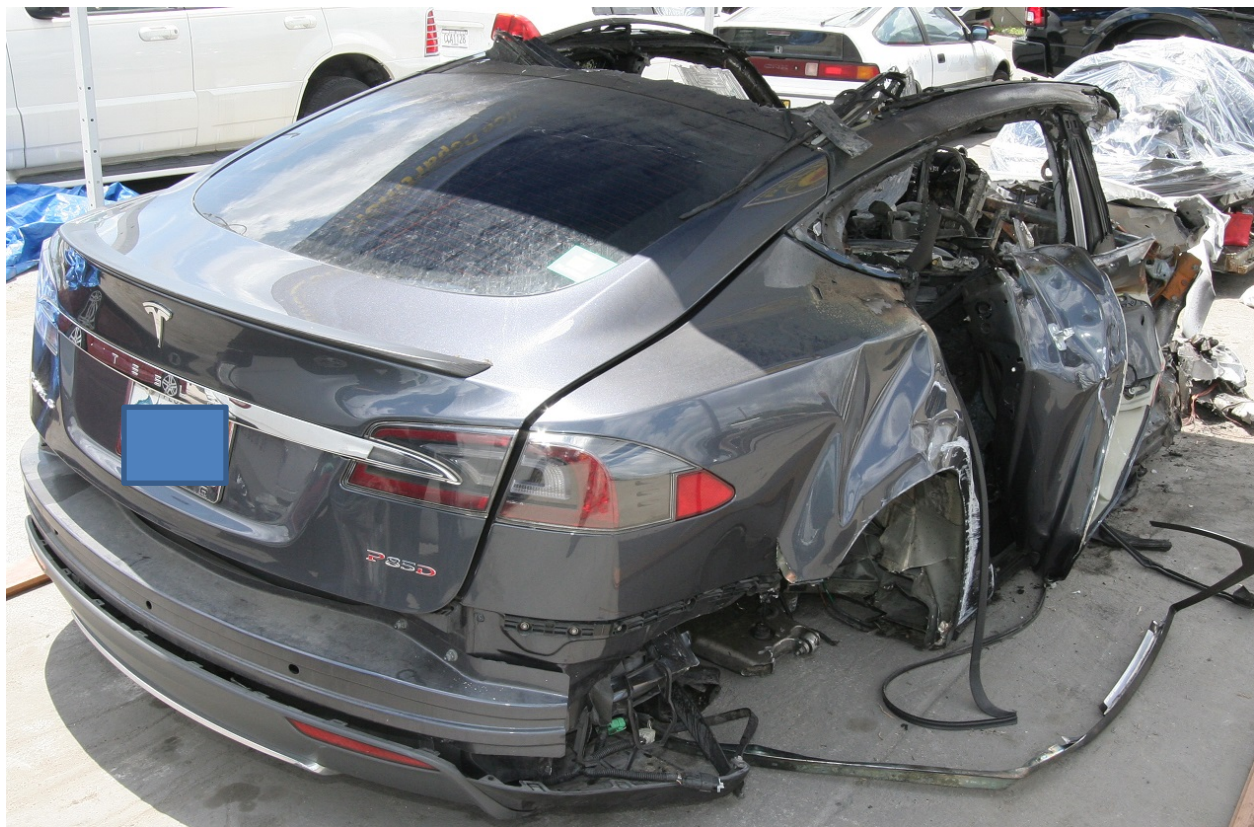
Figure 3. Right-rear of the Tesla.

The rear of the Tesla was mostly intact, but with the upper portion of the bumper trim displaced, as shown in Figure 3. The rear window glass was intact and fire damaged. The right rear corner of the car aft of the rear wheel was intact above the bumper, but damaged and with body panels missing at the level of the bumper and below the bumper. Impact damage extended from the right-rear wheel and forward the entire length of the car. All window glass on the right side was broken out. The right-rear door remained attached, but the entire aft-half of the door was deformed forward.

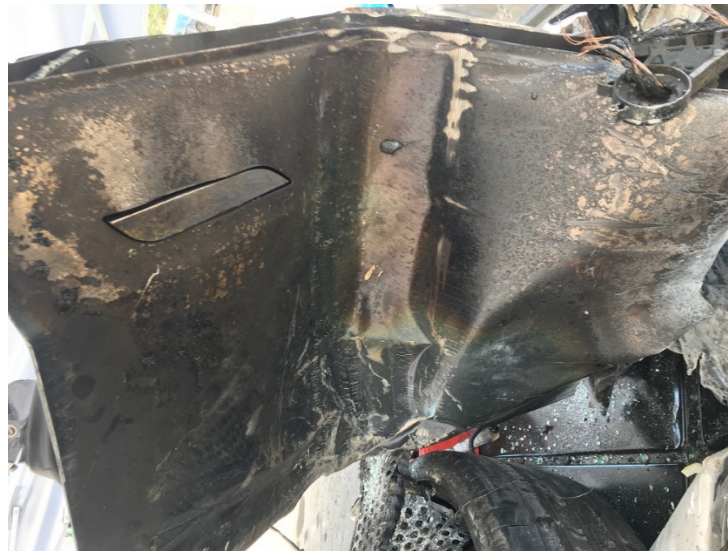
Figure 4. Tesla right front door.

The right front door was found in the debris pile. It exhibited severe thermal damage and a large vertical deformation pattern which had dimensions similar to the impacted light pole at the scene of the crash, as shown in Figure 4.

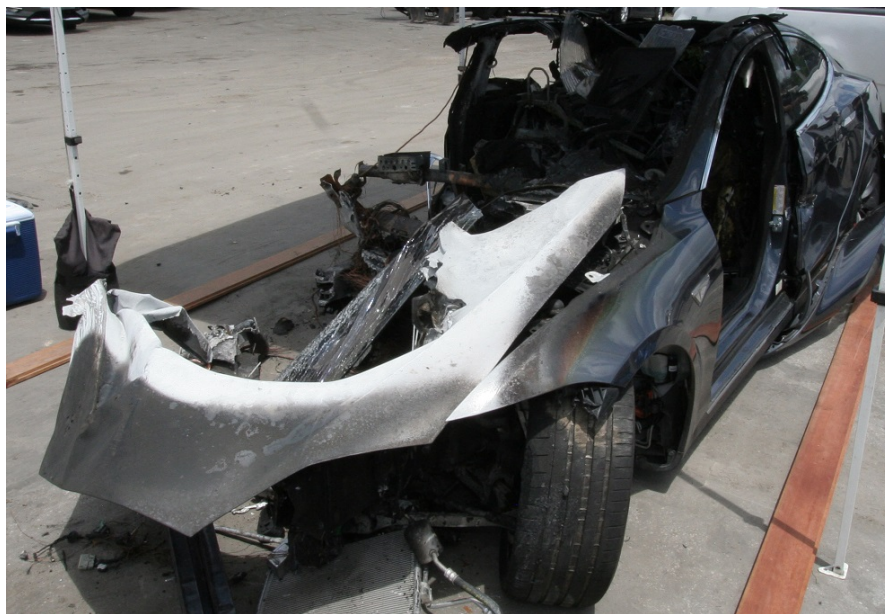
Figure 5. Tesla left front with hood.

The Tesla hood was found in the debris pile and placed onto the front of the car, as shown in Figure 5. The middle and aft portion of the hood were damaged and partially consumed by fire. Severe thermal damage was evident along the left side and front, and the right side exhibited impact damage. The left front fender, forward of the left front wheel, also exhibited thermal damage.
