NATIONAL TRANSPORTATION SAFETY BOARD

Survival Factors Group Chairman's Factual Report

ERA18MA099

Operator : Liberty Helicopters
Airplane : Airbus Helicopter AS350B2 [N350LH]
Location : New York, NY
Date : March 11, 2018
Time : 1908 eastern daylight time (EDT)

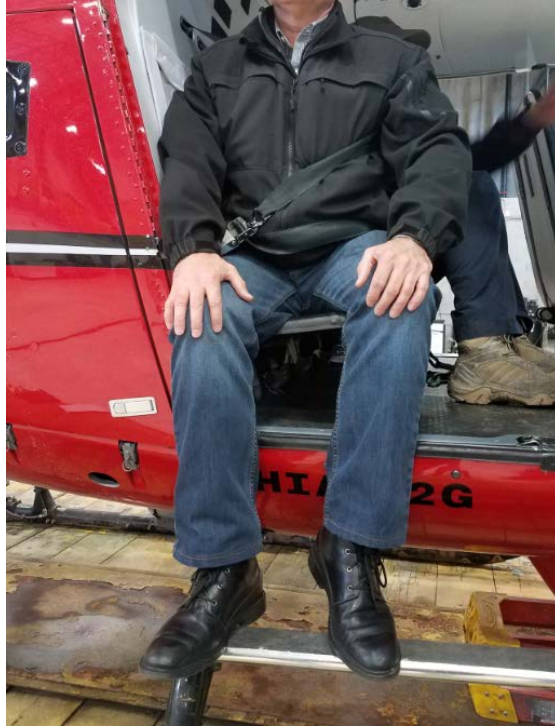
Upon arrival at the NYPD aviation hangar, the lapbelt of seat position 1 was buckled. Seat position 2 was fully assembled with the shoulder belt attached to the buckle and seat position 3 was unbuckled. Seat position 4 was fully assembled with shoulder belt attached to the buckle. The outboard front seat passenger restraint was unbuckled. The inboard front seat passenger restraint was fully assembled, and the pilot seat restraints were unbuckled. According to NYON Standard Operation Procedures (SOP)⁵, the Customer Service Representative (CX)⁶ would attach the FAA-approved shoulder belt restraint under the arm. According to multiple interviews, this was done so passenger could easily twist outward toward the aircraft door for taking pictures. See photograph 6.

Photograph 6- Picture showing FAA approved shoulder harness restraint routed under the arm.

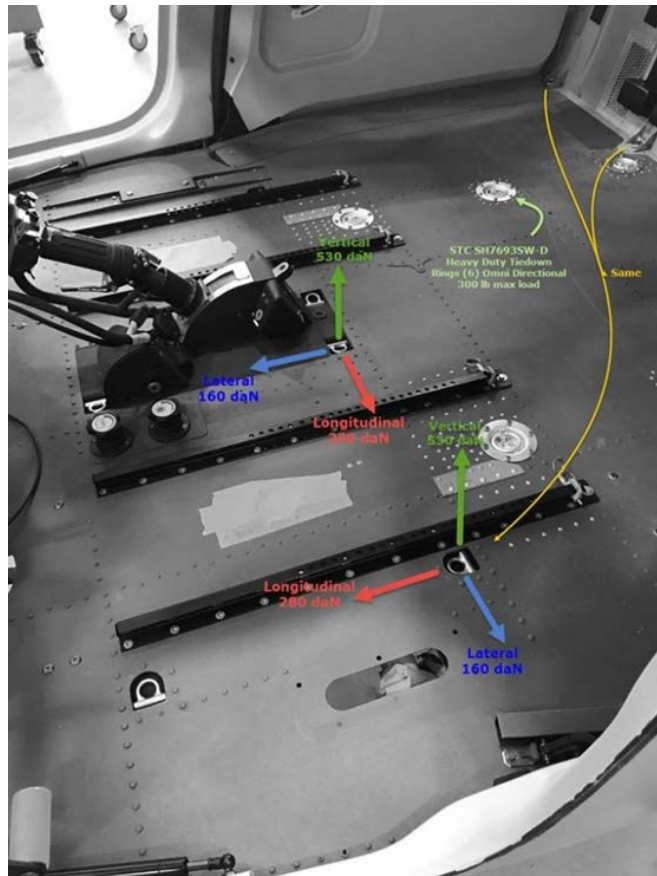
The front-left passenger and the rear bench seat tethers was connected to hard points via carabiners. The front-left hard point swiveled laterally. Load limitations are provided for the use of transport cargo in case of front left seat removal and rear benches folding back according to the AS350 B2 system Description Section 25-20-00, Chapter 01 (“Equipment and Furnishings – Seats – General), §4 (“Cargo”). The load limitations in the fore-aft, lateral, and vertical axes are described in photograph 7. Carabiners with tethers were attached to hard points on the rear bench bar tube anchors. According to the AS350 B2 documentation, no use is described on these anchors except for the lapbelts. According to Airbus, load limitations are not provided for the anchors located on the rear bench bar because they are not supposed to be used for anything other than the standard lap seat belts.

Photograph 7 - Load limitations for the hard points in helicopter.

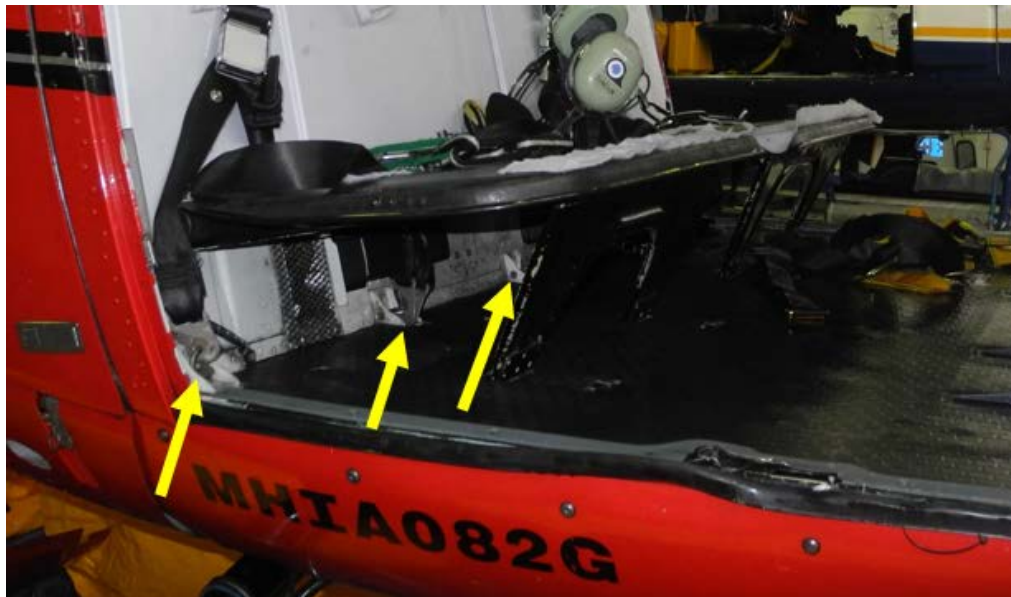
For all four seat positions on the rear bench, each seat’s lapbelts were found connected to the floor anchors/hard points adjacent to the rear bulkhead. According to the AS350 B2 Maintenance Manual section 25-22-00, chapter 4-4 (“Removal / Installation – Rear Seat Bench Passenger Seats”), tasks requested that the seat lapbelts to be disconnected/connected to the rear bench tube anchor for the four-seat rear bench configuration. No task was available to disconnect/connect the seat lapbelts on the floor. Figure 1 of the AS350 B2 Maintenance manual section 25-22-00, chapter 4-4 (“Removal / Installation – Rear Seat Bench Passenger Seats”) showed a partial representation of the lap seat belt connected to the rear bench bar tube anchor for the four-seat rear bench configuration. A diagram showing the complete lap seat belt connection configuration for all four-seat positions on the rear bench was not available in the AS350 B2 Maintenance Manual.

Photograph 8 - Lapbelts connected to the floor anchors/hard points adjacent to the rear bulkhead.

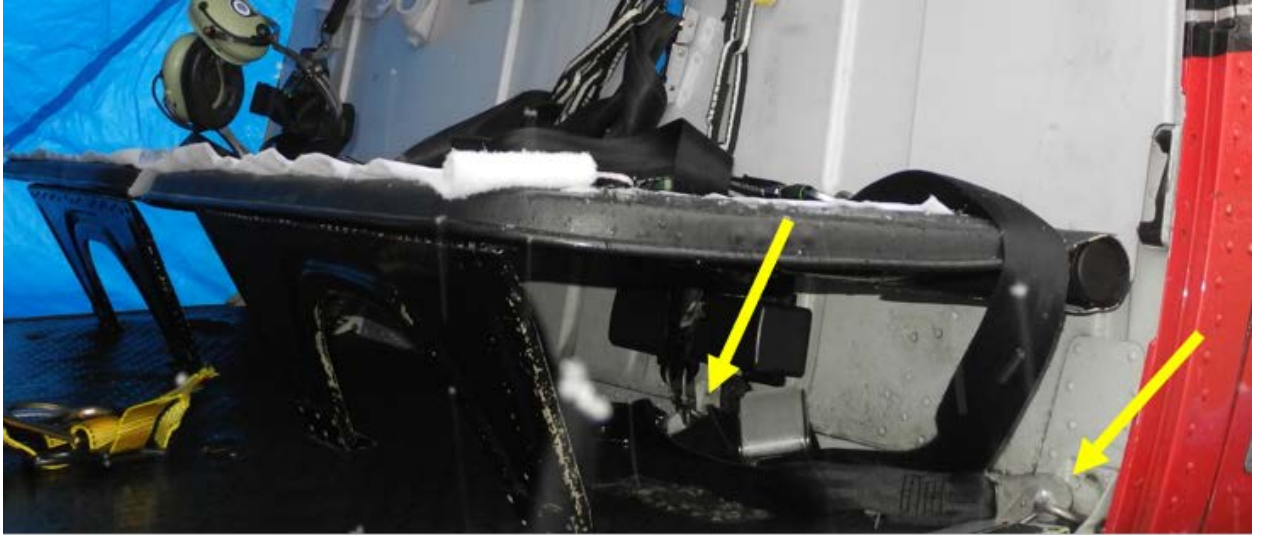
Photograph 9 - Lapbelts connected to the floor anchors/hard points adjacent to the rear bulkhead.

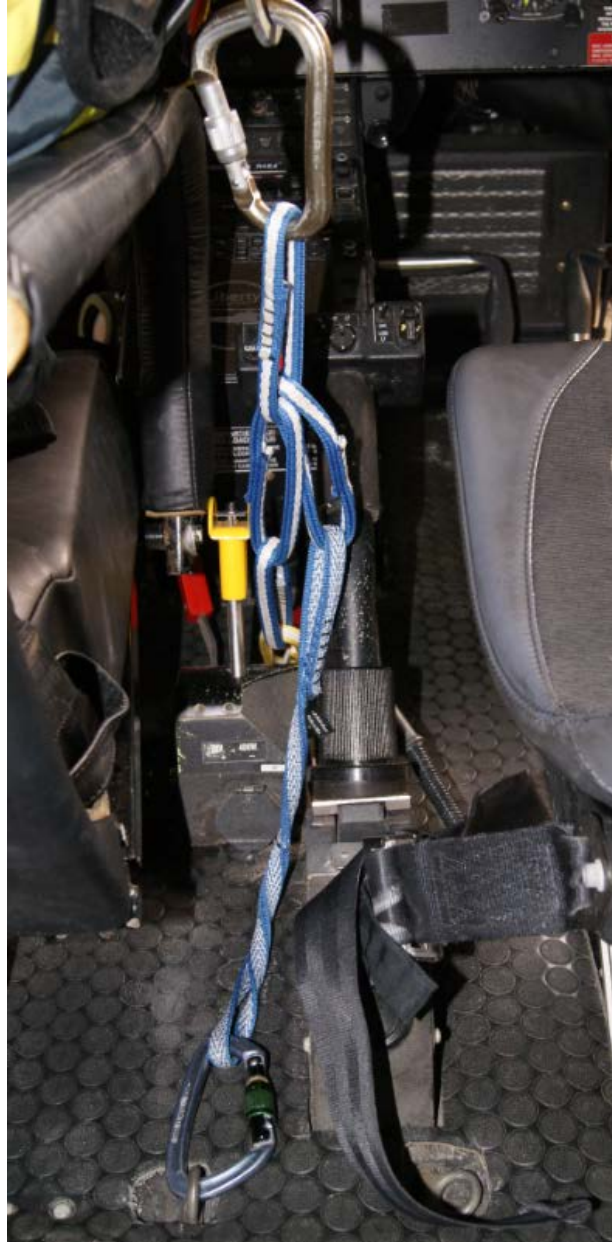
Photograph 20- Front seat occupant's tether showing additional tail length (4 loops) resulting from positioning of the carabiner within the attach loop (aft looking forward).

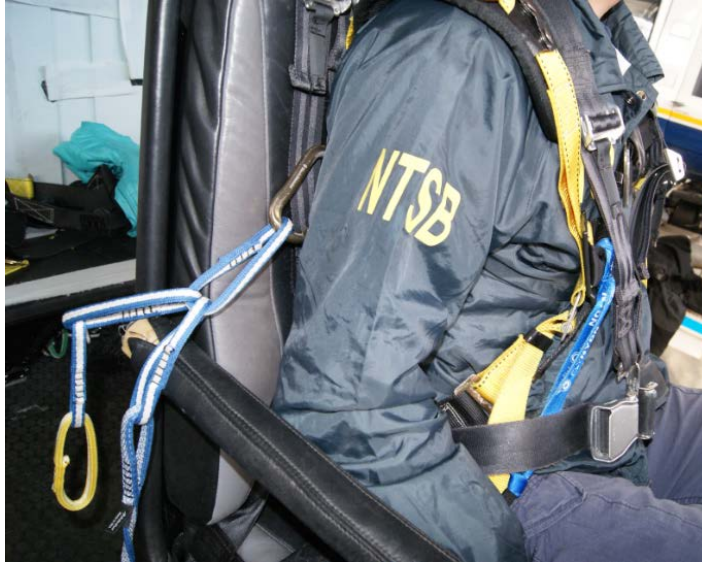
The survival factors group examined the area within the cockpit to verify the potential reach of the tether tail to the floor-mounted controls when routed over or under the armrest. A group member secured in the harness/tether system was seated in the front seat, and then moved through a range of positions similar to those necessary to accommodate a “shoe selfie.” According to multiple interviews, there was no standard procedure for routing the tether from the occupant to the hard point on the cabin floor. However, according to the pilot interview he generally routed the tether under the armrest during his flights.

Photograph 21- Front seat occupant's tether routed over the armrest.

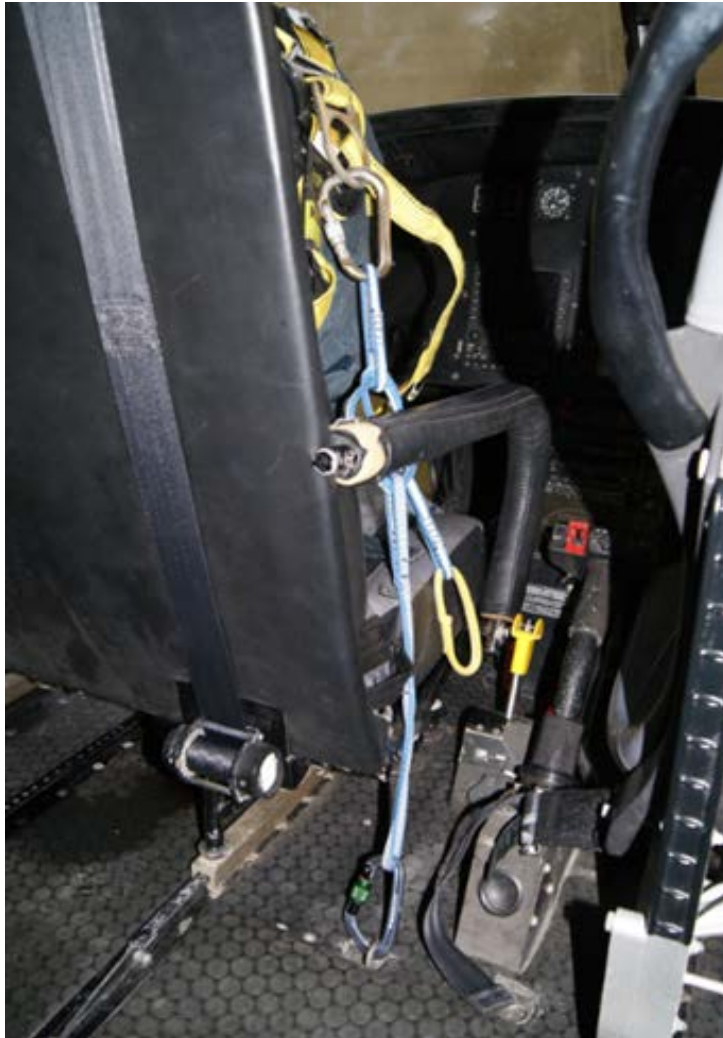
Photograph 22- Front seat occupant tether routed under the armrest.

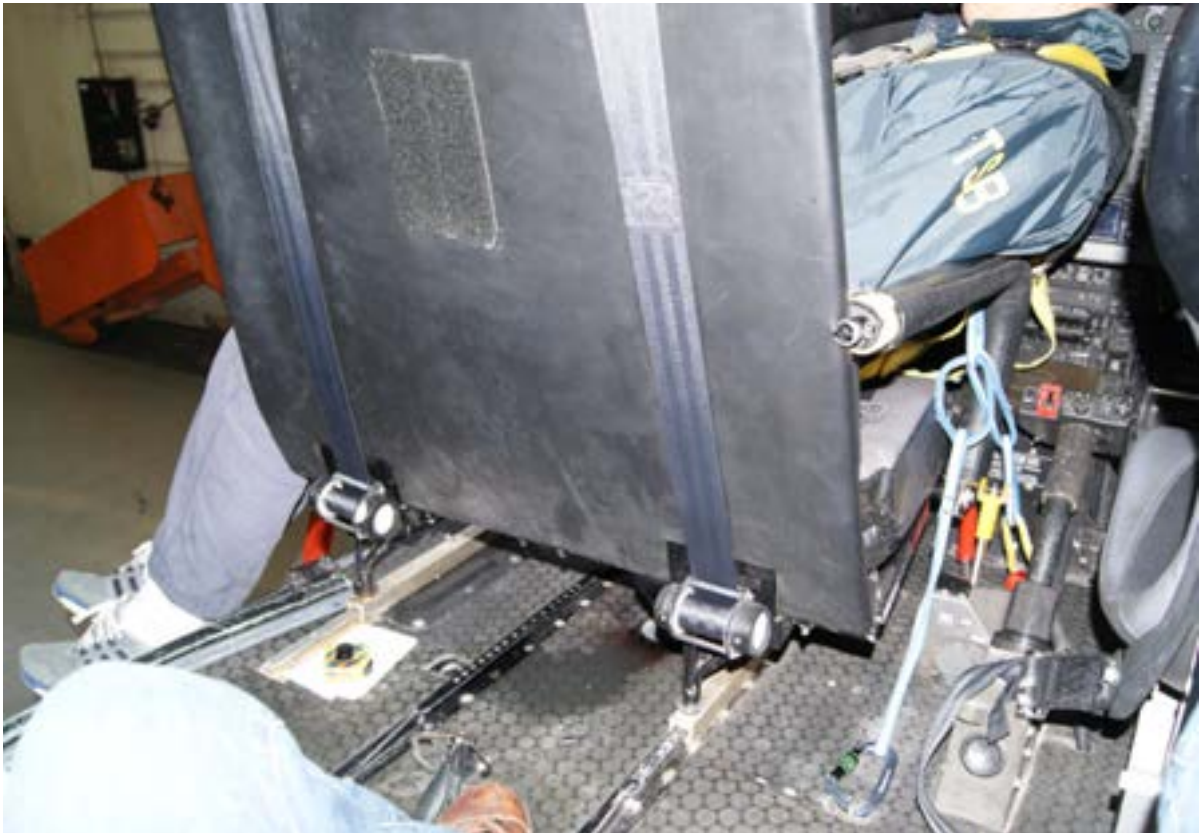
Photograph 24- Male subject in front seat reclined in position to take a “shoe selfie” with tether tail loops visible.

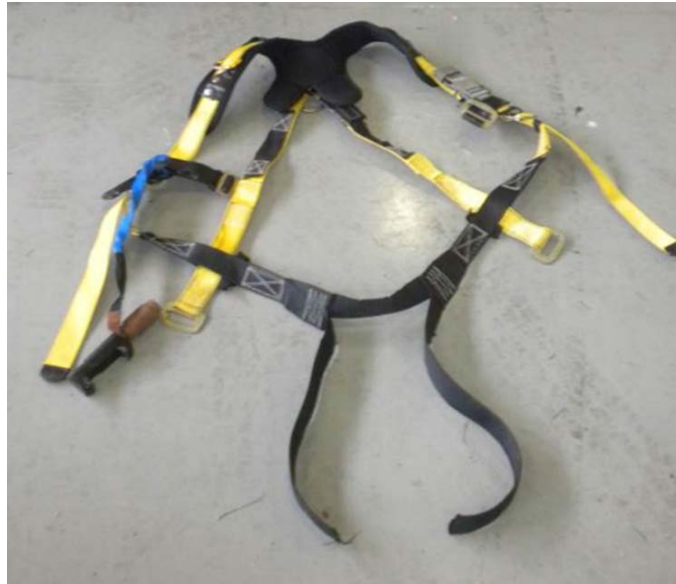
A portion of harness A was recovered and had a Benchmade olive green pouch attached that was labeled “made in the USA.” In the pouch there was a Benchmade Model 7 cutter, model number, NSN 4240-01-543-9618. There was an orange non-locking carabiner present, part #:11160-QC DOM 10/2015 and Serial # /01716.

Photograph 30- Harness A as recovered.

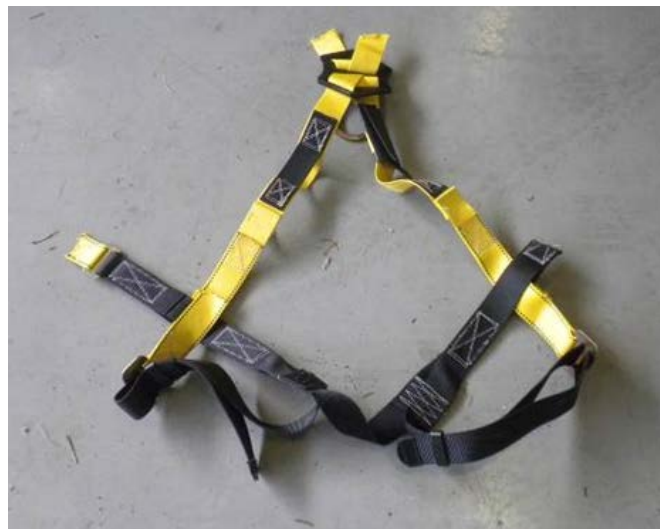
A portion of harness B was recovered still connected to tether and floor hard point at the front seat occupant position in the helicopter. It was missing the strap section that would hold this pouch and cutter. There was a part number present, Part #: 1160-QC DOM 05/2017 and Serial # 26765/ 03778.

Photograph 31- Harness B as recovered.

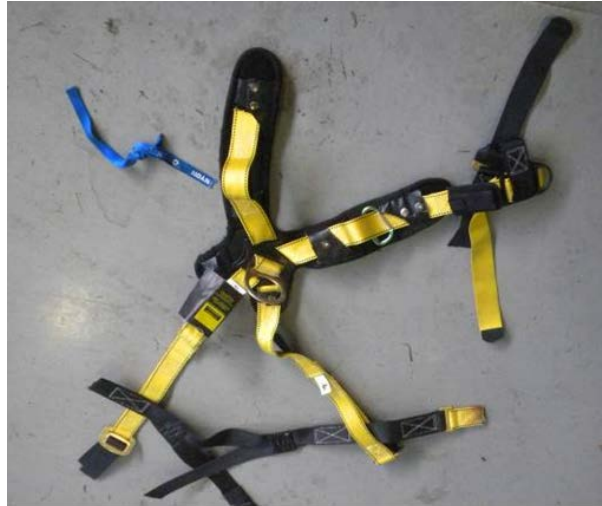
A portion of harness C was recovered. It was equipped with a black pouch to house a cutter however it was missing the cutter. There was a green non-locking carabiner present. It was labeled with part #: :11160-QC DOM: 05/2017 and serial #: 26765/ 04858.

Photograph 32- Harness C as recovered.

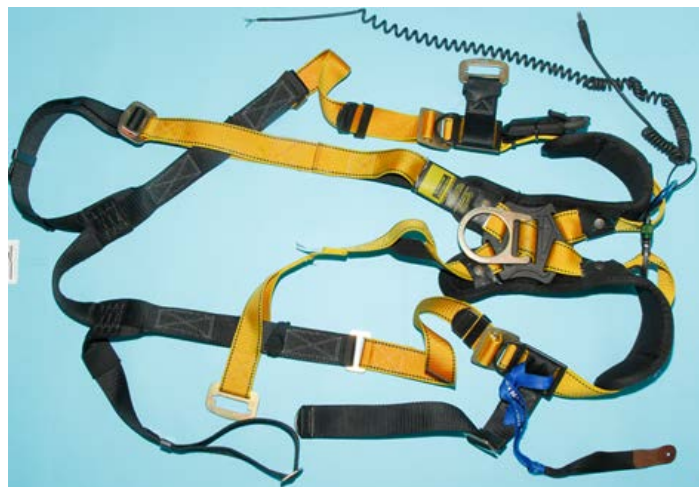
This harness was removed from the female occupant by the Medical Examiner. The harness was labeled as a Guardian Fall protection performance safety gear. The harness had a black pouch attached to the left side of the harness. In the pouch there was a StatGear cutter. There was no part number present on the cutter. There was a blue non-locking carabiner present, it was labeled 24 7 7kN 0333. There was a green locking carabiner attached to the two aft shoulder strap portions of the harness. It was labeled 25 8 8kN 033B 7214. A blue lanyard was tied to the right shoulder strap. Attached to the blue non-locking carabiner as a zip tie with a headset cord. The wires at the tip of the cord was frayed.

Photograph 33- Harness D as recovered.

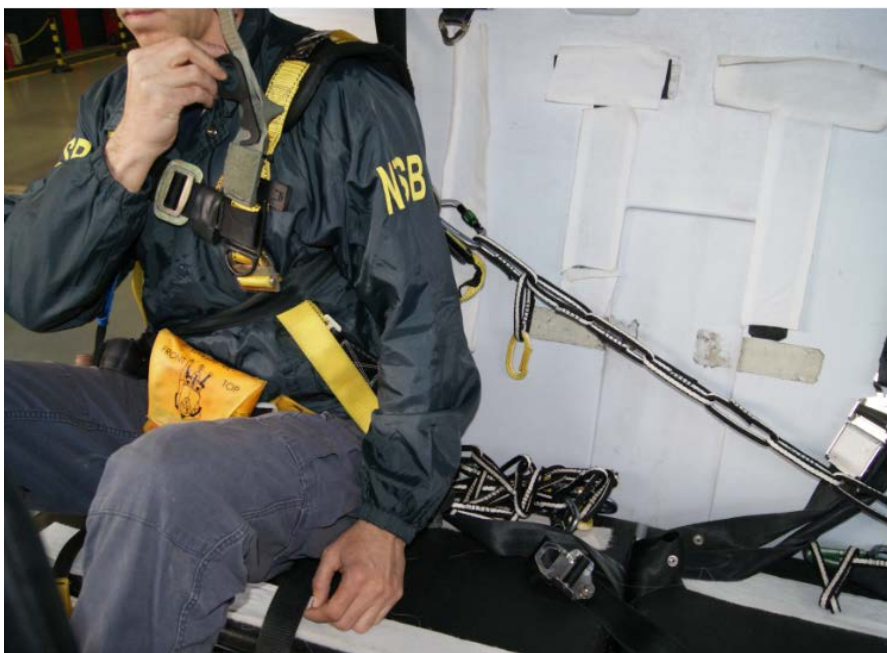
As shown photographs 37-39, the survival factors group documented a passenger removing a cutter from its pouch and reaching for the tether as shown in the passenger safety video. The group noted that, due to the routing of the tether behind the passengers, it was not possible to access the tether while two passengers were seated next to each other (as one passenger's upper body was obstructing it). The inboard passenger needed to lean over for the outboard passenger to have access to the tether. It was also noted that the outboard passenger's inboard rotation to reach the tether was restricted due to the tension in the tether caused by the rotation of the upper body.

Photograph 38- Investigator wearing the harness/tether system removing the cutter from its stowage pouch.

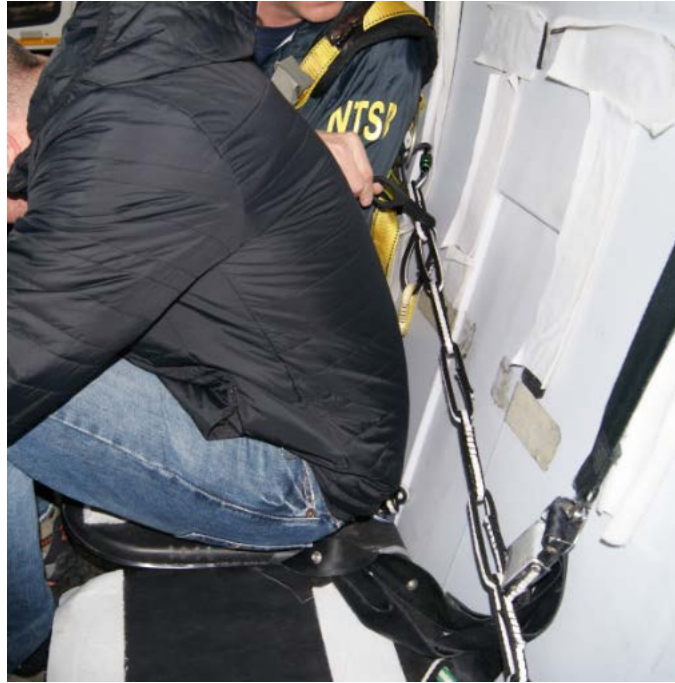
Photograph 39- NTSB investigator wearing the harness/tether system attempting to cut the tether with the cutter with another investigator seated beside him leaning forward to facilitate access to the tether.
