Global Exec Aviation  
Learjet 60  
Columbia, South Carolina  
September 19, 2009  
DCA08MA098

**Survival Factors Group Chairman's Report**

Runway Friction Survey

Main Runway, Columbia Metropolitan Airport  
Runway 11-29

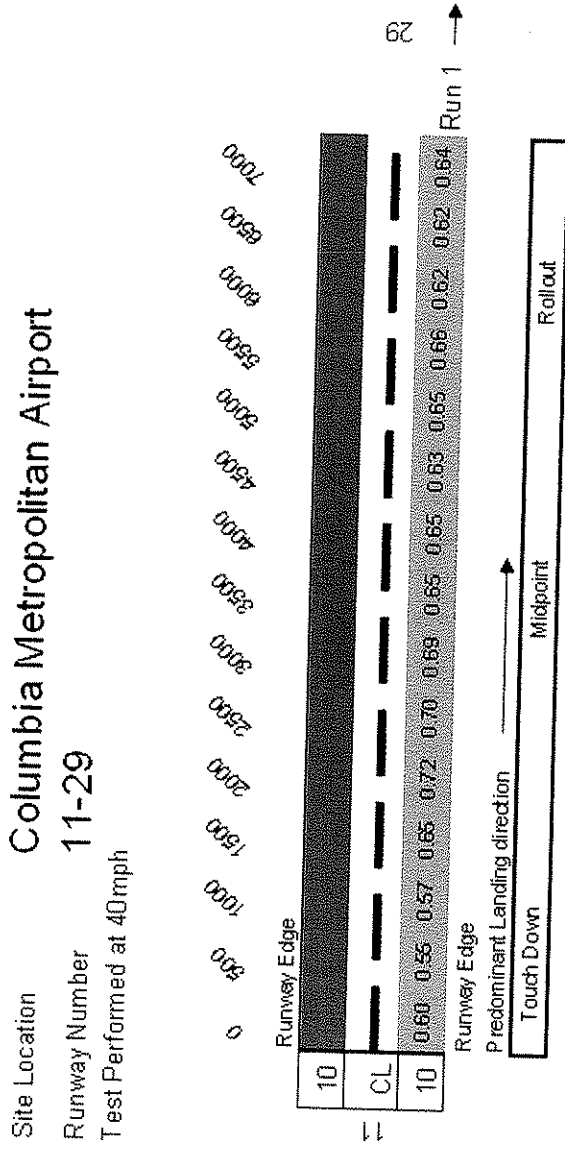
**Table 2 : 2 Dimensional Plan View of Runway Showing Average Friction Readings Every 300 Feet**

The overall Friction values obtained from this test shows that the runways surface has good drainage ability at both 40 and 60mph – Total Average Friction 0.64. No 500 foot section falls below the “Design Level”.

NAC Dynamics recommends a further test on this runway within 6 months (dependant on runway usage) to continue to monitor the surface drainage ability.

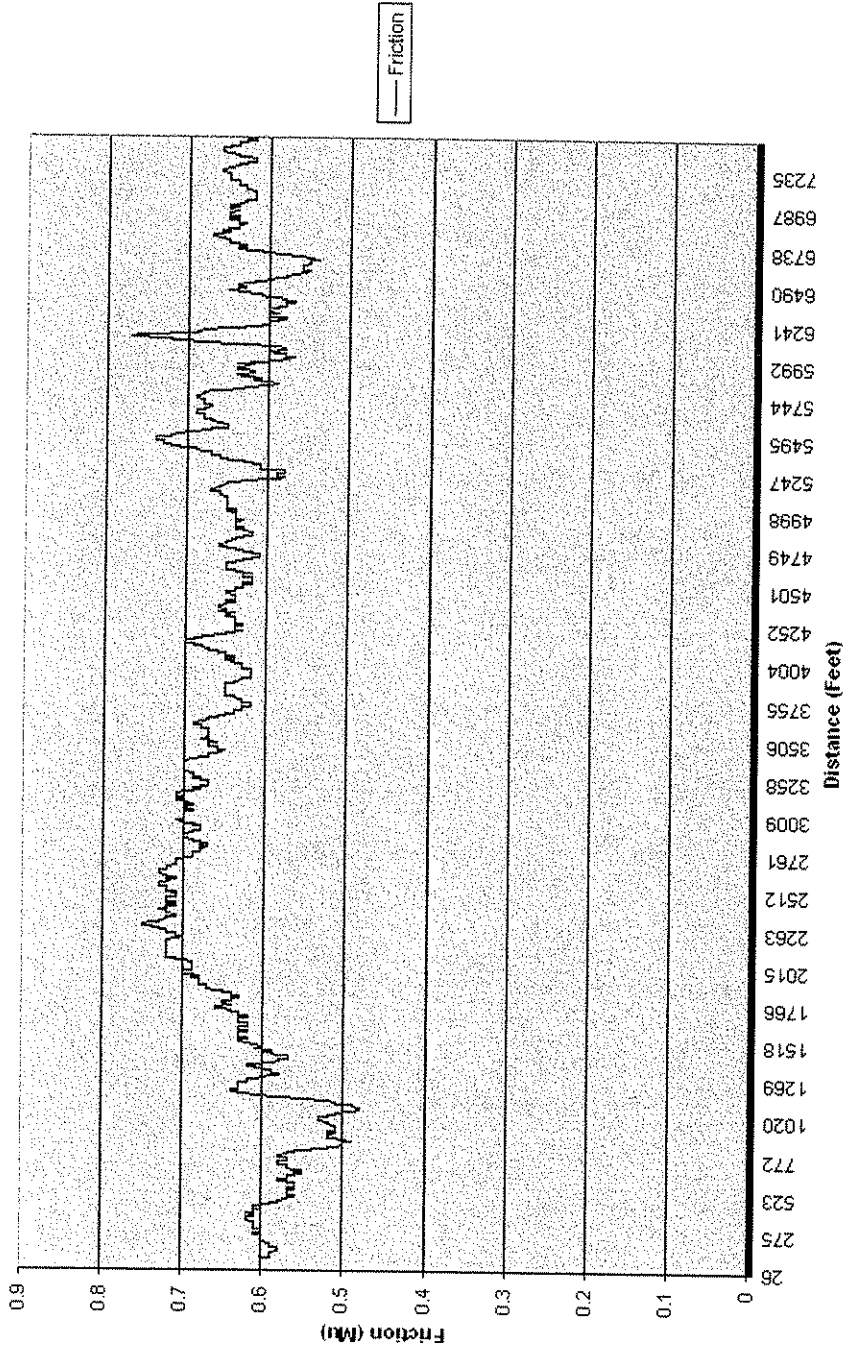
Chart 1. Friction Trace against Distance (Feet) - Direction 11

The test was started directly on the threshold line in direction of 11 to the right of the centre line. The test was started at the correct speed of 40mph. The deceleration data has been removed from the analysis.

Total Average Friction for Direction 11 – **0.64 Mu**
