Survival Factors Group Chairman's Factual Report

Crashworthiness Investigation

Railroad: National Railroad Passenger Corporation (Amtrak)
Train No. 89
Location: Chester, Pennsylvania
Date: April 3, 2016
Time: 7:50 am EDT
Number: DCA16FR007

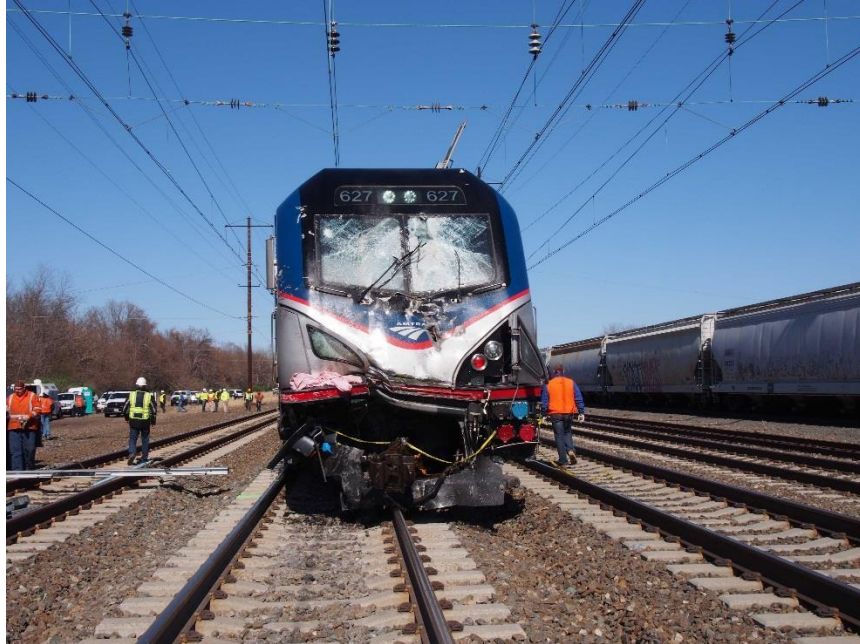
Figure 1-The front end of the locomotive

The lower right side of the locomotive's front end was crushed rearward and upward. The pilot was deformed rearward and under the locomotive, and the anti-climber was deformed downward. The coupler shank was rotated to the left, and the pushback feature was not engaged and did not activate. There was a long vertical impact mark on the left side of the nose of the locomotive. The left and right glazing panels were shattered. Inside of the cab, there was shards of glazing on the consoles, floor, and seats. The radio was dislodged.

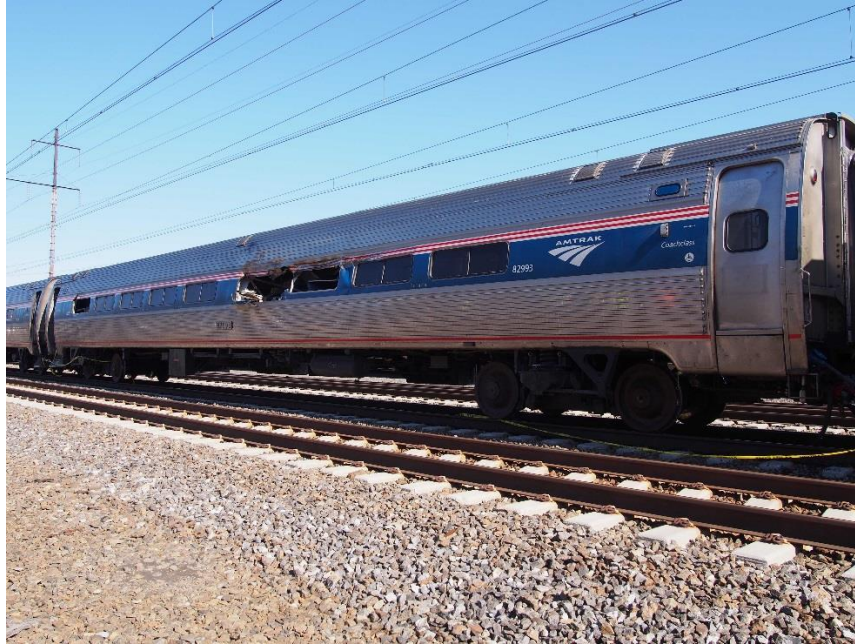
Figure 2- The right side of the first car

On the right side exterior of car 82993, the side of the car was deformed inward between the second and fourth windows. Above the second window, there was a horizontal gouge mark on the side sheet. The rear edge of the second window was pushed partially inward. At the third window opening, the window was completely pushed into the car. There was a horizontal gouge mark in the side sheet above the window opening. Between the third and fourth windows, the side sheet was torn. At the fourth window opening, the window was completely pushed into the car. There were gouge marks and tearing of the side sheet around the window opening. At the ninth window opening, the window was completely pushed into the car. There was a gouge mark at the upper, rear corner of the window opening.

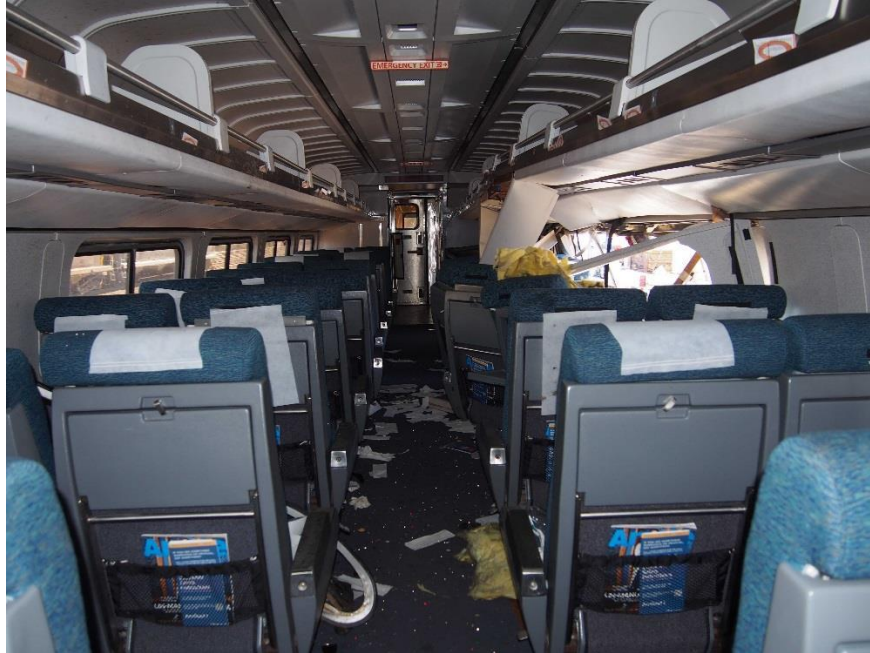
Figure 3- The interior of the first car

Inside of car 82993, the third, fourth, and ninth right side windows were found inside of the car. For the fourth window, the outer layer of the rear glazing panel was broken; the inside layer was intact. The leading edge of the window frame was bent in an inward direction.

On the right side of the car, the sixth row seat (6D/F) was separated from the wall and the floor pedestal. The bolts that secure the seat frame to the pedestal were found on the floor near the seat. The seventh row seat (7D/F) was separated from the wall and partially separated from the floor pedestal. The rear bolt that secures the seat frame to the pedestal was found on the floor below the seat. The bolts used to attach seat to pedestal had 3 rows of threads stripped. Near the eighth row seat (8D/F), there were blood drops on the wall. Near these seats, the baggage rack was bent upward and, the ceiling panels had fallen onto the seats, and the interior wall panels at the windows were cracked and torn. A windshield wiper was found on the floor. The fifth and eighteenth row seats were partially rotated. The first aid kit and its supplies were found out and used.

On the left side of the car, between the seventh (7C/A) and tenth seat (10C/A) rows, there was brown splatter on the side wall and luggage rack. The eleventh row seat was partially rotated.
