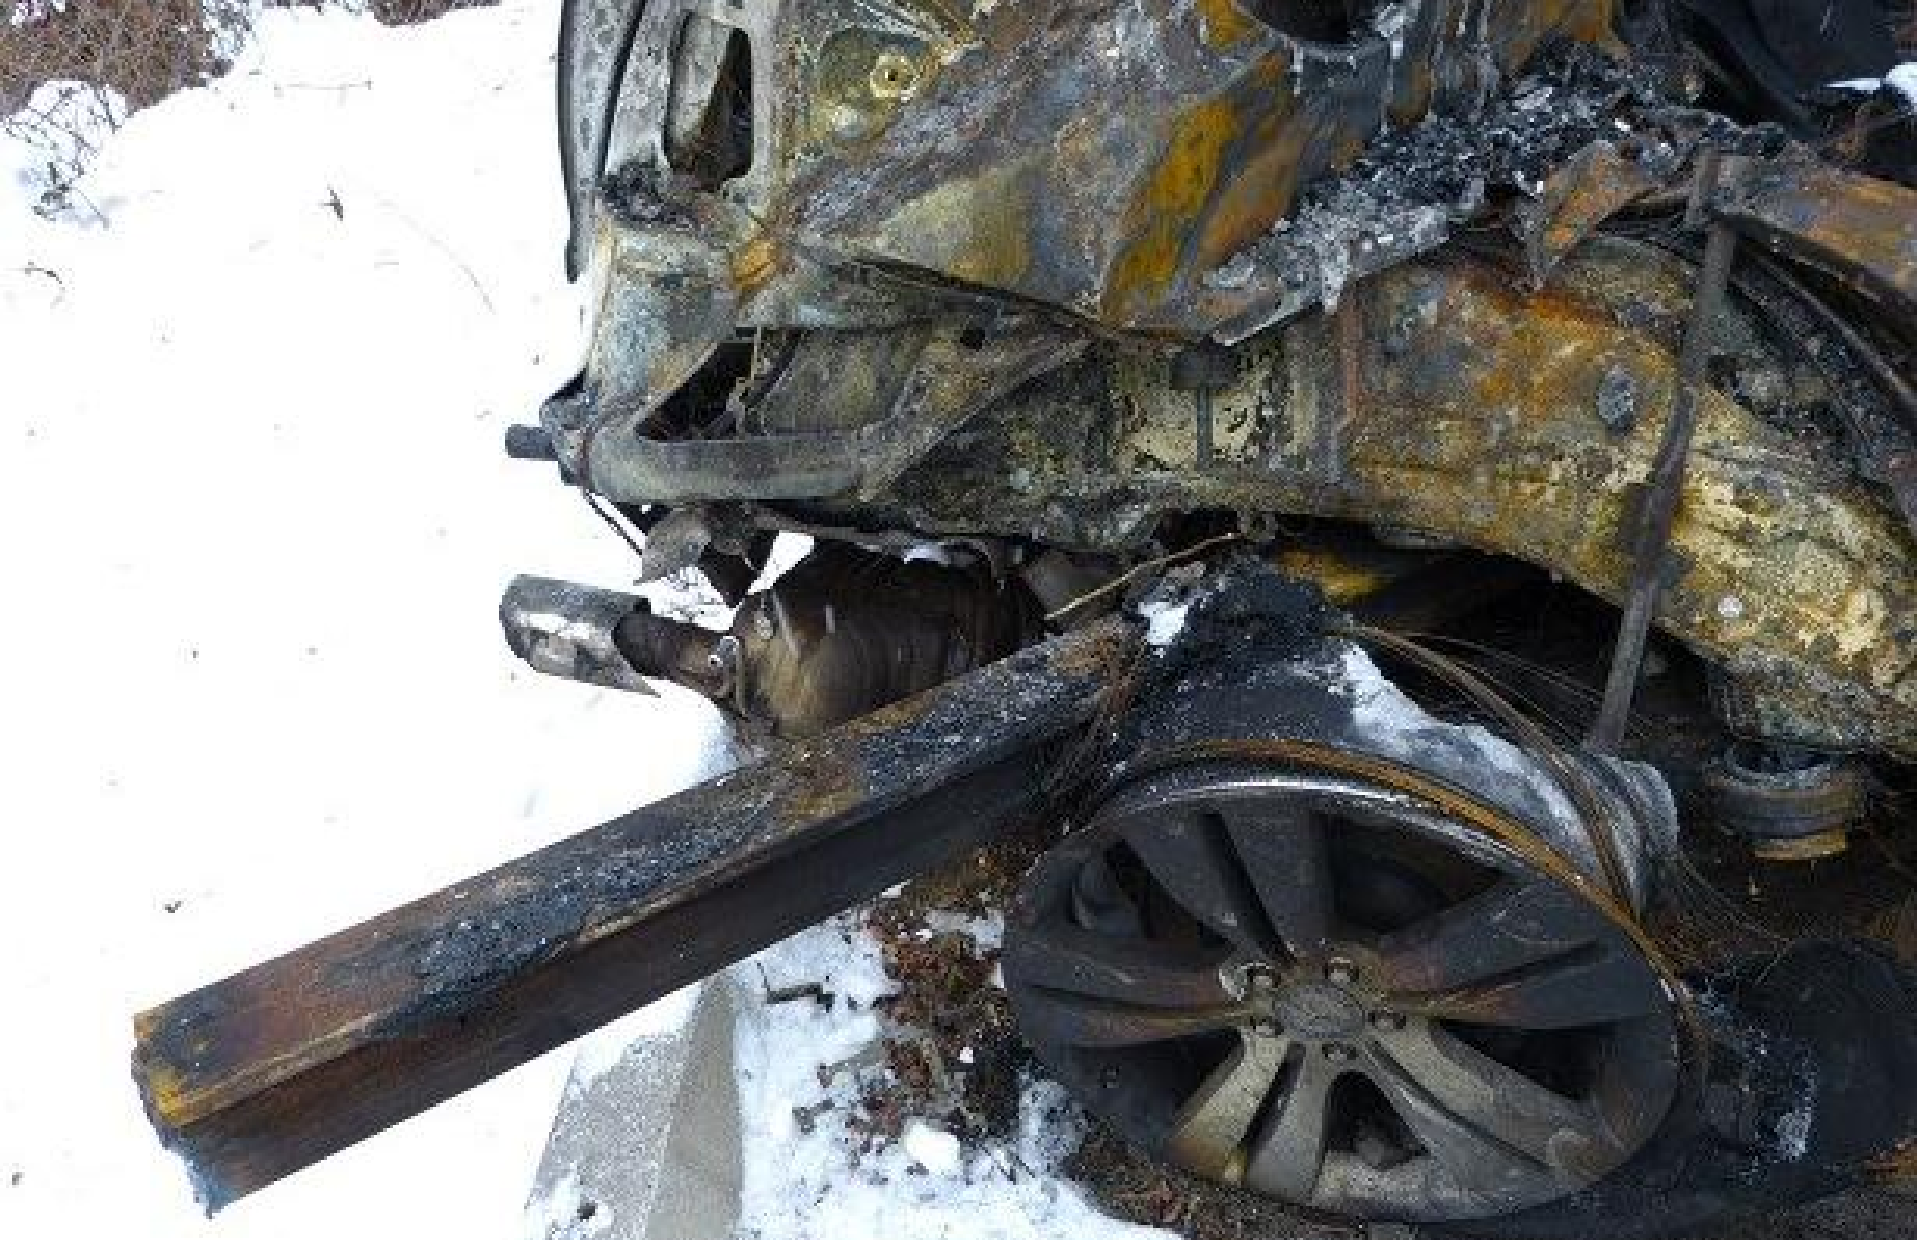
Details of the lower right rear portion of the SUV are visible. The right rear wheel with burned away tires and damaged right rear quarter panel are visible. A section of third rail is protruding from the upper left corner of the wheel well, and is in contact with the wheel.
