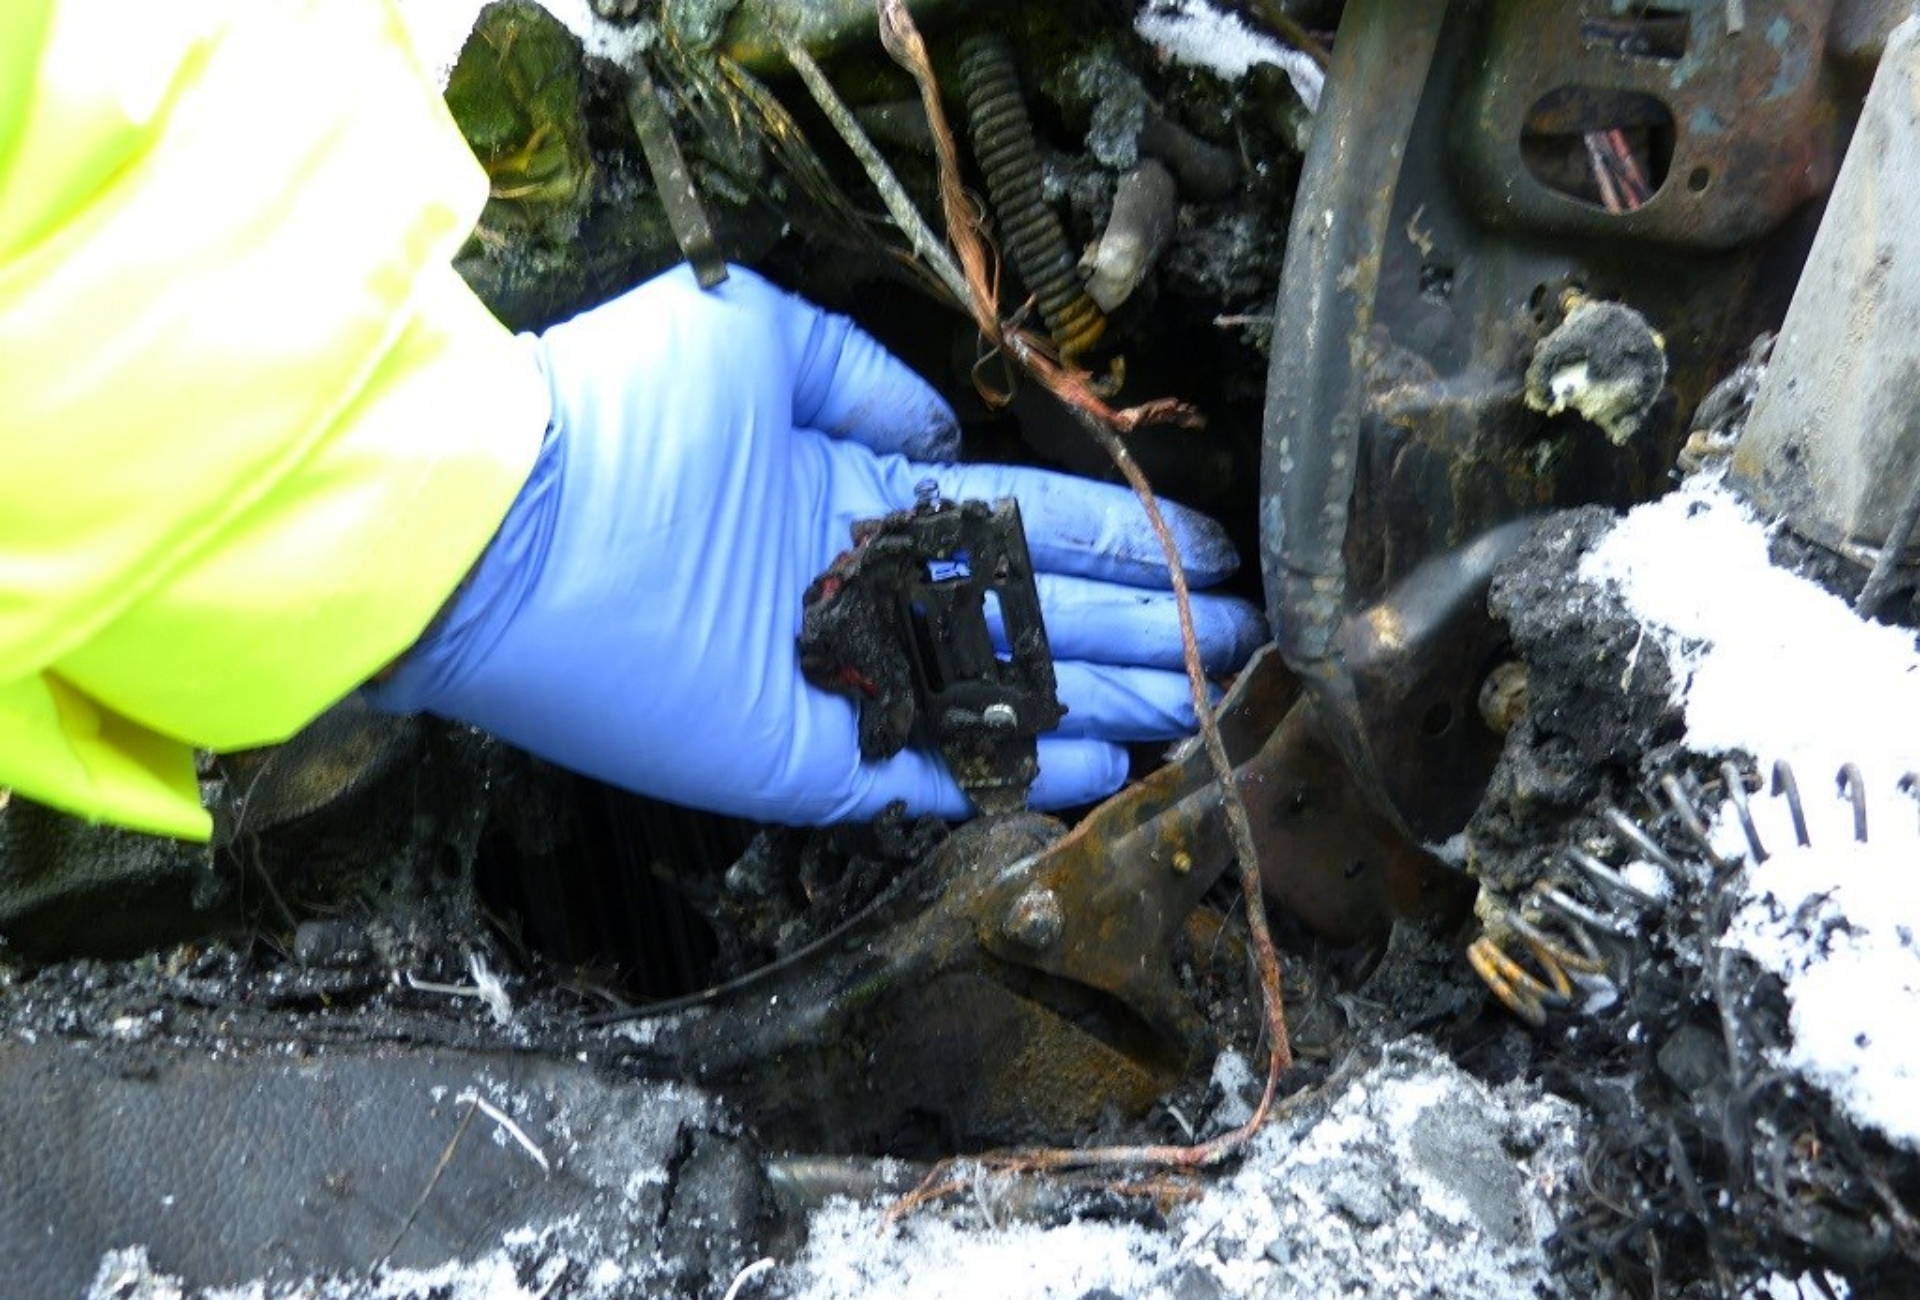
A detailed portion of the lower aft portion of the driver seat is visible. The driver seat belt buckle is visible, with severe fire damage having melted away most of the non-metal parts.
