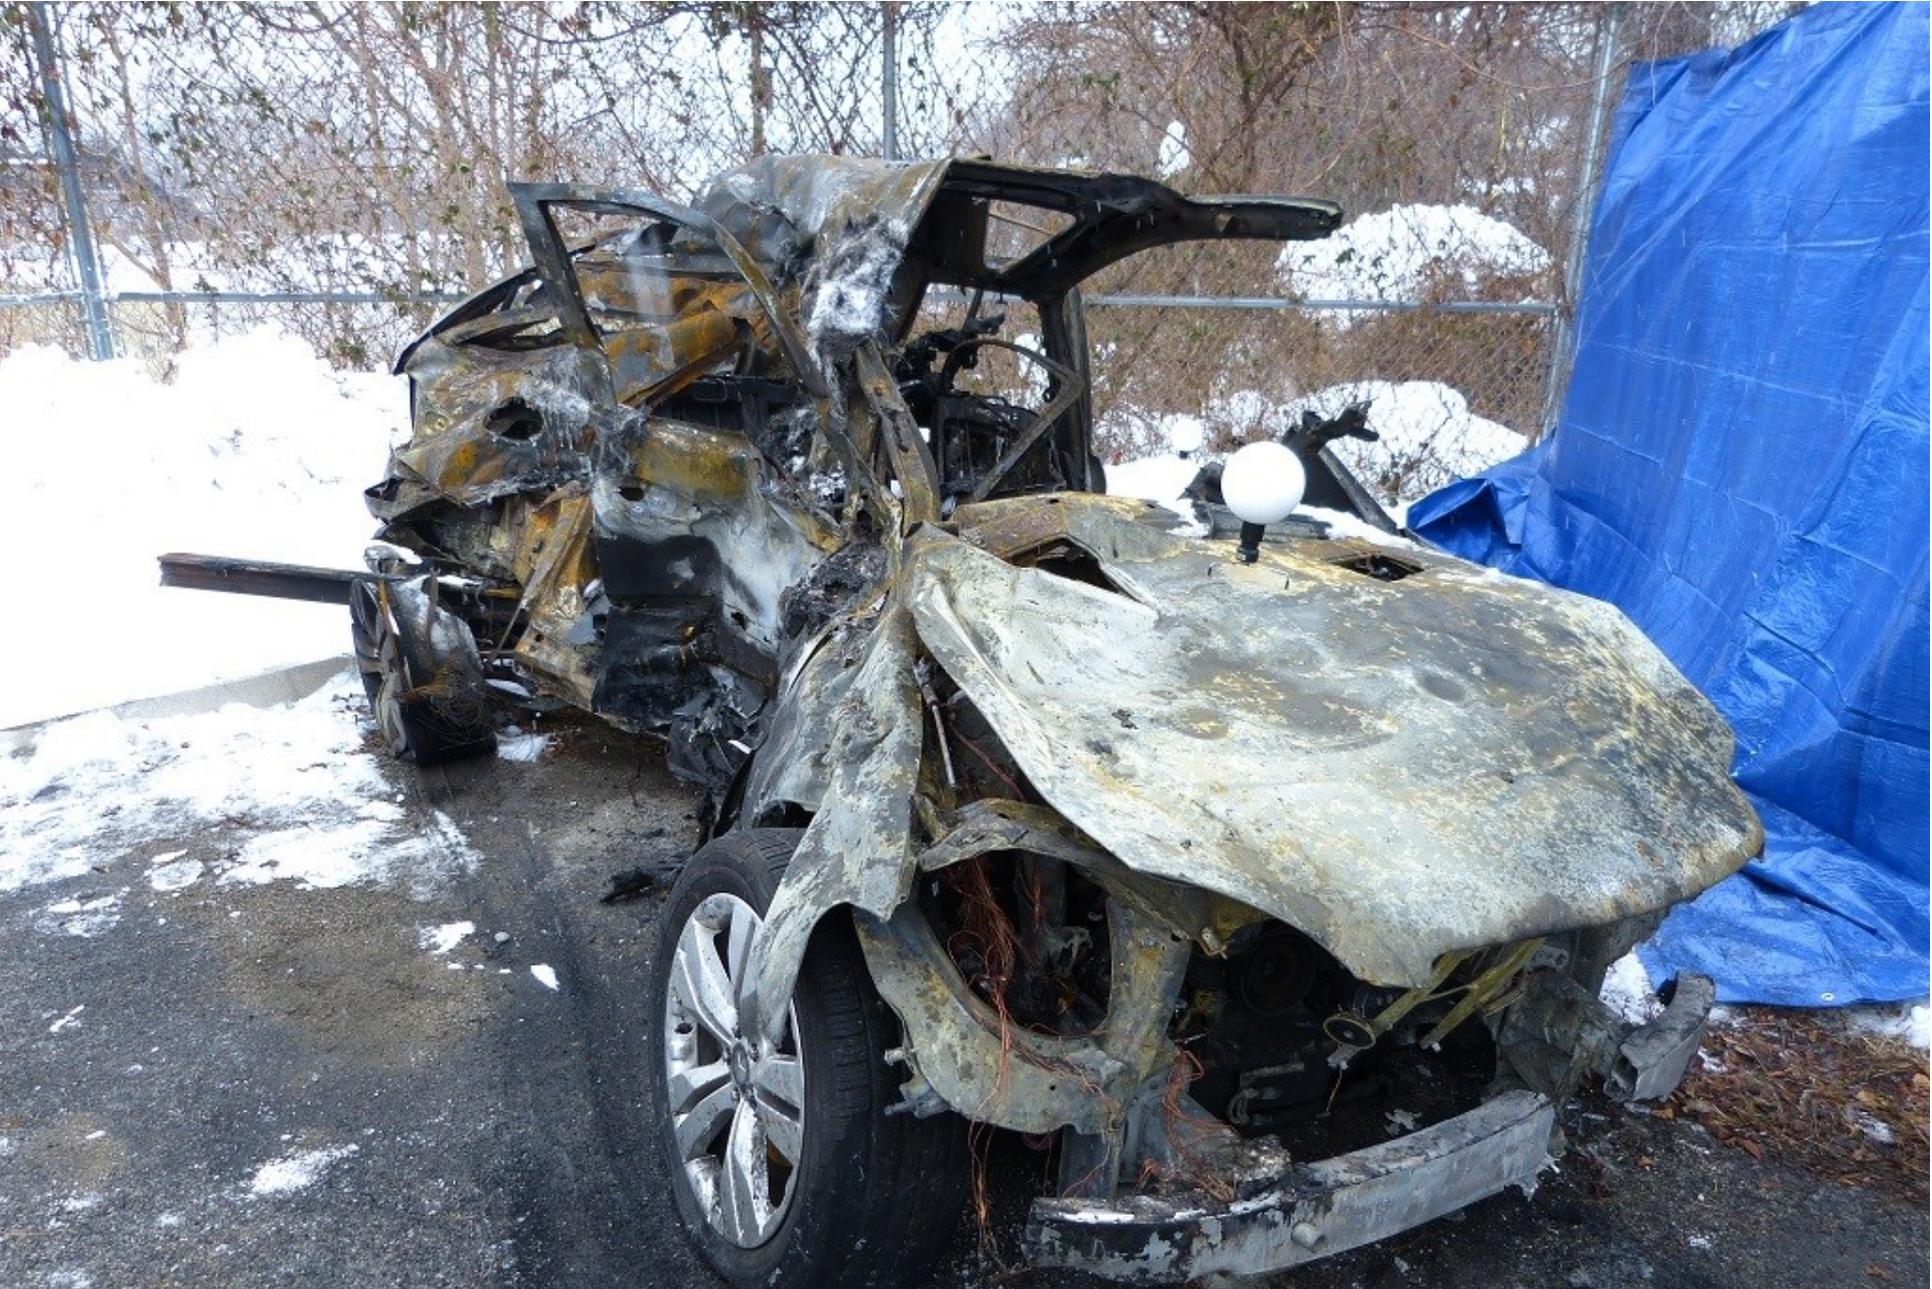
The front and a portion of the right side of the SUV is visible. The severe inward crushing of the right side is visible.
