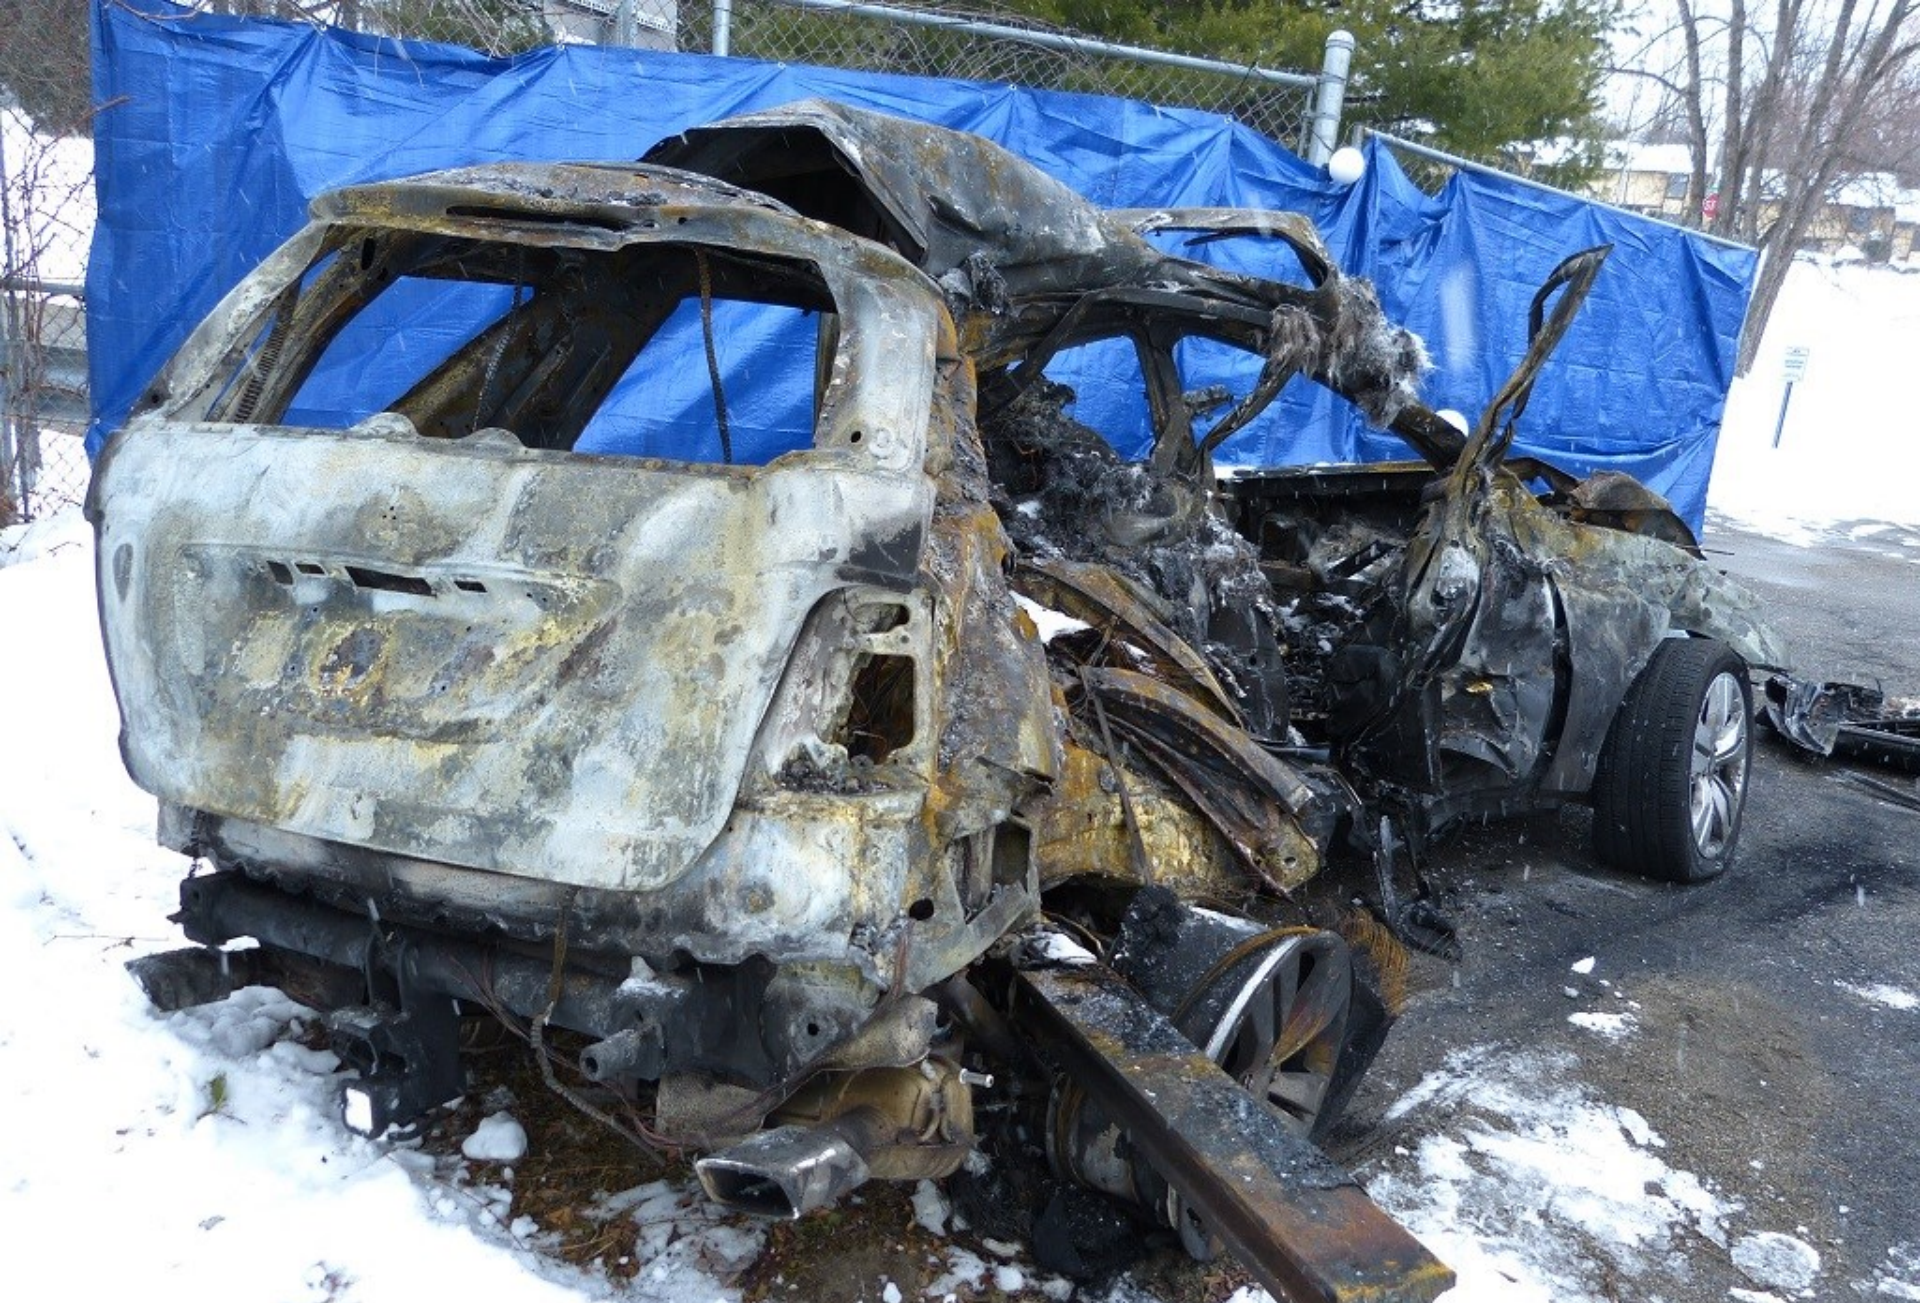
The rear and a portion of the right side of the SUV is visible. The railroad rail protruding from the right rear corner of the car is visible and the severe crushing of the right side of the car is visible.
