SURVIVAL FACTORS PHOTOGRAPHS

Palm Springs, California

HWY17MH005

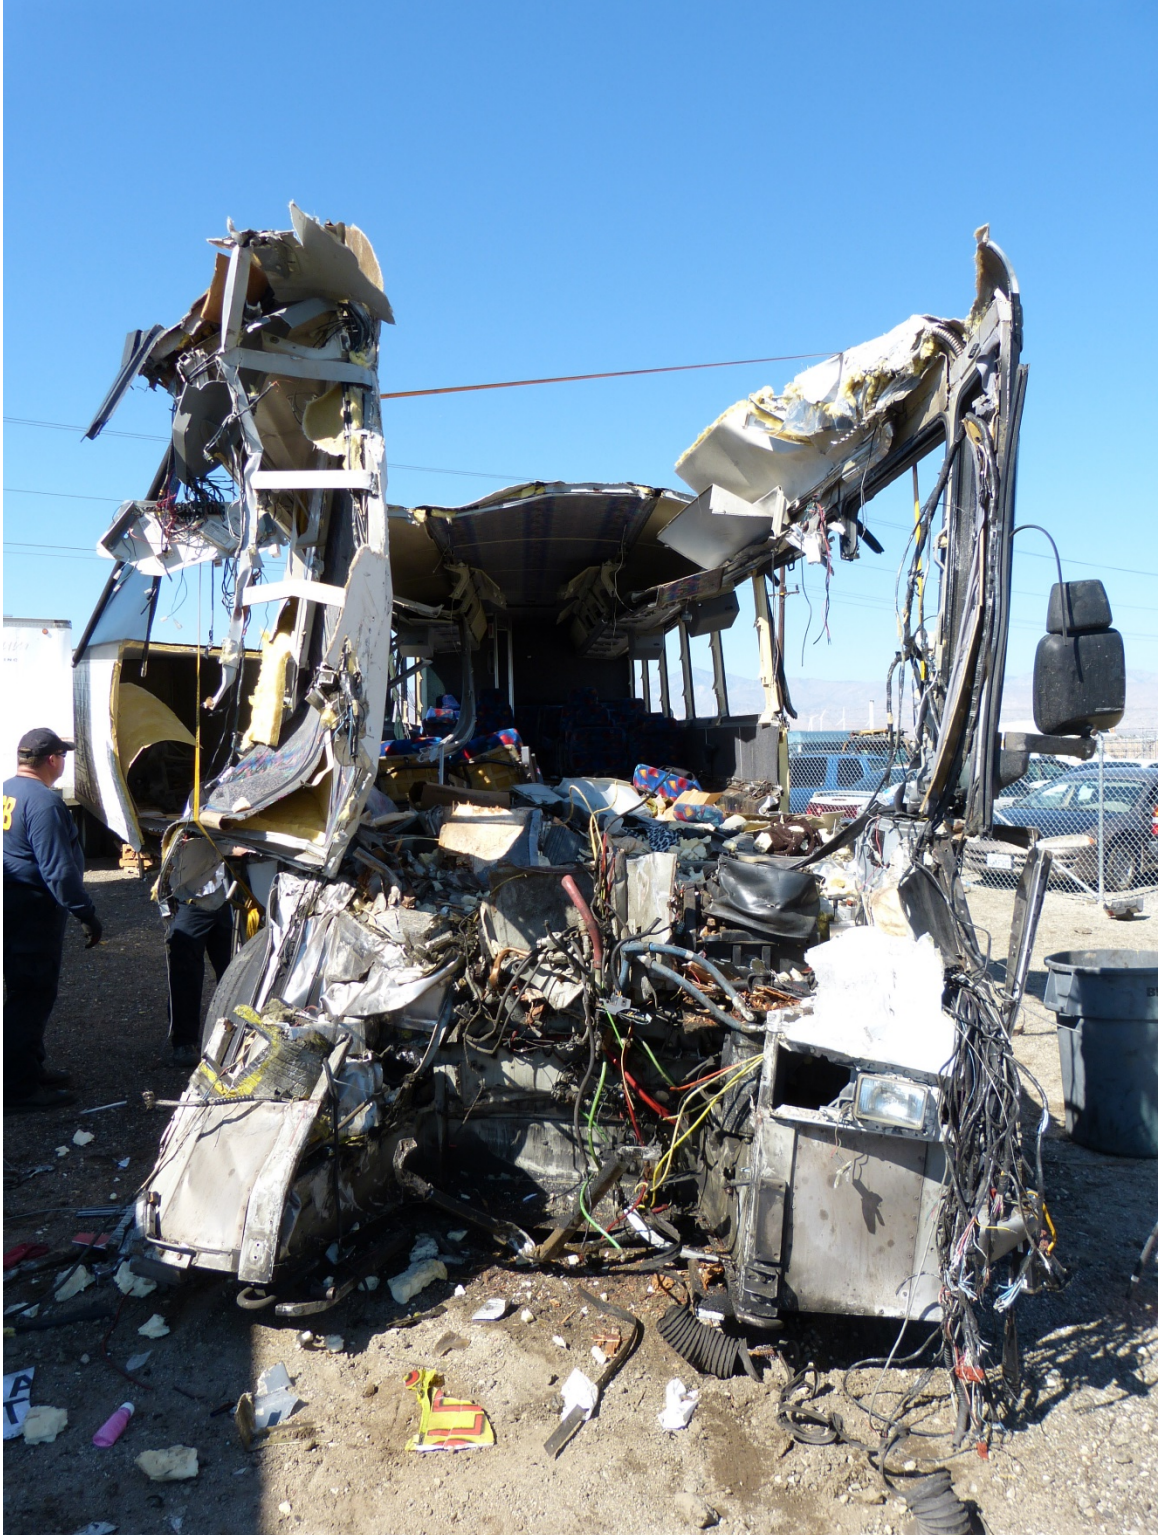
SF Photograph 1 shows a view of the front of the motorcoach. The front of the motorcoach exhibits severe damage with the entire windshield and front panel displaced. The internal components, wiring are visible. The driver seat, front passenger seats, front windows, and portions of the forward sidewalls are visibly displaced.

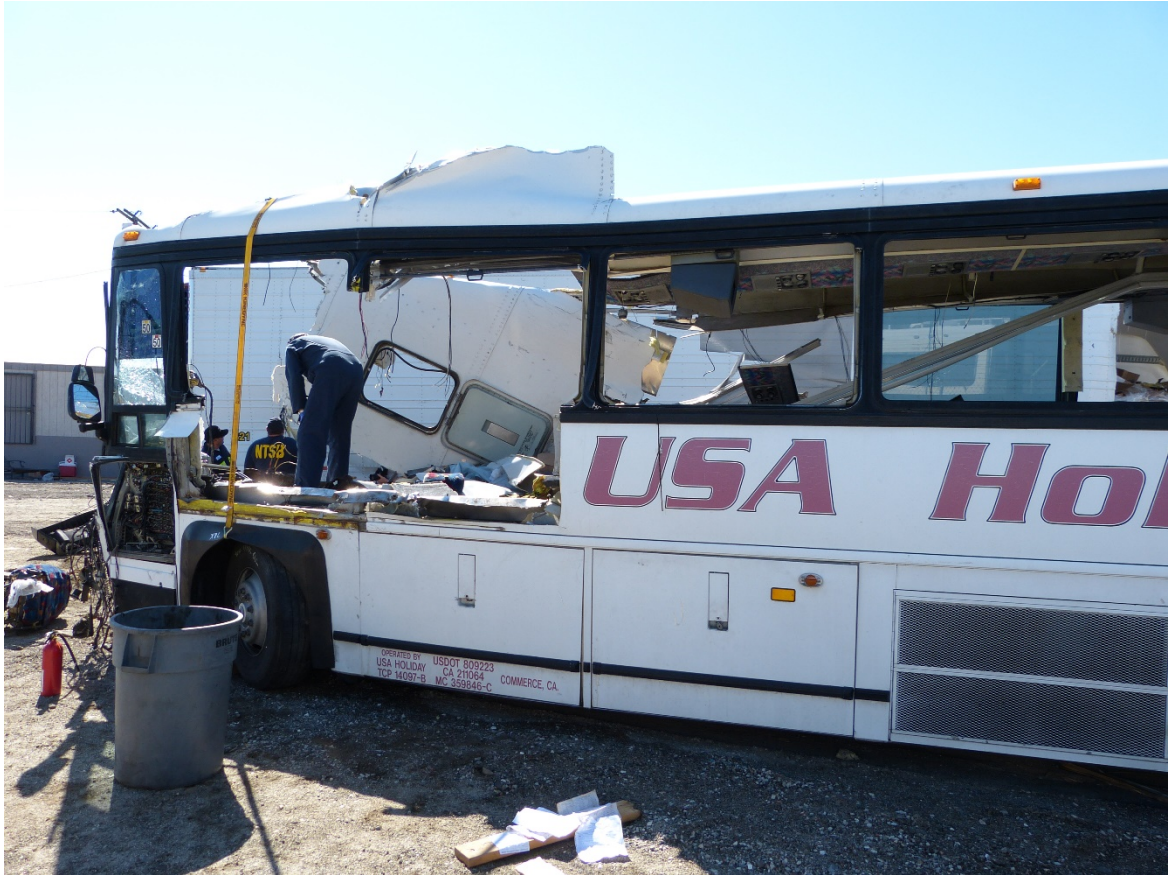
SF Photograph 2 shows a view of the front portion of the motorcoach on the driver side. Severe damage is visible at the sidewall and passenger window aft of the driver window and above the front tire. The sidewall is visibly cut away and portions of the interior can be seen, showing that the driver seat and passenger seats in the front are displaced. The front portion of the roof has collapsed and is visible with the driver side edge resting the floor, and the forward roof hatch open and visible.

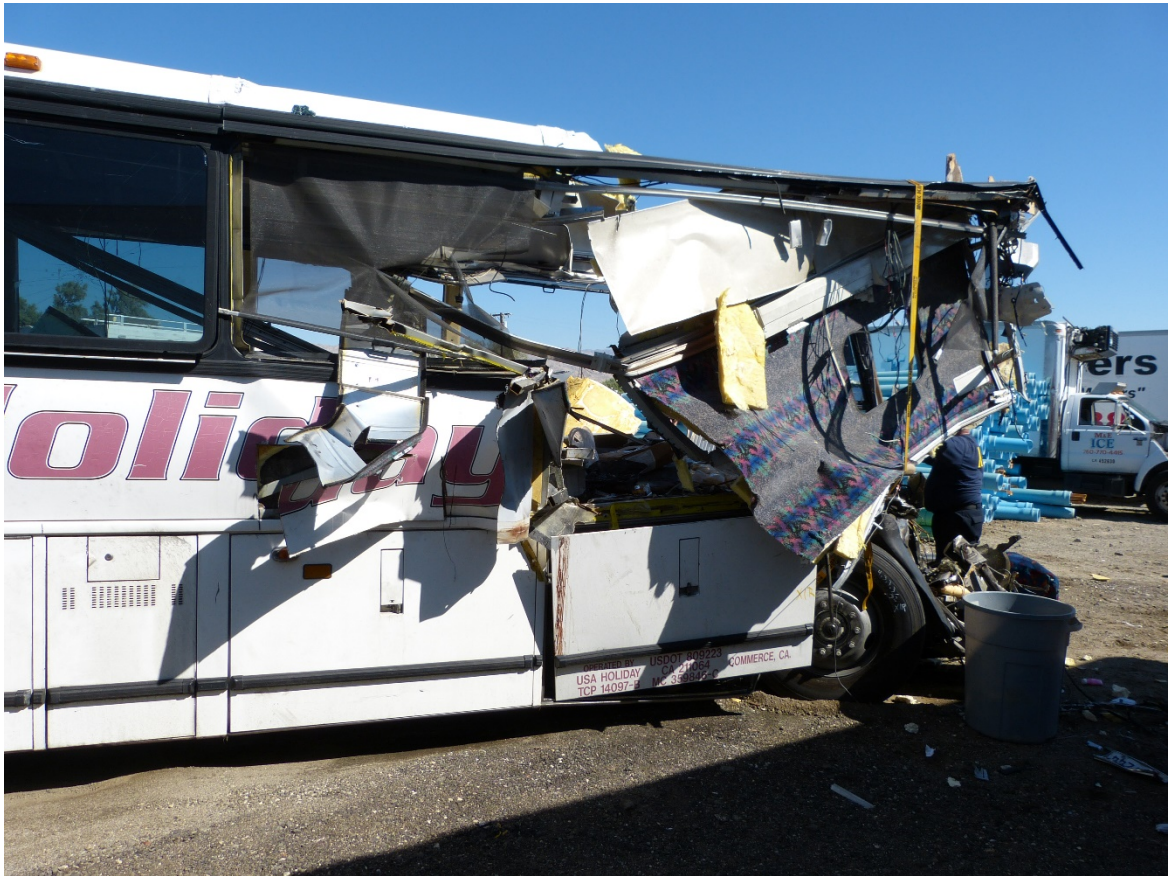
SF Photograph 3 shows the forward passenger side portion of the motorcoach. Extensive damage is visible, with large portions of forward of the front wheels, including the loading door missing; the roof of the motorcoach has collapsed and is visible hanging with the driver side edge resting on the floor. The forward 3 passenger windows are broken out. There are cuts visible in the sidewall from first responder extrication operations.

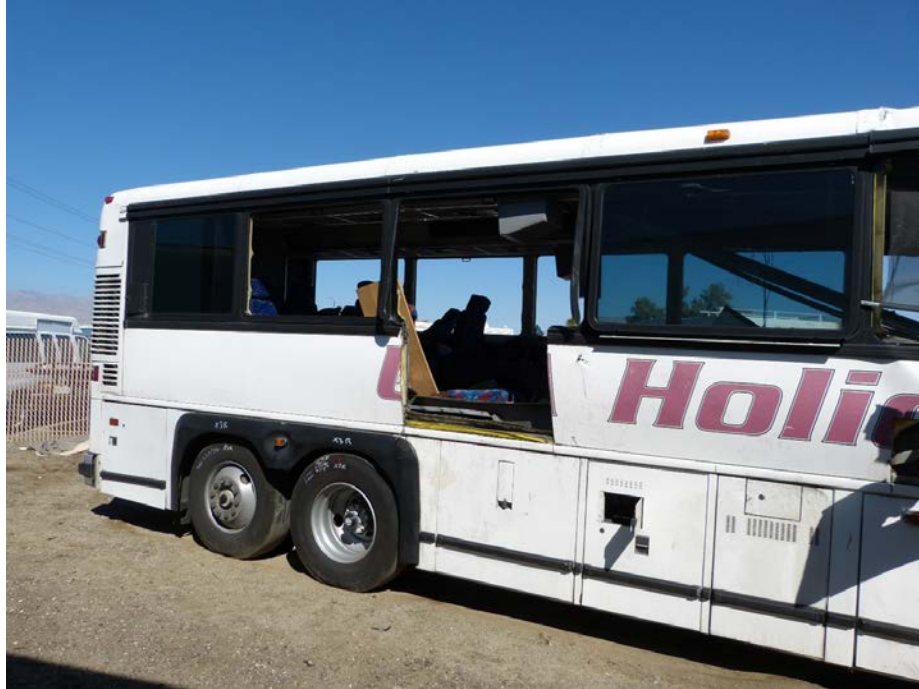
SF Photograph 4 shows the aft portion of passenger side of the motorcoach. The sidewall of the motorcoach forward of the rear wheels exhibits a cutout portion from first responder extrication operations, and the 2 passenger windows in front of the aft passenger window are broken out.

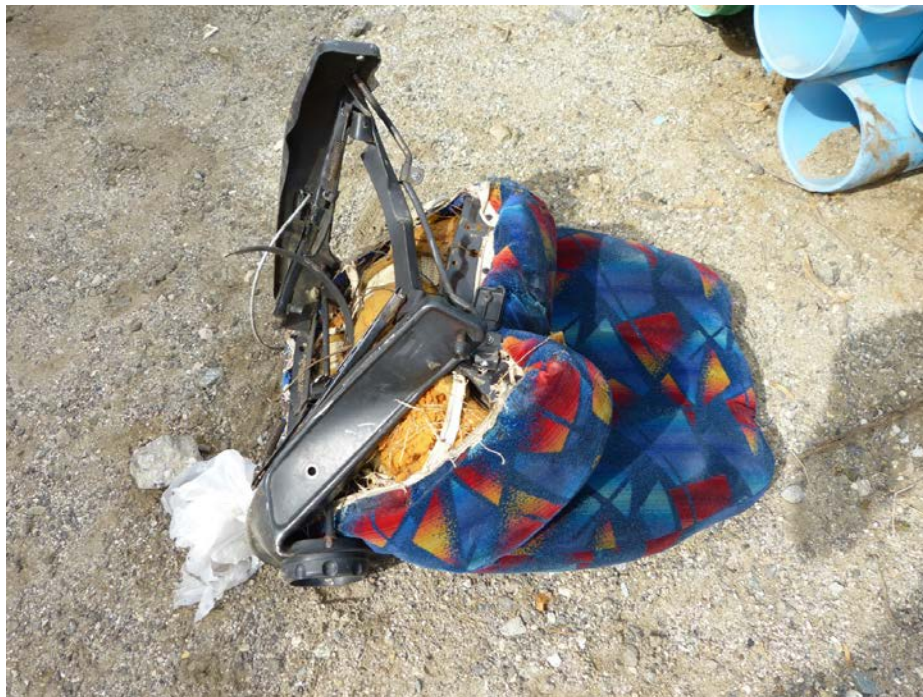
SF Photograph 5 shows a view of the front of the drivers seat. Severe deformation at the front middle section of the seat pan is visible. The lower portion of the seat frame is visible with extensive damage. The headrest is missing.

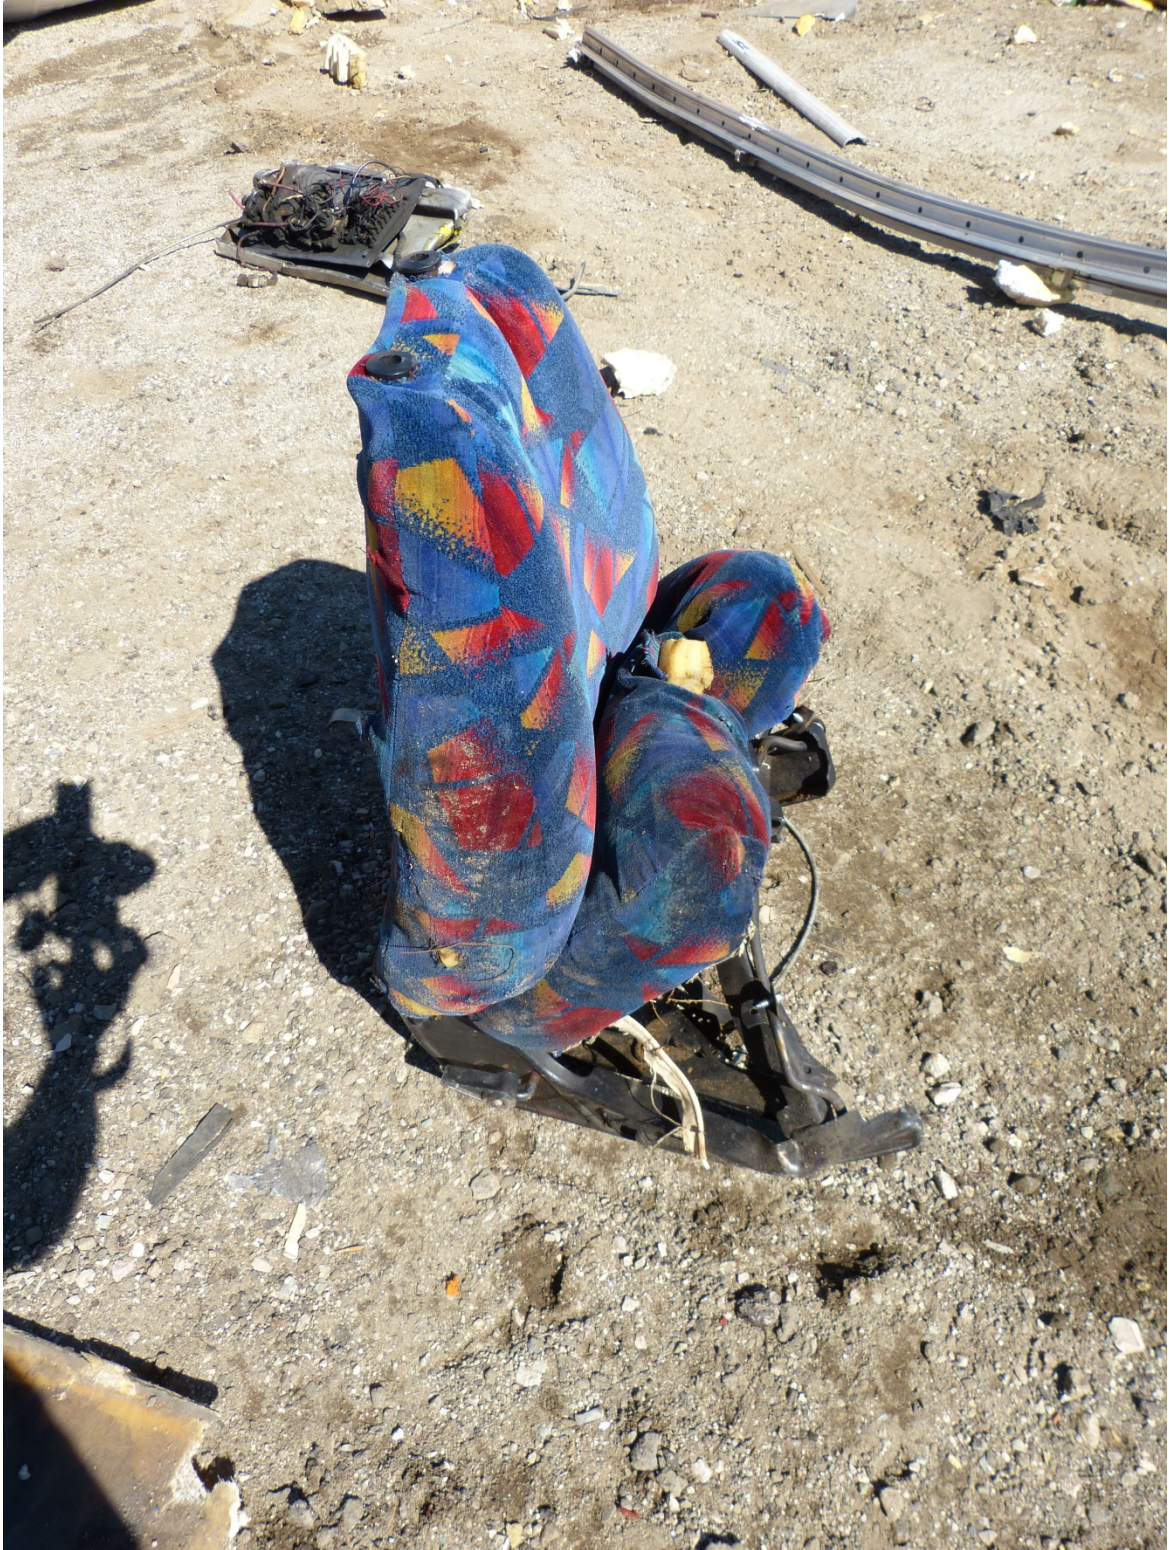
SF Photograph 6 shows an inboard side view of the driver seat. Severe deformation is visible at the middle portion of the seatpan, and the seatframe is severely deformed. The headrest is missing.

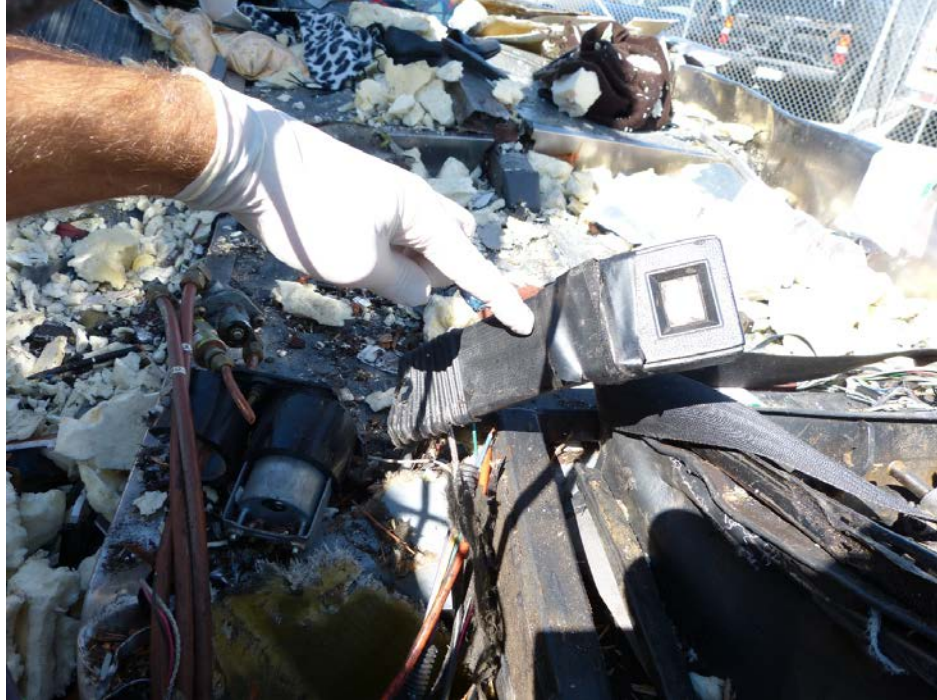
SF Photograph 7 shows the driver seat belt buckle attached to the lower portion of the driver seat frame, which remained attached to the floor of the motorcoach. The buckle is not connected to the belt, and the area surrounding the buckle is extensively damaged.

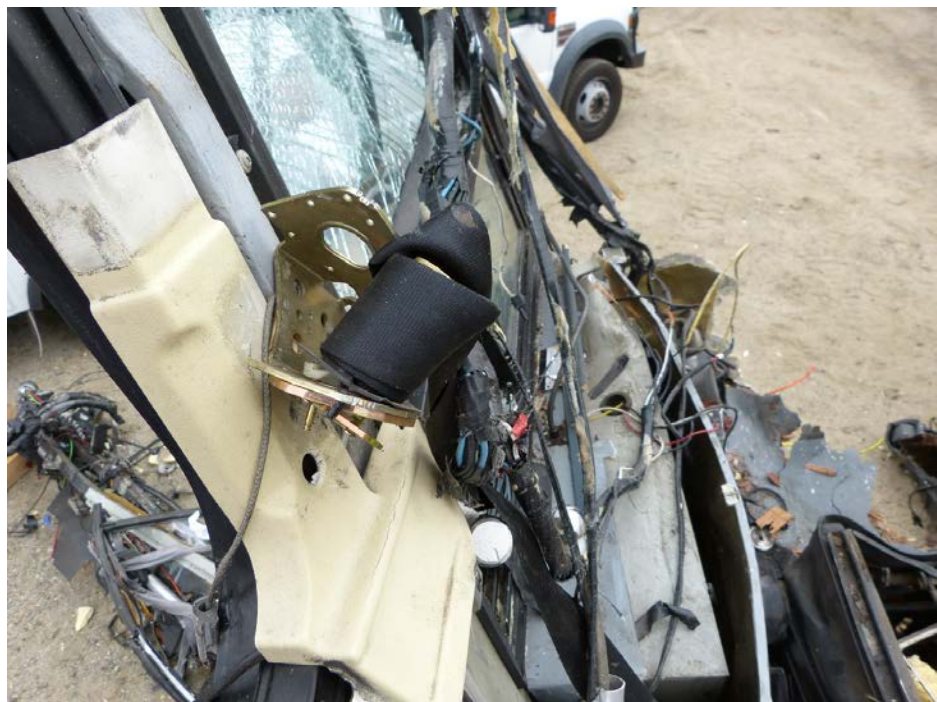
SF Photograph 8 shows the upper attachment point and inertia reel of the driver seat belt. The reel is damaged with the cover missing, the frame is fractured and seat belt webbing partially displaced from the reel.

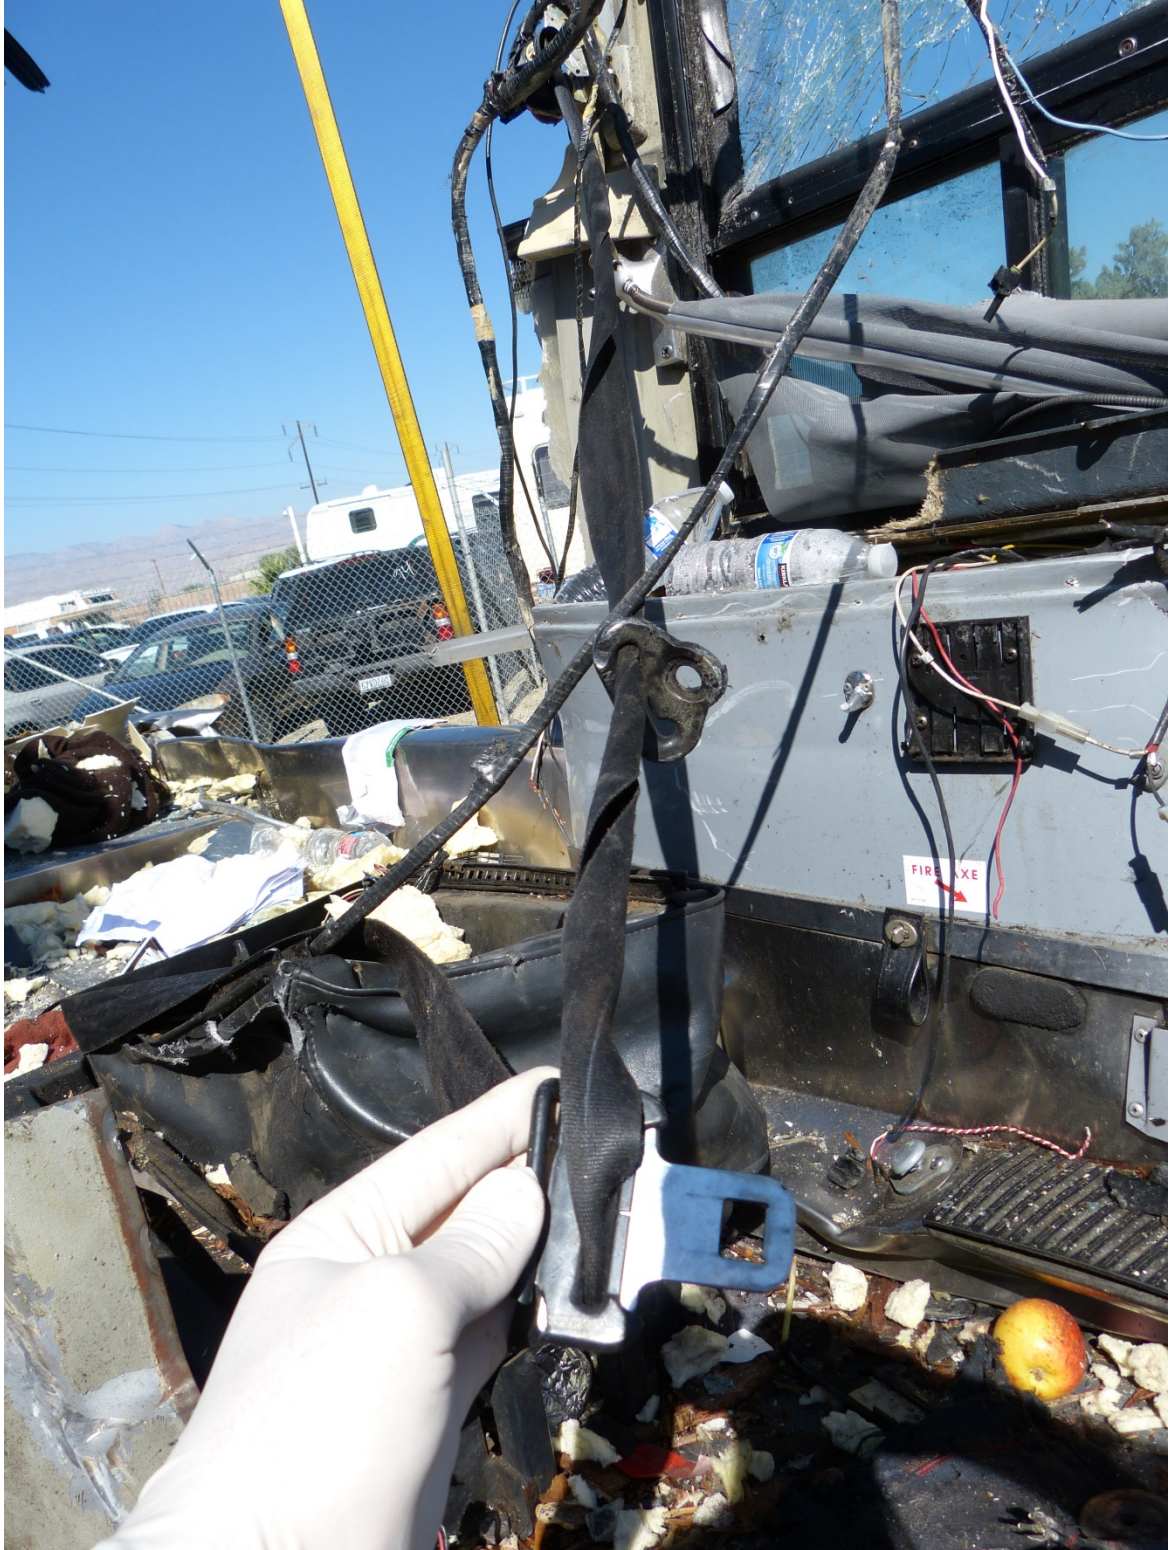
SF Photograph 9 shows a view of the driver seat belt with the webbing, connector, and attachment bracket visible. The attachment bracket is dislodged and the webbing is twisted. Severe damage to the surrounding motorcoach structure is visible, and the sidewall aft of the belt attachment has a large section cut away by responders.

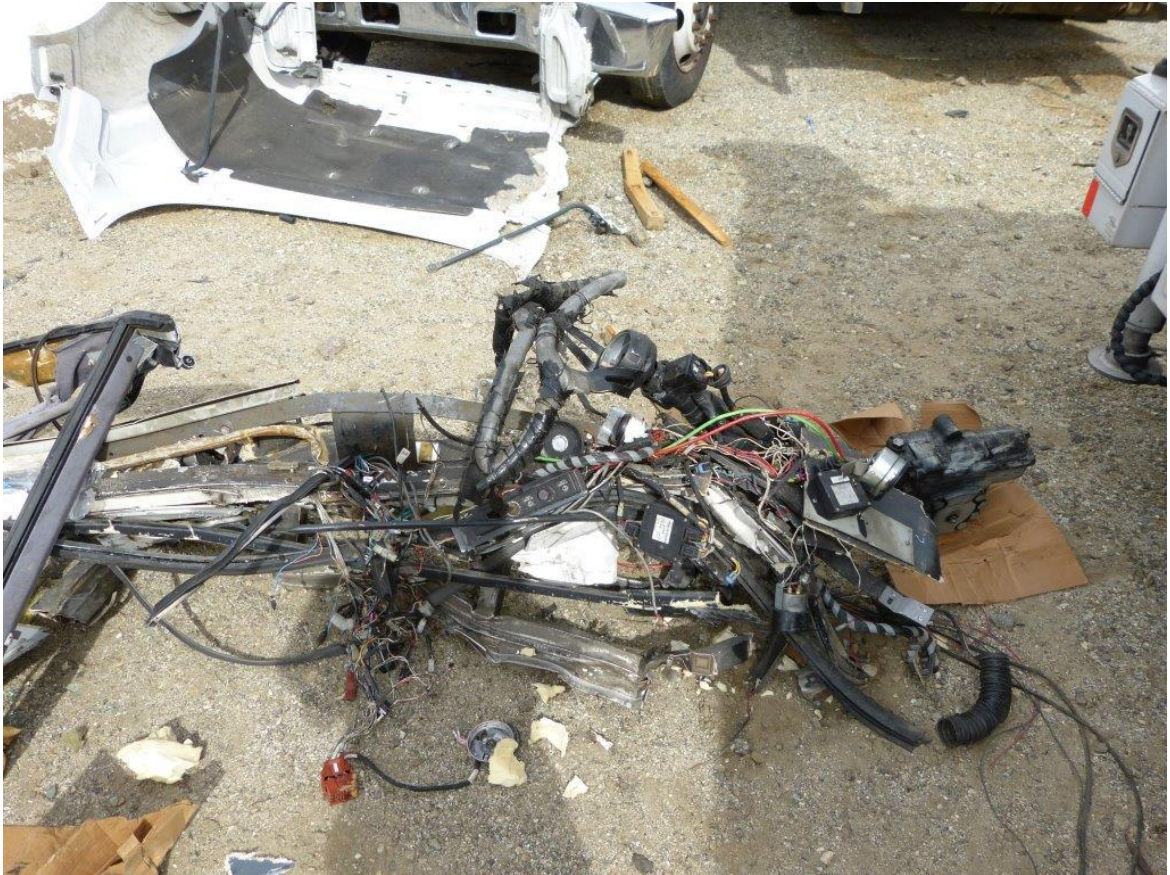
SF Photograph 10 shows the motorcoach steering wheel and portions of the steering column, steering gear, and portions of other surrounding components. The portions of the steering wheel that were found towards the front and back of the motorcoach have been crushed to the center of the wheel. The surrounding components exhibit severe damage.

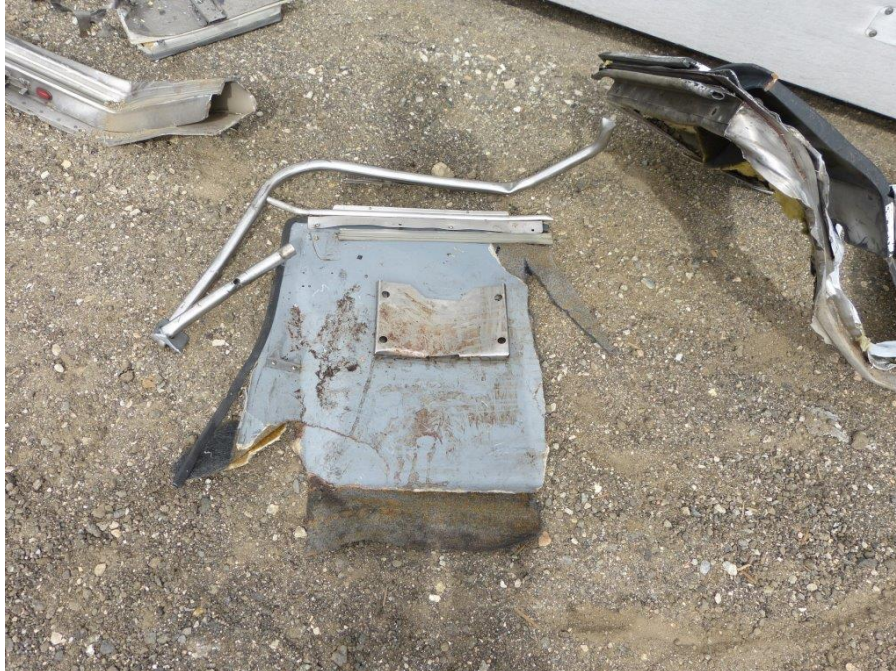
SF Photograph 11 shows the forward side of the driver side privacy panel. The panel was dislodged from the motorcoach and found in the debris pile. It exhibits extensive damage including a fractured portion at the lower inboard corner and steel tubing around the upper and inboard sides is deformed.

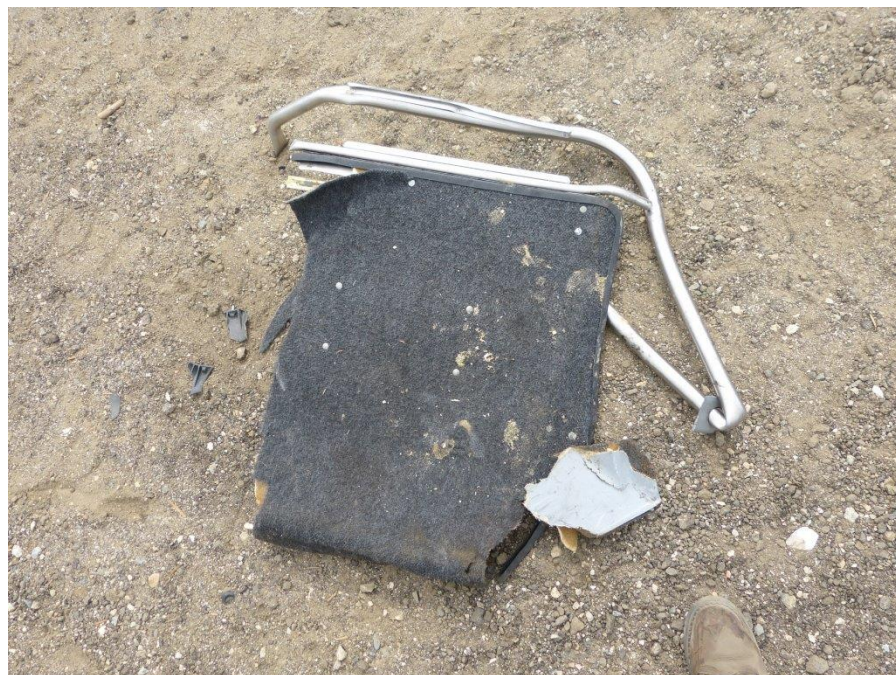
SF Photograph 12 shows the aft side of the driver side privacy panel. The panel was dislodged from the motorcoach and found in the debris pile. It exhibits extensive damage including a fractured portion at the lower inboard corner and steel tubing around the upper and inboard sides is deformed.

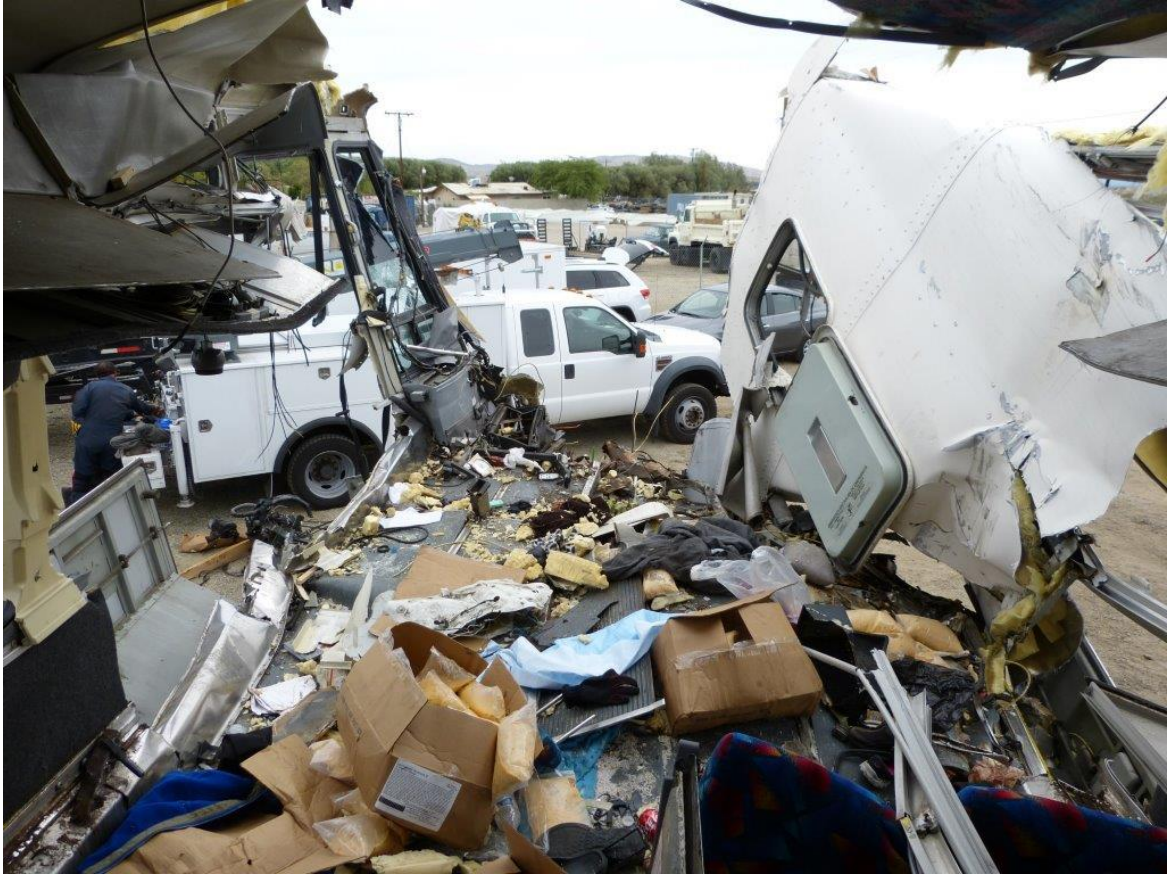
SF Photograph 13 shows a view of the interior looking from the middle of the motorcoach towards the front. Extensive damage and debris is visible. The entire front and roof in this region of the motorcoach is displaced with a large section of the roof visible partially attached to the passenger sidewall.

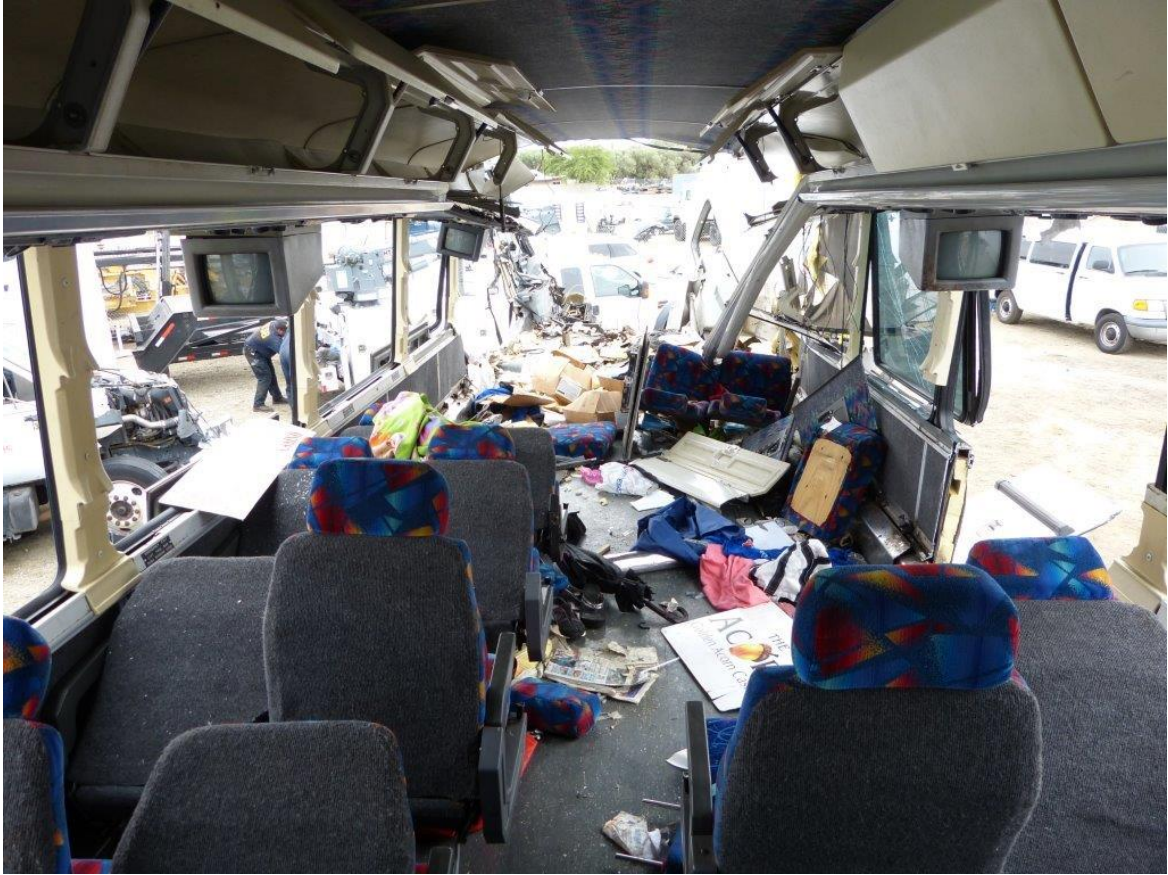
SF Photograph 14 shows a view of the interior looking from near the back of the motorcoach towards the front. The middle section of the motorcoach interior is visible. Seats in the section are missing and there is extensive damage and debris visible. A section of the sidewall on the passenger side is visibly cut away, and most of the passenger windows are broken out.

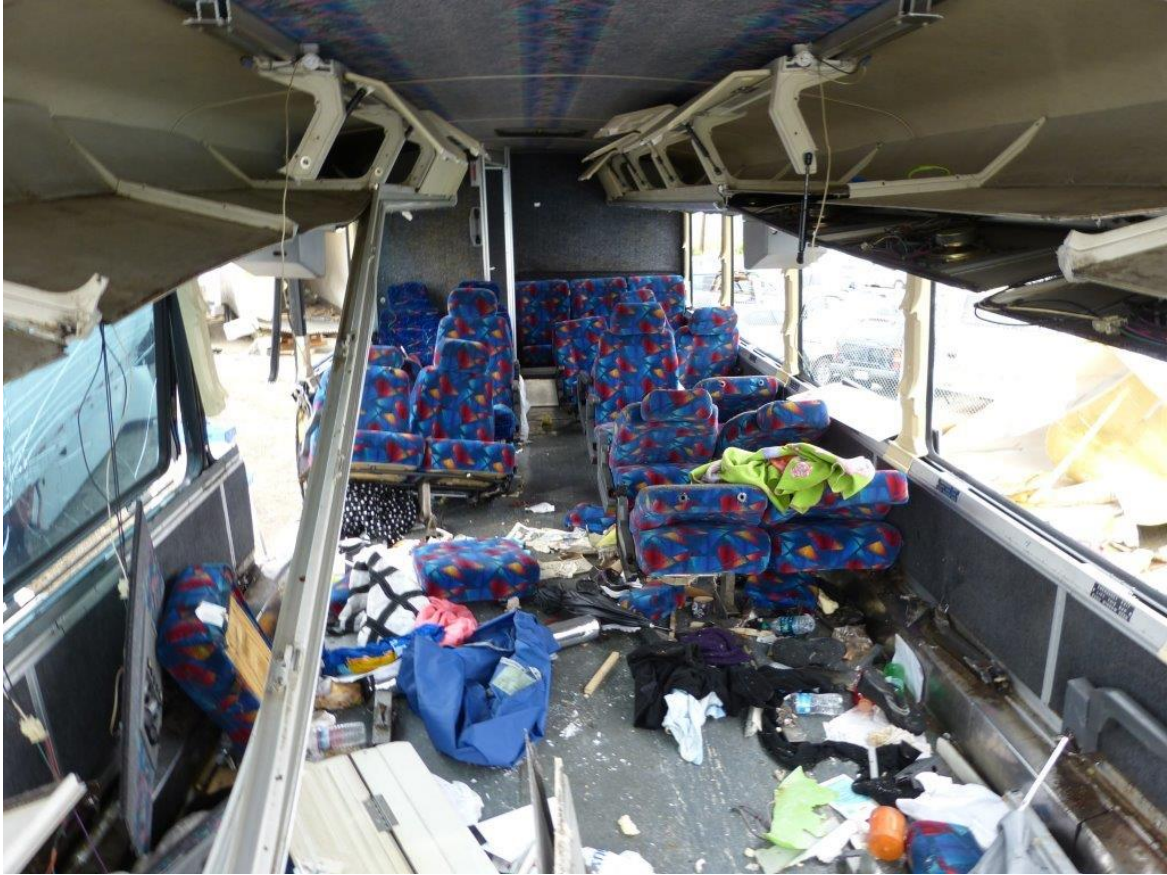
SF Photograph 15 shows a view of the interior looking from the middle of the motorcoach towards the back. The middle of the motorcoach has missing seats, and seats remain in the aft portion of the motorcoach with several exhibiting deformation or damage. The luggage rack are visible, and exhibit severe damage. The passenger windows on the driver side are broken out, and 1 window remains on the passenger side. A section of the passenger sidewall that has been cut away by first responders is visible.

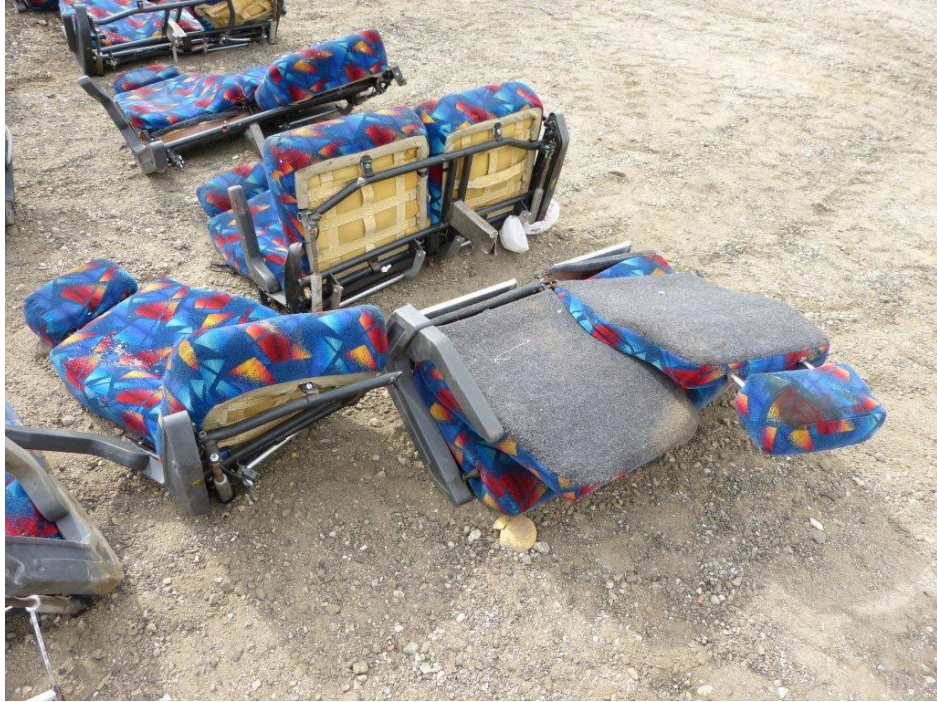
SF Photograph 16 shows a group of passenger seats that were dislodged from the motorcoach and found in the debris pile. The seats exhibit extensive damage, deformation, and evidence of the attachment points being cut by first responders.

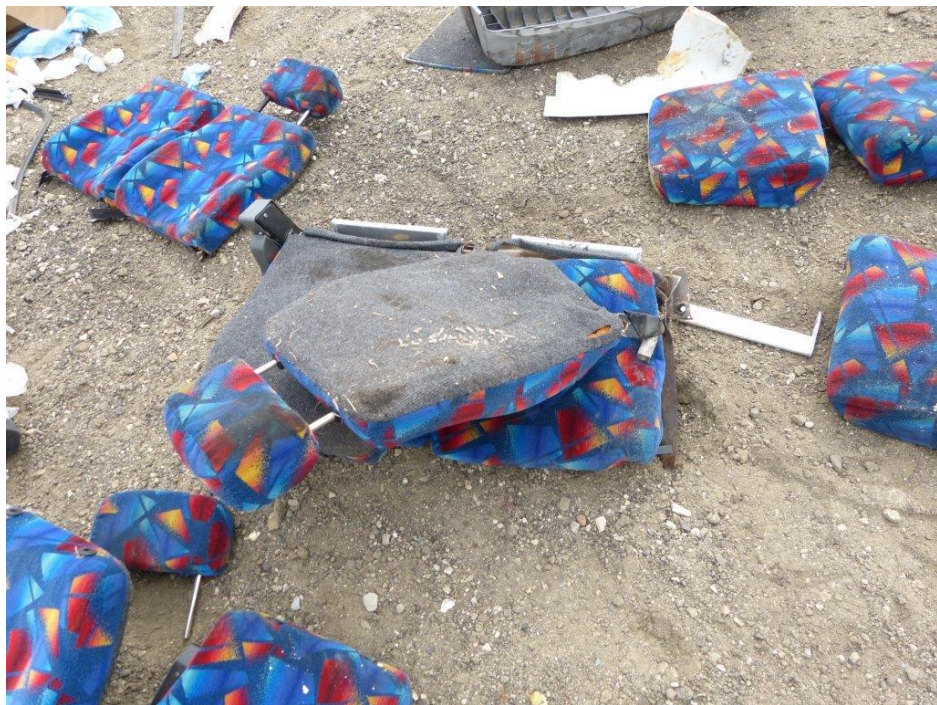
SF Photograph 17 shows a group of passenger seats and components that were dislodged from the motorcoach and found in the debris pile. The seats exhibit extensive damage, deformation, and evidence of the attachment points being cut by first responders. The seats in the middle of the view show deformation likely resulting from occupant impact.

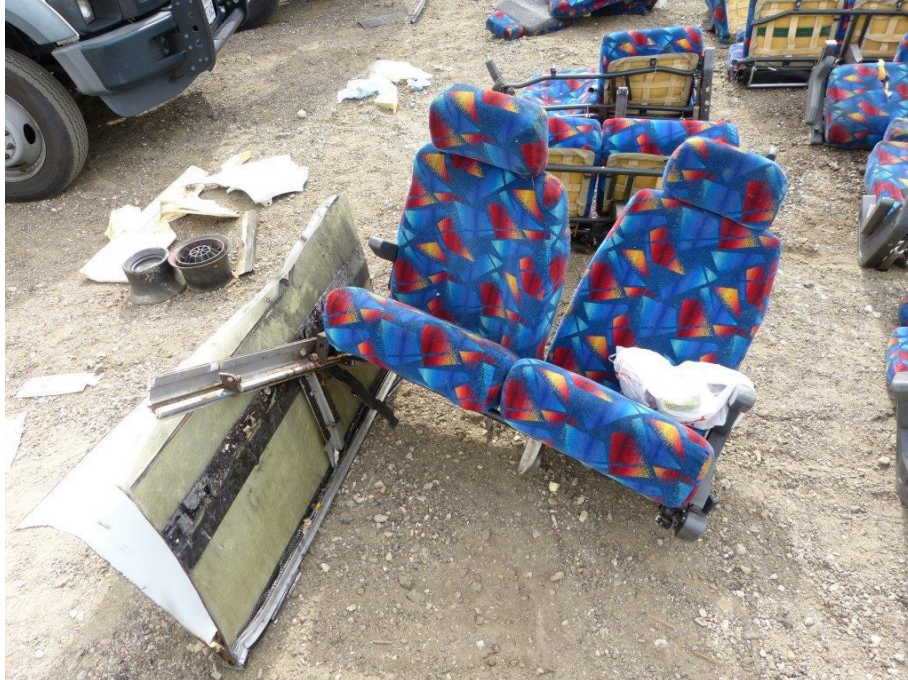
SF Photograph 18 shows a group of passenger seats and components that were dislodged from the motorcoach and found in the debris pile. The seats exhibit extensive damage, deformation, and evidence of the attachment points being cut by first responders. The seats in the middle of the view show a portion of the motorcoach sidewall that remains attached.

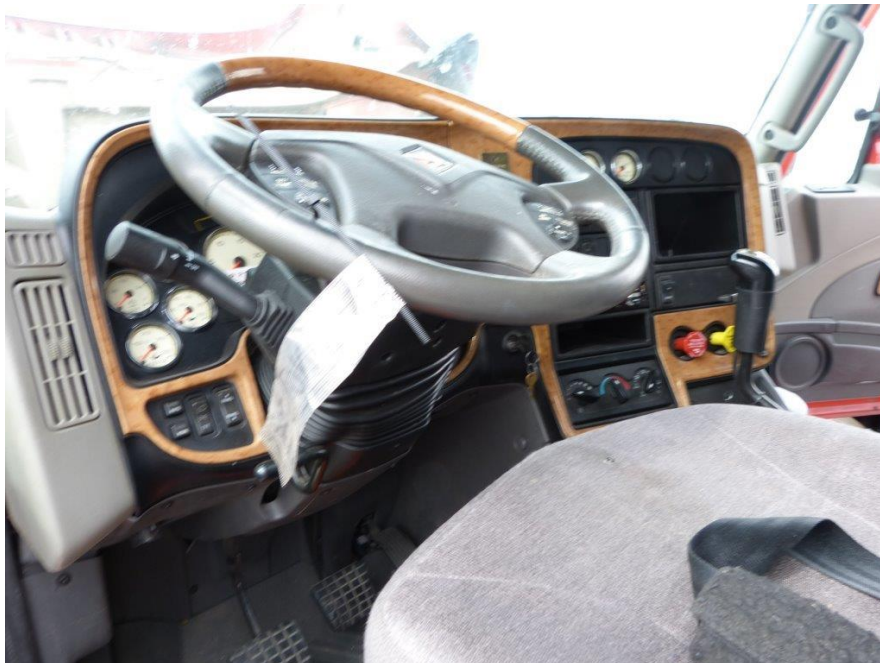
SF Photograph 19 shows a view of the truck driver seating area. The steering wheel, front portion of the driver seat cushion, portions of the controls and portions of the dashboard are visible. There is no apparent damage visible.

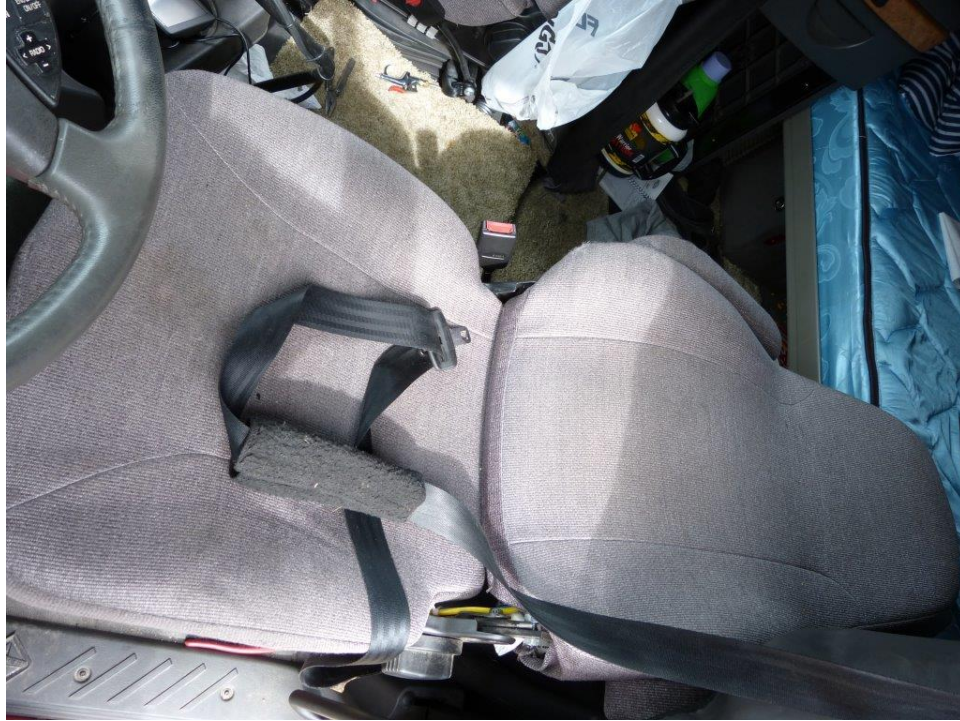
SF Photograph 20 shows a view of the truck driver seat and sleeper berth. Portions of the driver seatbelt visible, and is disconnected and resting on the seat. The seatback is fractured and resting in a reclined position onto the sleeper berth mattress.

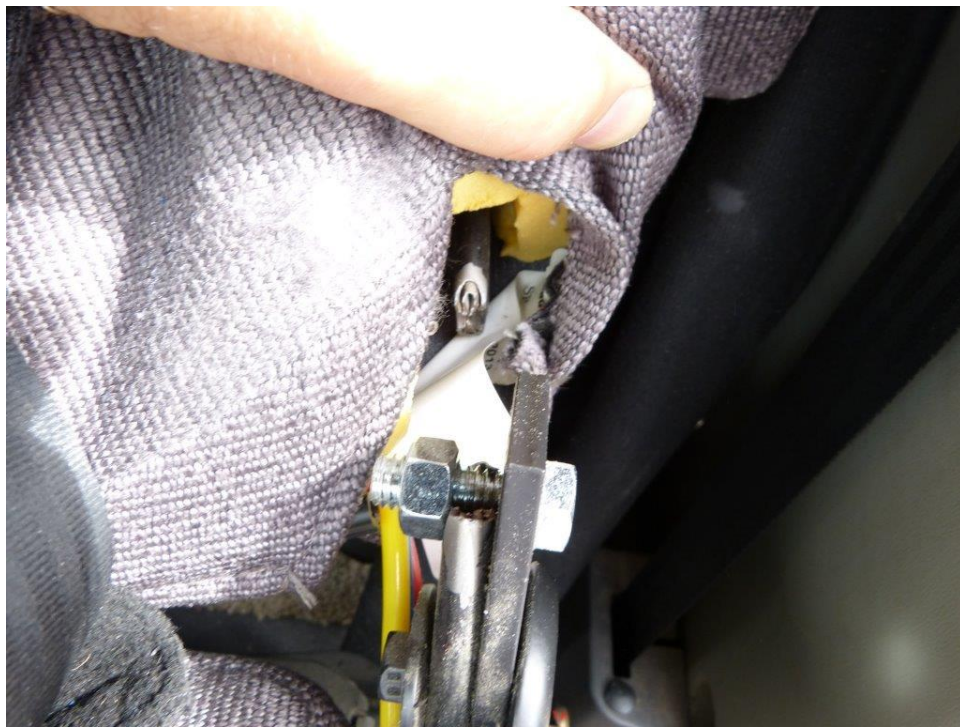
SF Photograph 21 shows a detailed view of the truck driver seat backrest mechanism. The backrest support structure is fractured and separated at the location of an attachment bolt.
