Survival Factors Photographs

Baltimore, Maryland

HWY17MH007

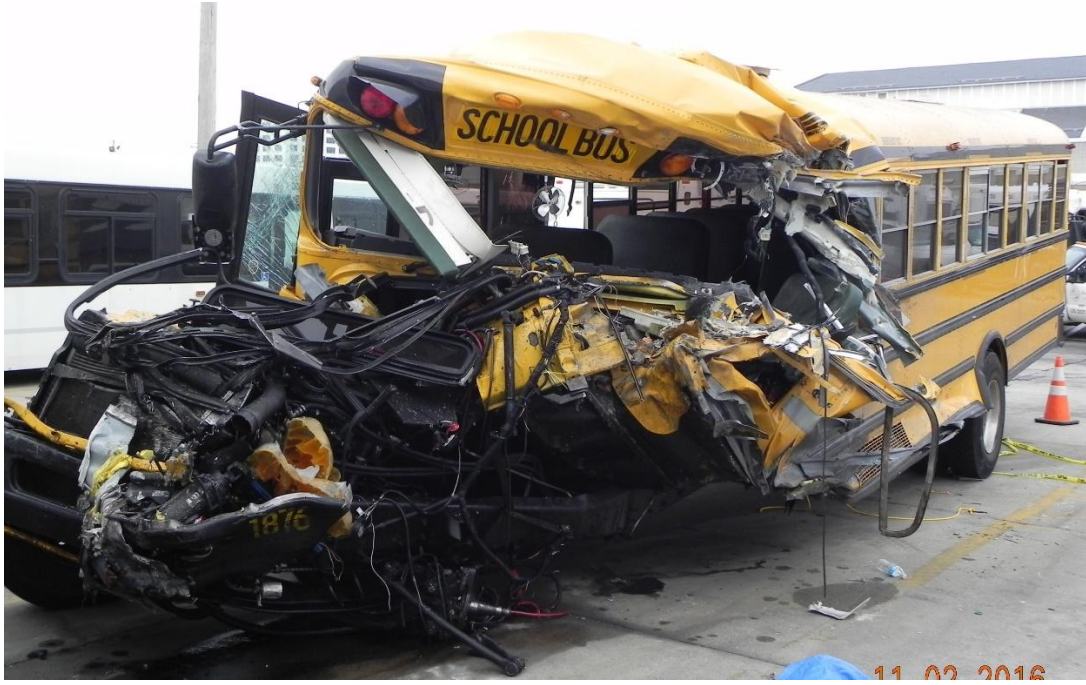
Photo 1 – Exterior view of deformation to front end and left side of IC school bus.

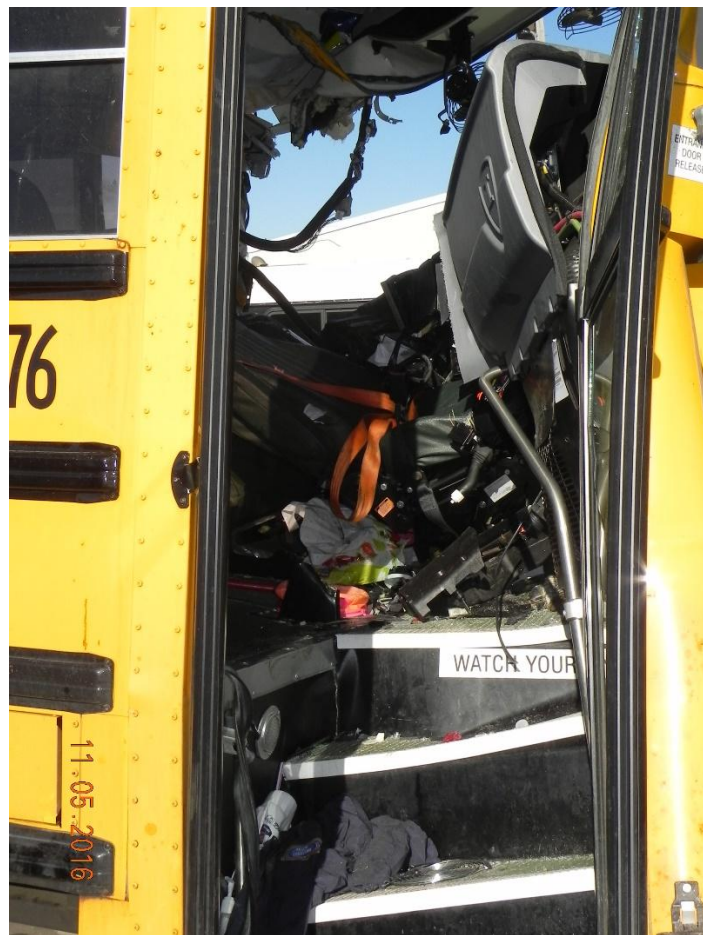
Photo 2 – View looking from outside entry door into loading stairwell and driver seating area showing interior deformation.

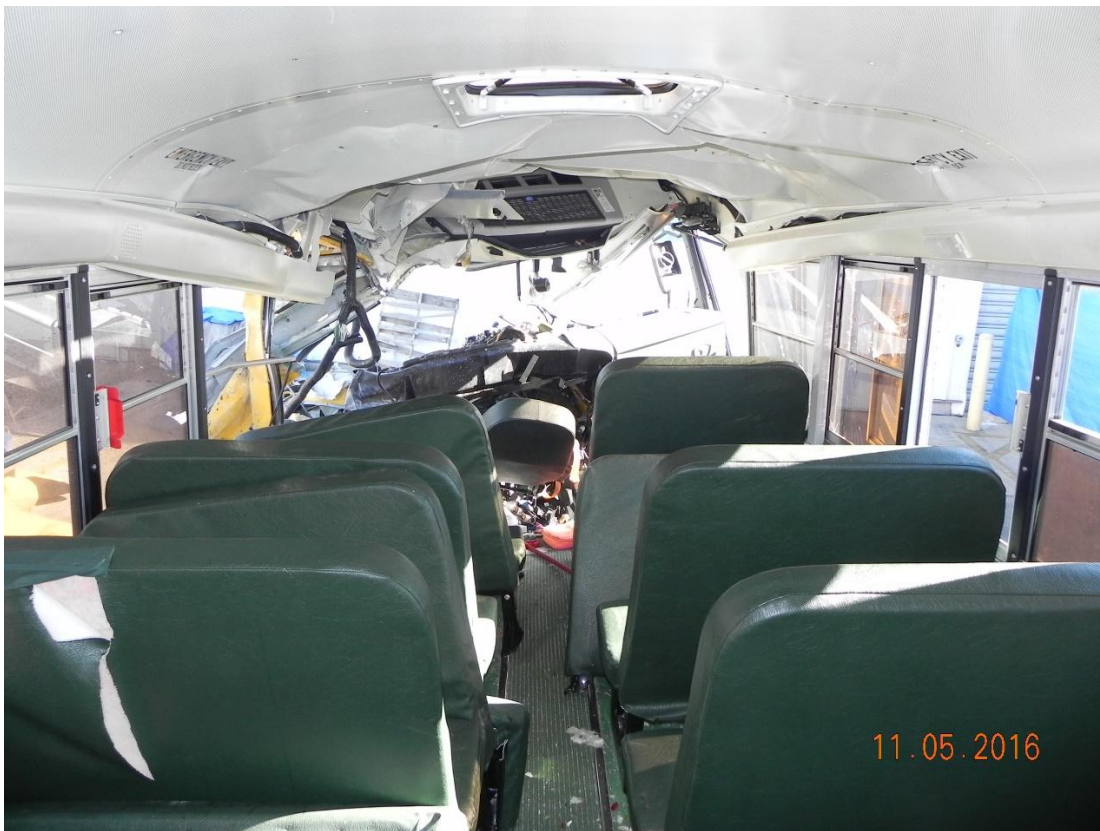
Photo 3 – Interior view of IC school bus looking from midway back to front showing buckling to roof and displaced driver seat.

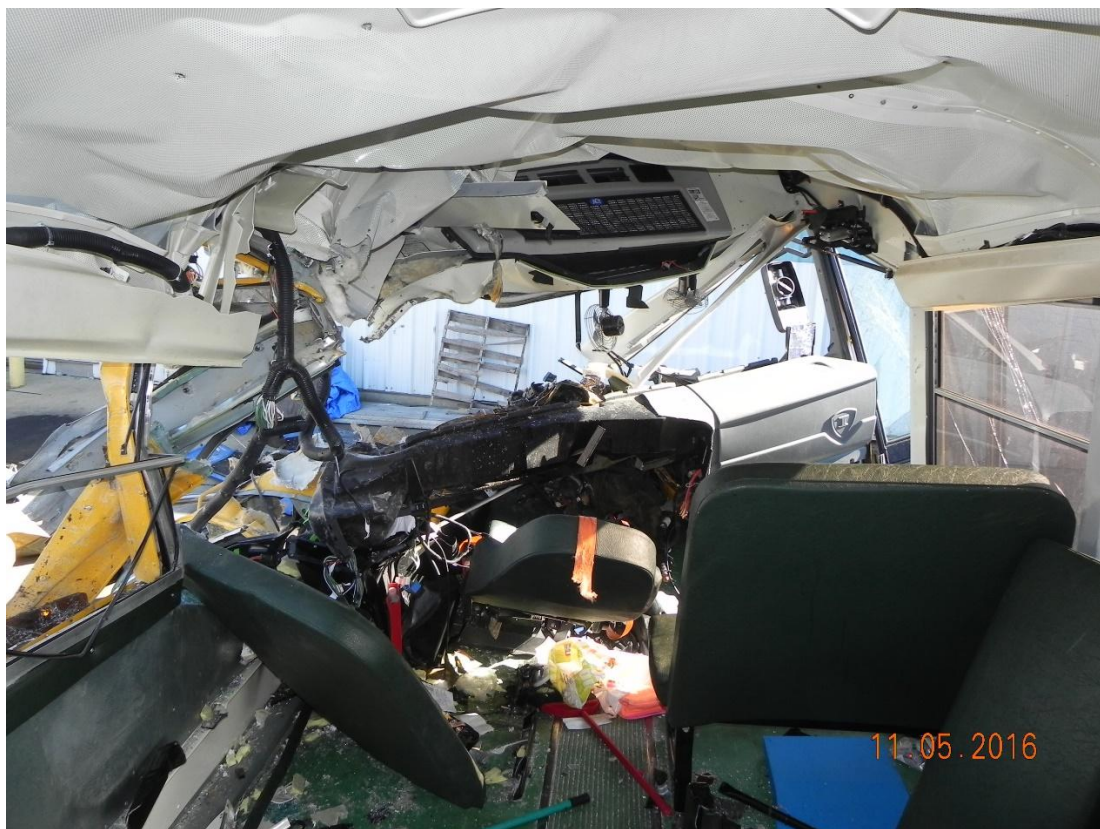
Photo 4 – Closer-up interior view of displaced driver's seat and area of intrusion.

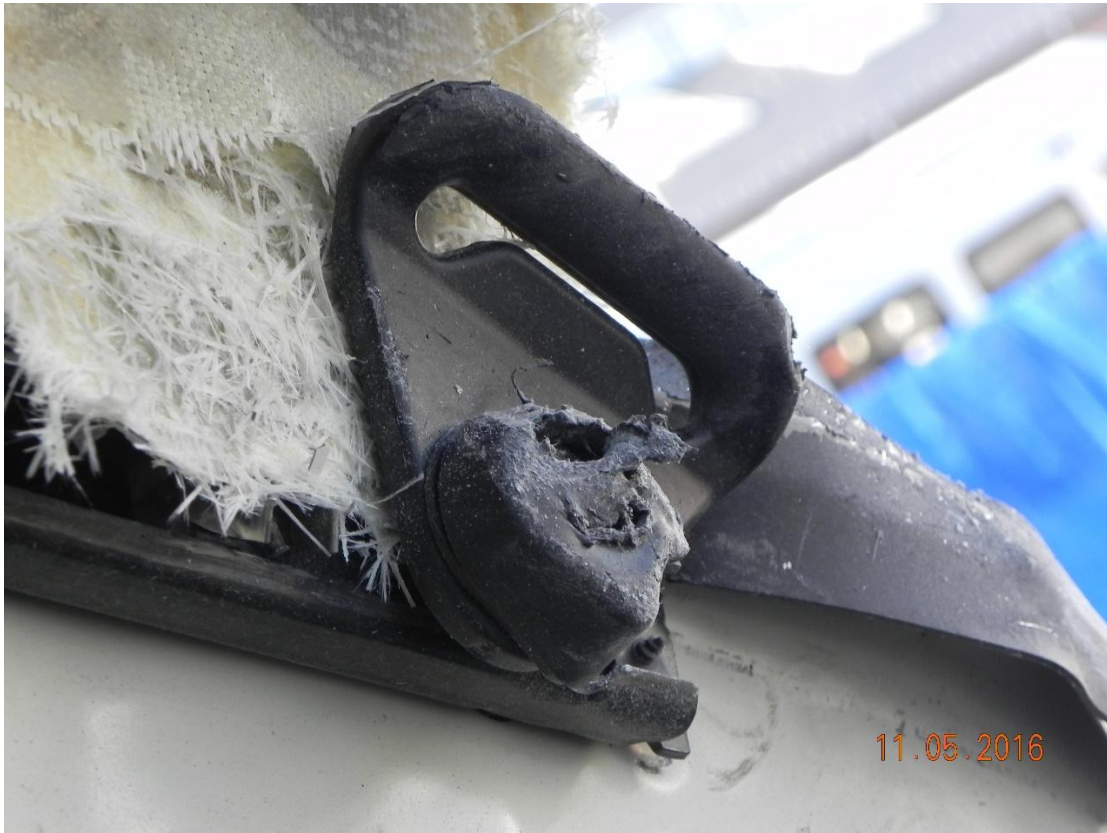
Photo 5 – Close-up view of damaged D-ring for school bus driver's shoulder belt.

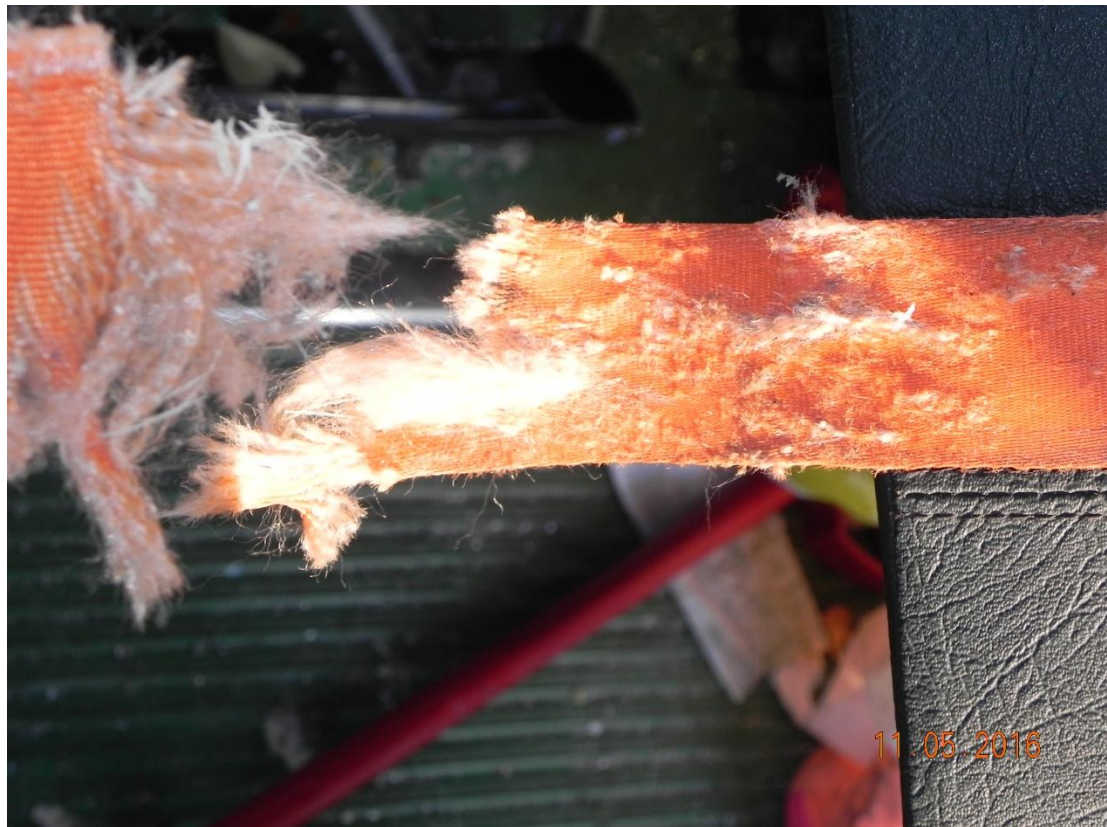
Photo 6 – Close-up view of separated driver seat belt shoulder webbing.

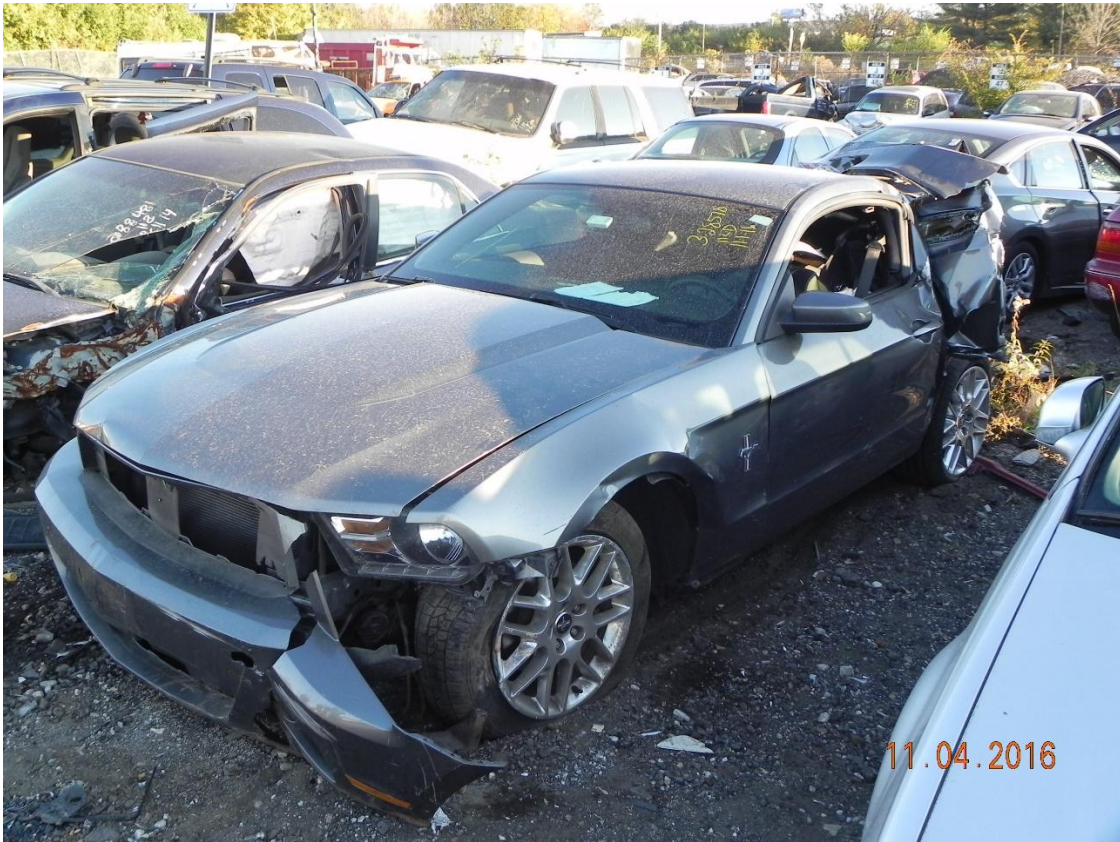
Photo 7 – Front left angle view of deformation to frontal plane of Ford Mustang.

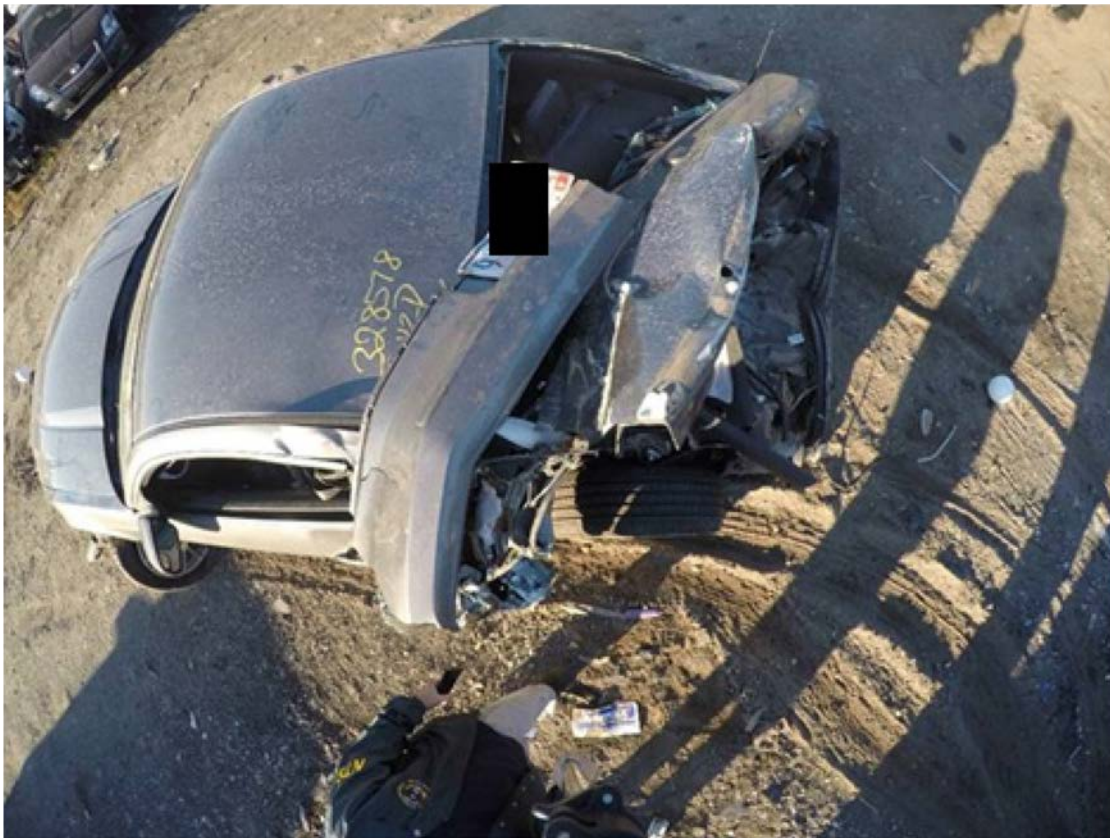
Photo 8 – Overhead view of deformation to rear plane of Ford Mustang.

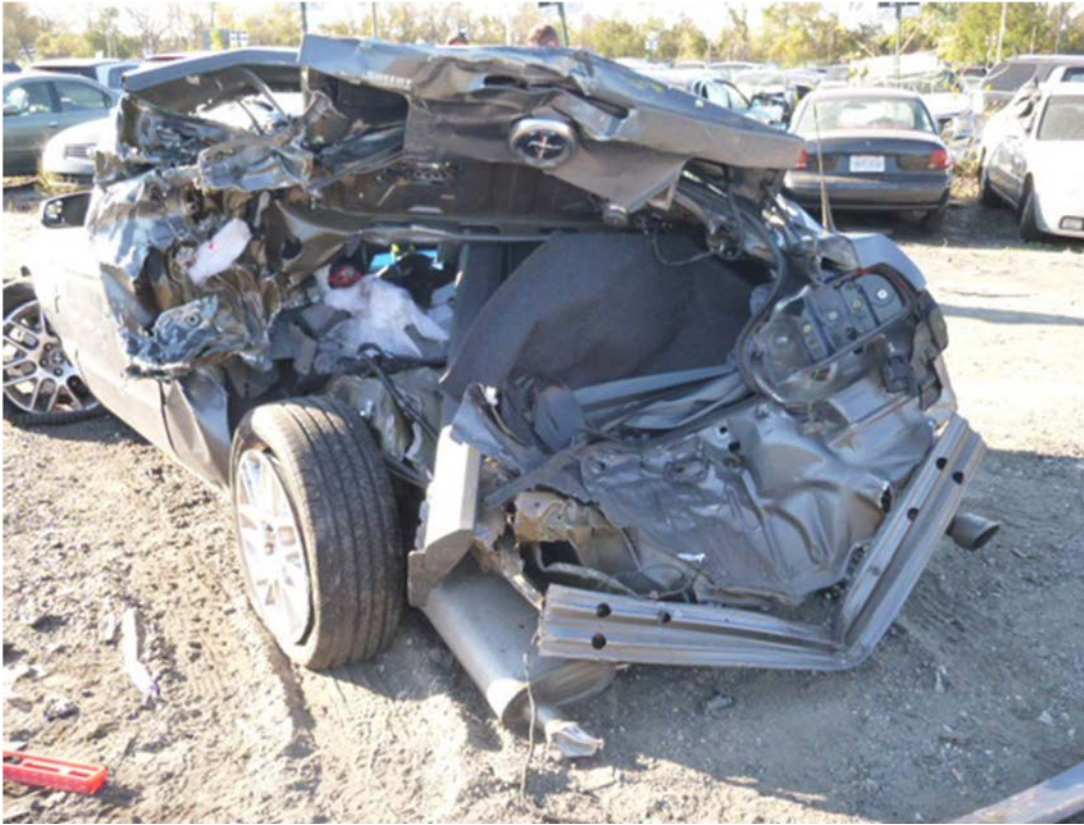
Photo 9 – Rear left angle view of deformation to rear plane of Ford Mustang.

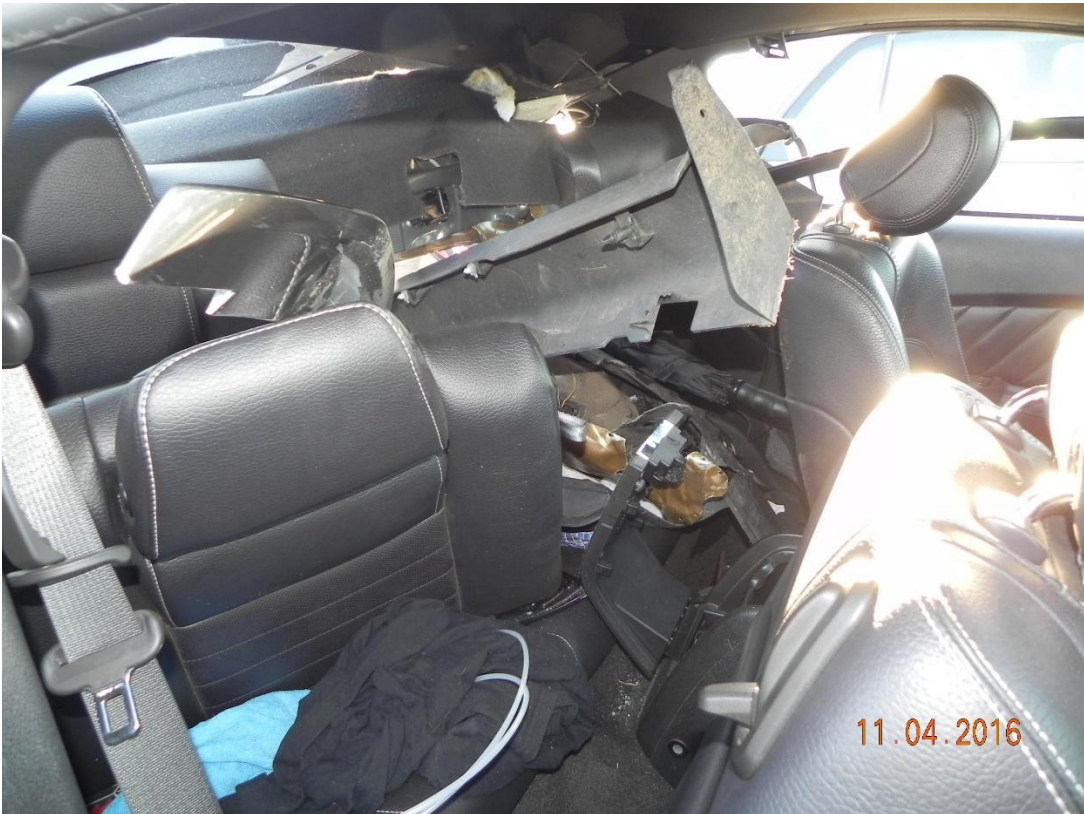
Photo 10 – Interior view of intrusion to back seat area of Ford Mustang.

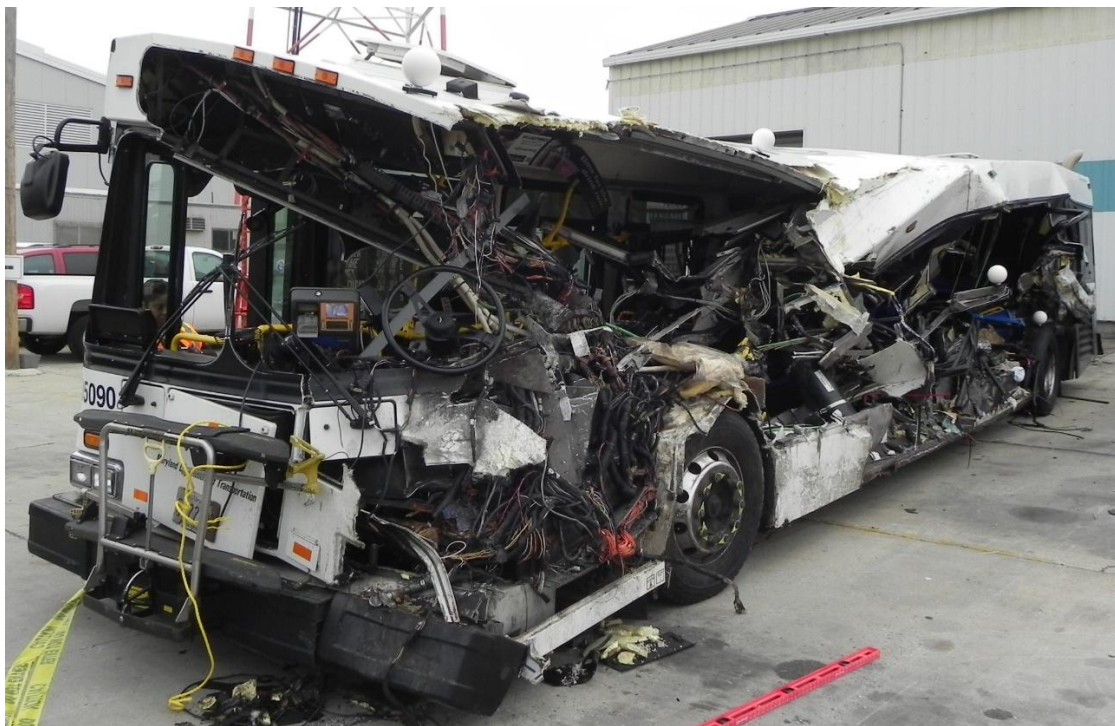
Photo 12 – Exterior view of extent of deformation to front left bumper corner and down left side of New Flyer.

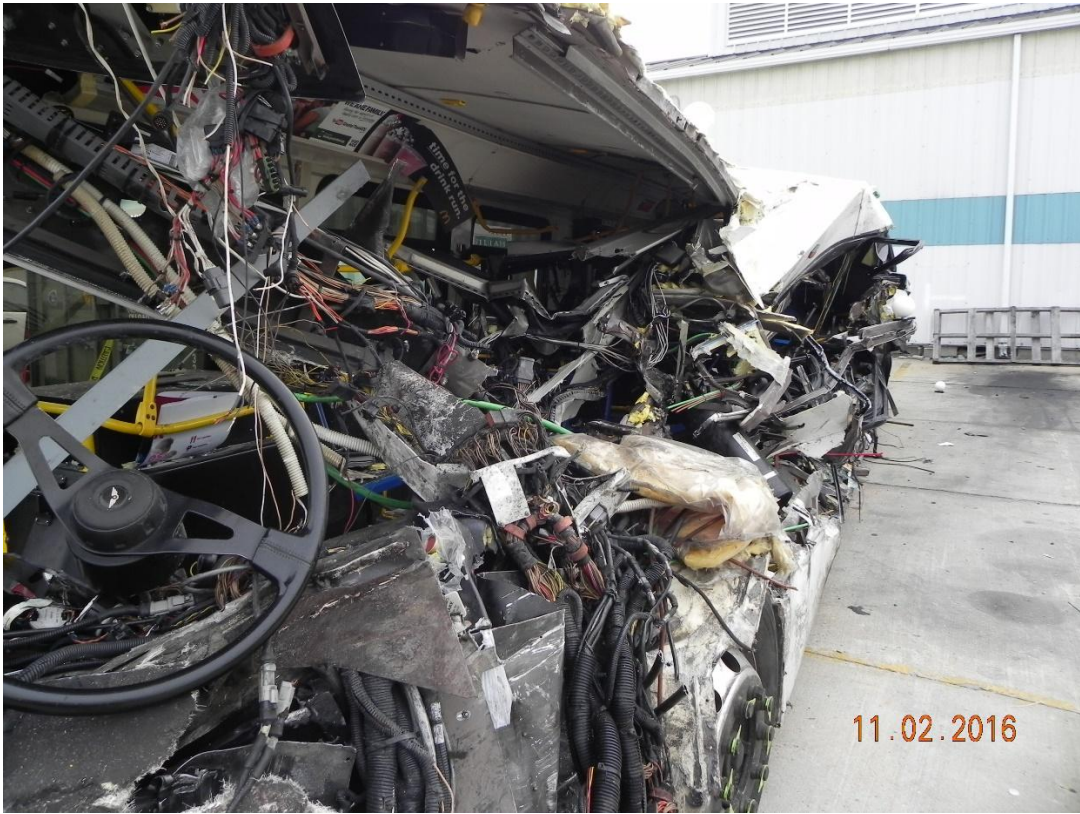
Photo 13 – Frontal view looking at deformation down the left side of New Flyer.

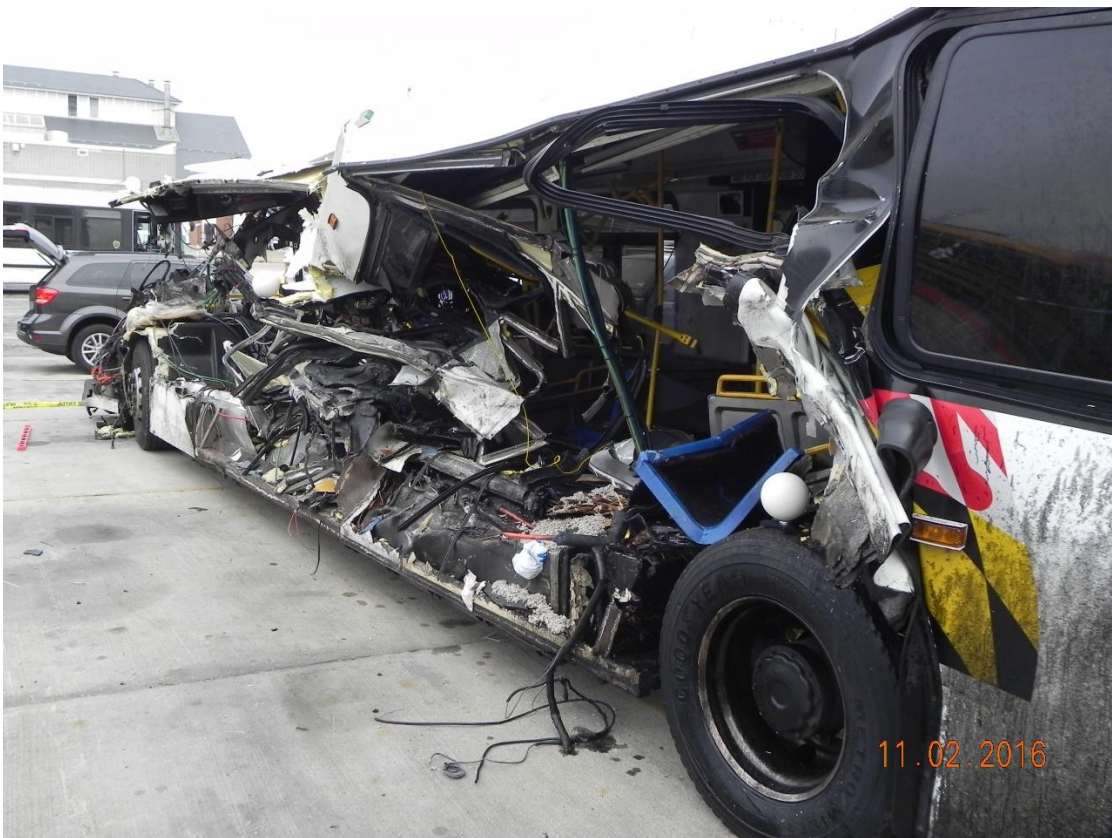
Photo 14 – Rear angle view of deformation to left side of New Flyer.

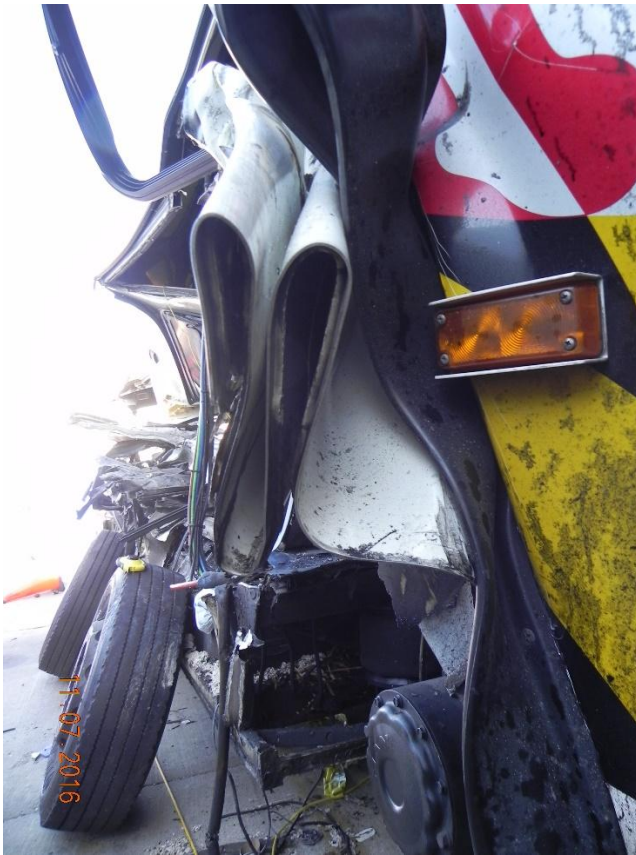
Photo 15 – Close-up view looking rear to front at left side New Flyer sheet metal buckled up accordion style.

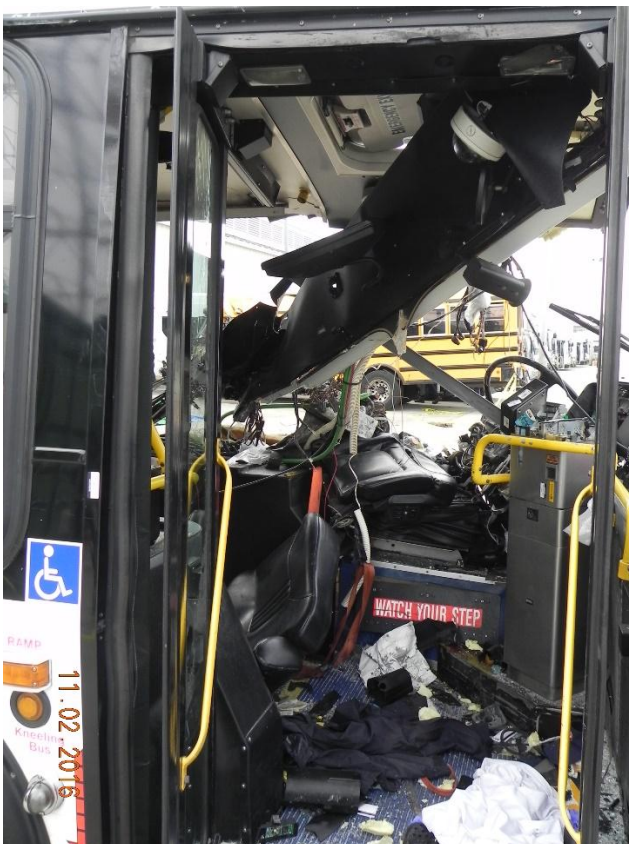
Photo 16 – View from outside loading door of New Flyer looking at damaged and displaced driver seating area.

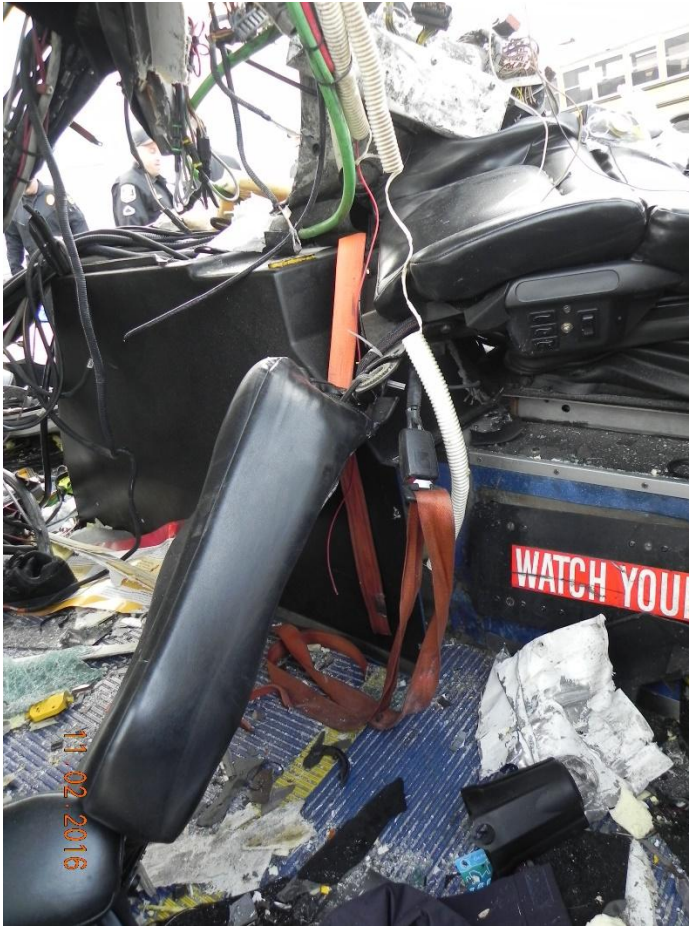
Photo 17 – Close up view of deformation and buckled seat belt of New Flyer driver.

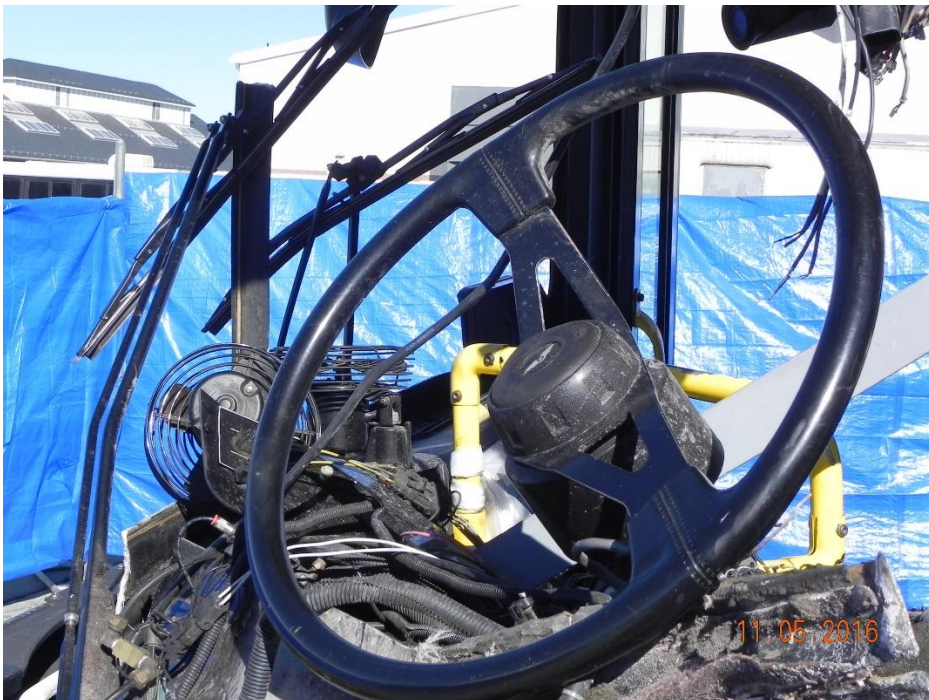
Photo 18 – Close-up of deformed steering wheel of driver in New Flyer.

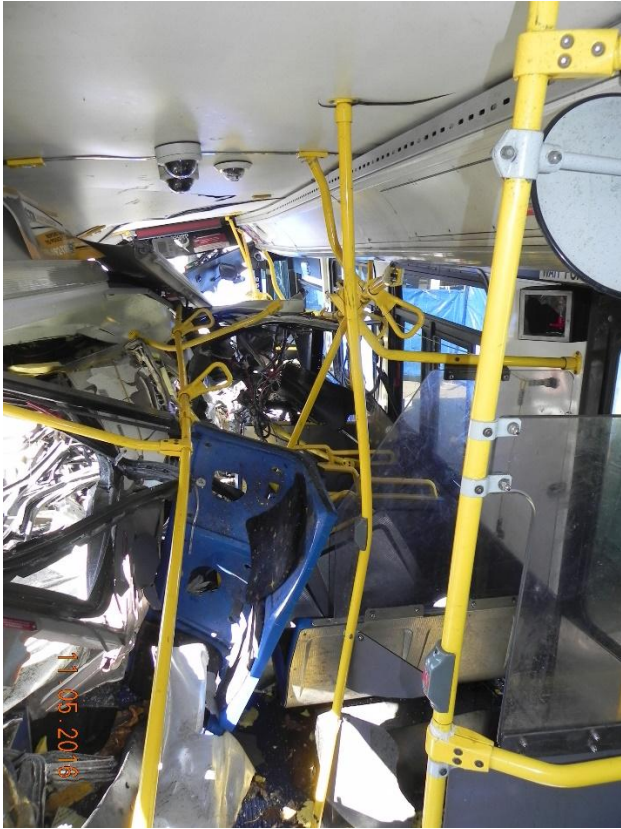
Photo 19 – Interior view looking from rear to front at intrusion to New Flyer.
