Survival Factors Photographs

Concan, Texas

HWY17MH011

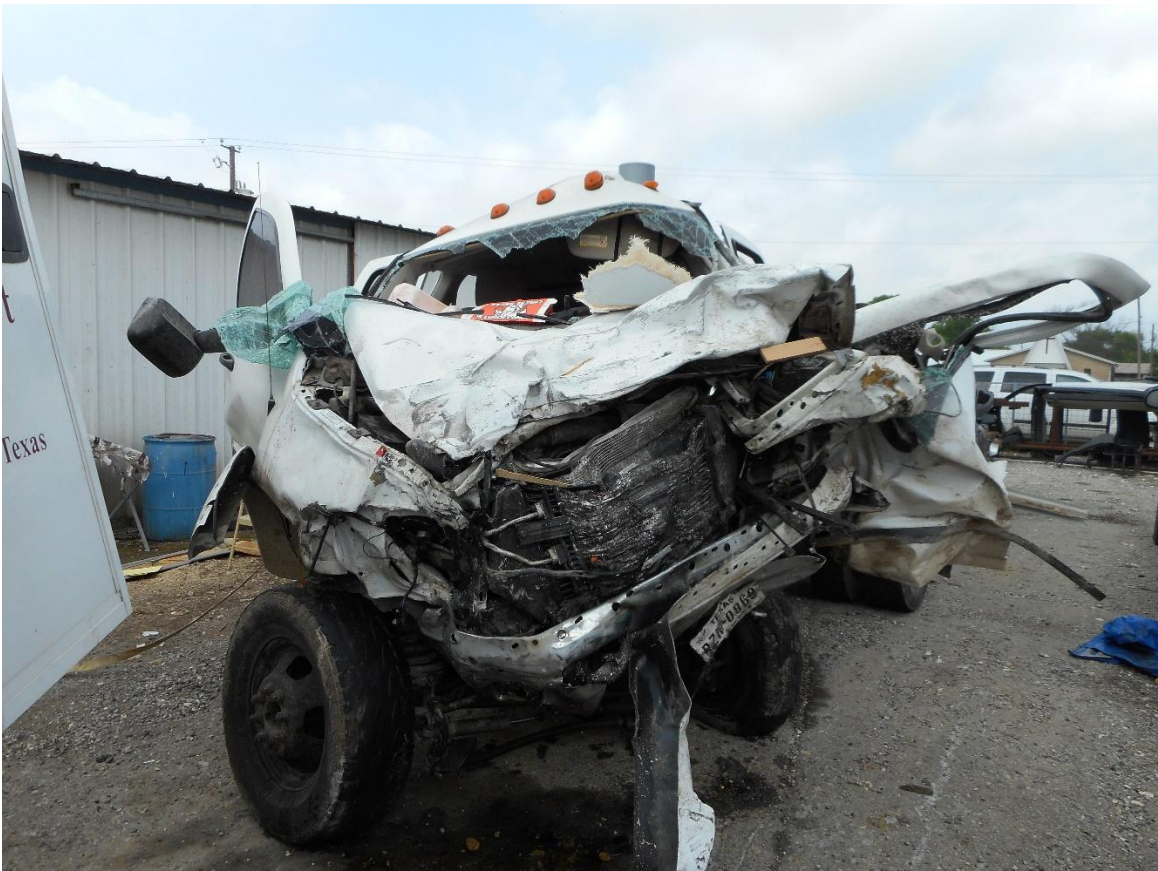
Photo 1 – Frontal view of deformation to 2007 Dodge Ram quad-cab 3500 pickup truck.

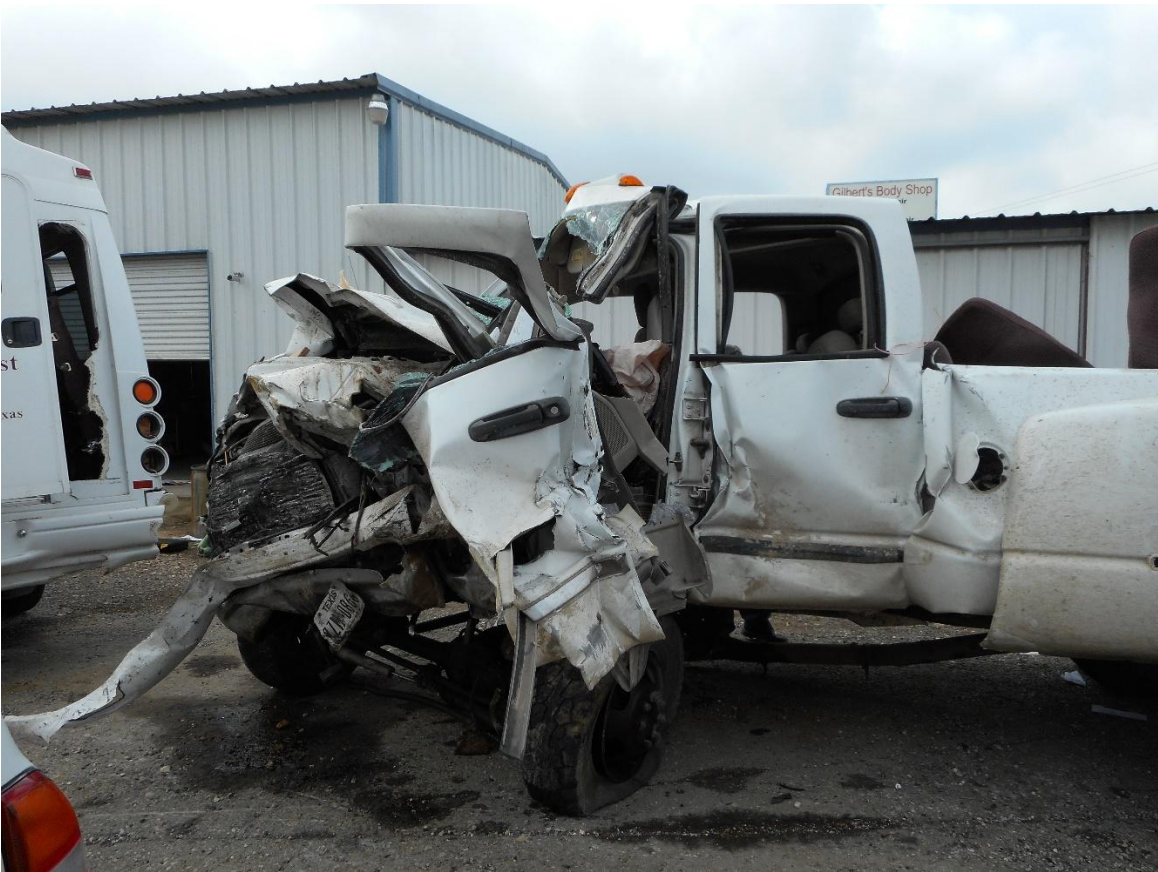
Photo 2 – Left side profile view of deformation to 2007 Dodge Ram quad-cab 3500 pickup truck.

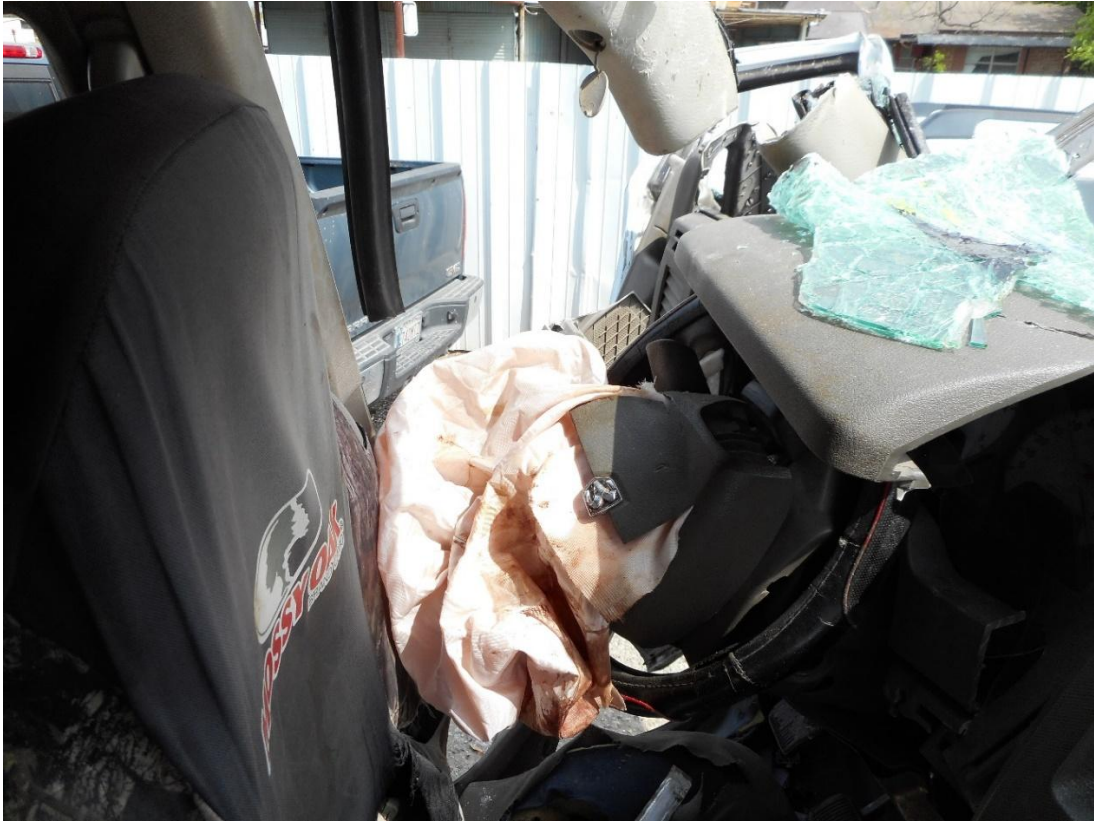
Photo 3 – Interior view of intrusion into driver seating area in 2007 Dodge Ram quad-cab 3500 pickup truck.

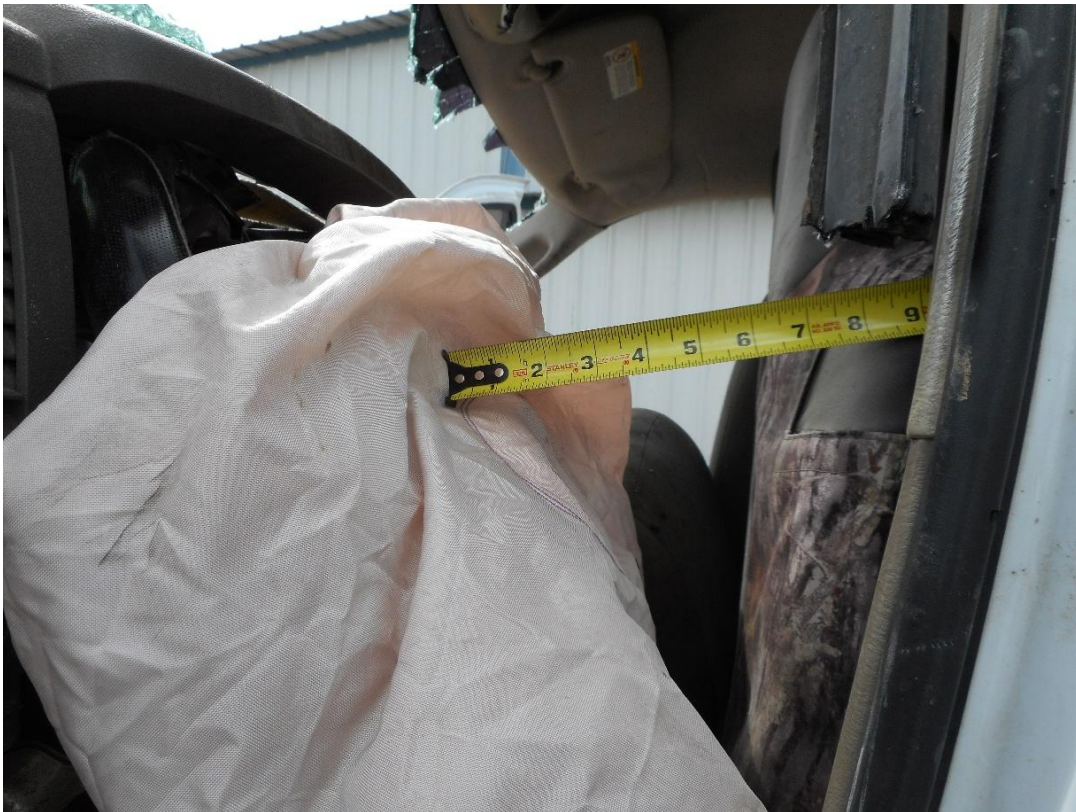
Photo 4 – Interior view from left side showing distance from steering wheel hub to driver seatback.

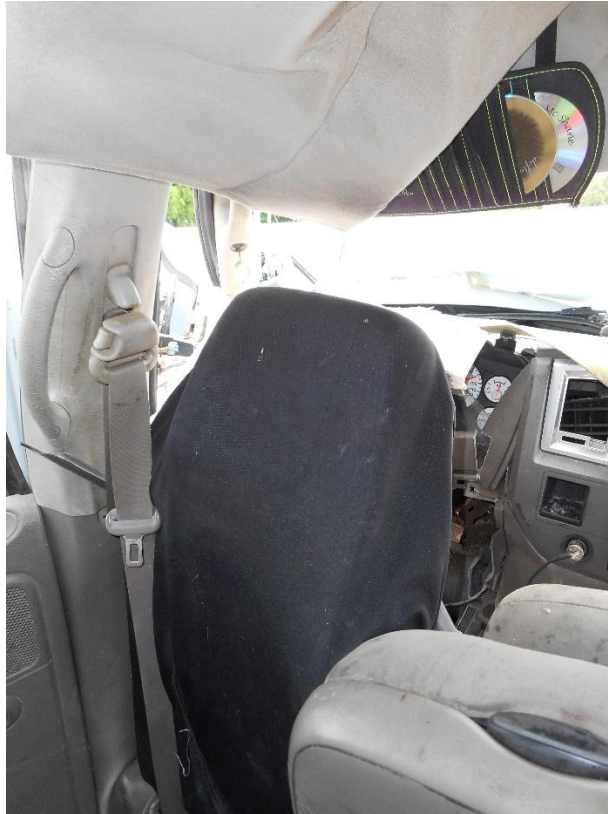
Photo 5 – Interior view of driver seating area in 2007 Dodge Ram quad-cab 3500 pickup truck. NOTE: Driver's seat belt is in locked and stowed position.

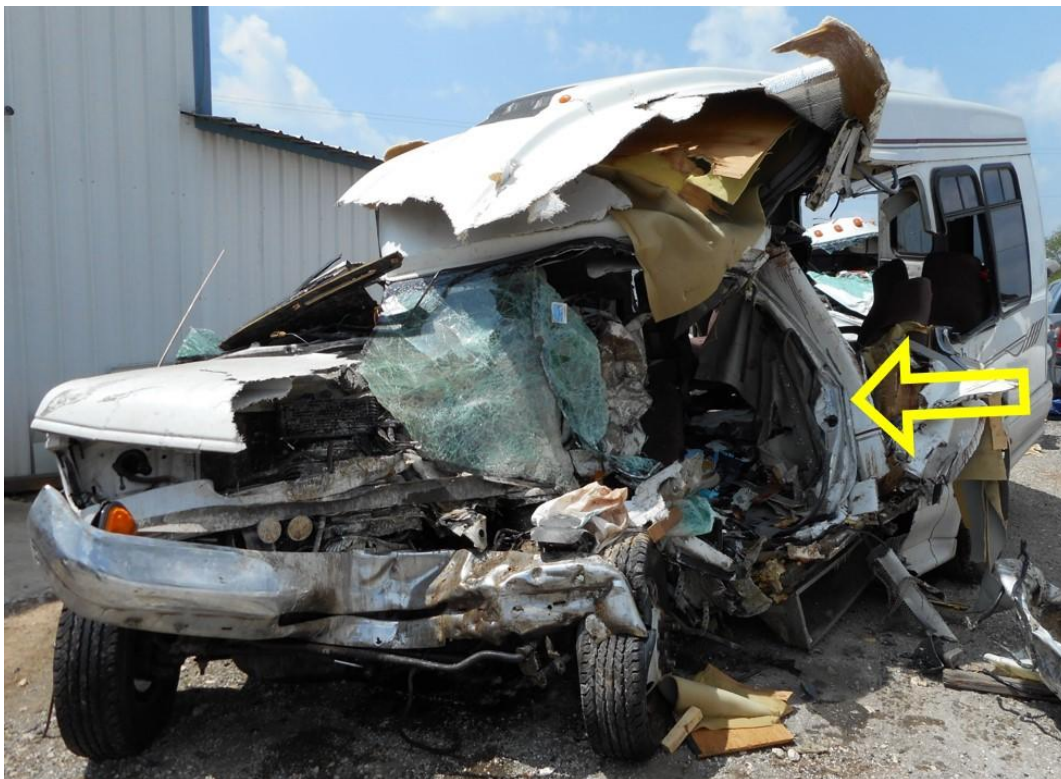
Photo 6 – Front left angle view of deformation to 2004 Ford E350 cutaway chassis with a 13-passenger Turtle Top Vanterra medium-size bus body. NOTE: Yellow arrow indicates area of accordion style crush.

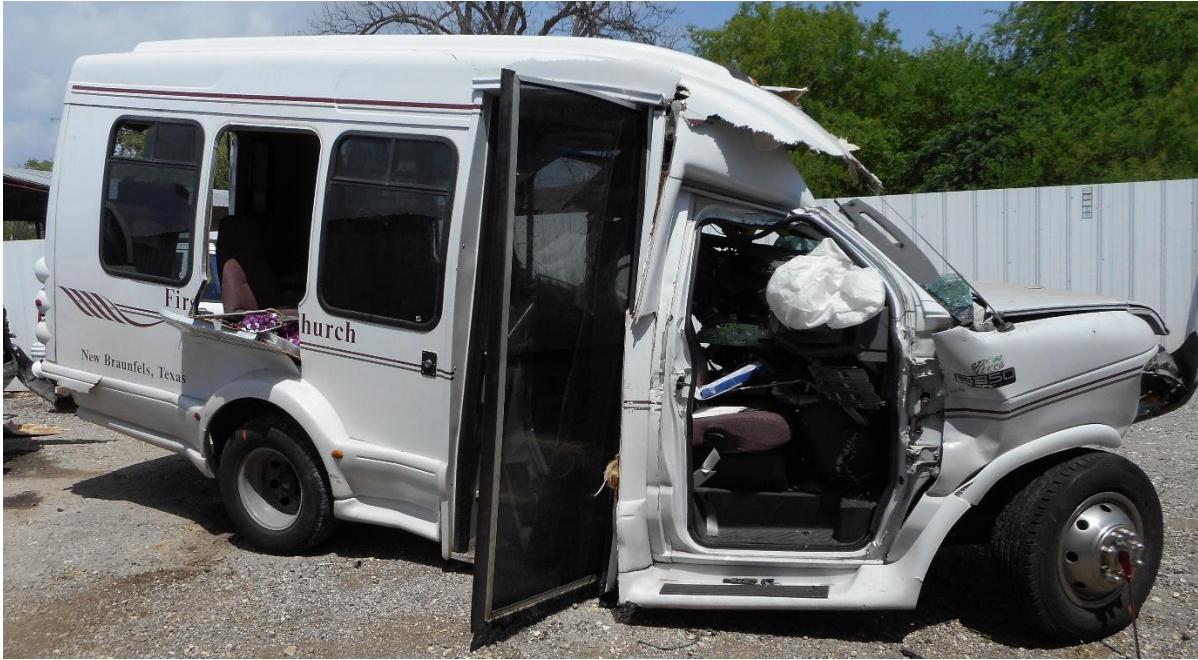
Photo 7 – Exterior view from right side showing deformation and extraction damage to 2004 Ford E350 cutaway chassis with a 13-passenger Turtle Top Vanterra medium-size bus body.

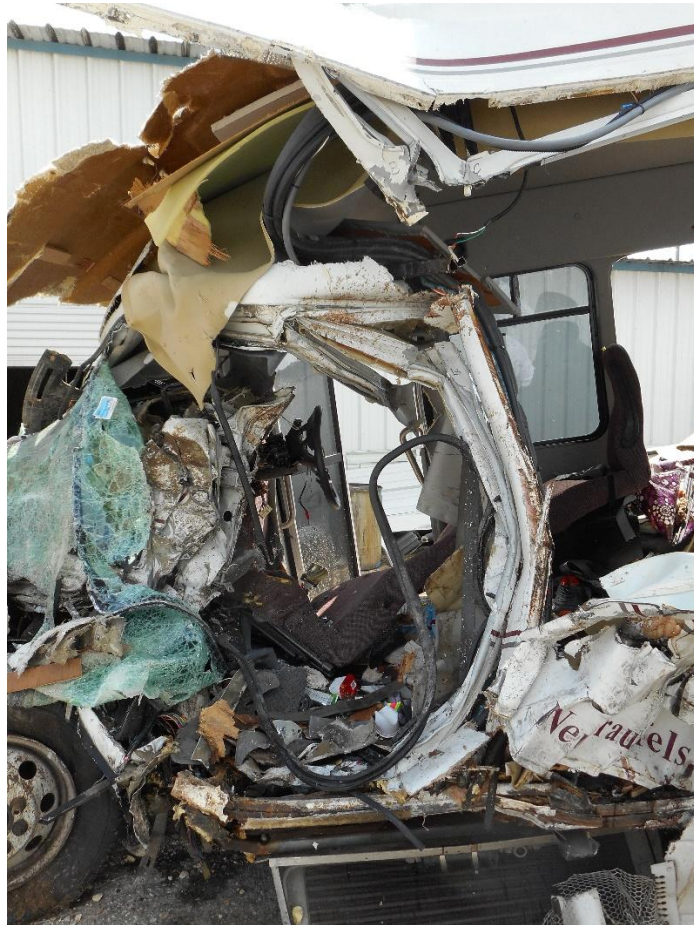
Photo 8 – View from left side looking into driver's seating area showing extent of intrusion.

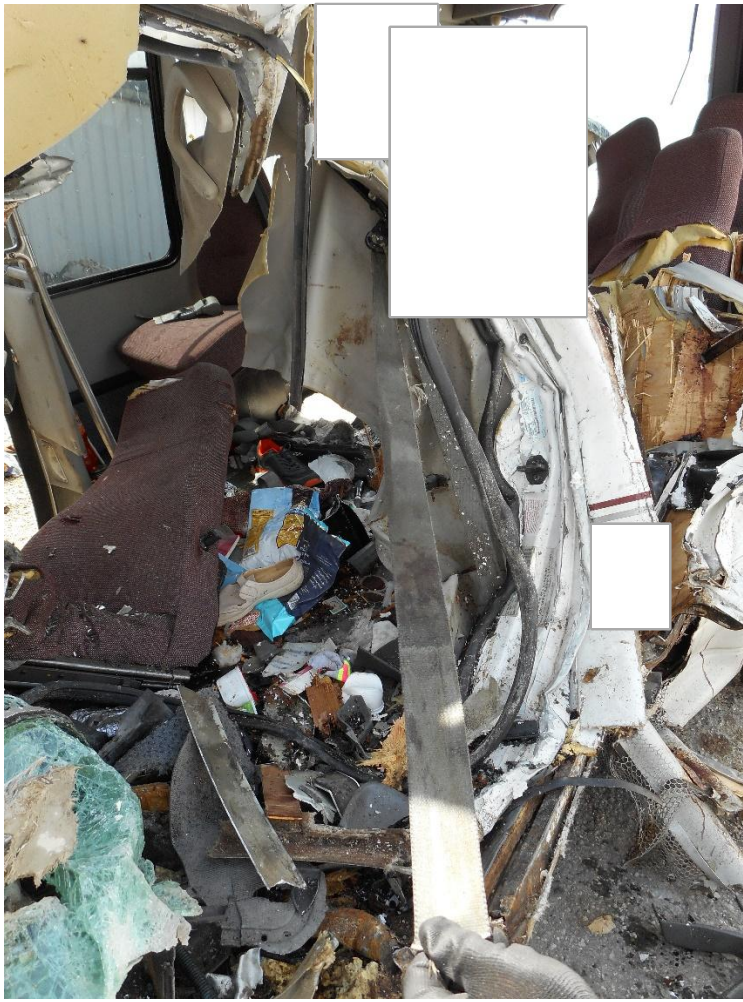
Photo 9 – Close-up view of driver's severed lap and shoulder restraint in 2004 Ford E350 cutaway chassis.

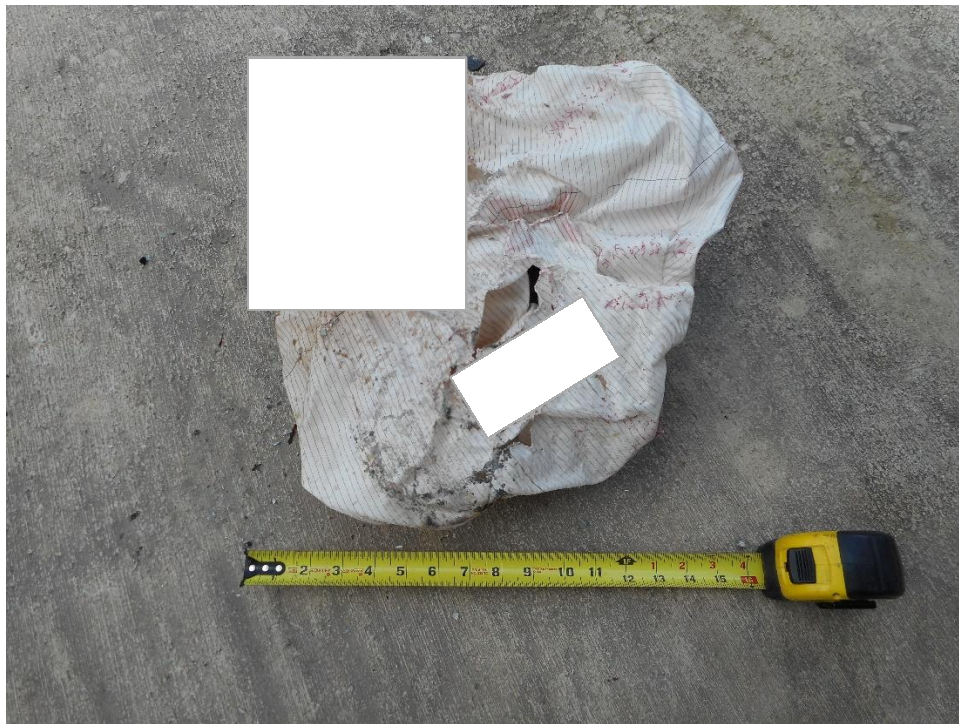
Photo 10 – View of driver's air bag module that was found outside vehicle.

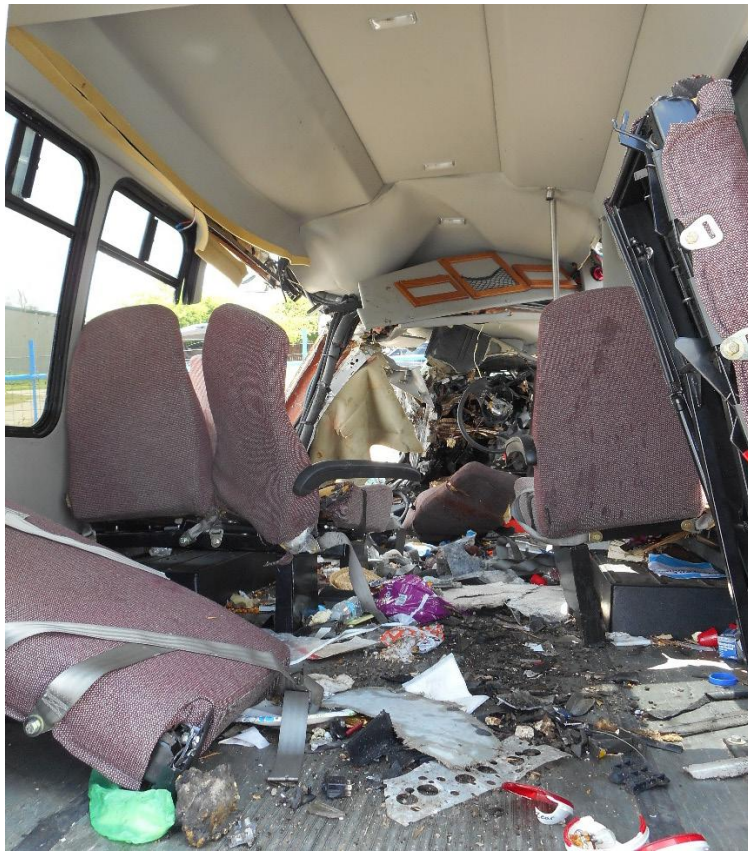
Photo 11 – Interior view from rear looking forward showing extent of intrusion and extrication damage to 2004 Ford E350 cutaway chassis.

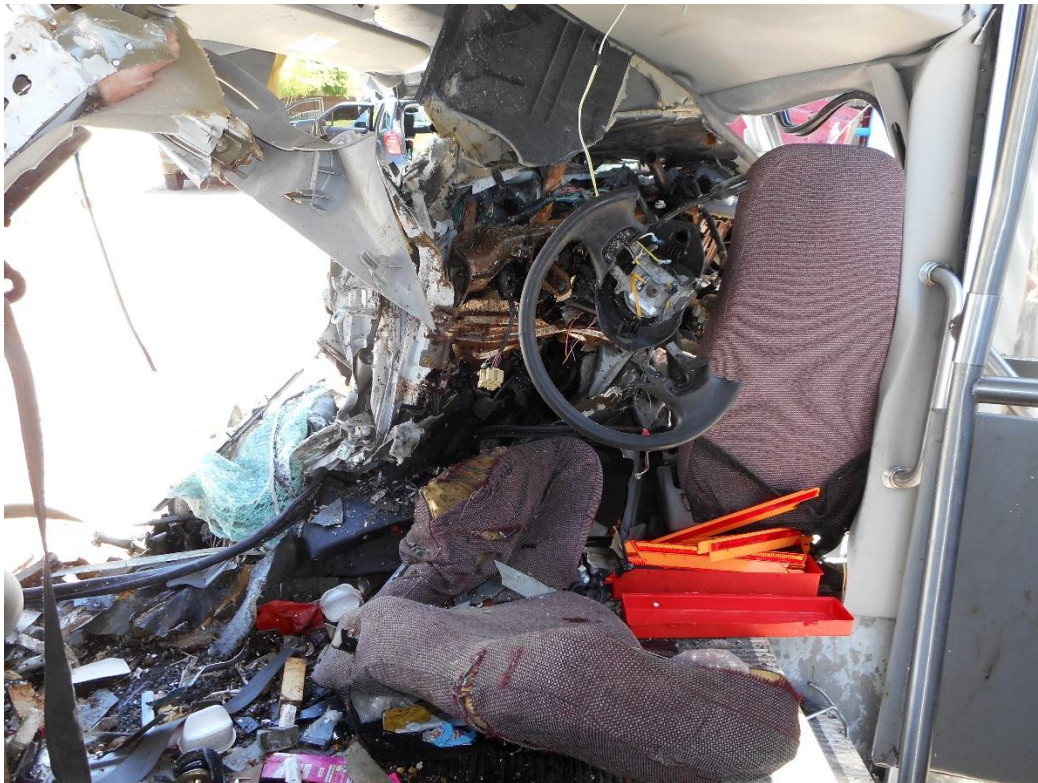
Photo 12 – Closer-up interior view of 2004 Ford E350 showing extent of damage and intrusion into driver and front right passenger area.

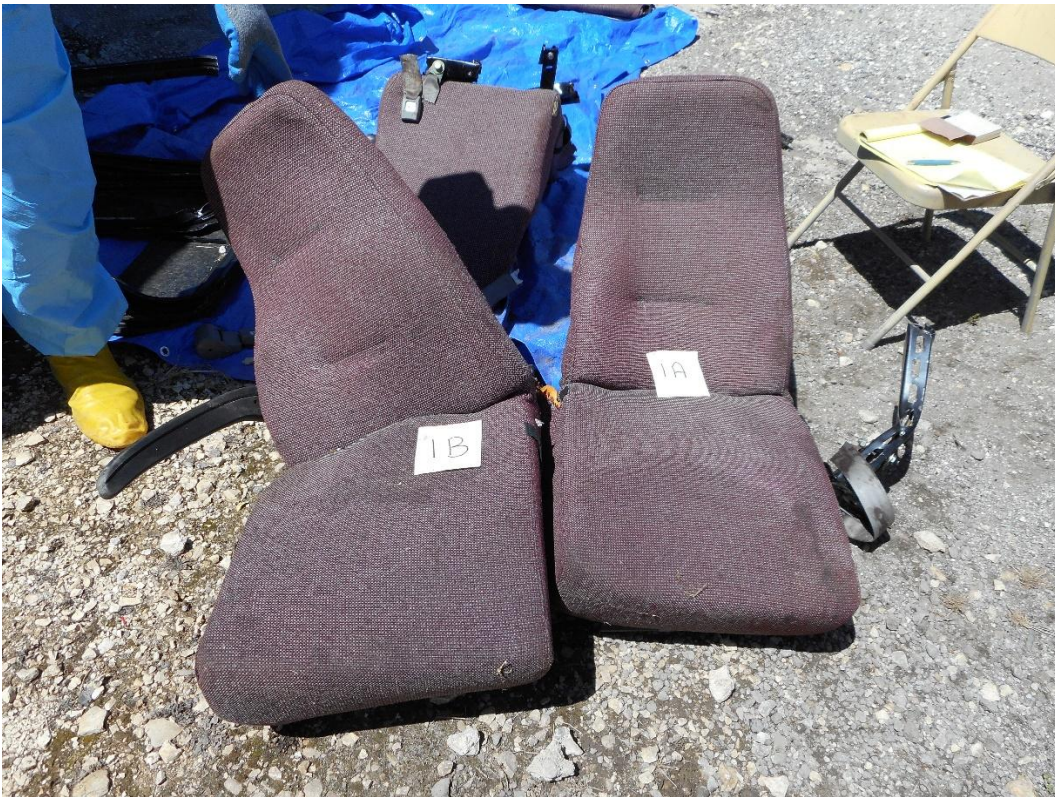
Photo 13 – View of front of seat row 1A and 1B that were removed during extrication.

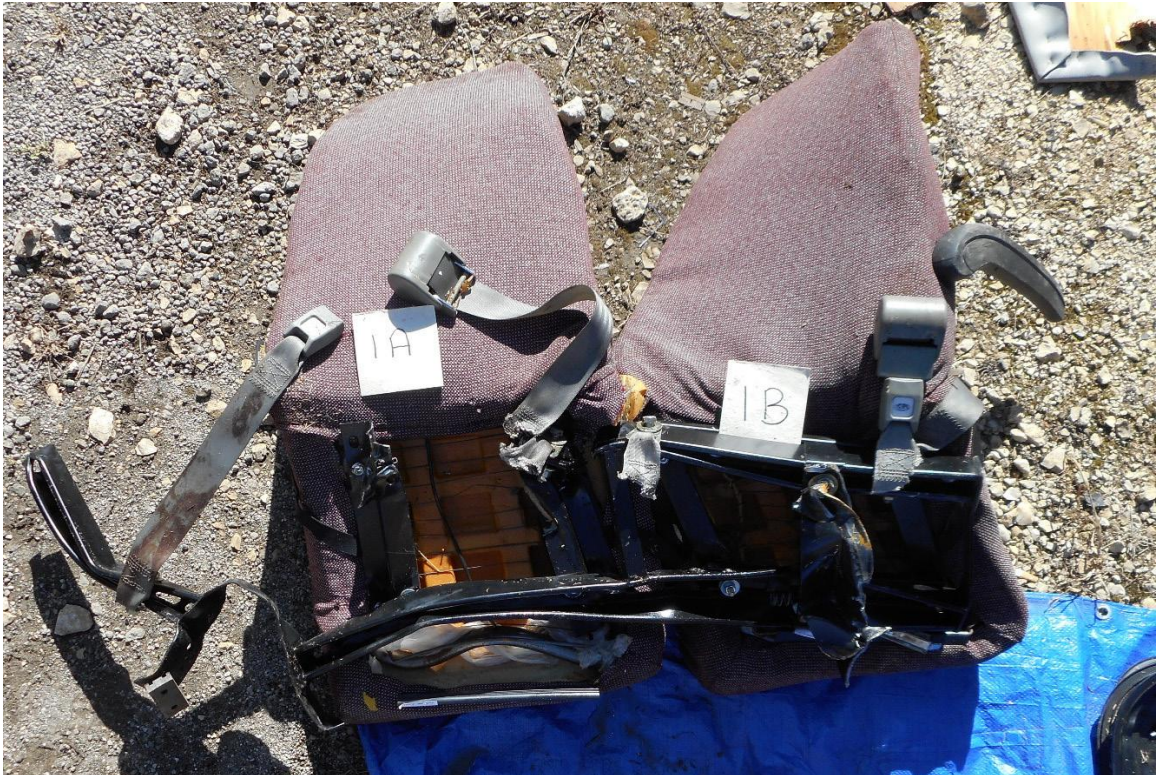
Photo 14 – View of backside of seat row 1A and 1B that were removed during extrication.

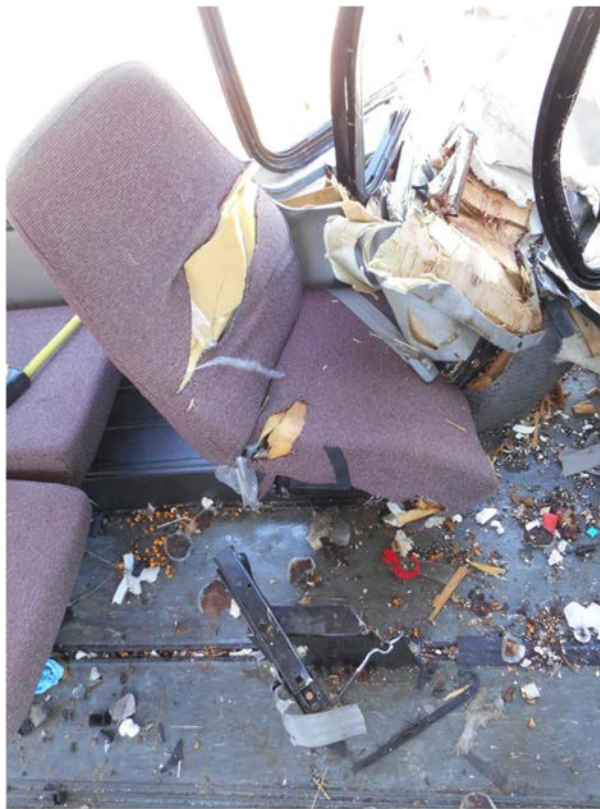
Photo 15. Interior view of seat 2A with seat 2B removed during extrication. NOTE: Sidewall intrusion.

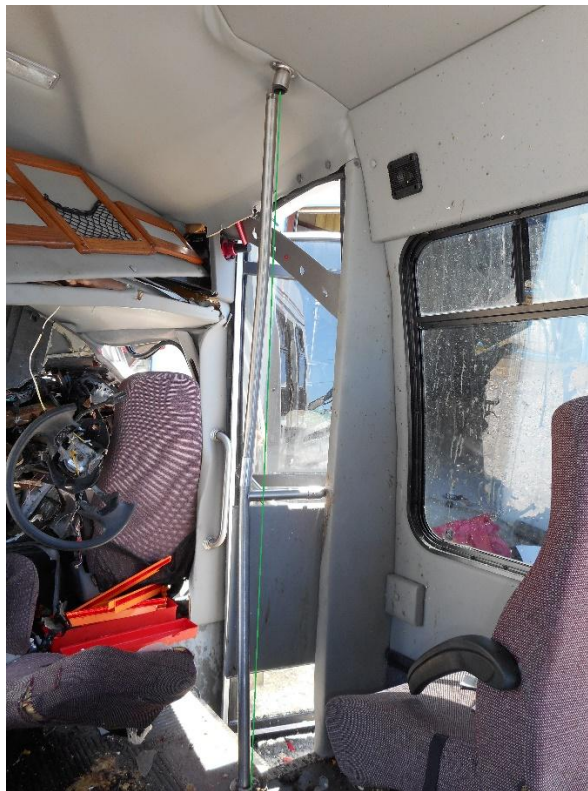
Photo 16. Interior view of loading door area in 2004 Ford E350 showing dislodged vertical entry grab pole.

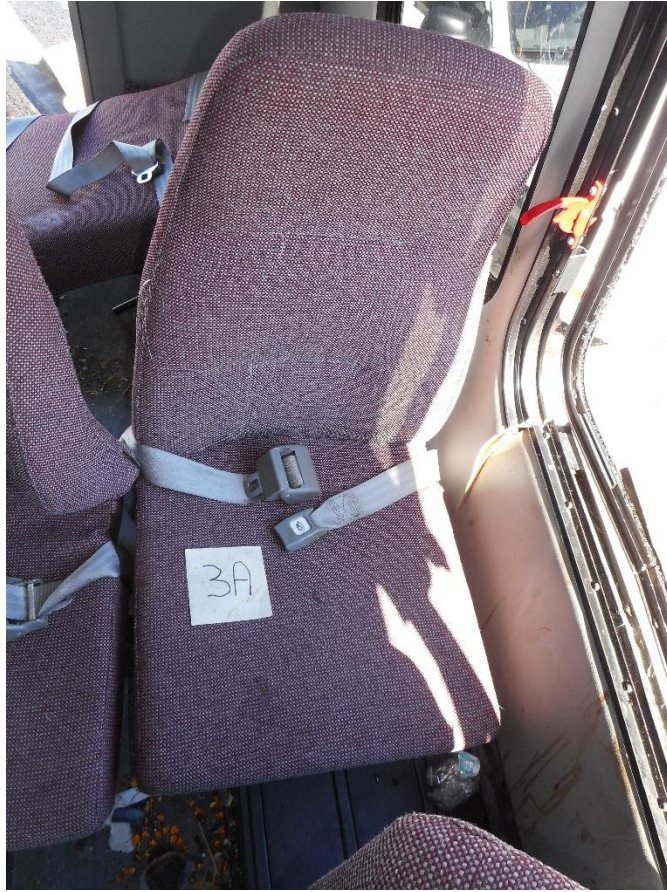
Photo 17. Interior view of seat 3A in 2004 Ford E350 showing “web winder” also known as a traveling retractor.

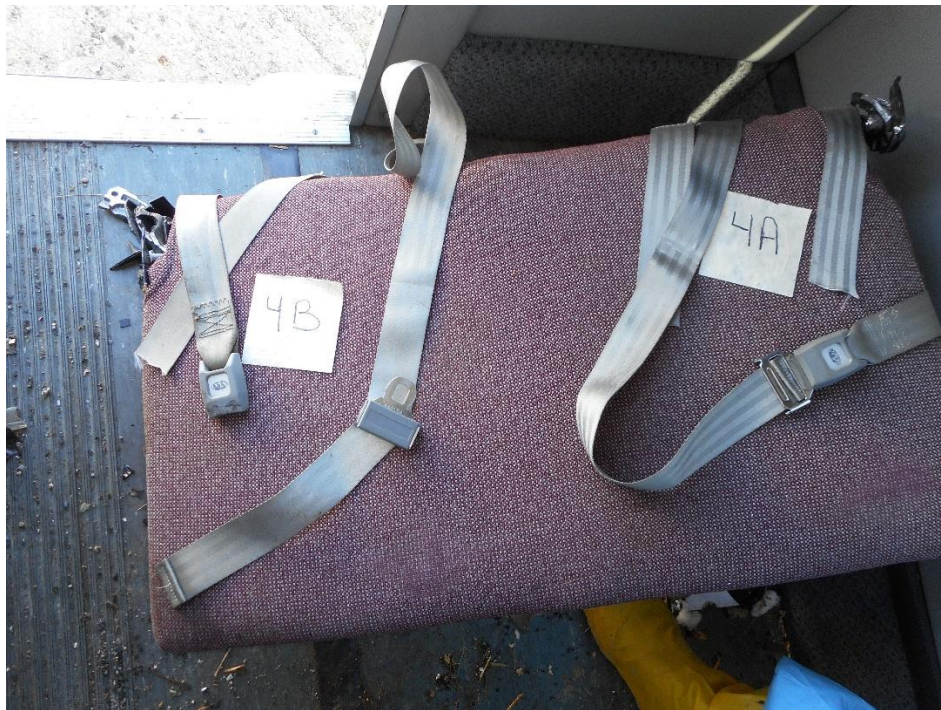
Photo 18. Interior view of row 4 folding bench seats A & B with self-tightening/synching lap belts.

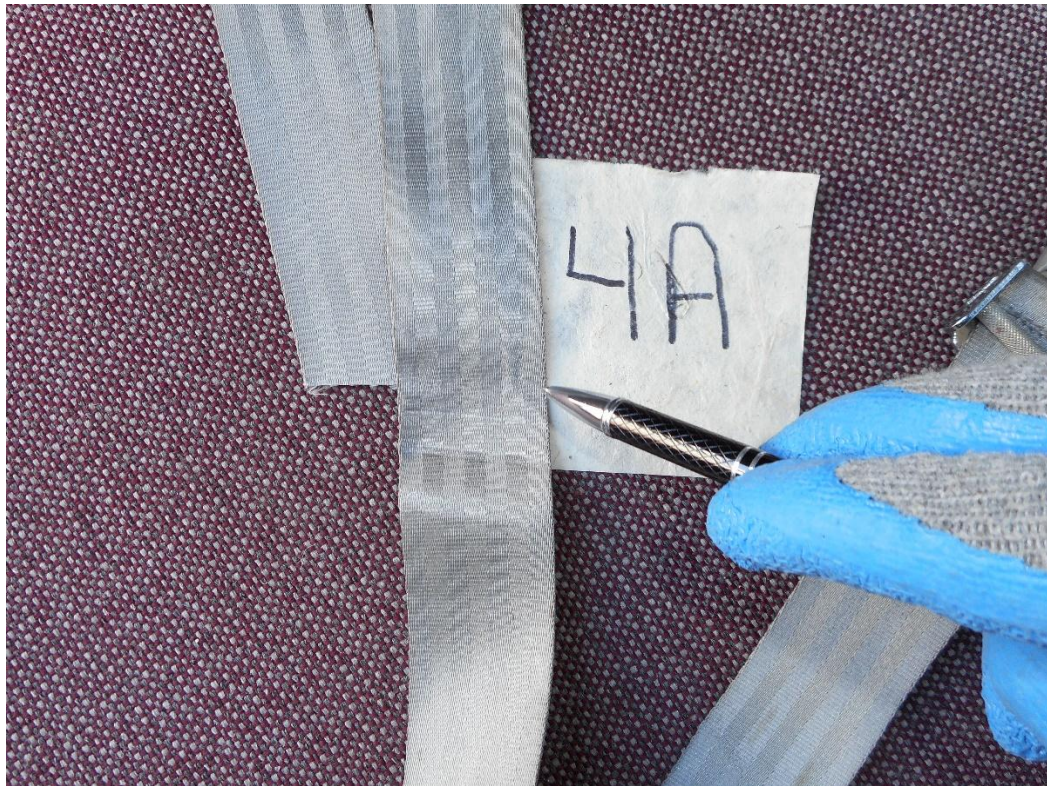
Photo 19. Close-up view of loading mark found on webbing in seat 4A in 2004 Ford E350. Similar loading marks were found on 3 of the 4 self-tightening/synching lap belts across the fourth row.

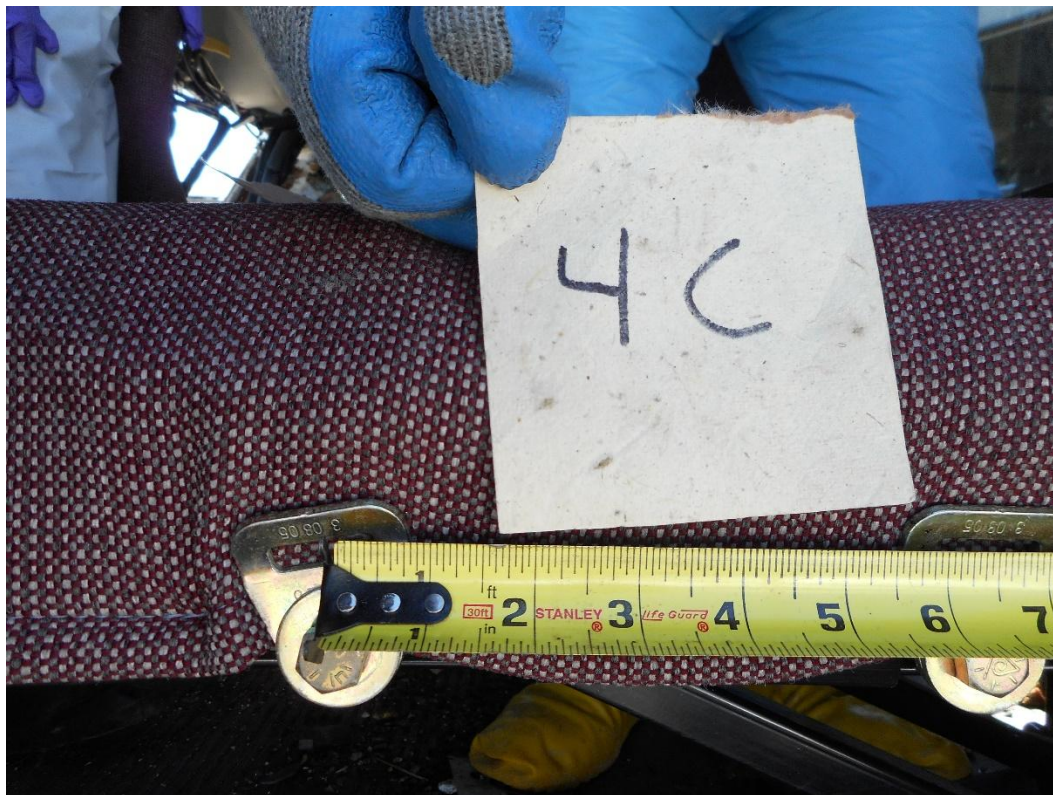
Photo 20. Close-up view of 6.5-inch lateral seat belt anchors in seat 4C. NOTE. Belt removed by first responders during extrication of passenger.
