NATIONAL TRANSPORTATION SAFETY BOARD
OFFICE OF HIGHWAY SAFETY
WASHINGTON, DC 20594

Survival Factors Specialist's Factual Report

Accident: CHI06FA210
Location: Sullivan, MO
Vehicle #1: Dehavilland DH-6, N203E
Date: July 29, 2006
Time: Approximately 1349 CDT

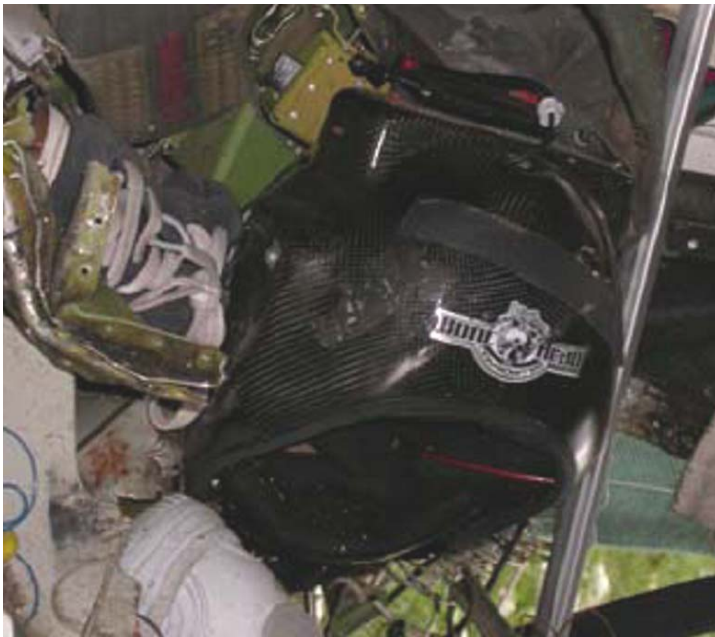
Figure 4: A post-accident photograph showing the Bonehead Composite Optik Illusion helmet.

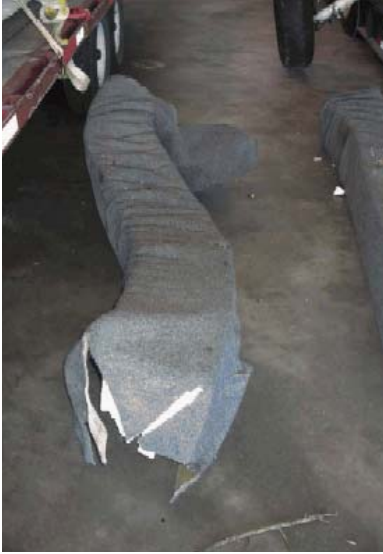
Although there is documentation that these straddle bench seats were installed in the accident aircraft and were approved by the FAA, evidence from the helmet camera videos and from the accident scene show that the aircraft was actually equipped with two foam cushions used as seating for the parachutists. These foam cushions, shown in Figure 1, were not attached to the aircraft. The approximate dimensions of the cushions were a 15"-18" square with a 5 – 6 foot length. A post-accident photograph showing the damage to the foam cushions can be seen in Figure 9.

Figure 9: A post-accident photograph showing the foam cushions used for parachutist seating in the accident aircraft.

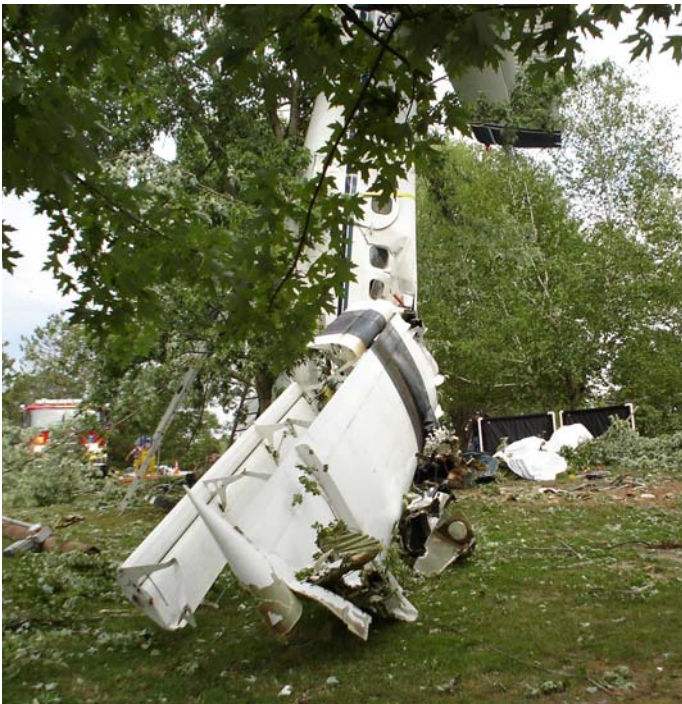
Figure 10: A photograph showing aircraft right before the right wing was removed. Wrinkling and cracking of the plane body can be seen as high as the right cabin door frame.¹⁵

Figure 10 and Figure 11 show the accident aircraft at rest. Crush damage can be seen immediately forward of the second window in the passenger compartment. Additional damage can be seen extending rearward to the right cabin door frame.

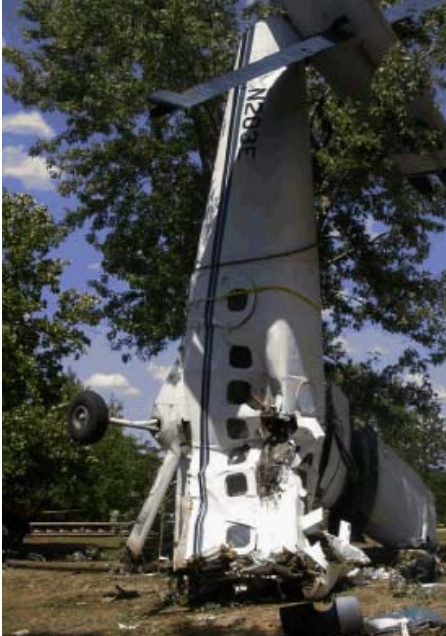
Figure 11: A photograph showing aircraft right after the right wing was removed. Crush damage can be seen immediately forward of the second window in the passenger compartment.

Approximate dimensions of the aircraft and the region of crush were scaled from the diagram in Figure 12. Since this is a long nosed version of this aircraft, that crush line would correspond to approximately 172 inches of crush. But, the nose region of the aircraft is not structural.¹⁷ The nose is constructed from balsa wood and fiberglass. Thus, the region forward of station 60 (the approximate location where the nose wheel attaches) can not be considered structural and will not add measurable resistance to crush. As a result, the length of crush is approximately 172 inches – 81 inches = 91 inches long (7'7").

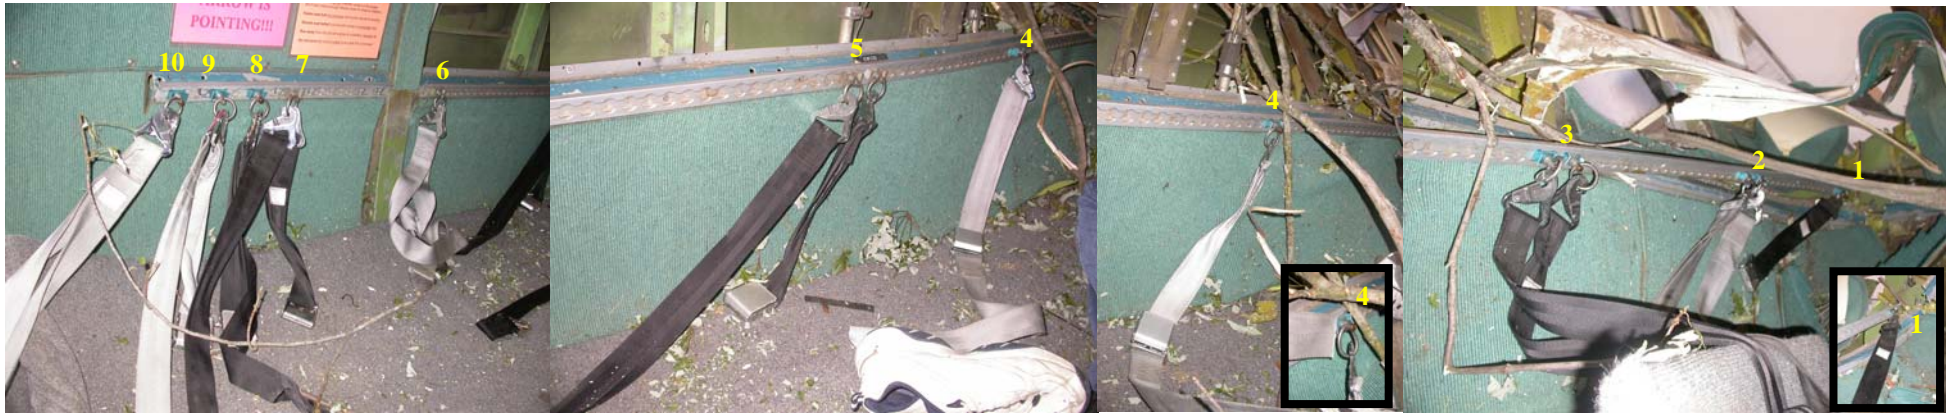
The intrusion along aircraft left appeared to extend to just in front of restraint 1 with the track broken at that location. Aft of the break, the track seems to be in good condition. All attachment points were present and photographed post-accident. Damage was noted to restraint 4. The pre-accident photographs appear to show two hooks attached to the single attachment point for restraint 4 but post-accident photographs only show the single attachment hook. The latch and buckle from restraint 4 were photographed in the connected position, post-accident. The end of the webbing not attached to the track appeared to be cut. The attachment ring was deformed. This deformation to the ring and the cut end of the webbing can be seen in the inset photo for restraint 4 in Figure 14.

Figure 14: Post-accident photographs showing the restraints along aircraft left from back to front. The restraints are labeled as shown in Figure 13.

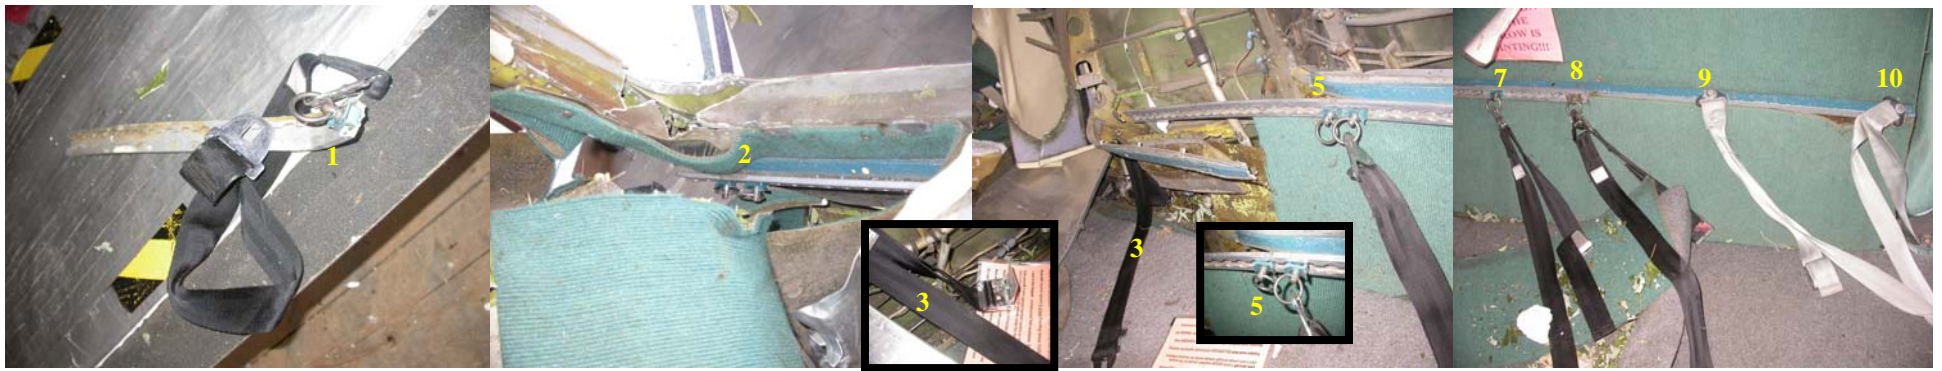
Much damage was seen at the front of the aircraft and in the region of the forward most restraints along aircraft right. There is uncertainty about the position of the restraint labeled 1 in Figure 15. That restraint was photographed outside of the accident aircraft. The restraint best matched location 1 on aircraft right based on damage to the aircraft, evaluation of the other restraint positions, webbing colors along aircraft left and restraint types along aircraft left. Uncertainty also existed for the attachment point labeled restraint 2 in Figure 15. These two attachment rings were determined to be part of restraint 2 based on the surrounding damage, the orientation of the green sidewall liner, the appearance of an open hatch in the upper right quadrant of the photograph, rectangular cut-outs in the green sidewall liner similar to those below the hatch in the pre-accident photographs and the damage seen on the left in the photograph showing restraints 3 and 5 (Figure 15). The restraint webbing was missing from the attachment points for restraint 2. Because of the limited photographs pre-accident, it is unknown if webbing was present for this restraint position before the accident. Photographs of the attachment points for restraint 3 were not available but the latch for belt 3 was deformed so that it would not close normally. Based on the pre-accident photographs, restraint 4 appears to be approximately 20 or 21 attachment points¹⁸ forward of the restraint with the black webbing believed to be restraint 5. (Restraint 5 has a label above it stating 'C5'. This label likely corresponds to the moment arm C5 in the jumper station assignment diagram shown in Figure 16.) Counting forward of restraint 5 in the accident photographs shows that there is a break in the track approximately 20 attachment points forward of restraint 5, which is the likely location for restraint 4 (grey webbing identified in the videos). No post-accident photographs were available showing restraint 4 or its attachment points. In addition, half of the webbing is missing from restraint 5. (There should be a second restraint attached to the forward ring at restraint position 5.) Also, the aft attachment pin from restraint 5 appears to be slightly pulled out from the track. No post-accident photographs were available for restraint 6. The webbing of restraint 9 appears to be folded below the stitching. Folding may indicate loading to webbing.

Figure 15: Post-accident photographs showing the restraints along aircraft right from front to back. The restraints are labeled as shown in Figure 13.

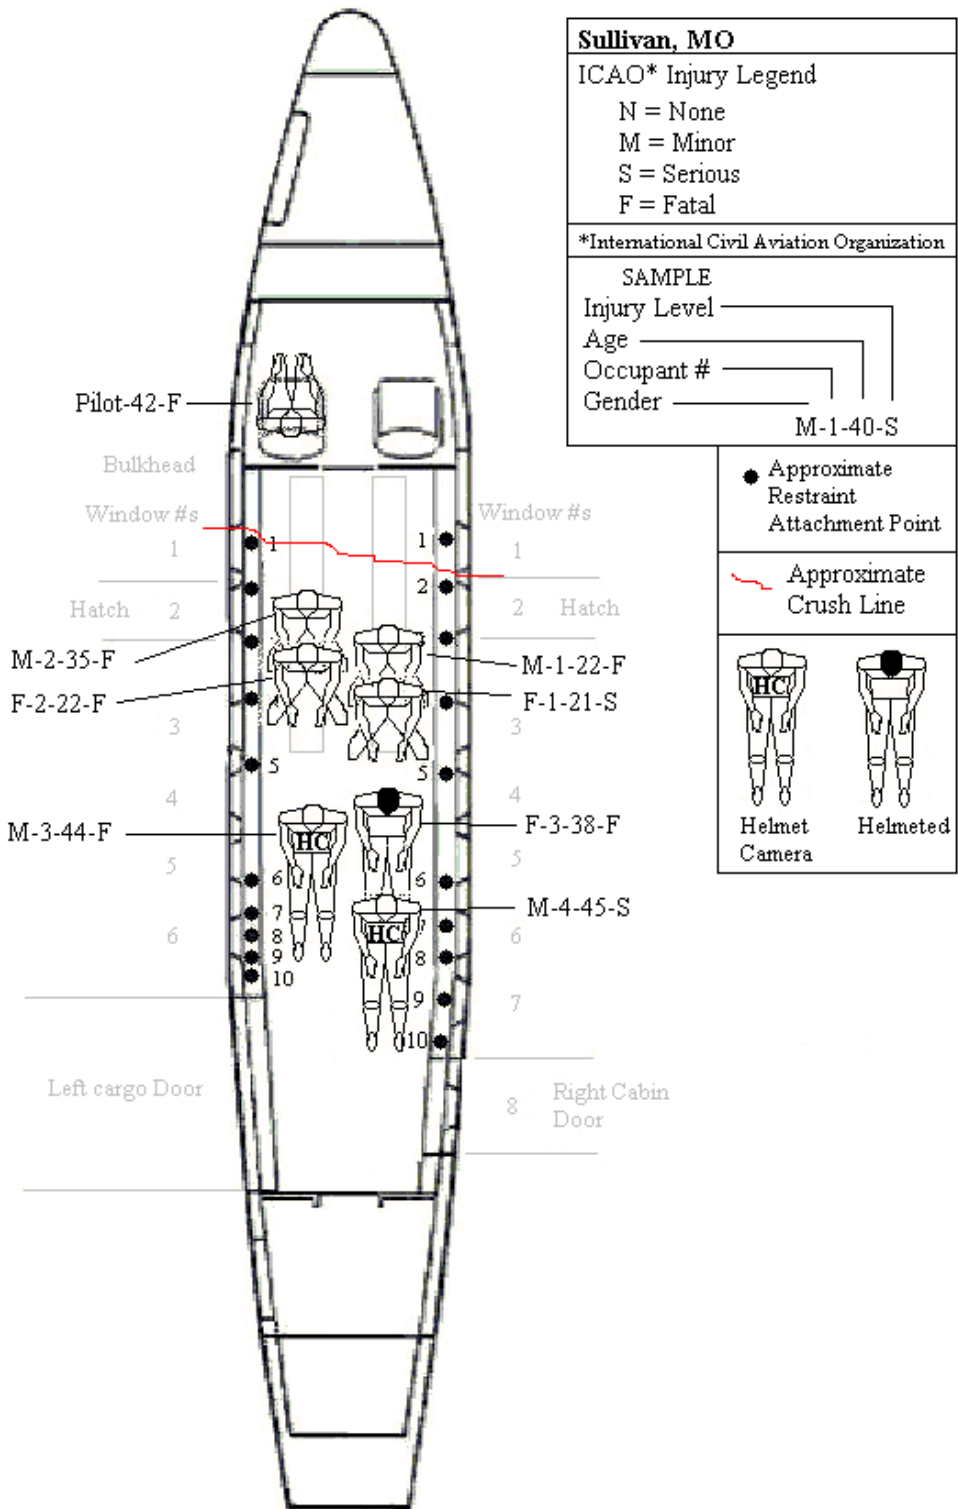
A seating diagram was developed based on the observations from the two helmet camera videos. Gender, age and injury level (presented in section 4.6 of this report) are included on the seating diagram for clarity. In addition, the approximate crush line for the aircraft was labeled based on photographs taken on-scene. Approximate restraint attachment points are also labeled. Passengers wearing a helmet or a helmet camera were also labeled. Windows were numbered for reference. The aft cargo and cabin door and the window hatch locations were also labeled on the diagram.

Figure 17: A diagram showing the seating positions and orientations based on observations from the video cameras.
