**National Transportation Safety Board
Office of Aviation Safety
Washington, DC**

Survival Factors Specialist's Factual Report of Investigation

A. Accident : WPR11IA055

Airplane : Gulfstream 200, N718QS

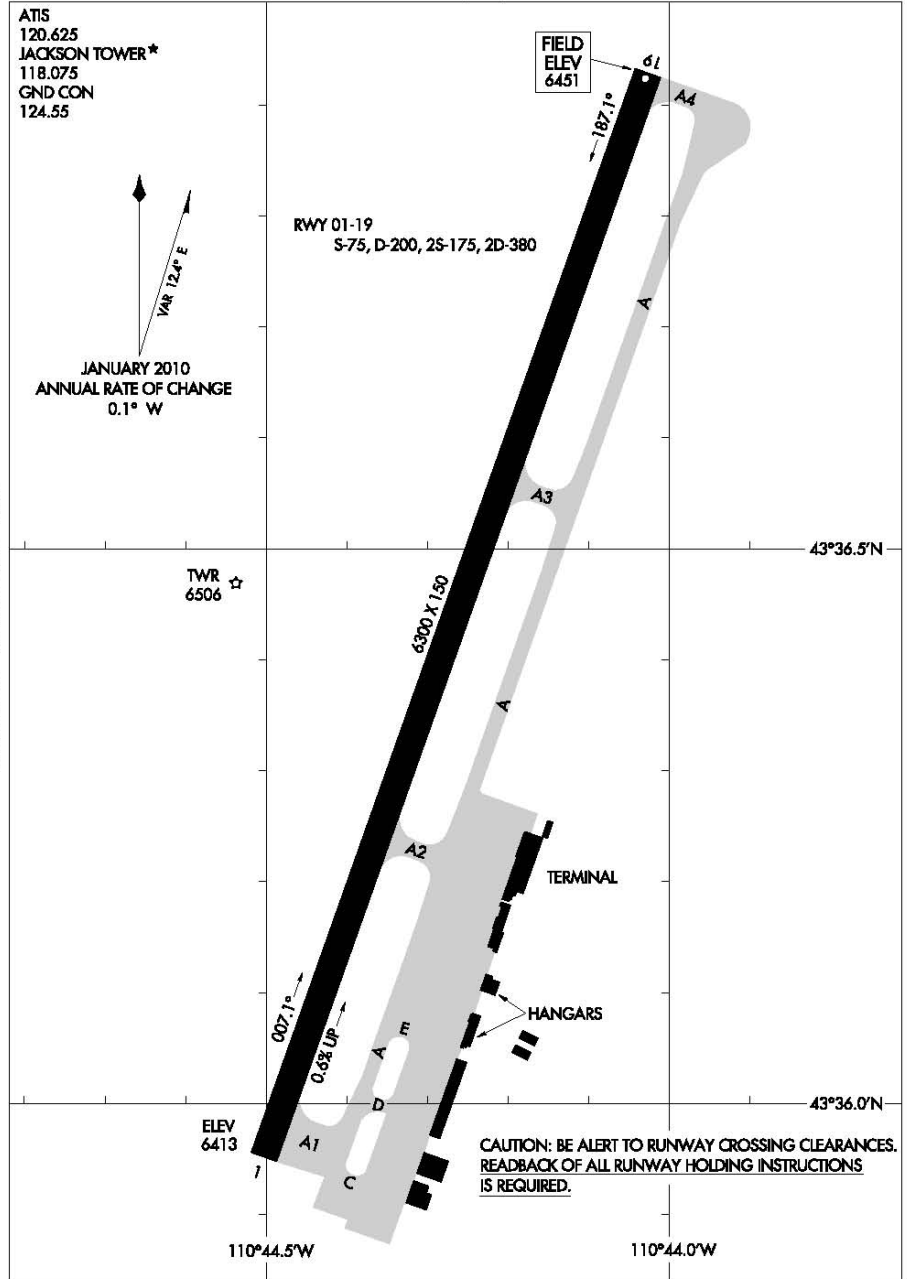
Figure 1. JAC Airport Diagram

There was one runway available at JAC (Figure 1); Runway 01/19 was 6,300 feet in length by 150 feet wide, was paved with porous friction course (PFC) asphalt, and had high-intensity runway edge lighting installed. The runway also had precision instrument markings, medium intensity approach lighting systems (MALS), and precision approach path indicators (PAPI, set at 3 degrees), for operations on both Runway 01 and Runway 19.
