# SURVIVAL FACTORS

## SPECIALIST'S FACTUAL REPORT

Operator : British Airways  
Airplane : Boeing 777-200 [G-VIIO]  
Location : Las Vegas, NV  
Date : September 8, 2015  
Time : 1627 Pacific daylight time (PDT)<sup>1</sup>  
NTSB # : DCA15FA185

On September 8, 2015, about 1627 Pacific daylight time (PDT), British Airways flight 2276, a Boeing 777-200ER, equipped with two GE90-85B engines, registration G-VIIO, experienced a #1 engine uncontained failure during takeoff ground roll on runway 7L at McCarran International Airport (LAS), Las Vegas, Nevada. The #1 engine, inboard left wing, and a portion of the left and right fuselage sustained fire damage. Resulting fire was extinguished by aircraft rescue and firefighting. The 157 passengers, including 1 lap child, and 13 crewmembers evacuated via emergency slides on the runway. The airplane was substantially damaged. The flight was operating under the provisions of 14 Code of Federal regulations (CFR) Part 129 and was en route to London – Gatwick Airport (LGW), Horley, England.

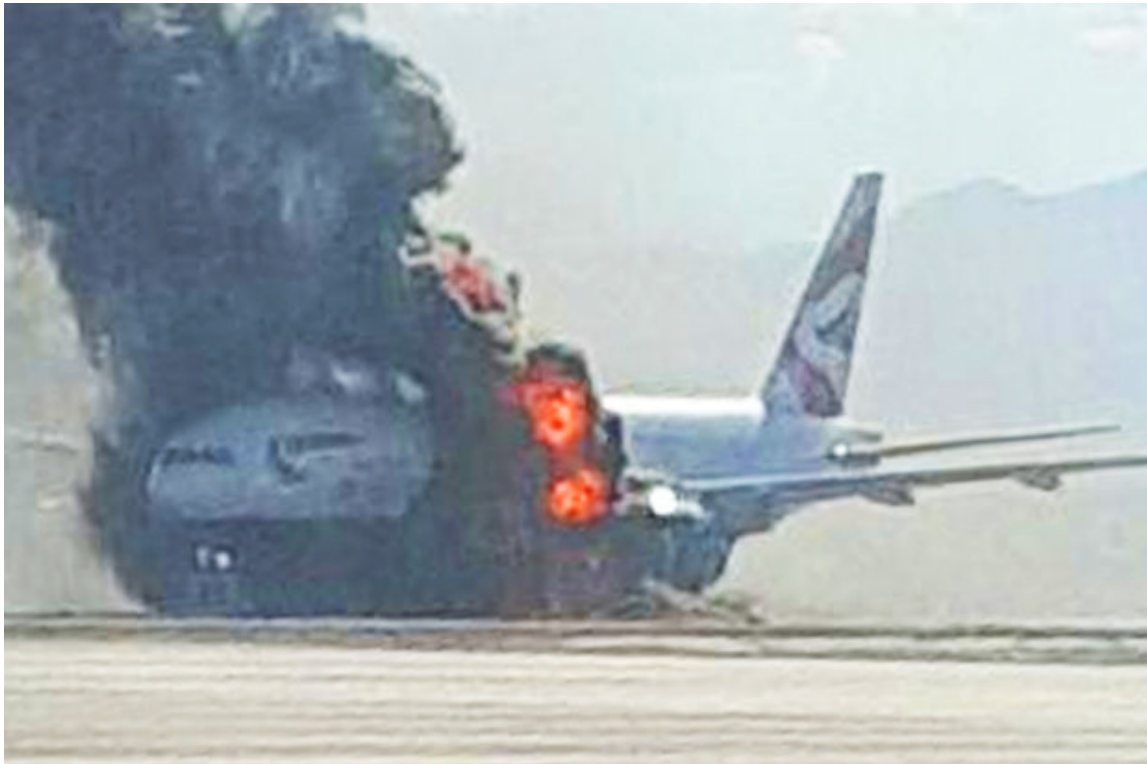
*Photo 1. Flames and smoke surround the airplane prior to the evacuation.*

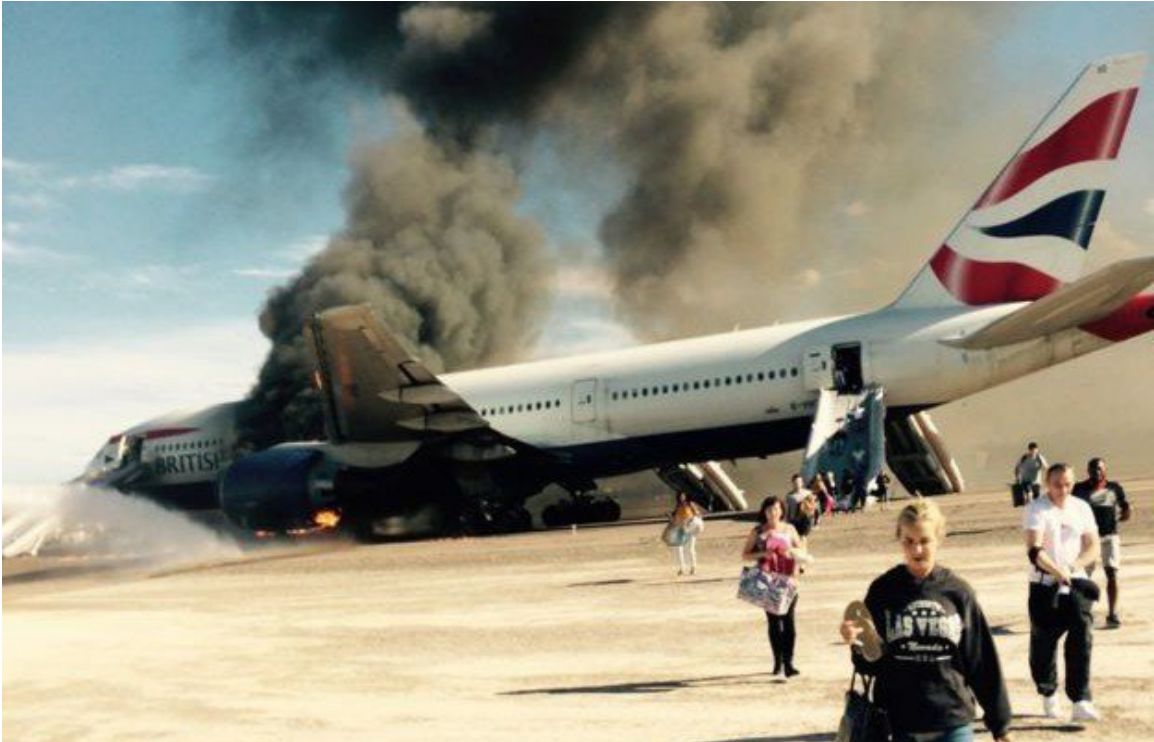
*Photo 2. Passengers evacuating out door 4L with fire visible beneath left engine.*

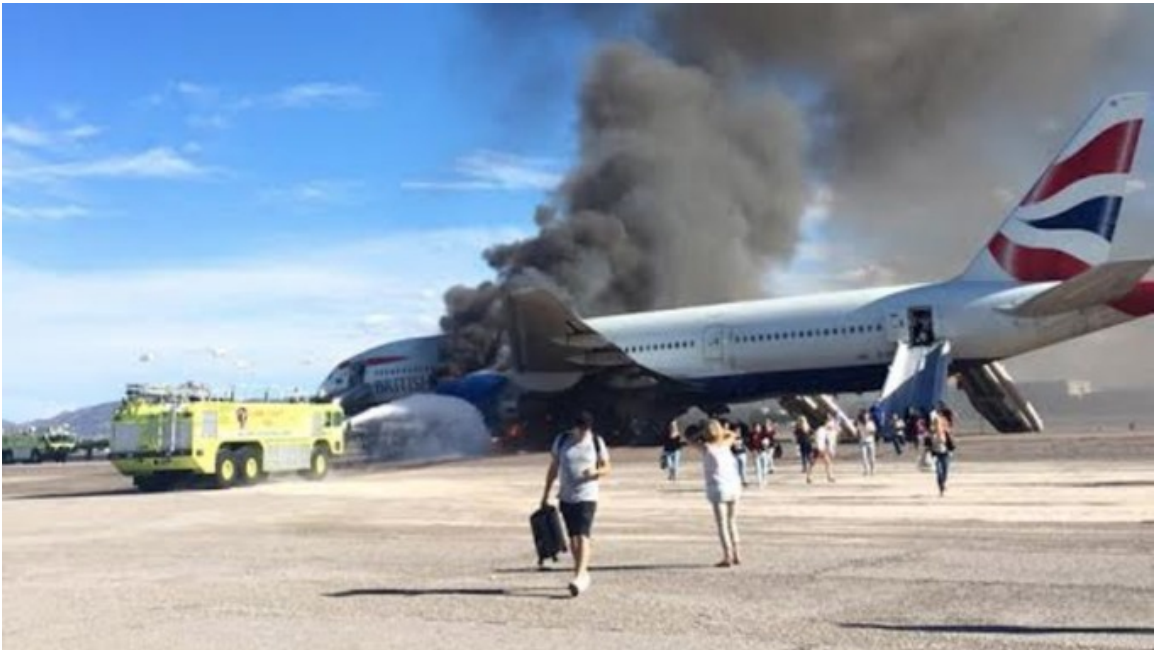
*Photo 3. Passengers evacuating out door 4L with RD41 discharging agent.*

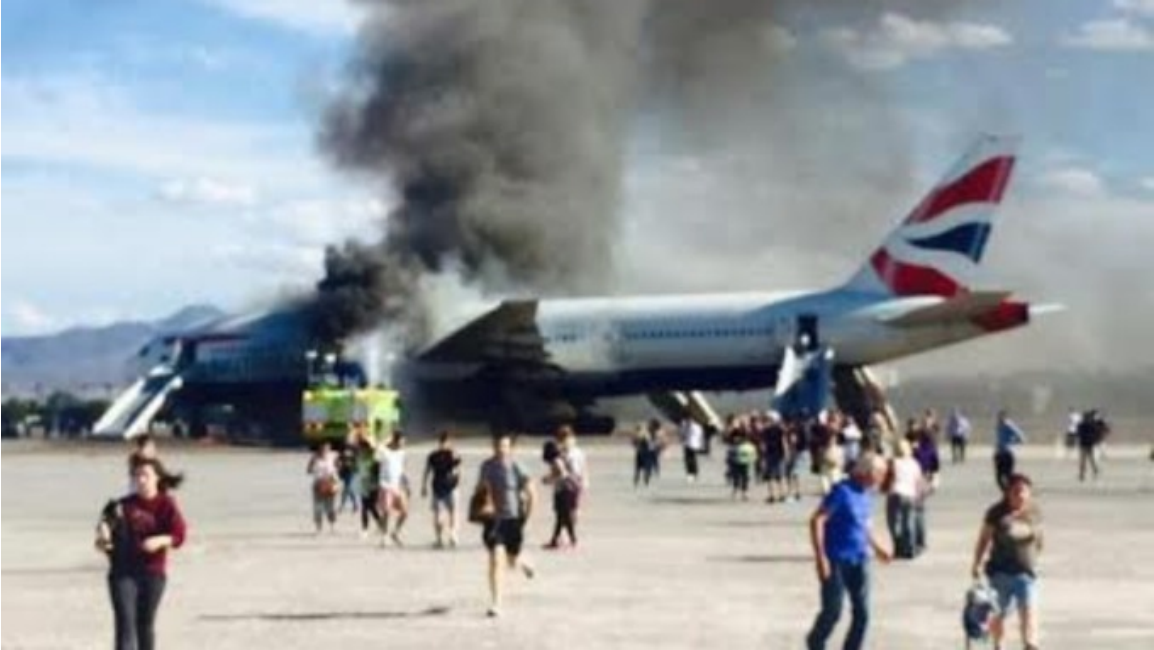
*Photo 4. Passengers evacuating out door 4L with RD41 discharging agent.*

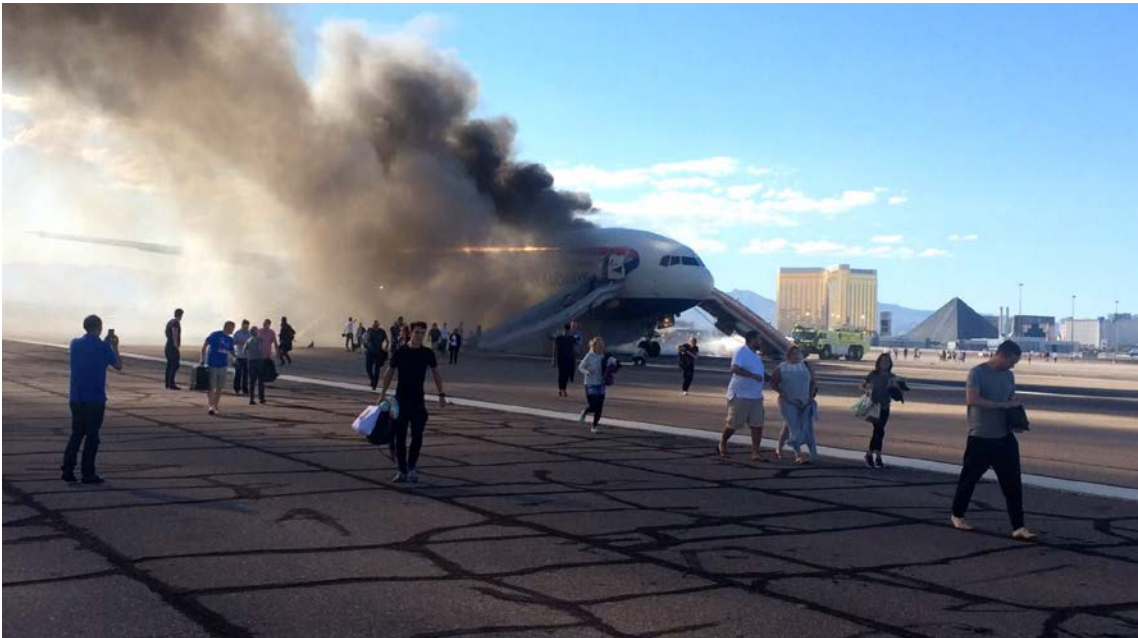
*Photo 5. Passengers evacuating out door 1R prior to the arrival of RD44.*

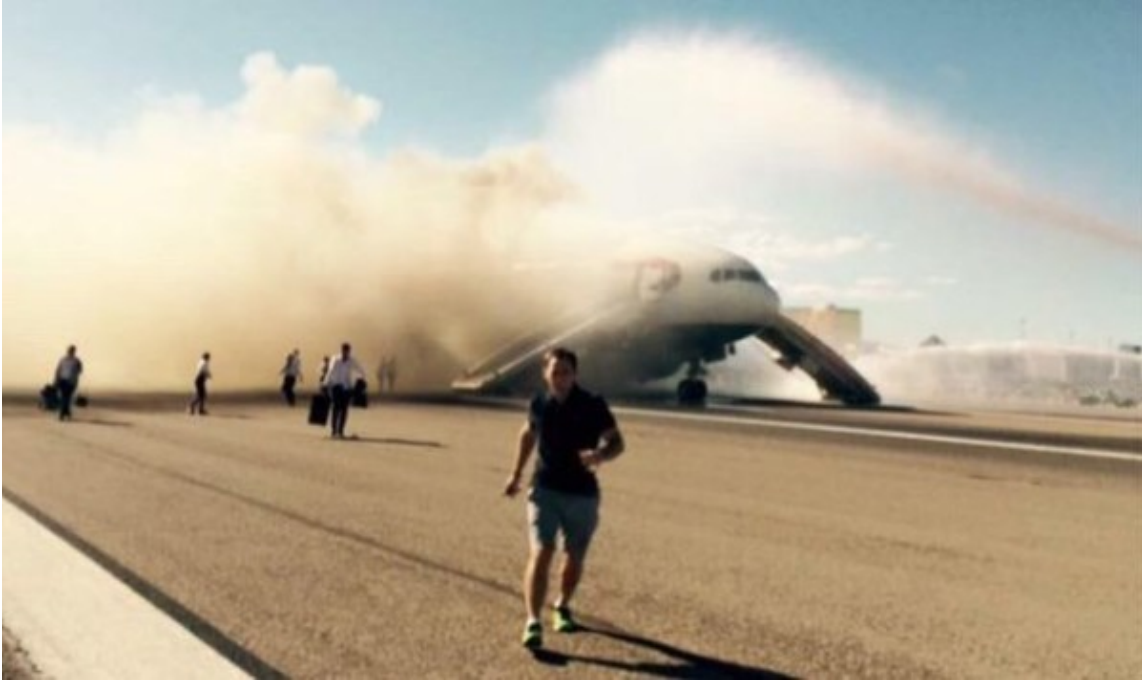
After RD41 positioned near the left wing, RD44 arrived and positioned to the right side of the nose “to protect passengers exiting from both sides of the aircraft.” The vehicle discharged agent from the HRET which initially impacted the area near the 1R door and slide/raft. The vehicle’s stream was unable to reach the fire from its location and repositioned closer to the airplane’s nose about 45 seconds later. The HRET was elevated and agent was discharged onto the fire side of the airplane aiding the fire attack.

British Airways reported 19 passengers sustained minor injuries and one occupant sustained a serious injury during the event. F/A #1 reported that the 1R slide/raft was wet and slippery from the extinguishing agent being applied to the airplane. She fell upon reaching the end of the slide/raft and fractured her left radius (forearm). She also suffered a compression fracture of the 1<sup>st</sup> lumbar vertebra in her lower back. The Clark

*Photo 6. Passengers evacuating out door 1R after the arrival of RD44.*

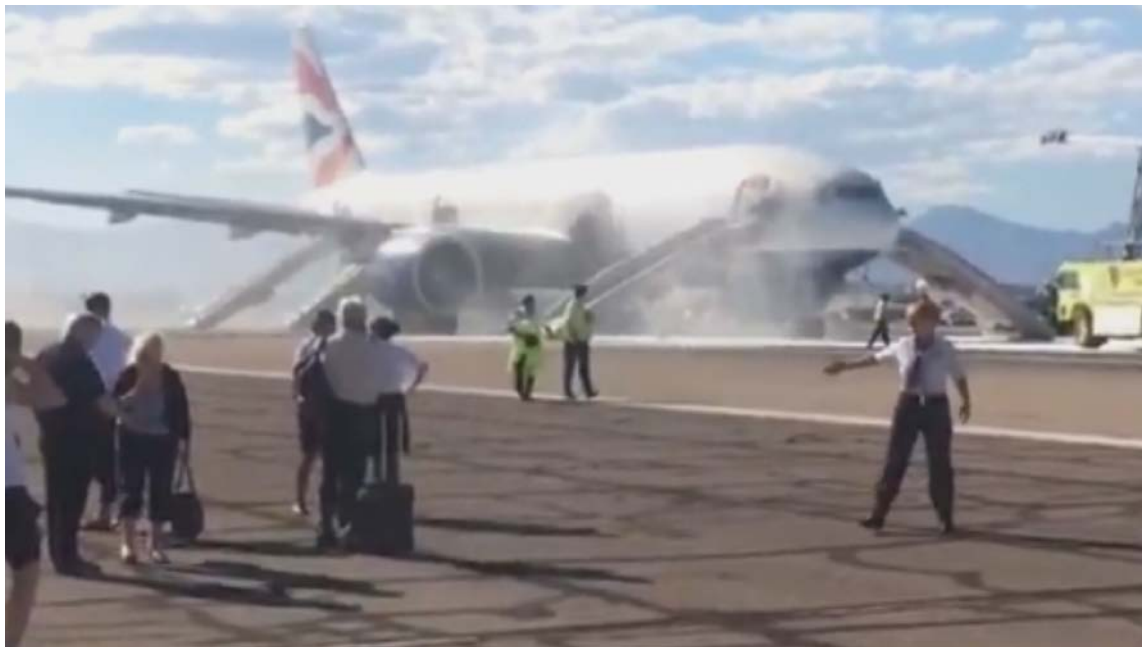
*Photo 7. Passengers on the right side of the airplane after extinguishment of fire.*

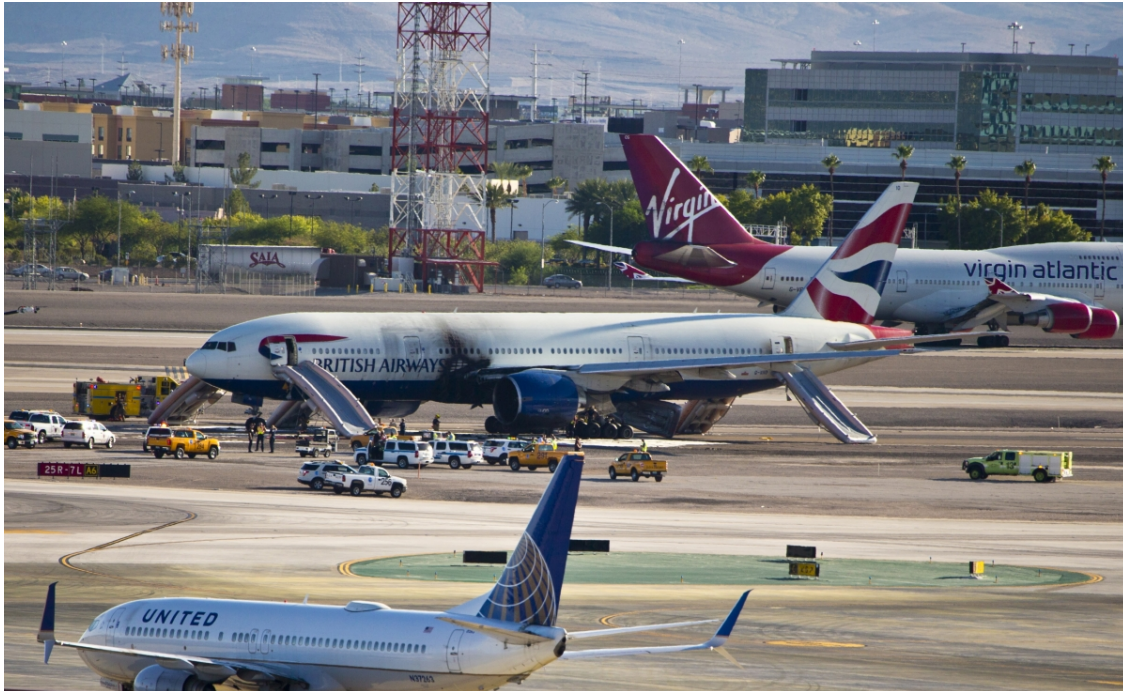
*Photo 8. Left side of the airplane after fire extinguishment.*
