**Survival Group Chairman
Factual Report**

**SURVIVAL FACTORS GROUP
FACTUAL REPORT OF INVESTIGATION**

Operator 1: Kinnicutt Bus Company
Vehicle 1: 1997 International AmTran 66 Passenger School Bus
Operator 2: MVF Construction Company
Vehicle 2: 1987 Mack Tandem Axle dump truck, 1988 Interstate Utility Trailer
Location: Intersection of SR 30A and SR 7; Schoharie County, Central Bridge, NY
Date: October 21, 1999
Time: 10:30 a.m. Local Time
Accident: School Bus Collision with Dump Truck/Utility Trailer
NTSB #: HWY-00-FH-001

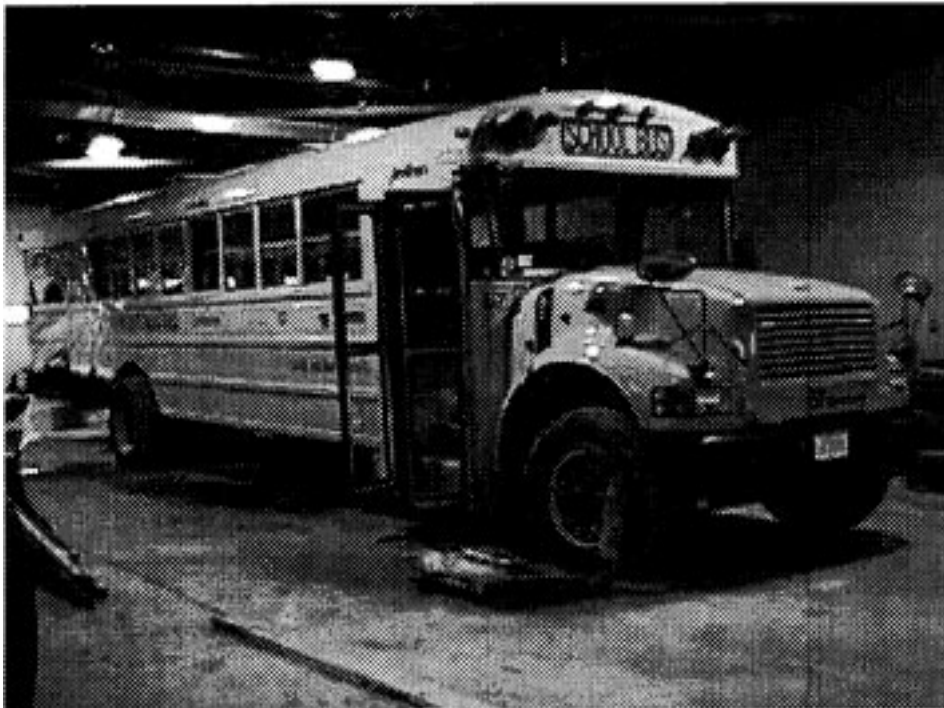
Figure 1 shows a picture of the final rest positions of the school bus and the dump truck. The exterior damage to the bus and the location of the major impact forces can be seen in Figure 2.

Figure 2: The exterior damage to the school bus

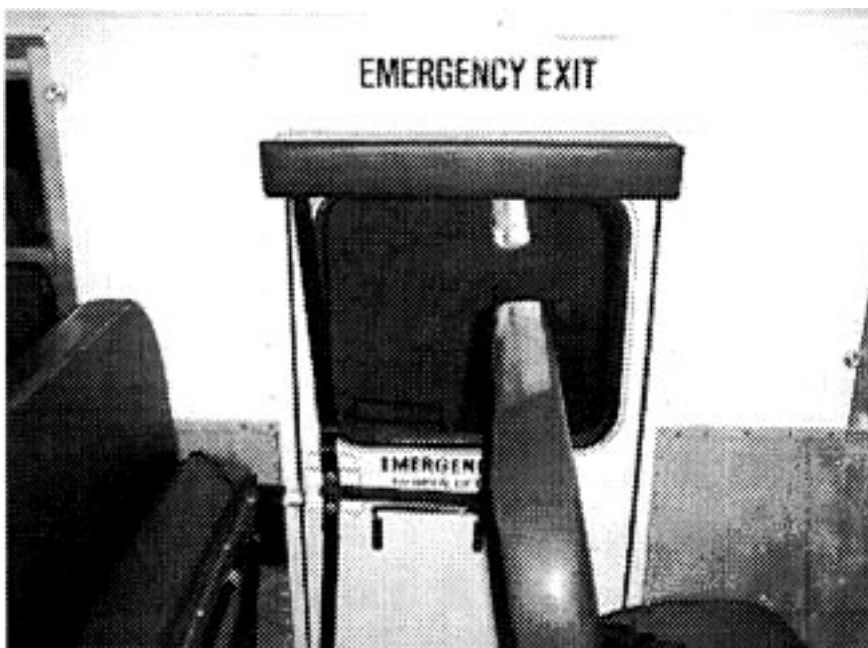
Figure 5: A photograph of the side emergency exit door with the flip seat in the up position

² According to 49 CFR 571.217 S5.4.2.1, a seat can be positioned in front of an emergency exit "if the seat bottom pivots and automatically assumes and retains a vertical position when not in use".

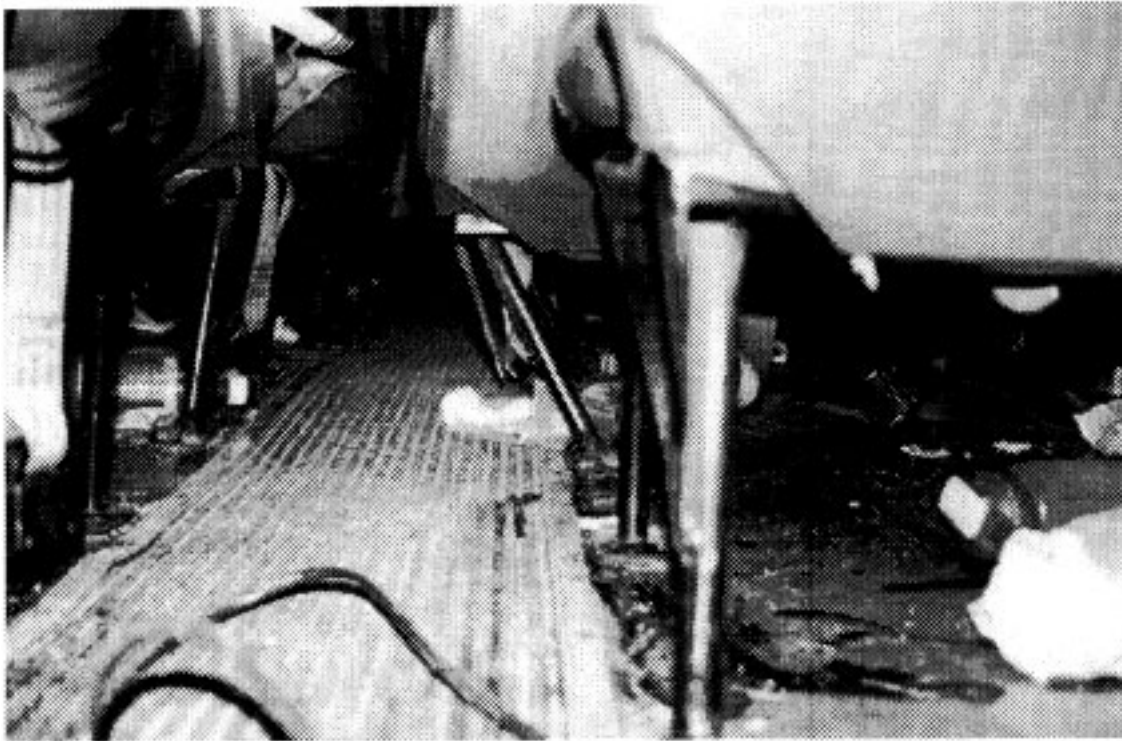
Slight deformation of seat frame legs but not measurable Small amounts of blood identified on seat cushion Blood splattered in aisle beside this seat Possible dripping of blood on aisle side of seat frame towards the floor
	DS	Seat not properly latched to frame Small amounts of blood identified on seat cushion Corner of vinyl on seat cushion damaged and repaired
9	PS	Seat not properly latched to frame Seat cushion laterally shifted to the left Deformation of rear attachment to side wall Deformation of the attachment points to the floor Deformation of seat frame legs causing a bend of approximately 18 degrees from vertical in the direction of the aisle (see Figure 8) Front retaining clip on seat cushion bent and not functioning Scratch marks on the vinyl located across back of seat back
	DS	Seat cushion laterally shifted to the right by approximately 1 inch
10	PS	Seat not properly latched to frame Maximum intrusion occurred at this seat location Seat cushion and seat back laterally shifted to the left Significant wall and floor deformation in this area Deformation of seat frame legs causing a bend of approximately 29 degrees from vertical in the direction of the aisle (See Figure 8) Seat back displaced laterally to the left by 2.5 inches from the wall, measured at the base of the window frame

Figure 8: A photograph showing the deformation of the seat frame legs on the passenger side of the bus.

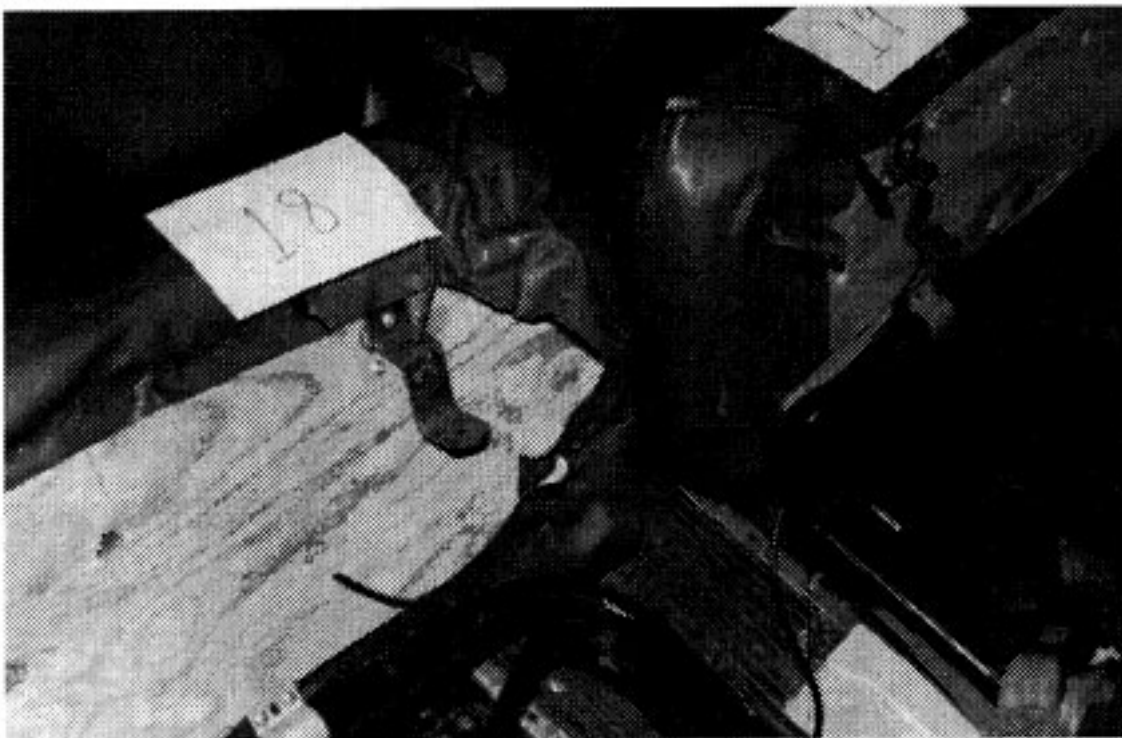
Row	Side	Documentation
1	PS	Seat not properly latched to frame' (See Figure 9)
	DS	Seat not properly latched to frame
2	PS	
	DS	Seat not properly latched to frame
3	PS	Seat not properly latched to frame
	DS	-
4	PS	Seat not properly latched to frame
	DS	-
5	PS	Seat not properly latched to frame
	DS	Seat needs to be manually lifted ² . (Seat found folded up)
6	PS	-
	DS	Seat frame laterally shifted to the right
7	PS	Seat not properly latched to frame. Seat cushion laterally shifted to the left. Beginning of wall deformation
	DS	Seat not properly latched to frame
8	PS	Seat not properly latched to frame, retaining clip loose Minor lateral shift towards the left

¹ The seat cushions were attached to the frame with a hinge at the front and two retaining clips at the base of the seat cushion. Some of these retaining clips were found unlatched or loosely screwed in so that the seat cushion was not fixed to the frame at the base of the cushion.

Figure 9: A photograph showing the retaining clips used to fix the seat cushion to the frame at the base of the cushion. This photograph shows the seats in row 10 of the school bus.

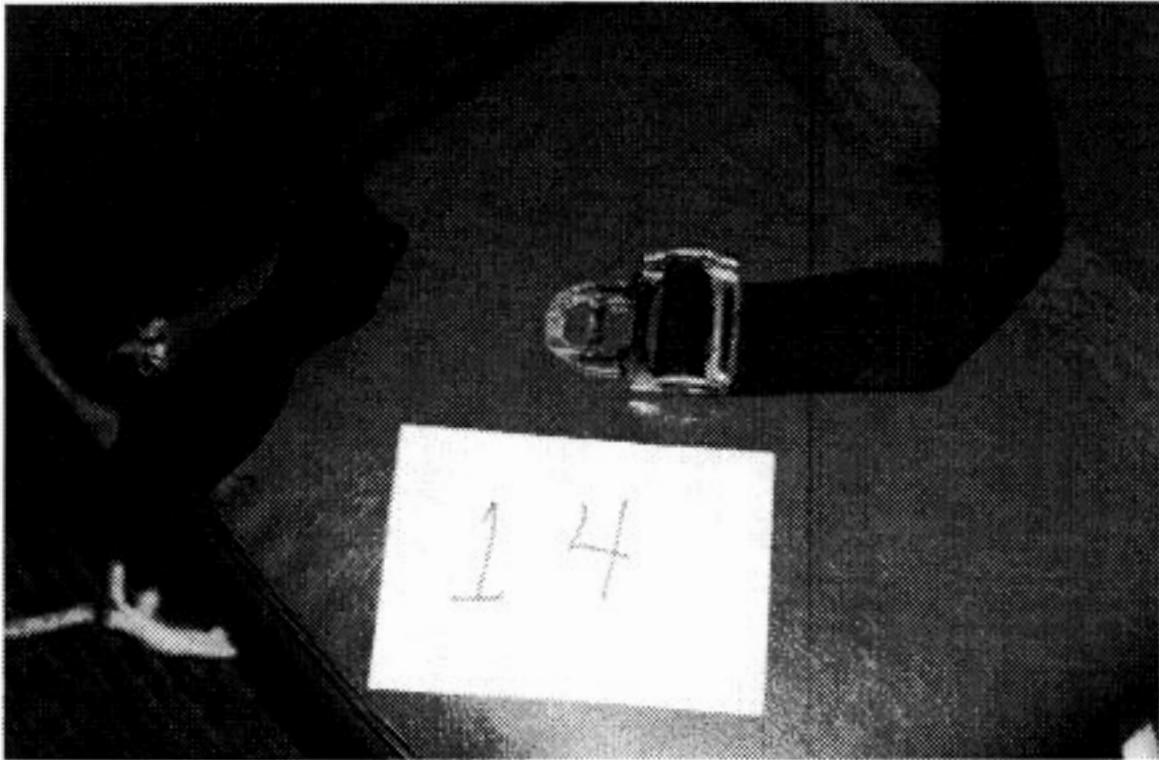
The length of the webbing on the buckle side of the belt was 12 inches (11 inches for the replaced belt, discussed in more detail below) and the buckle was 2 inches long. The length of the webbing on the tongue (clasp) side of the belt was 41 inches (37 inches for the replaced belt) at the maximum length. The length of the clasp was 2.9 inches with the tongue portion accounting for 1.6 inches of the length. The buckle was manufactured by I.M.M. Inc. with patent number 4,128,924 (A30023). A tag was found on the webbing, except at seat location 8C, indicating compliance with FMVSS 209 and 302.

Figure 10: A photograph of the replaced belt in row 8 on the driver's side of the bus. Note the black webbing, the missing tongue portion, and the fraying of the webbing.
