National Transportation Safety Board

End of Track Collision

Long Island Rail Road

System Safety Group Factual Report

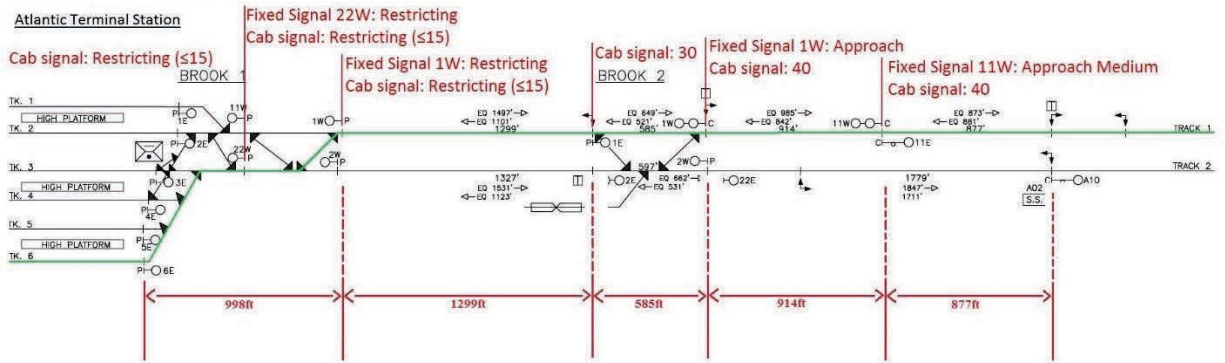
Figure 1. Track Chart of Atlantic Terminal

9 Figure 1 illustrates the route and signal indications for train No. 2817 with the route
10 highlighted in green and the signal locations, the signal aspect, and the distance between signals
11 in red. After passing through Brook 2 interlocking the train received a Restricting Signal at
12 Brook 1 Interlocking on Brook 1 track 1 that required the Locomotive Engineer to slow the train
13 to Restricted Speed not exceeding 5 mph. The train then crossed over from Brook 1 track 1 to
14 Brook 1 track 2 at Restricted Speed, not exceeding 5 mph. As the train continued west towards
15 the station on main track 2, the train encountered another Restricting Signal. Maximum
16 authorized speed through Brook 1 Interlocking and Station Track 6 was 5 mph. Under this
17 circumstance, the Locomotive Engineer must comply with restricted speed, that part reading,
18 “being prepared to stop in one-half the range of vision...” but also not exceed 5 mph. Then the

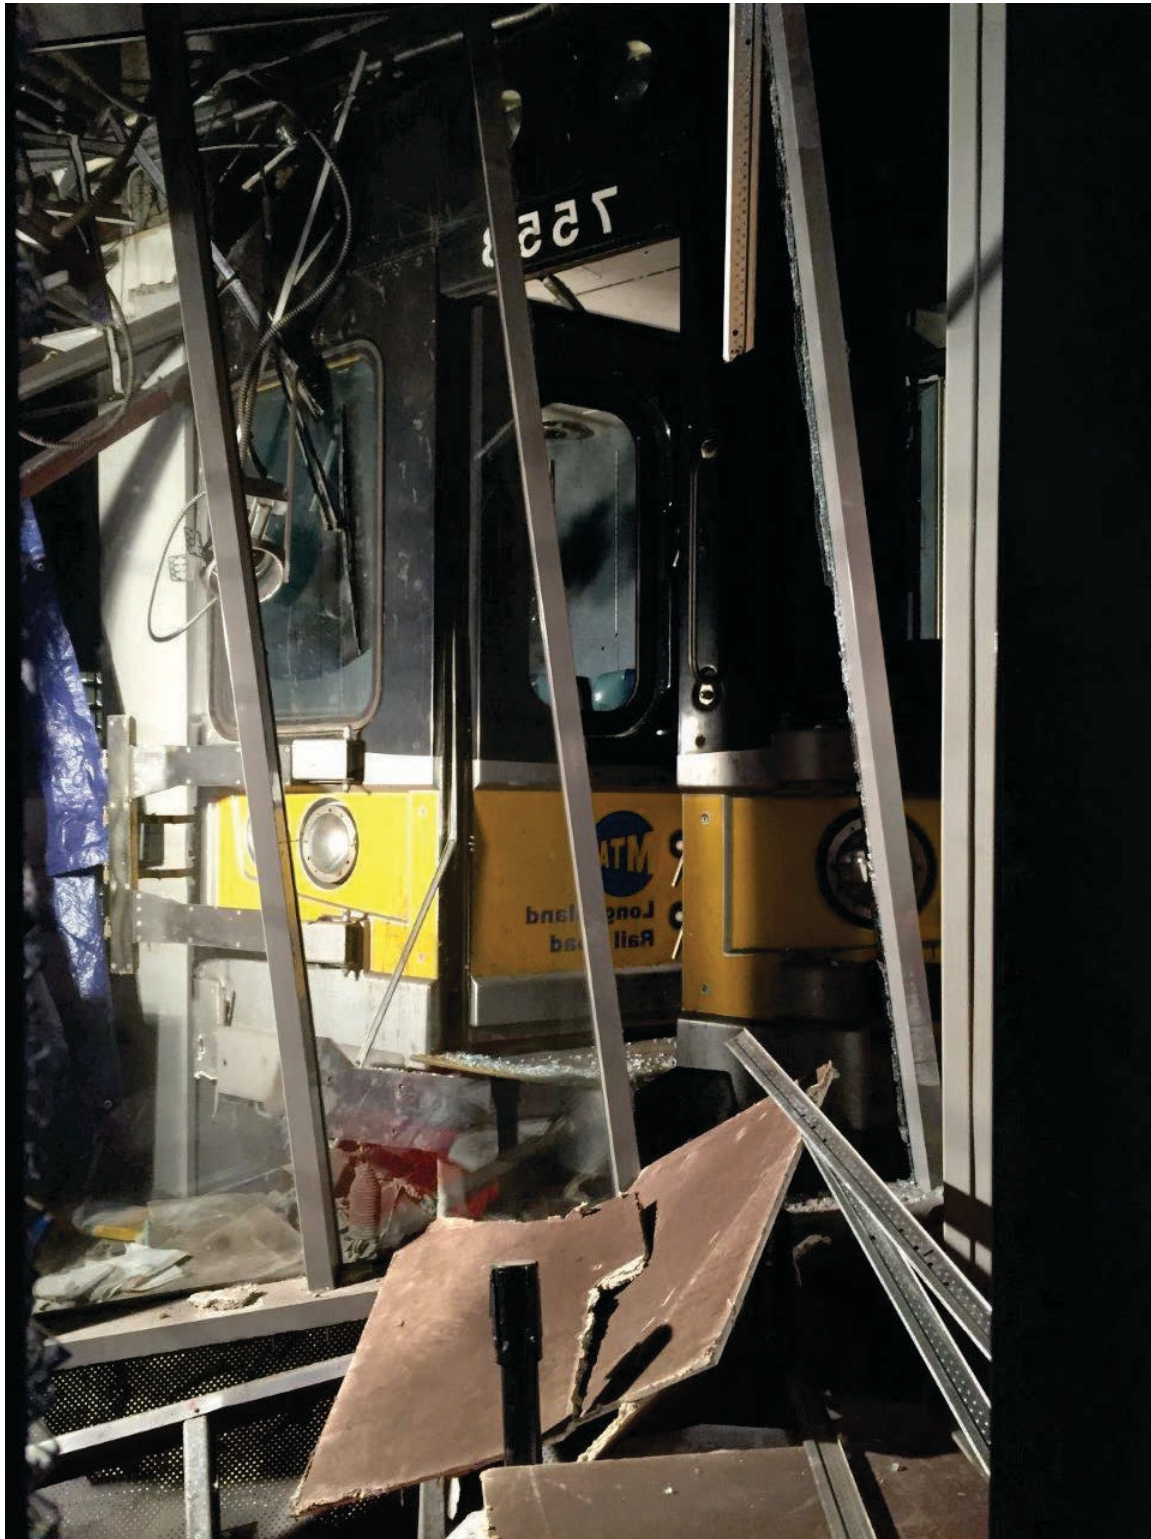
- 4
- 5 the concrete structure at the end of the track. The concrete was level with the platform that runs
- 6 parallel to the station track. The end of the lead car also pushed through a wall that the Long
- 7 Island Rail Road had installed for an “employee only” area. (See Figure 2.)

2 **Figure 2.** Resting point of Train no 2817 after collision.
