NATIONAL TRANSPORTATION SAFETY BOARD

Systems Group Chairman's Factual Report of Investigation

DCA12IA113

Location: El Paso, Texas
Date: July 27, 2012
Time: 1414 mountain daylight time (MDT)
Aircraft: Southwest Airlines flight 1871, a Boeing 737-3H4,
registration N379SW

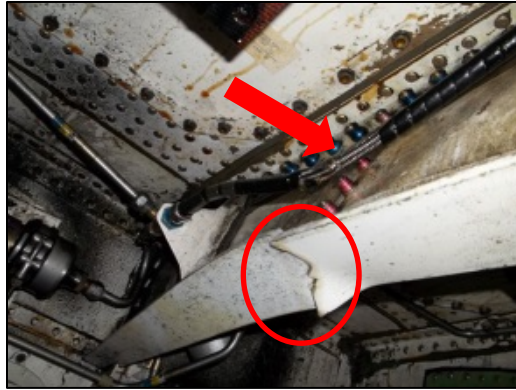
Prior to removal, the location of a damaged flexible hydraulic hose and a fracture of the Nose Gear Retract Actuator Support Beam Assembly¹ were documented. See Figure 5.

Figure 5 - The flexible hydraulic hose prior to removal. The fracture of the Nose Gear Retract Actuator Support Beam is circled; the abrasion on the flexible hydraulic hose is noted by the arrow.

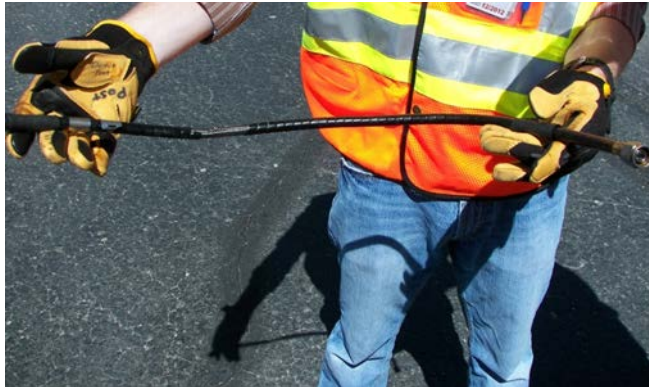
The damaged flexible hydraulic hose was identified as the Retract Hose. Figure 6 shows the hose after removal from the airplane:

Figure 6 - The Retract Flexible Hose after removal from the airplane.

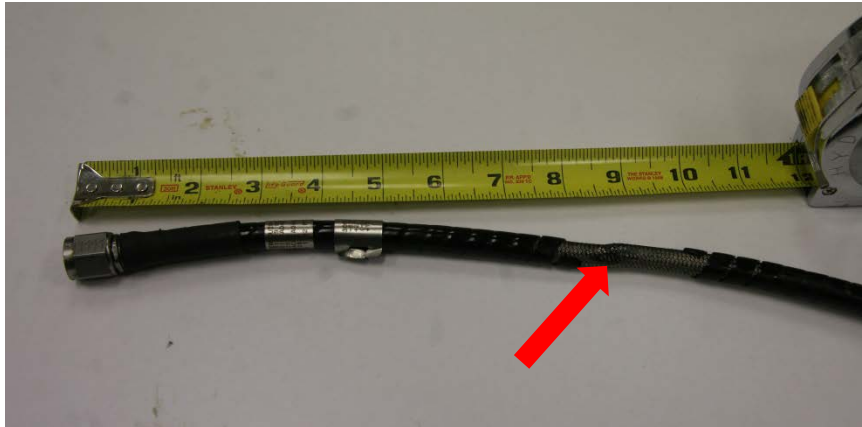
Figure 7 - Location of Hose Damage

- A rupture of the hose was identified 8.5 inches from the “A” end (the end with the data plate tag) of the hose. Approximately 3.18 inches of black outer plastic spiral wrap was missing in the area of the rupture. In this area, the ends of the wrap showed abrasions mostly aligned with the axis of the hose; however an arc shape was evident. See Figure 7.

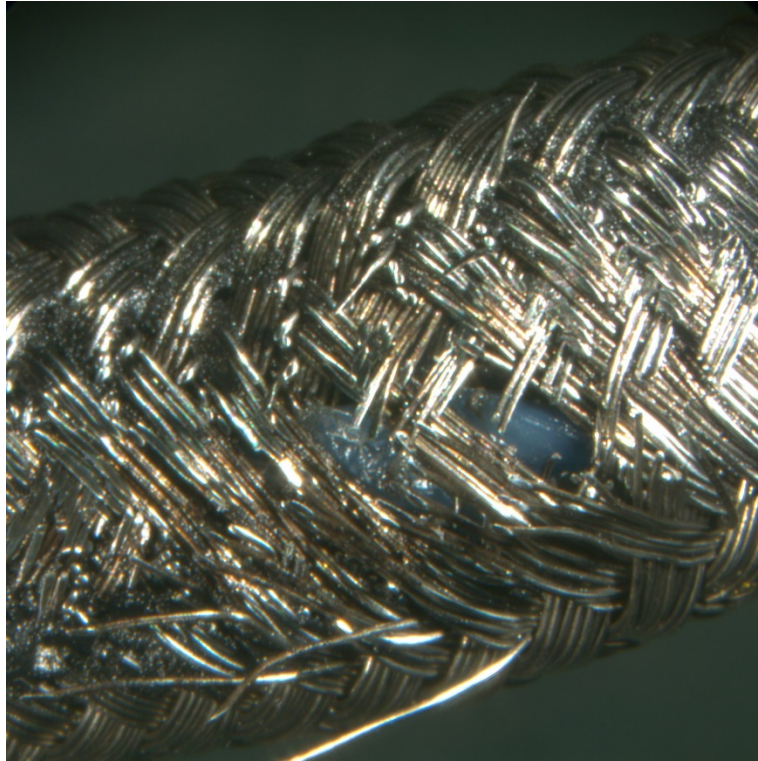
Figure 8 - Area of Abrasion

- Abrasion marks were also evident on the corrosion resistant steel (CRES) braid, also aligned with the axis of the hose. Individual CRES strands were broken with the free ends abraded down to “chisel points” in numerous locations. The free ends of a number of broken CRES strands were bent over remaining intact strands and were pointing in the forward direction. The Teflon inner liner was ruptured in the area of the damaged CRES braid. Black debris was evident in and around the damaged CRES braid strands, but was not evident in other areas of the hose. Comparison with on-scene photos showed that the abraded area was the outboard side, facing away from the actuator beam. The damaged area was examined under the microscope and photographs were taken. See Figure 8.

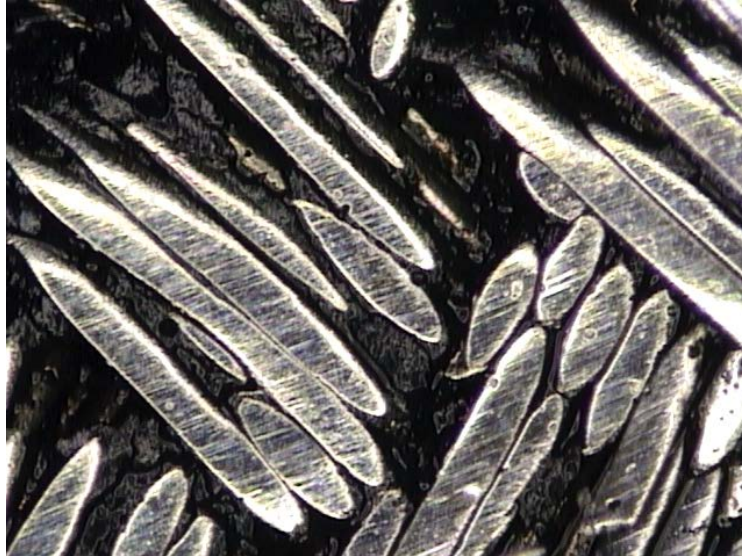
Boeing EQA personnel and Boeing Research & Technology (BR&T) personnel collected samples of the black debris noted within the CRES braid (See Figure 9). The samples were provided to BR&T for identification. In addition, a piece of the spiral wrap was removed from the hose and provided to BR&T for comparison. See section 2.5.0 for results of the BR&T examination.

Figure 9 - Area of abrasion, magnified, showing black material located in the CRES braid.

- As indicated in Section 2.1 of this report, the collected samples of the black debris noted within the CRES braid of the Hydraulic Hose BACH8A04EE0263S was examined by BR&T. The examination concluded that the black material was consistent with material from a nose gear tire sidewall (an exemplar Goodyear 275K22-1/276K22T1 nose gear tire).
- The rupture in the flexible hydraulic hose was coincident with section of missing spiral wrap and abrasion marks on the corrosion resistant steel (CRES) wire braids.

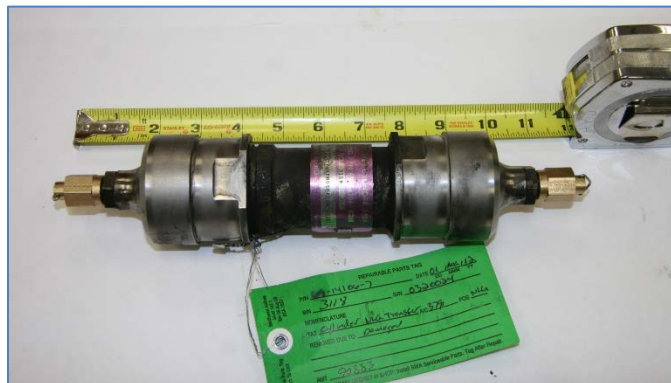
Figure 10 - Nose Landing Gear Transfer Cylinder, As Received

The transfer cylinder was visually examined, with no visible damage or defects noted, except that a tab on the identification tag was broken. The lock wire was intact and the end caps were tightly installed on the cylinder ports. See Figure 10.

The transfer cylinder passed the CMM Leakage and Operational Tests with no faults found. The group decided that disassembly of the cylinder was unnecessary. The unit was repackaged for shipment back to Southwest Airlines.

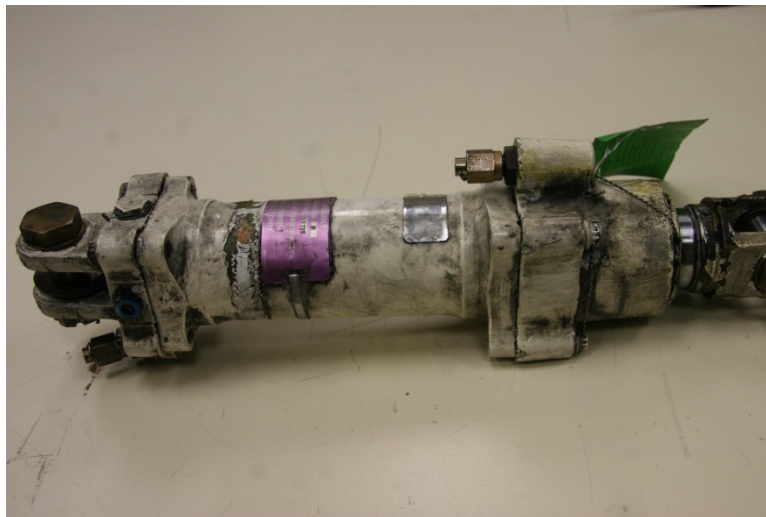
Figure 11 - Nose Gear Retract Actuator, as Received at Boeing EQA Laboratory

The shipping box containing the nose landing gear retract actuator was removed from a secure locker and the unit removed from the plastic packaging. The Southwest Airlines quarantine seals on the packaging were intact. See Figure 11.

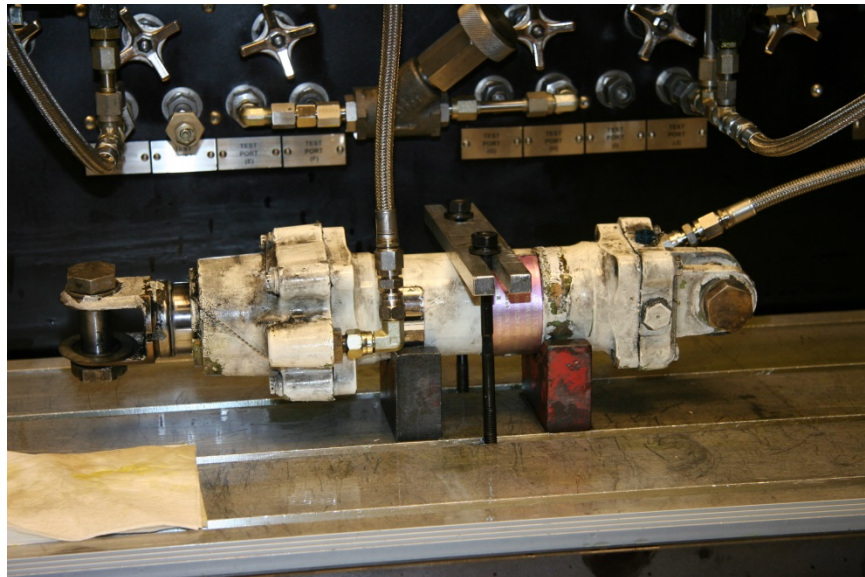
Figure 12 - Nose Landing Gear Retract Actuator, Installed on Test Bench

The actuator was installed in the EQA Laboratory Hydraulic Test Bench #1 and a functional test of the actuator was conducted. The functional test was conducted in accordance with the Component Maintenance Manual (CMM) Section 32-30-41, revision 21. See Figure 12.

Additional testing beyond the scope of the CMM was conducted on the actuator. While in the horizontal position, the actuator was extended as if in the gear retract position, and then hydraulic pressure was removed. The gear extend hose fitting was removed, which would be similar to opening the cylinder retract port to atmosphere, in an attempt to simulate a ruptured hydraulic hose. Leakage started as a drip and progressed to a steady stream.

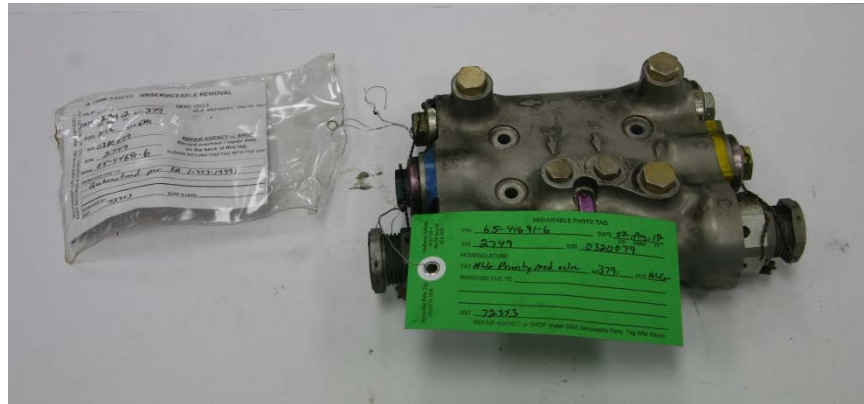
Figure 13 - Nose Landing Gear Modular Package, as Received

The package was visually examined, with no visible damage or defects noted. The plugs were tightly installed on the ports. See Figure 13.

The hydraulic modular package assembly passed all 10 elements of the functional test, with no faults found. Based on this finding, the group determined that a disassembly of the unit was not necessary.

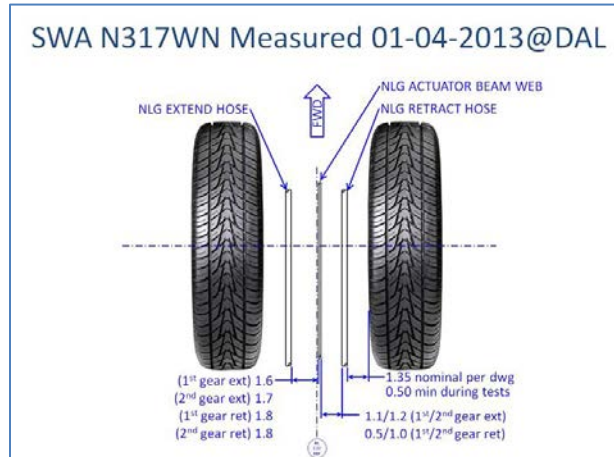
Figure 14 - Measured Clearance from Tires to Flexible Hoses

- The closest proximity of the NLG retract hose to the NLG tire surface was measured to be 0.5”;
- The NLG retract hose could be manually moved into contact with the retracted tire; significant hand force was needed to achieve contact;
- The hose clearance varies about ± 0.35 ” during NLG cycling;

- The hose motion appears to be generally in a vertical plane. The NLG retract actuator motion during gear retraction appears to slightly shorten the hose run, so the extra length of the hose tends to move in a vertical plane (along the NLG actuator support beam);
- The flexible hydraulic retract hose "jumps" or pulses once when the gear handle is selected "OFF", but hose appears to come back to approximately the same position after the jump;

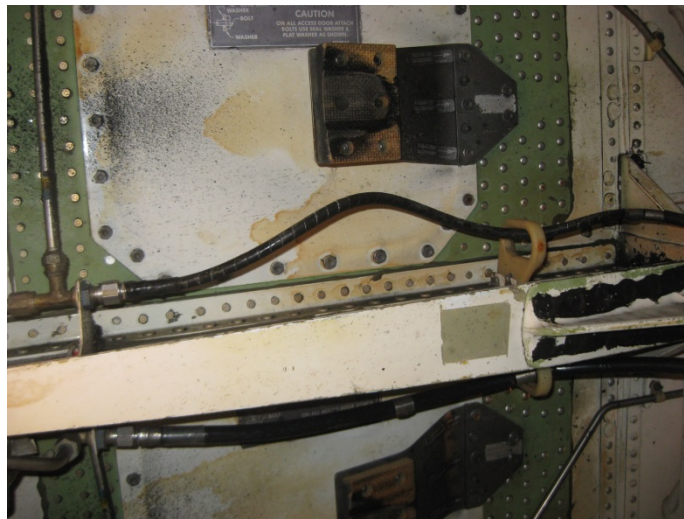
Figure 15 - Intentionally Twisted Flexible Hose

After one end was loosened, the flexible hydraulic retract hose was twisted and then retightened to secure the hose with a twist outward towards the NLG tire. Approximately 1.5 revolutions of the hose were required to move the hose a sufficient distance to contact the tire.

- a) A twist of the hose during installation can cause horizontal motion as well as vertical motion of the hose during gear extension and/or retraction. See Figure 15.
- b) While it seems natural to install the hose with the as-new curve in the vertical plane, it is possible to install it per the Aircraft Maintenance Manual Chapter 20 with the hose bowed in a horizontal plane, away from the NLG actuator beam web and towards the area where the NLG wheels are positioned after gear retraction. The hose tends to accommodate the excess length on gear retraction by accentuating the original as-new curve, whether it was installed horizontally or vertically.
