NATIONAL TRANSPORTATION SAFETY BOARD
Office of Aviation Safety
Washington, D.C. 20594

Airworthiness Group Chairman's Factual Report

A. ACCIDENT DCA15FA085

Location: LaGuardia Airport, Queens, New York
Date: March 5, 2015
Time: 1102 Local Time
Aircraft: Delta Air Lines flight 1086, a Boeing MD-88, registration N909DL

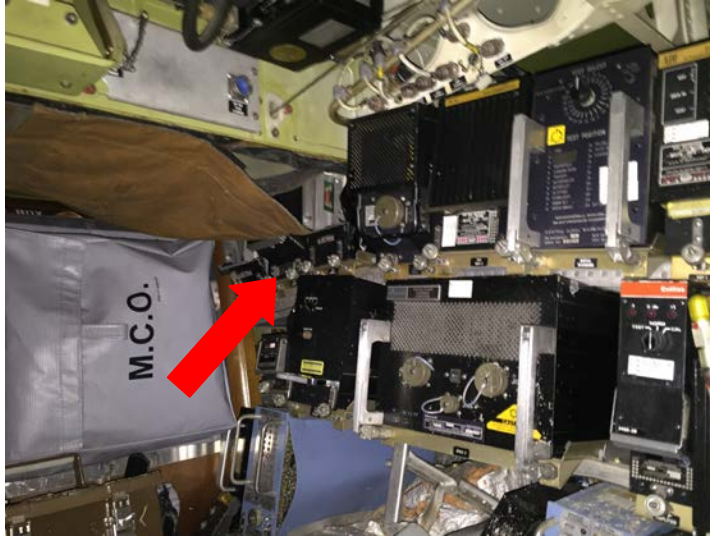
In the Electrical/Electronics Compartment the VHF #2 and #3 radio units were noted as crushed. The VHF #1 unit was displaced with its associated radio rack displaced. See Figure 1.

Figure 1- Damage to Electronics Compartment Rack, including VHF Radio Receivers (Red Arrow)

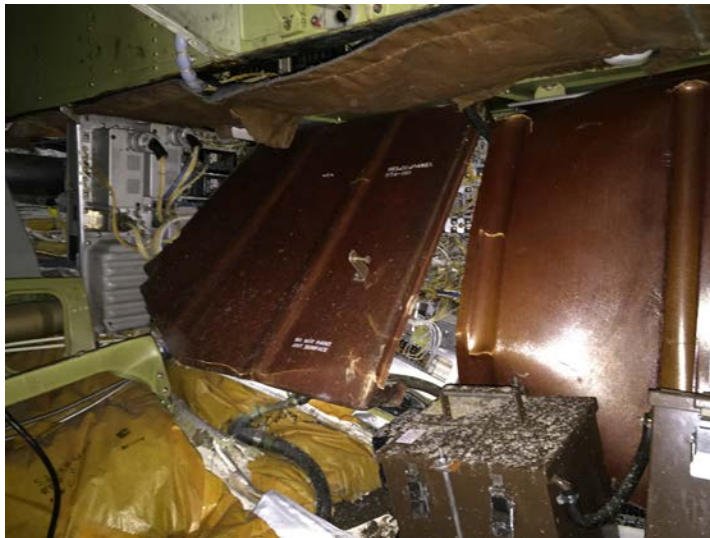
Damage was noted in the lower areas of the Electrical/Electronics compartment. Several of the lower avionics racks in the compartment, as well as the avionics units installed on them, were displaced, bent, and damaged. The access door to the Station 110 relay panels was displaced and broken. See Figures 2 and 4.

Figure 2 - Damage to Electronics Compartment, including Station 110 Relay Panel Cover.

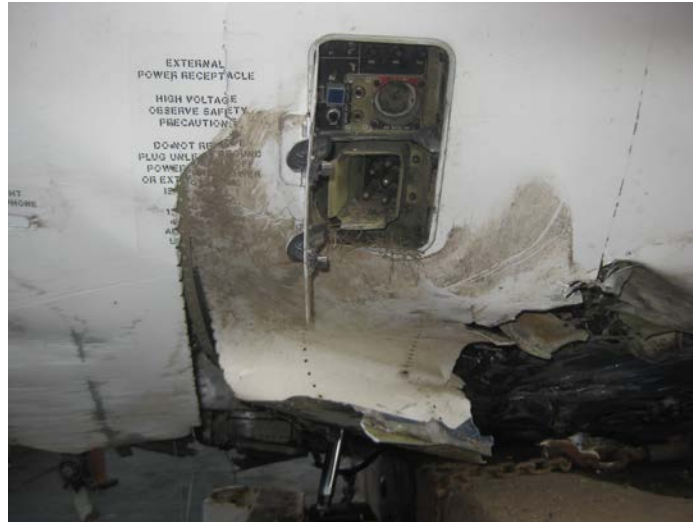
Significant damage to the area around the external power receptacle was noted. See Figure 3.

Figure 3 - Damage to area around the External Power Receptacle.

Damaged structure at this location along with displacement of structure located within the Electrical/Electronics Compartment led the group to conclude the application of electrical power on this airplane posed a safety risk. The noted damage included electrical power feeder cables for external power were displaced. This determination limited testing of systems and components to hydraulic testing (using a hydraulic mule) without the application of electrical power.

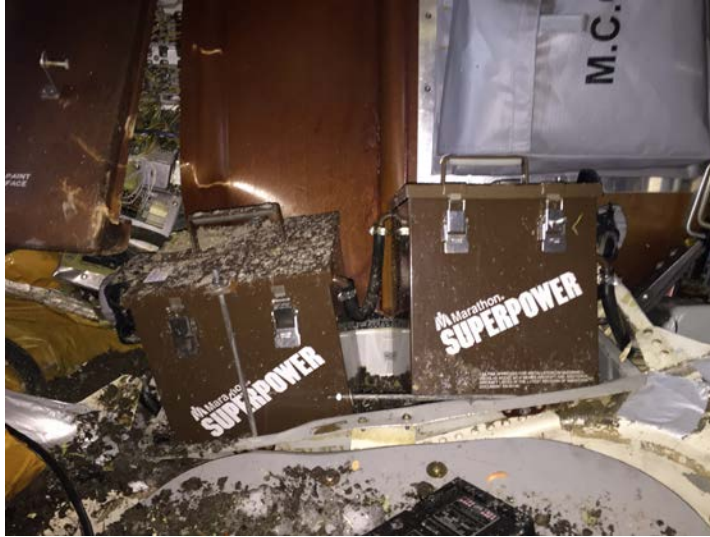
Due to damage to the Electrical/Electronics Compartment Door on the underside of the forward fuselage, access to the Electrical/Electronics Compartment was limited to the hatch located behind the Captain's seat in the flight deck. To observe damage to the components located within, one group member climbed down through the opening to document the compartment. The Antiskid Control Unit along with the Autobrake Control Unit was inspected and no evidence of water or other liquid dripping into the boxes were found. Damage was observed including excessive damage to the station 110 relay panel. The left and right main batteries were observed to be displaced from their shelves. See Figure 4. The right battery connection was cracked and twisted from contact with structure. The forward right radio rack was damaged. The number 2 and 3 VHF communication boxes were crushed. The generator rack was also damaged.

Figure 4 - Damage to Airplane Main Batteries and Shelf. The 110 Relay Panel is behind the batteries.

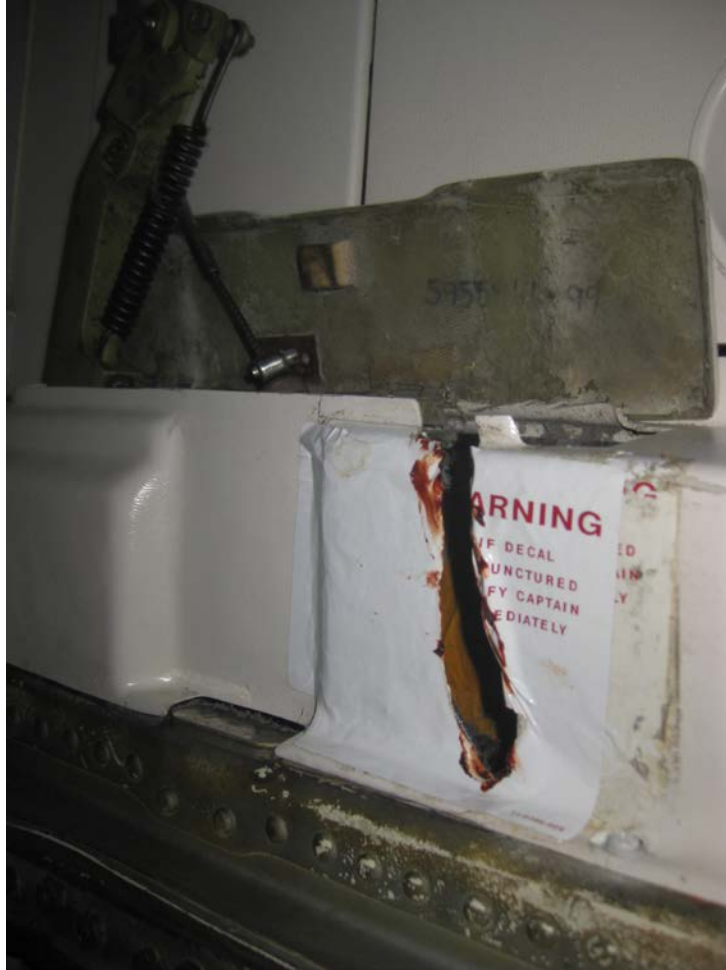
Figure 5 - Ripped tailcone placard above aft passenger door.

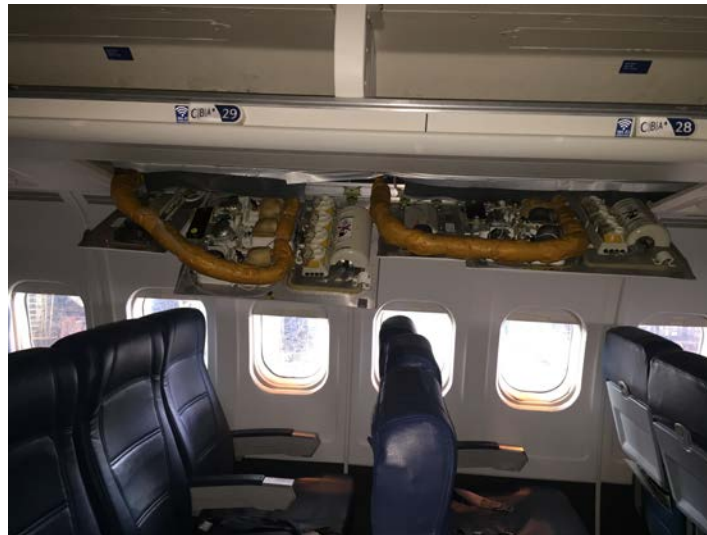
The panels were dislodged on the inboard (aisle) side, hanging down approximately 8-10 inches, but the window side of the panels was still in their normal position. See Figure 6.

Figure 6 - Dislodged passenger service unit panels.

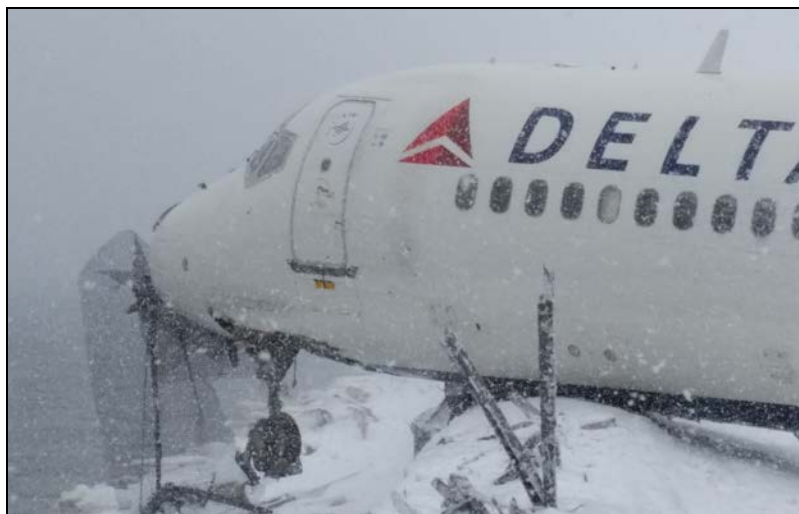
The nose landing gear (NLG) was attached to the aircraft after the accident but was damaged and partially separated during the accident sequence. See Figure 9. Delta Air Lines indicated that the drag link brace and landing light wiring were cut to remove the NLG prior to moving the airplane into the hangar.

Figure 9 - Airplane on berm following the accident, prior to removal of the nose landing gear.

The Captain-side trunnion structure was damaged and the first officer's side trunnion pin was found sheared.

The nose wheel steering actuator on the captain's side was broken and the first officer's side nose wheel steering actuator was bent.

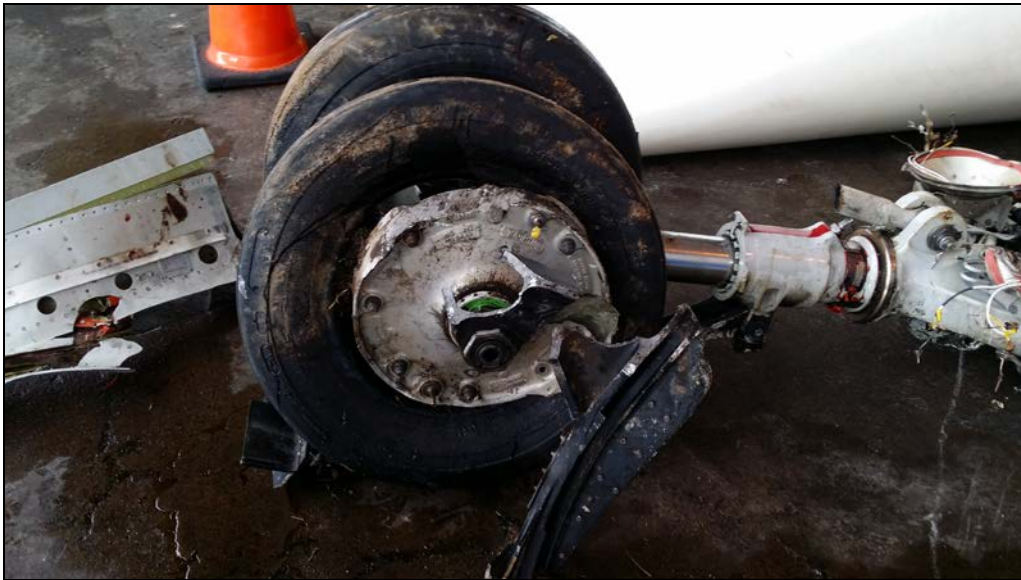
The right NLG tire assembly was still inflated but the left NLG tire assembly was deflated, with damage to the wheel and tire. See Figure 10.

Figure 10 - Nose Landing Gear in hangar, after removal from the airplane
