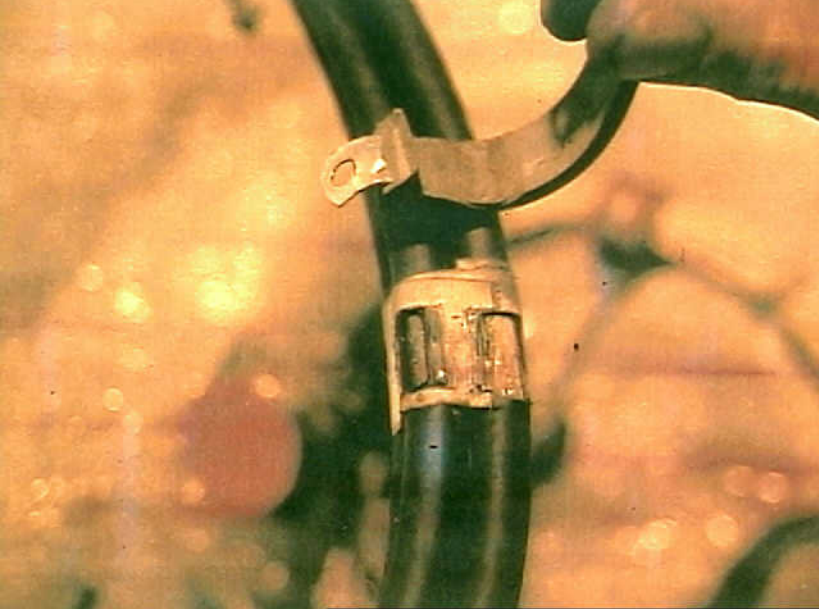
Systems 9 - 747-SL-20-048 - Fig. 1. Vibration caused chafing under the bundle clamp. Note that the clamp cushion shows little sign of wear.
