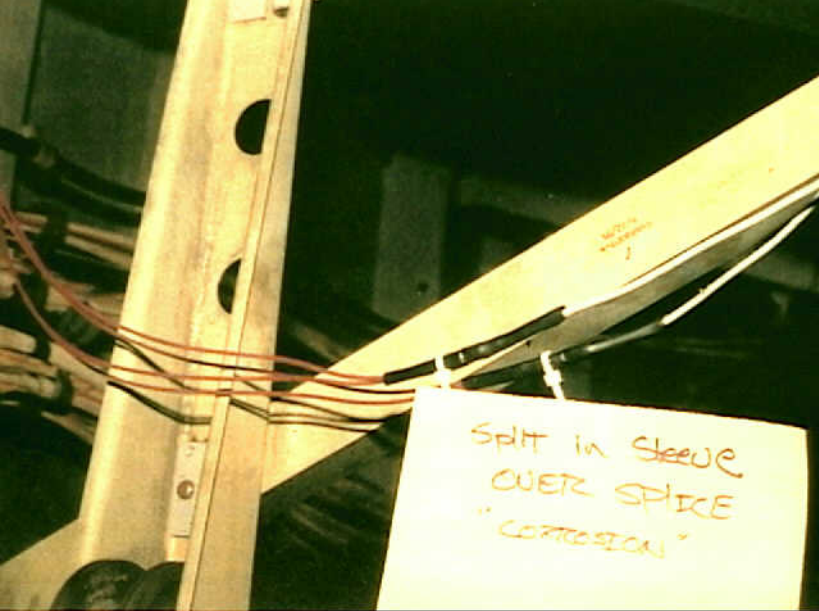
Systems 9 - 747-SL-20-048 - Fig. 10. Sleeving over splices failed, allowing splice corrosion.
