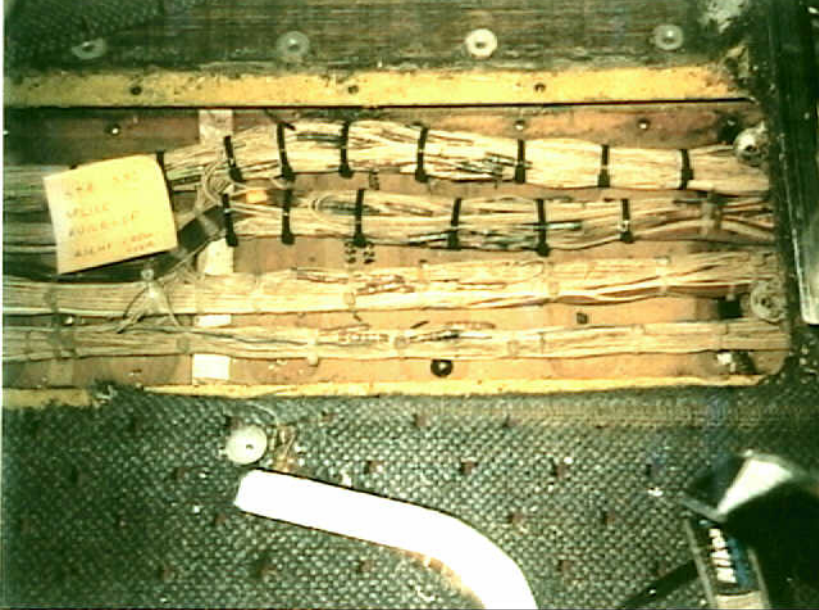
Systems 9 - 747-SL-20-048 - Fig. 13. Clumps created by concentrating a large number of splices on the flight deck floor crossover bundle. Splices should be staggered throughout the bundle, this reduces the potential for wire - to - wire (text cut-off).
