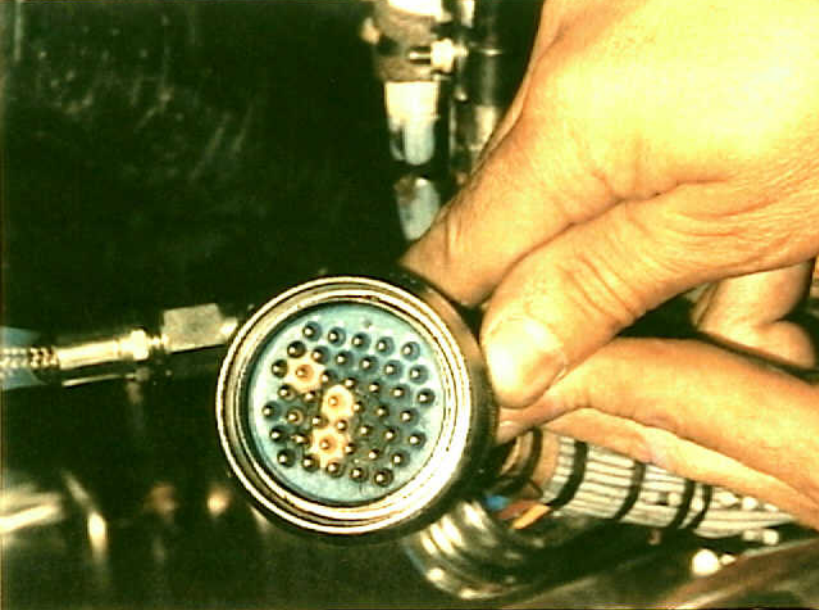
Systems 9 - 747-SL-20-048 - Fig. 15. Damage from hydraulic fluid on a connector grommet. Initially a color change is observed, then cracking occurs as the grommet dries out. If contamination is severe enough, all grommet material may be eroded.
