Systems 9 - 747-SL-20-048 - Fig. 18. Wires broken at the connector backshell.

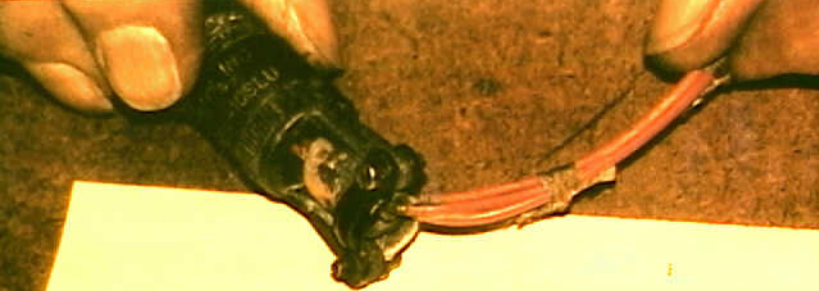
BACKSHELL
BUILD-UP
MISSING
