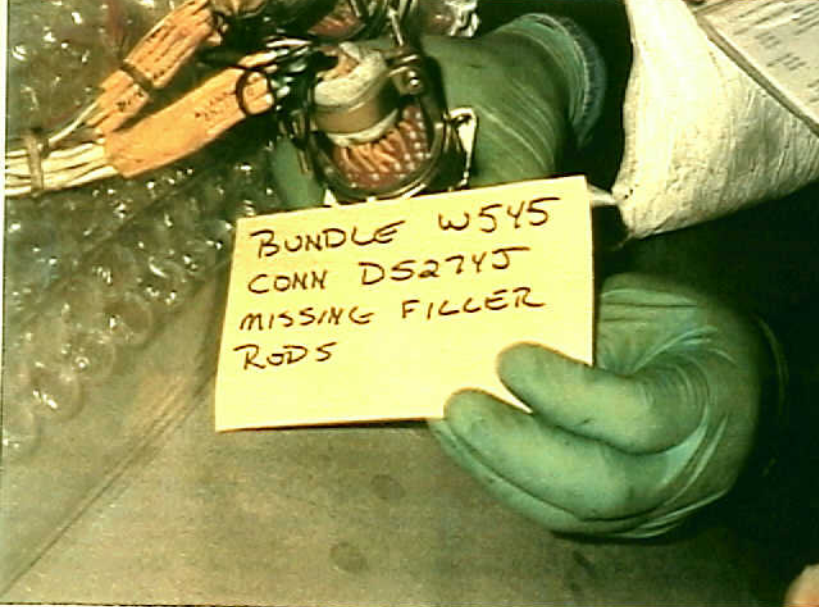
Systems 9 - 747-SL-20-048 - Fig. 19. Missing connector filler rods. The compromised environmental seal can contribute to internal connector corrosion.
