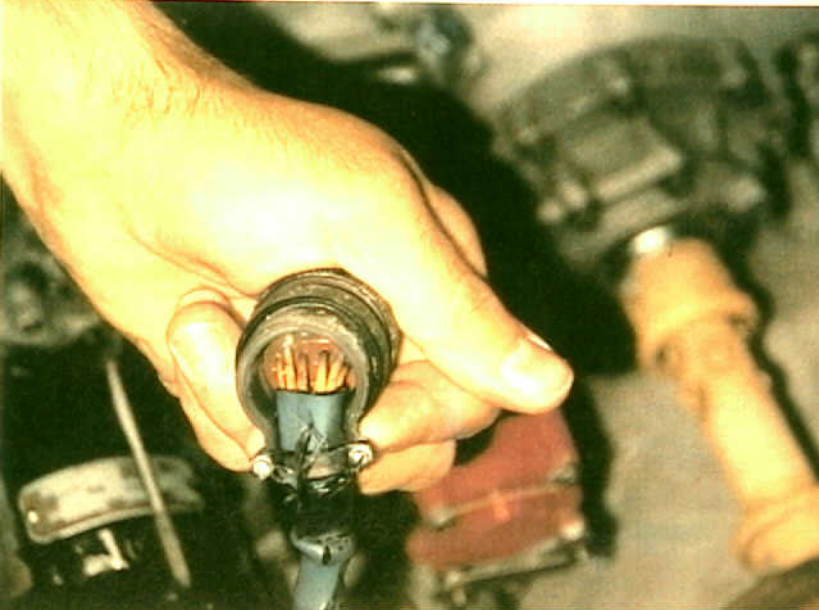
Systems 9 - 747-SL-20-048 - Fig. 20. Wing leading edge connector with lateral pressure due to missing backshell buildup and missing filler rods. This connector did have corrosion on the contacts.
