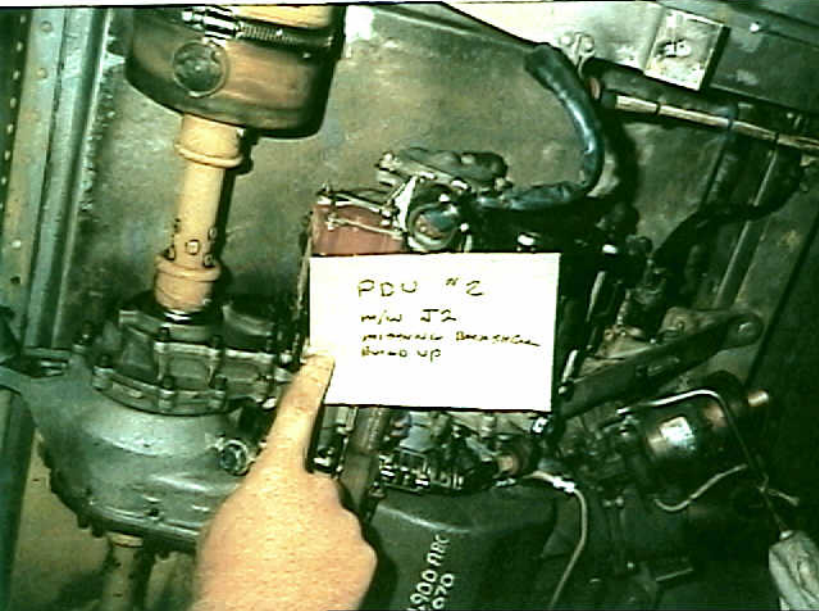
Systems 9 - 747-SL-20-048 - Fig. 21. Missing connector backshell buildup. Due to the harsh environment and high maintenance, the wing leading edge power drive units often exhibit installation deficiencies.
