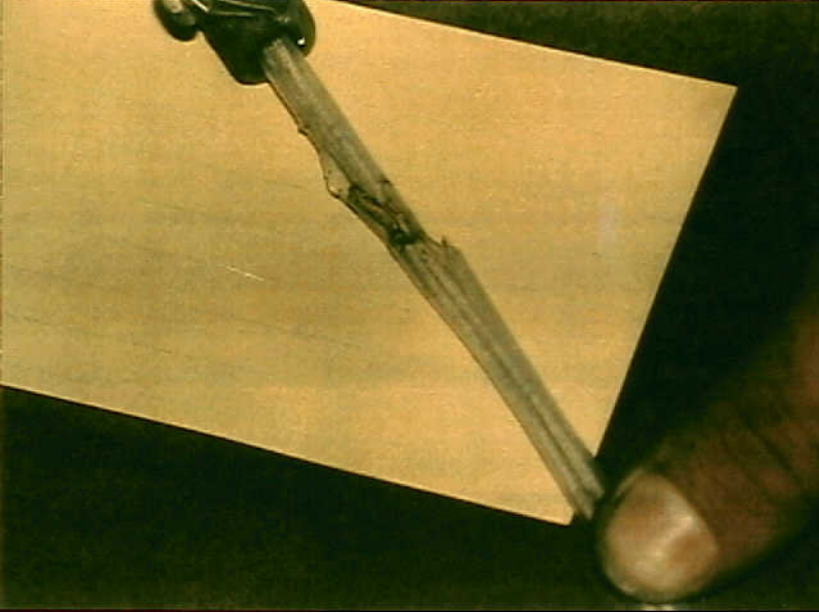
Systems 9 - 747-SL-20-048 - Fig. 23. Damage to Teflon sleeving due to lacing tape internal to the sleeving. Boeing does not recommend the use of lacing tape inside sleeving or conduits.
