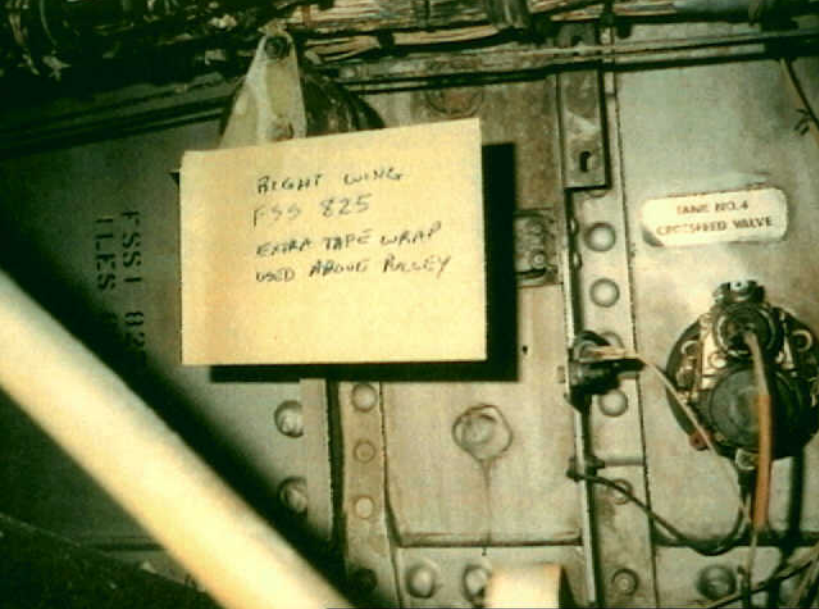
Systems 9 - 747-SL-20-048 - Fig. 28. When prior wire repairs are found, steps may need to be taken to ensure the damage is not repeated.
