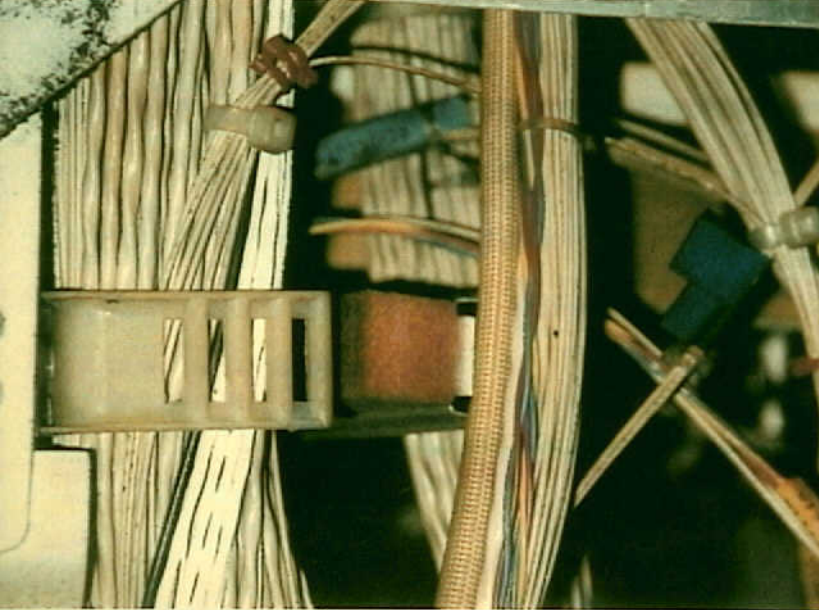
Systems 9 - 747-SL-20-048 - Fig. 3. Sprung open raceway clamp. This creates additional stress on wire and adjacent clamps. In this instance no wire damage was observed.
