Power Feeder Cable
Chafing at
Clamping Points
7/27/80

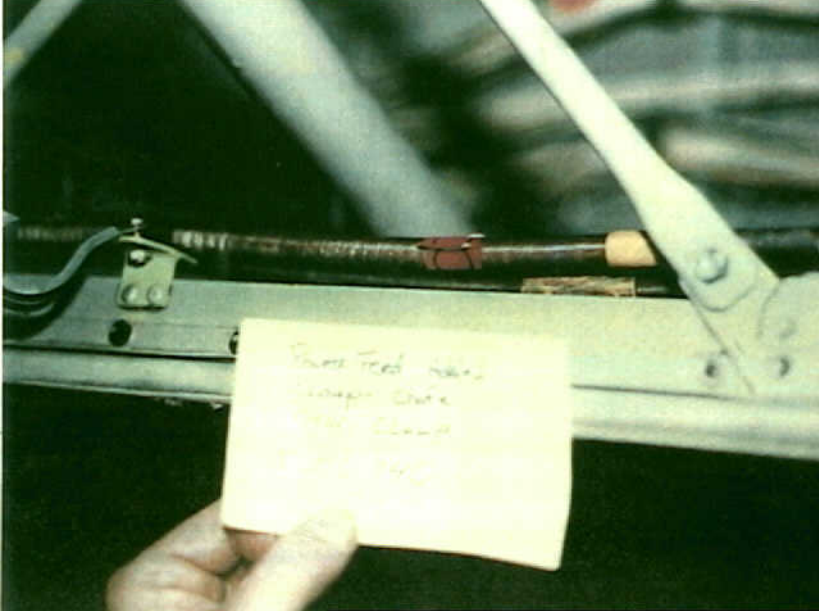
Systems 9 - 747-SL-20-048 - Fig. 35. Power feeders chafing at clamping points.
