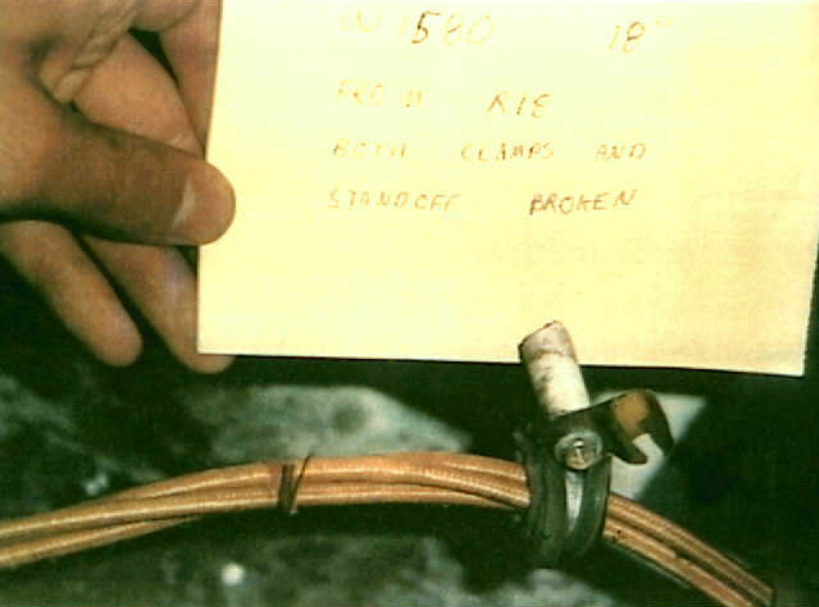
W 1580 18°
FROM RIS
BOTH CLAMPS AND
STANDOFF BROKEN

Systems 9 - 747-SL-20-048 - Fig. 6. Failed bundle clamps and standoff. Again, wire and adjacent clamps experience additional stresses.
