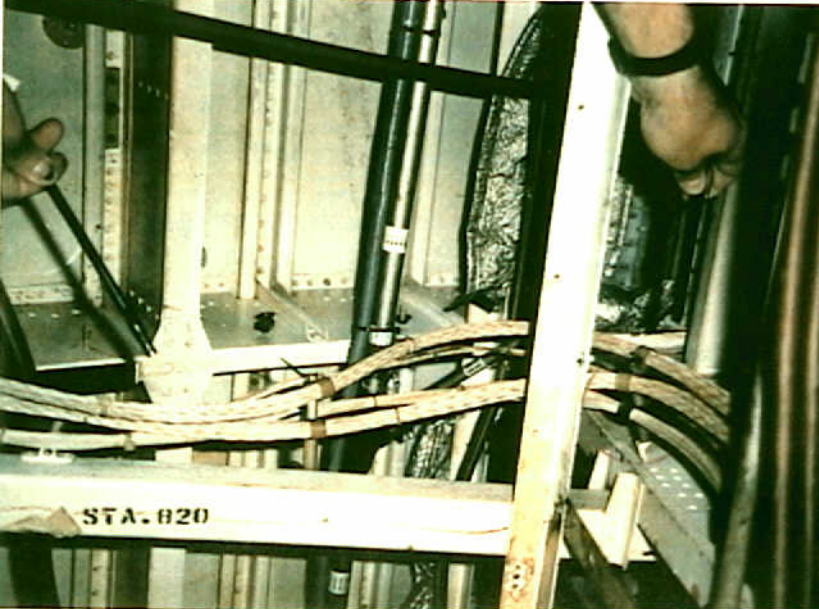
Systems 9 - 747-SL-20-048 - Fig. 7. Bent clamp bracket causing excess bundle length further down the bundle.
