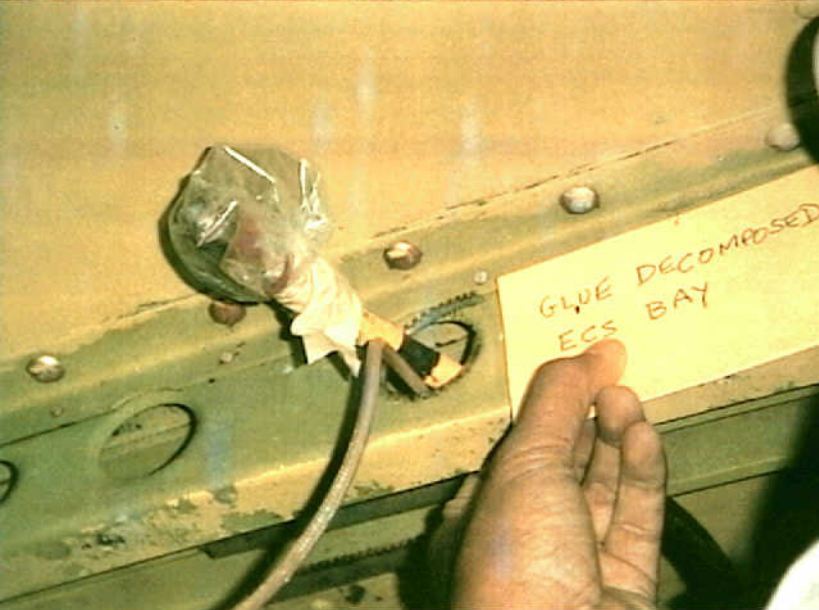
Systems 9 - 747-SL-20-048 - Fig. 9(a). In locations where wire bundles route through structure, caterpillar grommets or other protective material should be replaced when they fail.
