**NATIONAL TRANSPORTATION SAFETY BOARD
OFFICE OF AVIATION SAFETY
WASHINGTON, D.C. 20594**

**ADDENDUM NUMBER 5 TO THE SYSTEMS GROUP CHAIRMAN'S
FACTUAL REPORT OF INVESTIGATION- AUTOPILOT SERVOMOTOR
EXAMINATION**

DCA02MA001

Operator: American Airlines
Aircraft: A300-600R
Location: Belle Harbor, New York
Date: November 12, 2001
Time: 09:16 EDT

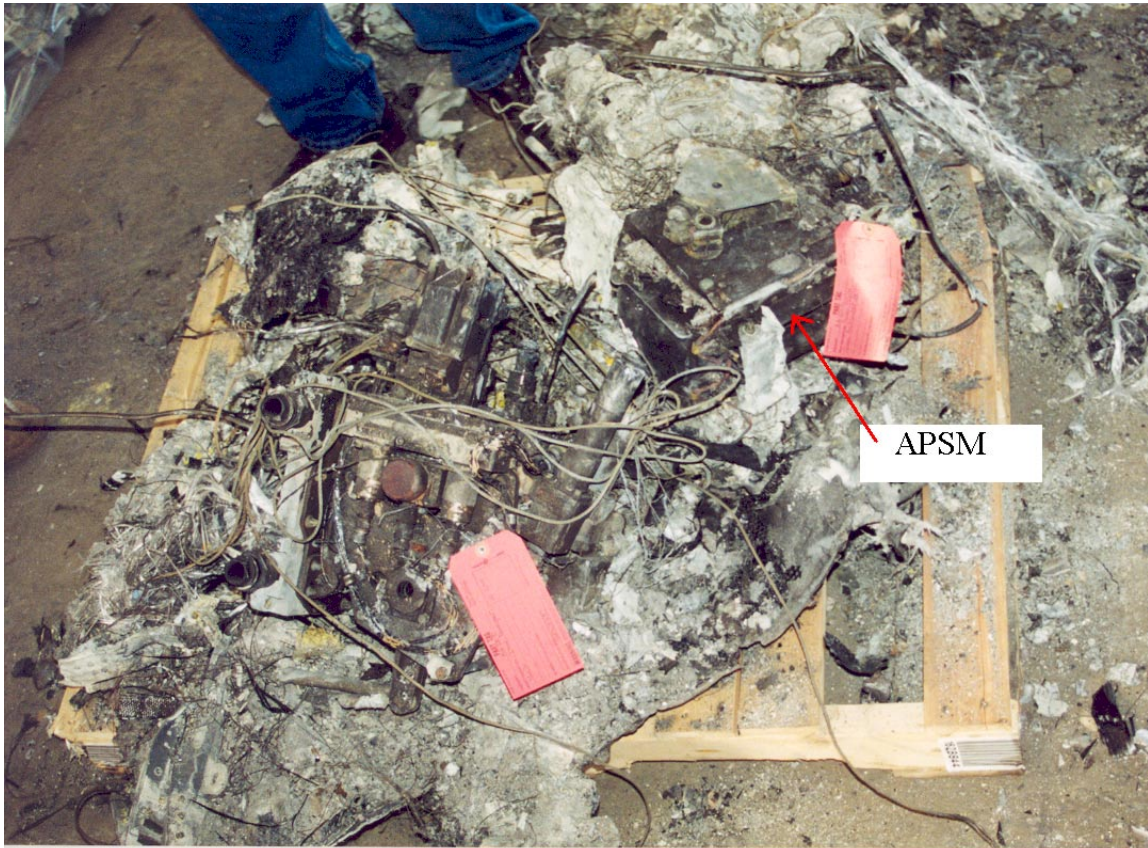
The APSM was recovered from the accident site with a large amount of debris attached. The debris consisted of re-solidified molten metal, fibrous material, cables, wires and general debris, Figure 5.

Figure 5. APSM as Recovered from Wreckage.

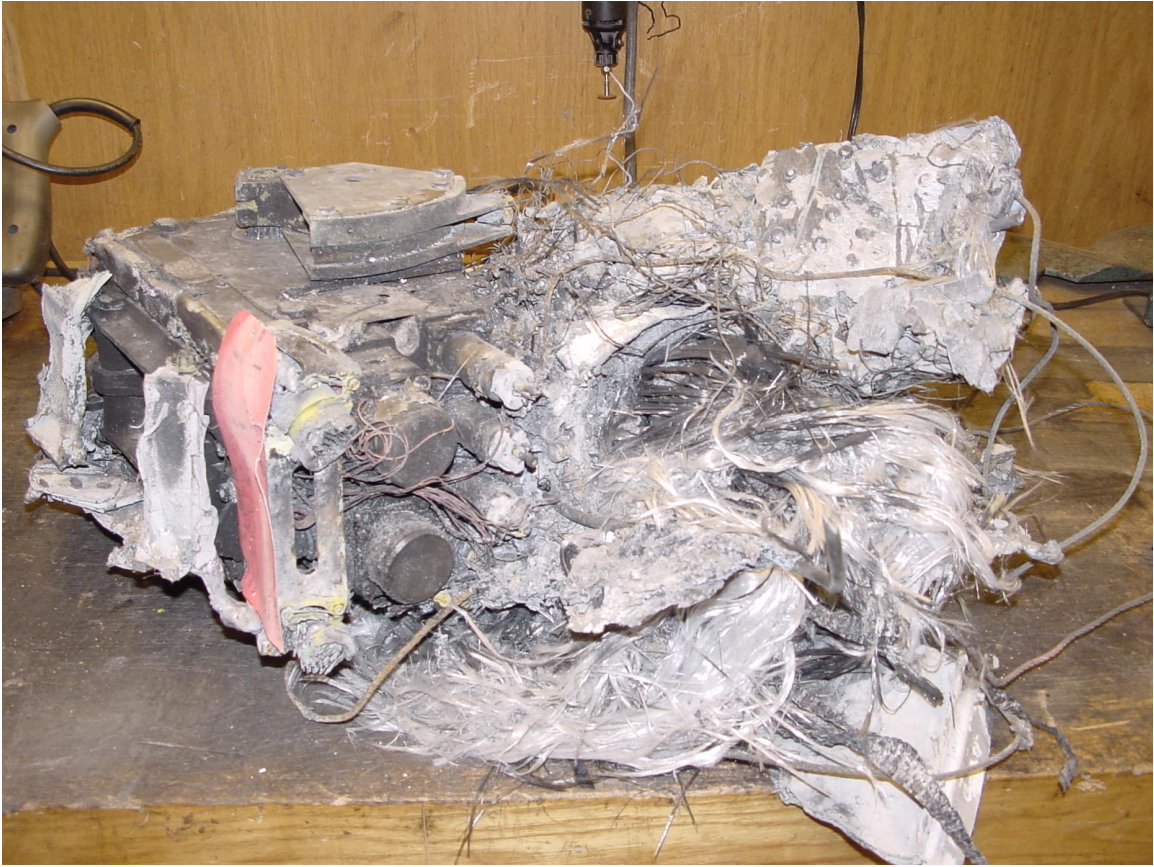
Figure 6. APM Prior to Removal of Debris.

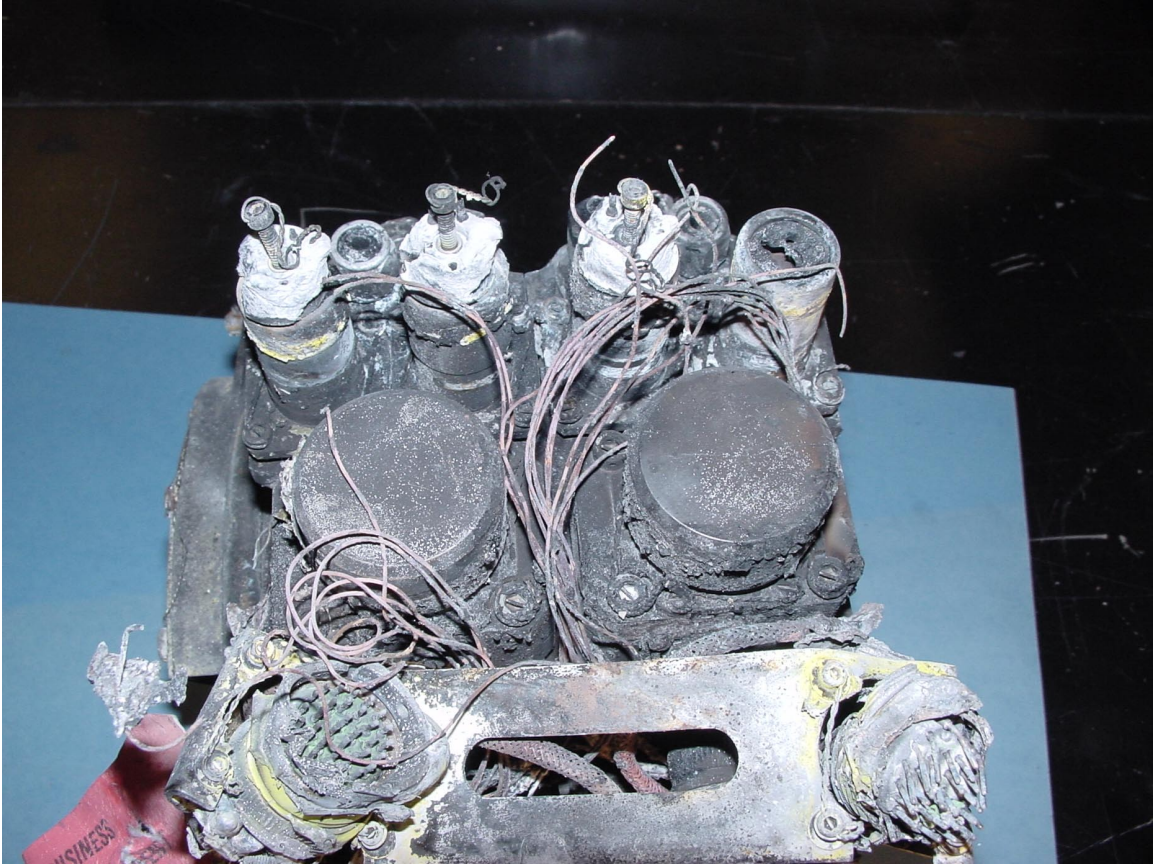
Figure 7. Front of APSM after removal of Debris.

The actuator was observed to be thermally damaged, the plastic wiring looms and wiring insulation was melted. The Driving side connector was intact, while the Driven connector was thermally and impact damaged. The identification plate was recovered from the Driving electrical harness, which confirmed the correct harness P/N 338827-140 was installed. The wires from the connector were no longer attached to any of the solenoids though some of the wire routing appeared to be unaltered. Figure 9 and Figure 10 show the wire routing of an undamaged APSM.

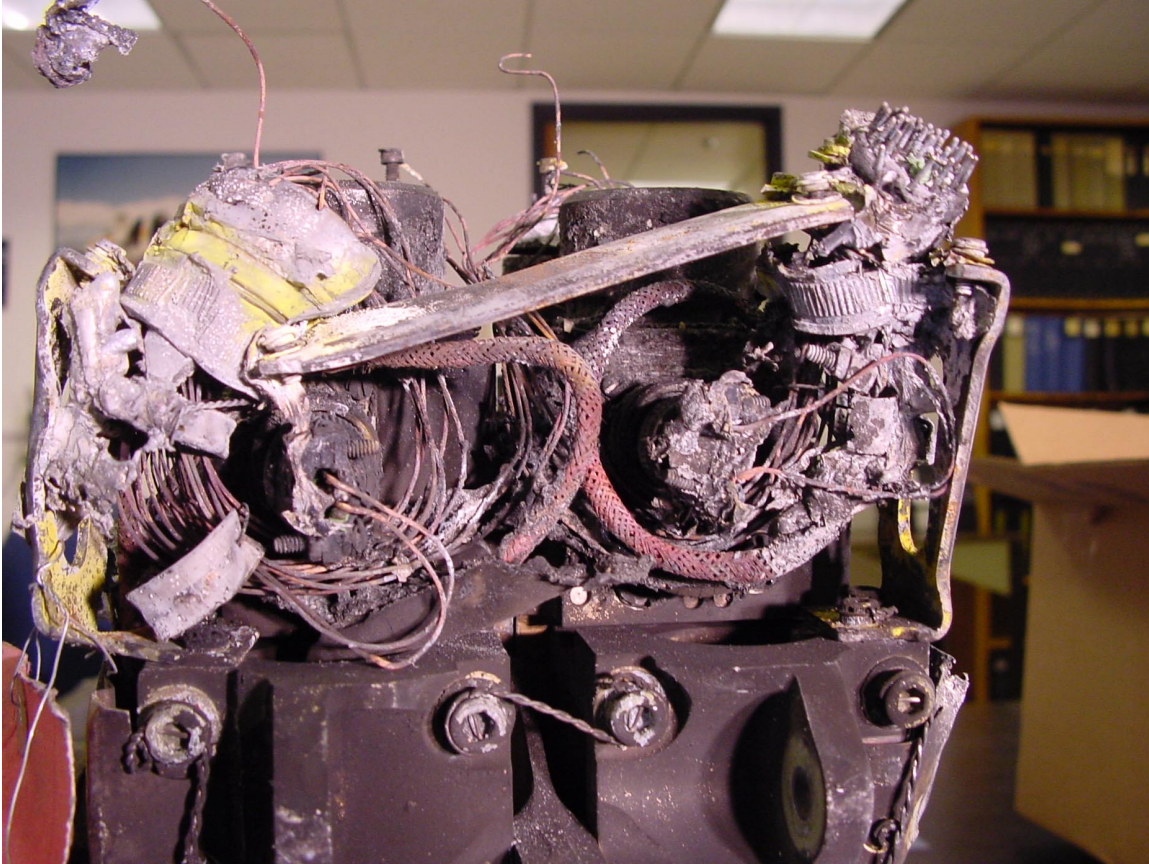
Figure 8. Bottom View of Connectors After Removal of Debris.

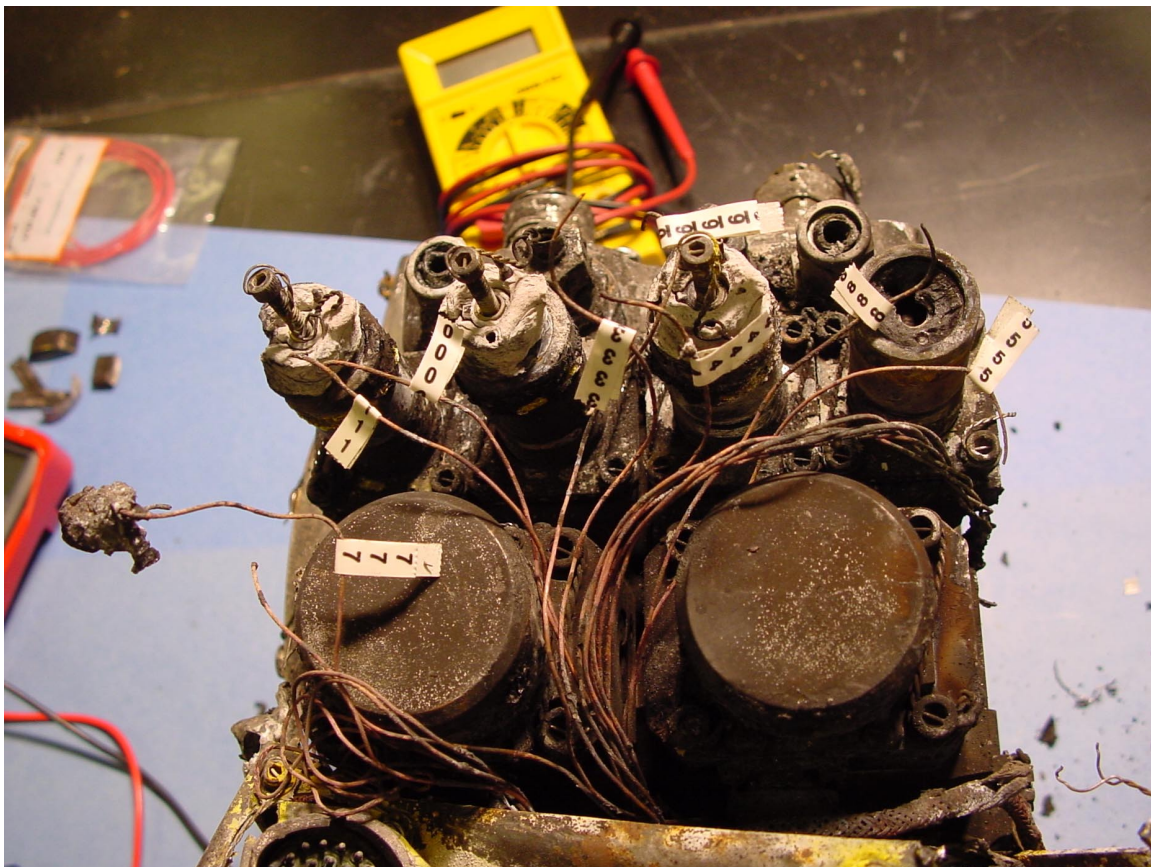
The wires to the solenoids were labeled from 0 to 8 (#2 not used) as shown in Figure 11. The pin arrangement of the Driving channel connector was verified as correct. Continuity tests identified individual wires leading to the solenoids. The Driving channel's Engage solenoid wiring was positively identified through its proximity to the solenoid (far left in Figure 7). The Driving channel's Pressure solenoid wiring was identified. The position of the wiring made it impossible to identify to which solenoid the wires were connected.

The pin arrangement of the Driven channel connector was verified as correct through identification of pins X and c from the engagement detection microswitch. From that point of reference, relevant pins and individual solenoid wires were identified through continuity tests (Table 1). Pins a and b appear to be paired together as well as pins Y and Z. The position of the wiring made it again impossible to determine to which Pressure solenoid the wires were connected. The Driven channel's Engage solenoid wiring appeared to be from pins a and b through their proximity to the solenoid.

Figure 11. APSM with Wires Labelled.

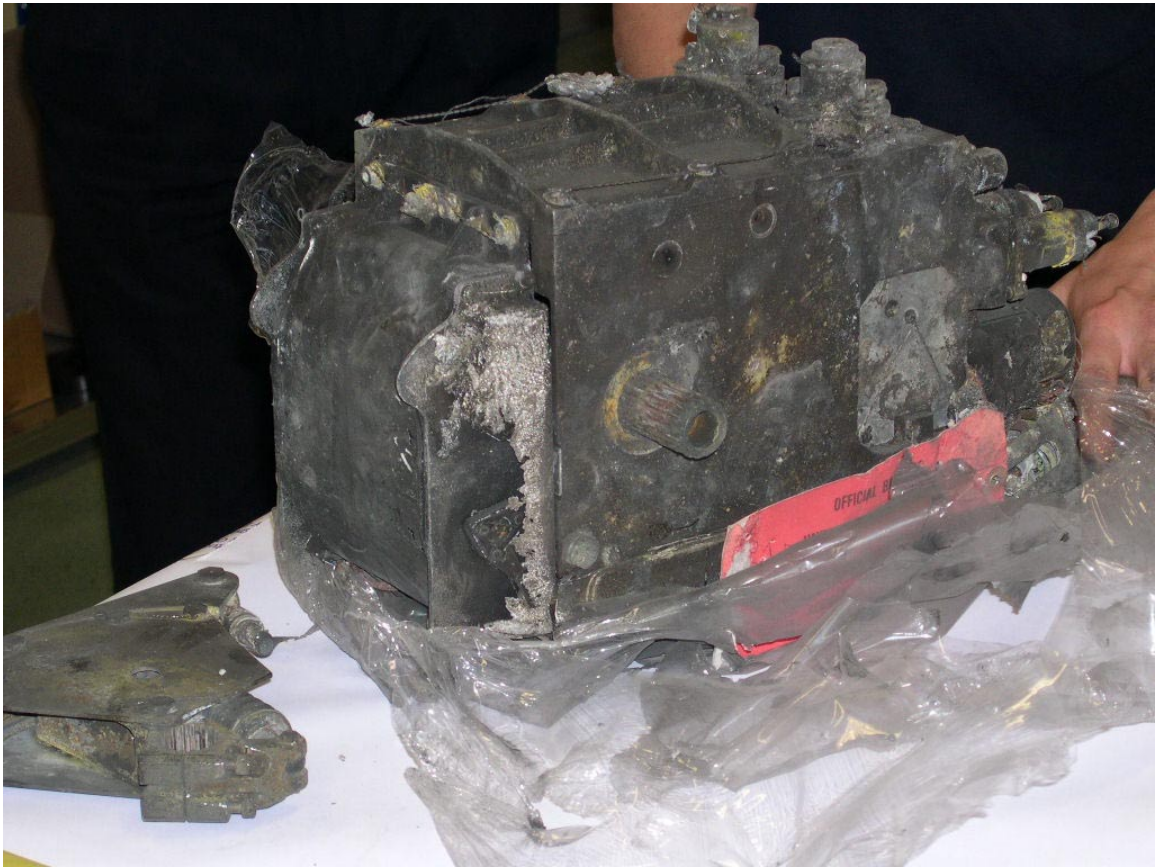
The group began with documenting the external condition of the APSM prior to disassembly. Figures 12 through 15 show the condition of the unit. In Figure 12, the torque limiter was shown removed. It was removed in Washington DC, prior to shipping. Figure 13 and 15 showed the Driving side and Driven sides with the engage switch cover plates removed. The cover plates were removed in Washington DC during the continuity checks performed previously.

Figure 12. APSM Driving Side. Torque Limiter Removed (left, Bottom).

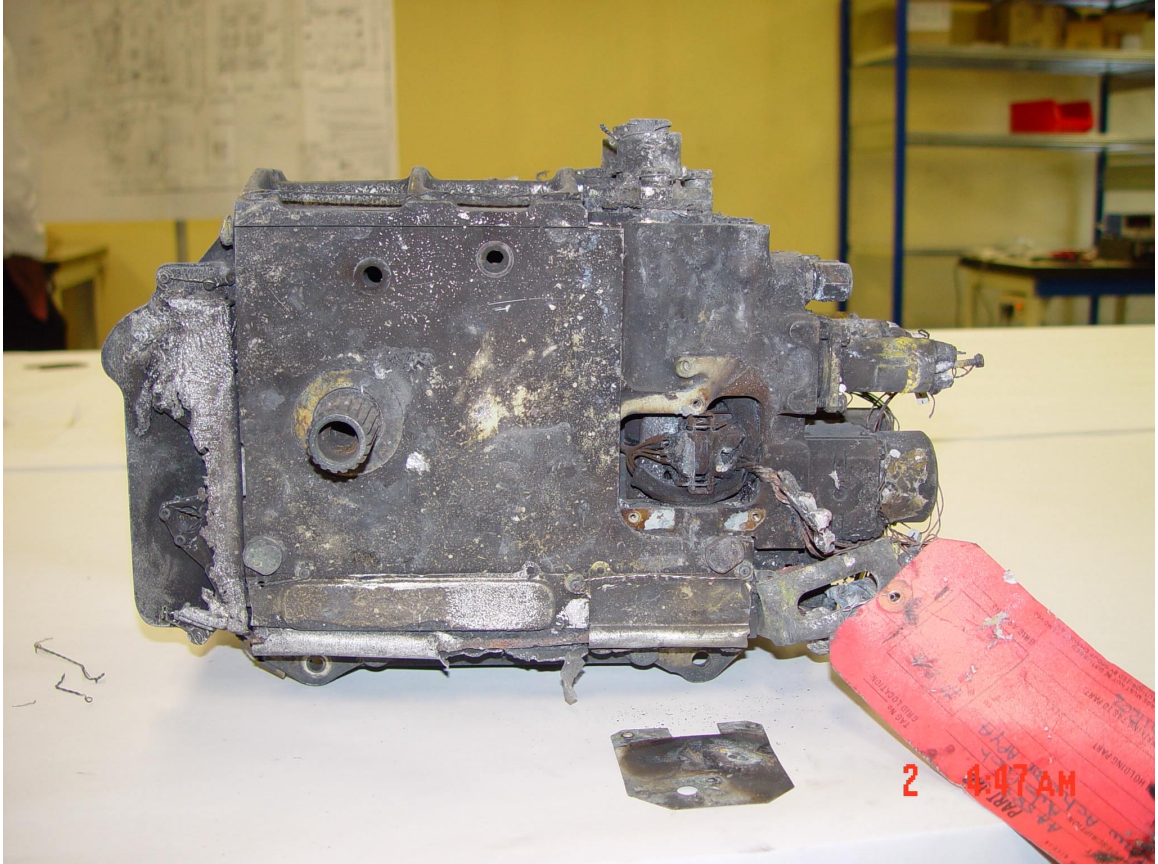
Figure 13. Driving Side of APSM.

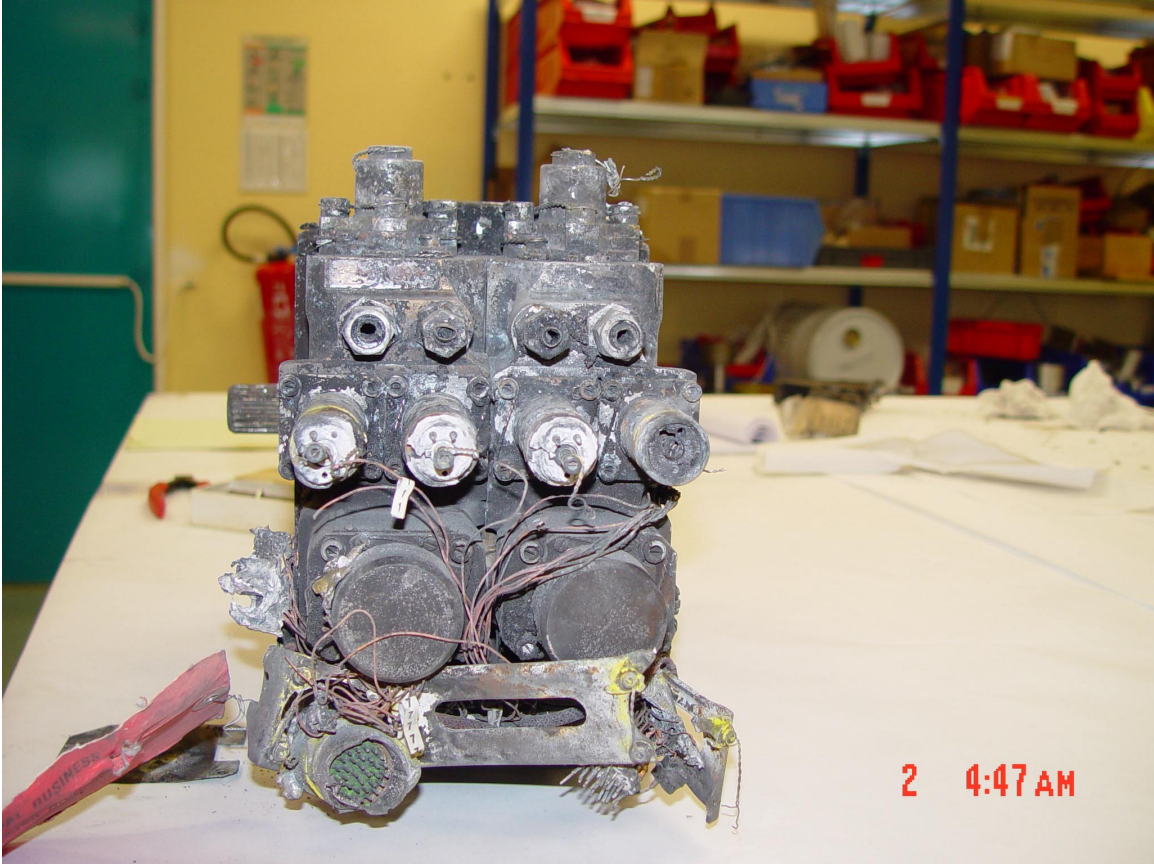
Figure 14. Front of APSM.

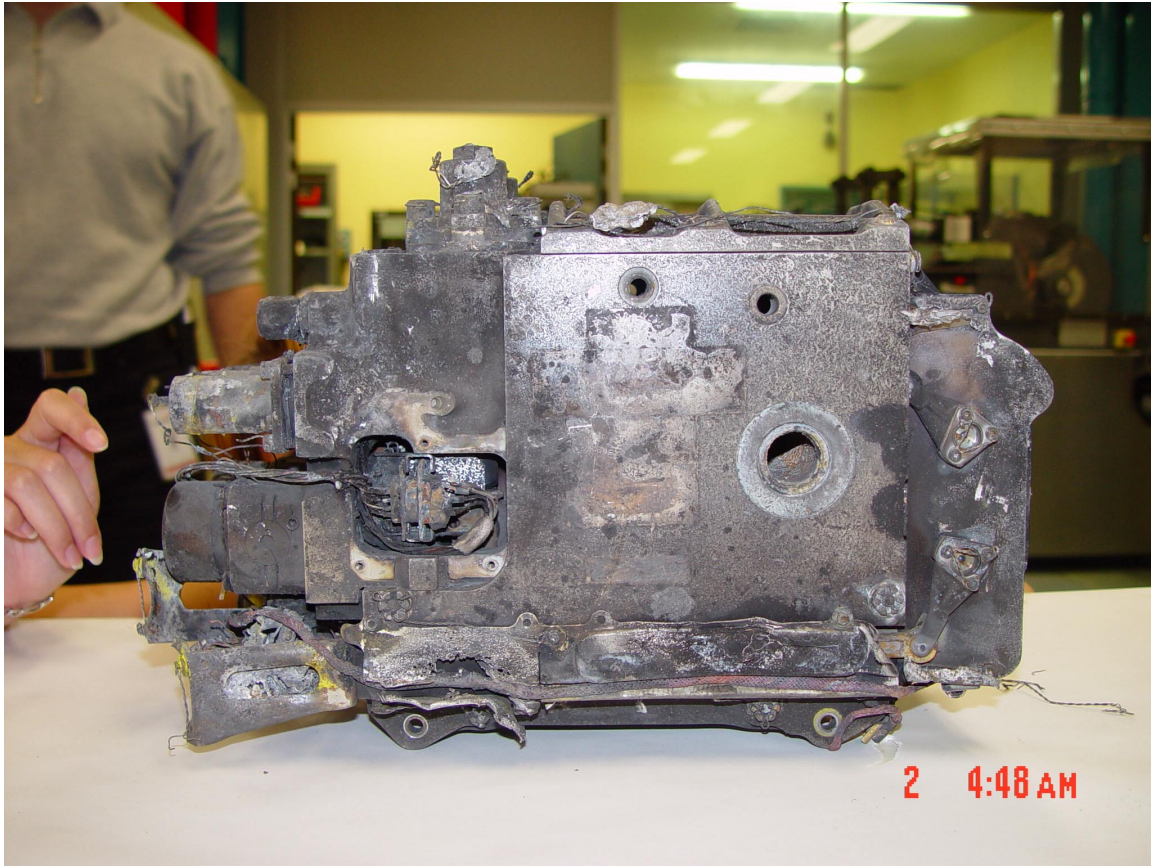
Figure 15. Driven Side of APSM.

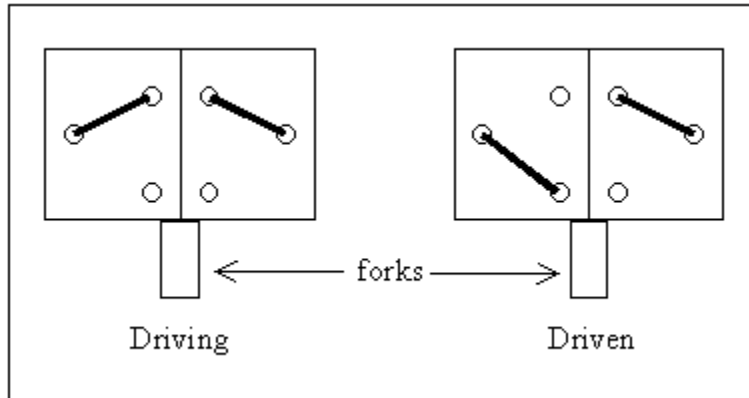
Wires were cut at the engagement switches and continuity was confirmed between 2 of the 3 pins as documented below in Figure 16. The switches are shown in top view. Appendix A, Figures 12 to 15 are the Driven and Driving switches.

Figure 16. Engage Switch Continuity

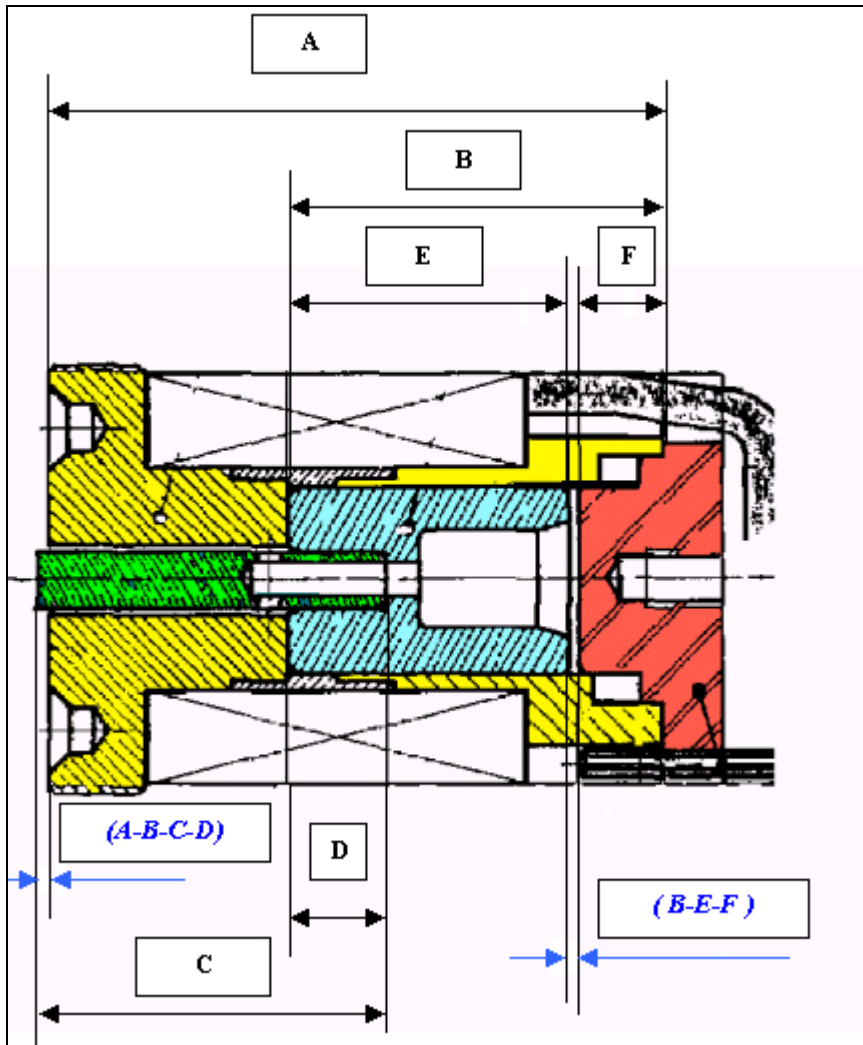
Upon disassembly of all of the 4 solenoid valves, the packings were observed to be heat damaged but not to the extent that they were powder. All small parts were collected into containers. Goodrich later performed a dimensional check of the solenoid parts. The results are provided in Figure 17 and Table 2.

Figure 17. Dimensional Check of APSM Solenoids

Note: For Dimension C and Dimension (A-B-C-D) the specified value is not achieved because C is subsequently machined per drawing 38215-262 (Appendix C, Figure 3) so that the pushrod protrusion is 0.08 +/- 0.01 mm.

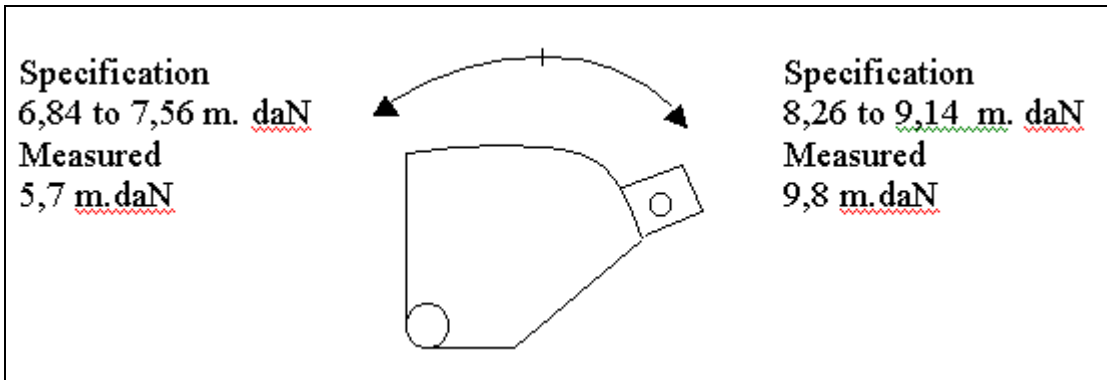
The torque limiter was partially cleaned of melted metal, and the torque required to move the output to maximum travel was measured. The output could not reach full travel. The results are provided in Figure 18.

Figure 18. Torque Limiter Test Results

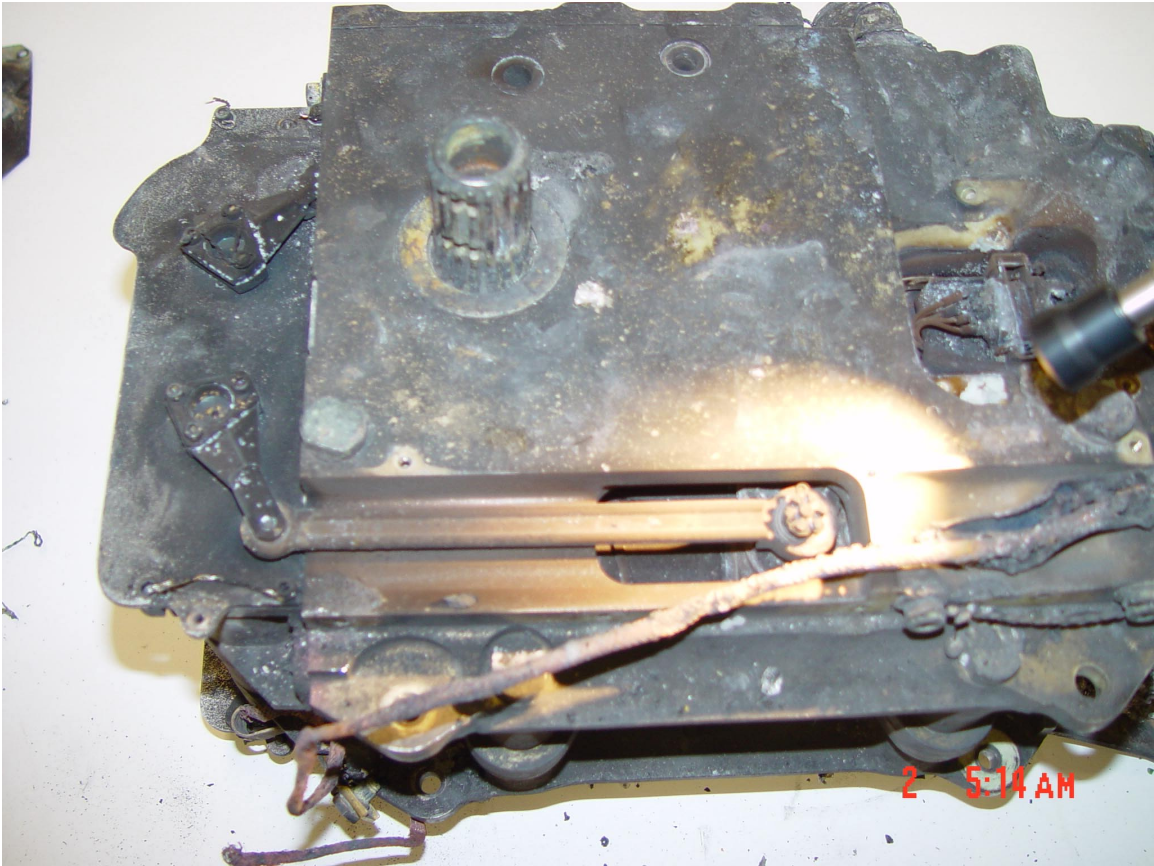
The Driving detection linkage (IPL 11-150) was observed to be against the stop in the direction of the servovalve. The linkage was in a position which corresponded to a full counter clockwise movement of the output shaft when the clutch is engaged and the cam is in the center of the roller, or when the clutch is disengaged and the actuator is correctly synchronized to a full counter clockwise position of the output shaft.

Figure 1. Position of Driving Detection Linkage.

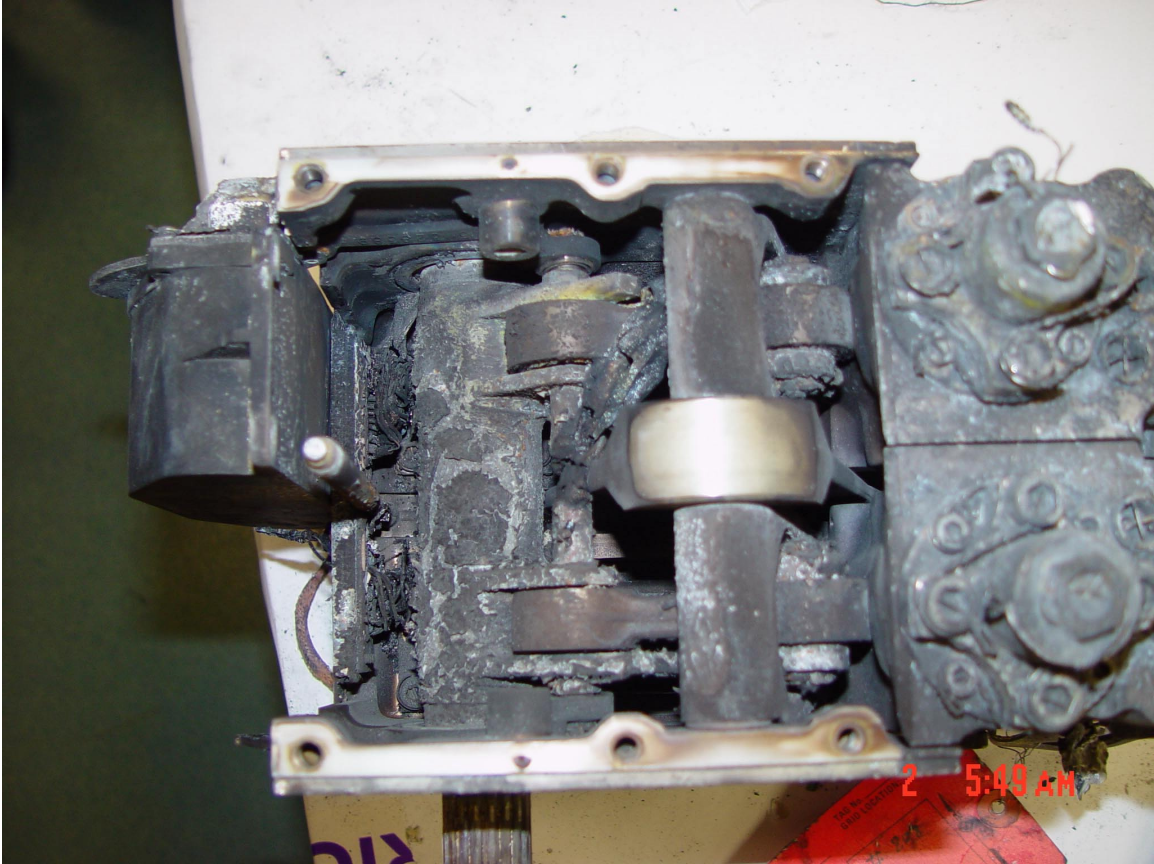
It was observed that the output shaft (IPL 8-310) is in the full clockwise position against the mechanical stops as observed from the Driving side of the actuator. This corresponds to a left rudder command.

Figure 2. View of Internal Linkage Looking Down.

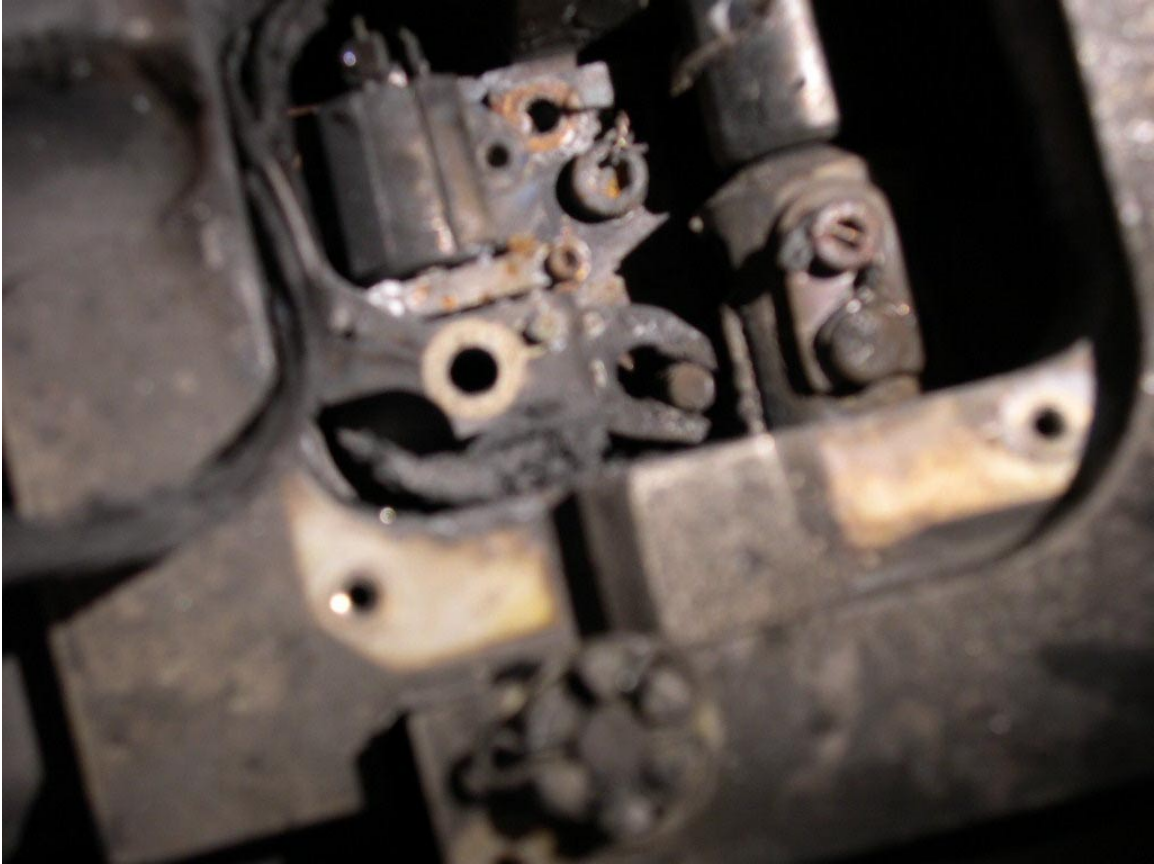
The Driven side engage piston and switch were observed to be in the un-clutched position, Appendix A, Figure 7.

Figure 7. Driven Side Showing Engage Piston and Switch in Un-Clutched Position.

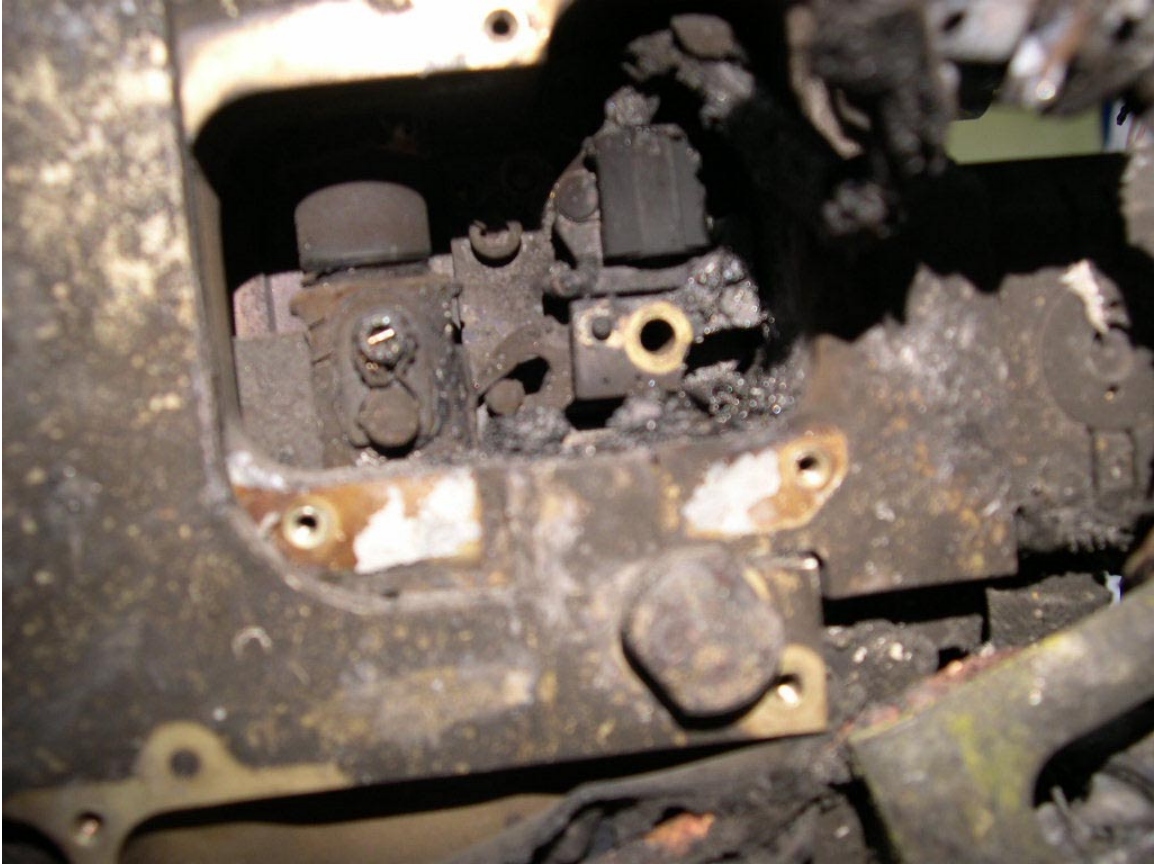
The Driving side engage piston and switch were observed to be in the un-clutched position, Appendix A, Figure 8.

Figure 8. Driving Side Engage Piston and Switch in Un-clutched Position.

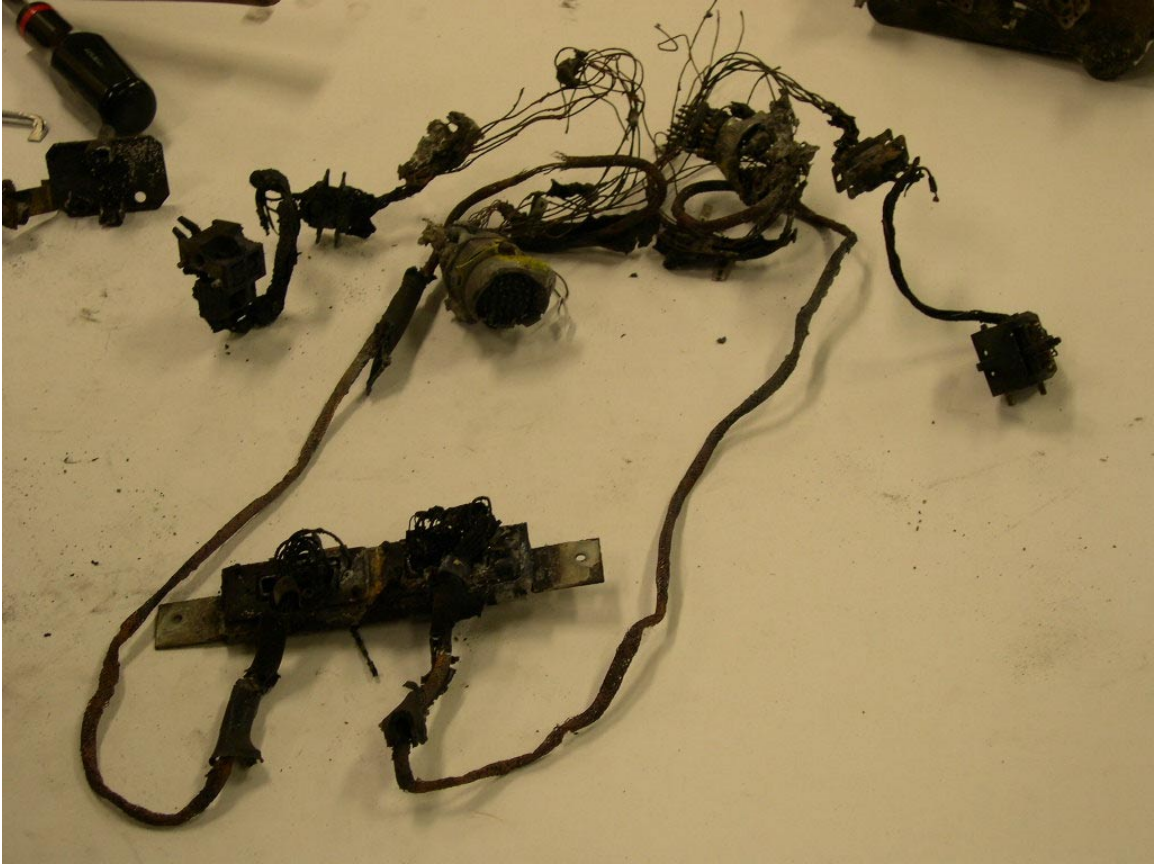
Continuity checks were attempted but insulation was lost due to heat damage, Appendix A, Figure 11. Visual examination of the wires routing was not conclusive because of the substantial damage to the connectors.

Figure 11. APSM wiring.

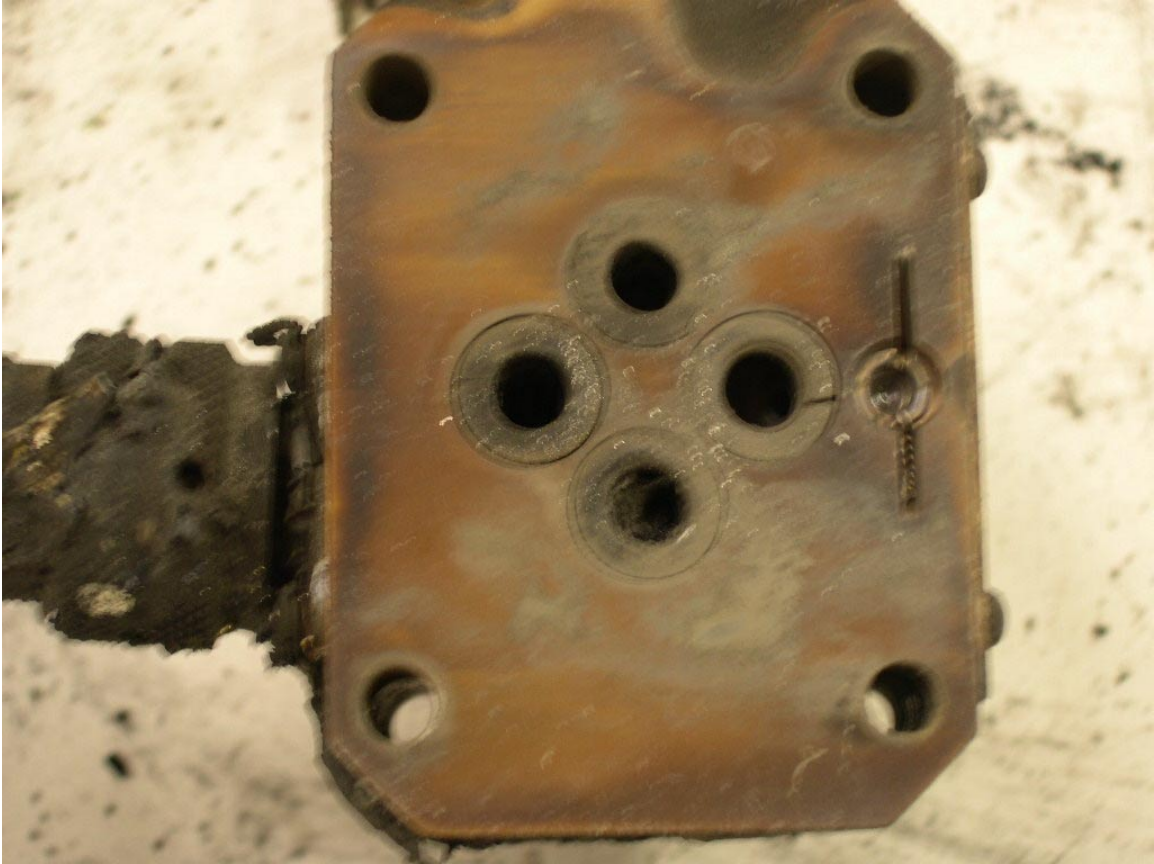
The servovalves were removed (IPL 1-260) and heat damage was observed, Driving Appendix A, Figure 18 and Driven Appendix A, Figure 19.

Figure 18. Driving Side Servovalve

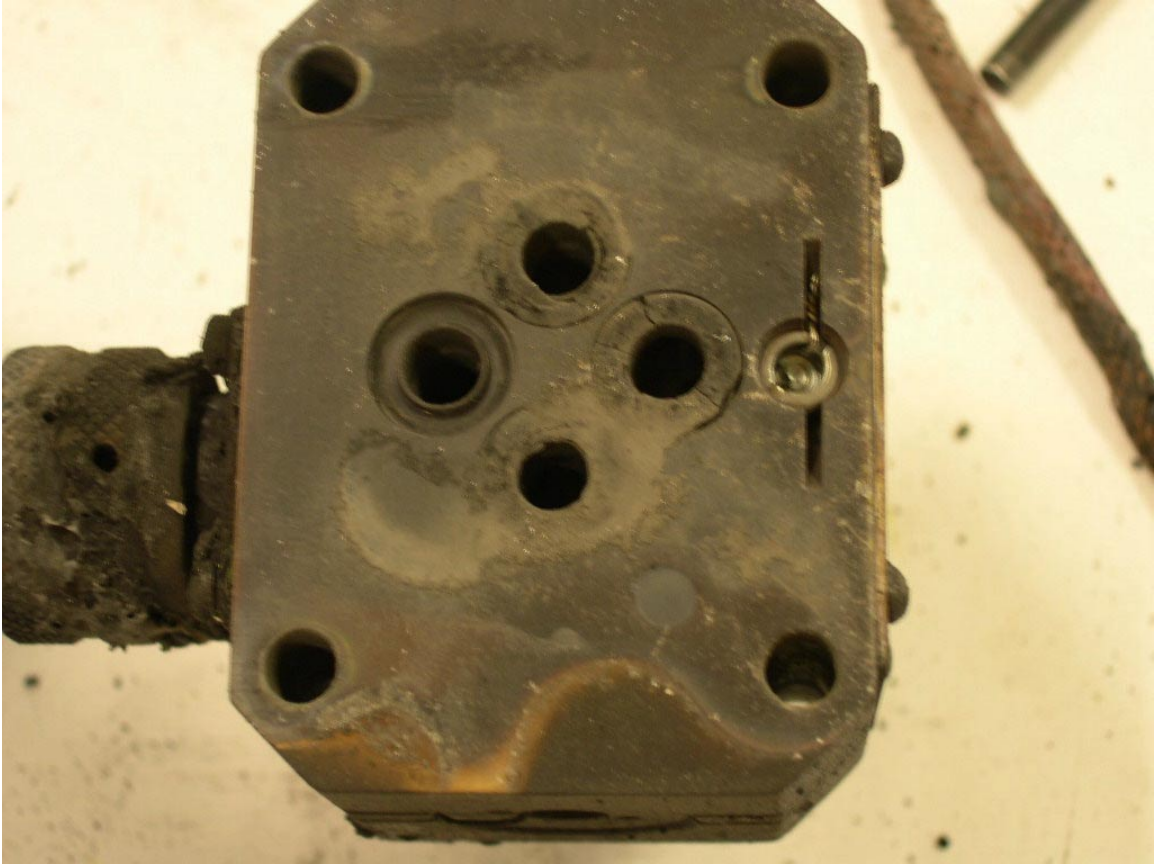
Figure 19. Driven Side Servovalve.
