**NATIONAL TRANSPORTATION SAFETY BOARD
OFFICE OF AVIATION SAFETY
WASHINGTON, D.C. 20594**

**ADDENDUM NUMBER 5 TO THE SYSTEMS GROUP CHAIRMAN'S
FACTUAL REPORT OF INVESTIGATION- AUTOPILOT SERVOMOTOR
EXAMINATION**

DCA02MA001

Operator: American Airlines
Aircraft: A300-600R
Location: Belle Harbor, New York
Date: November 12, 2001
Time: 09:16 EDT

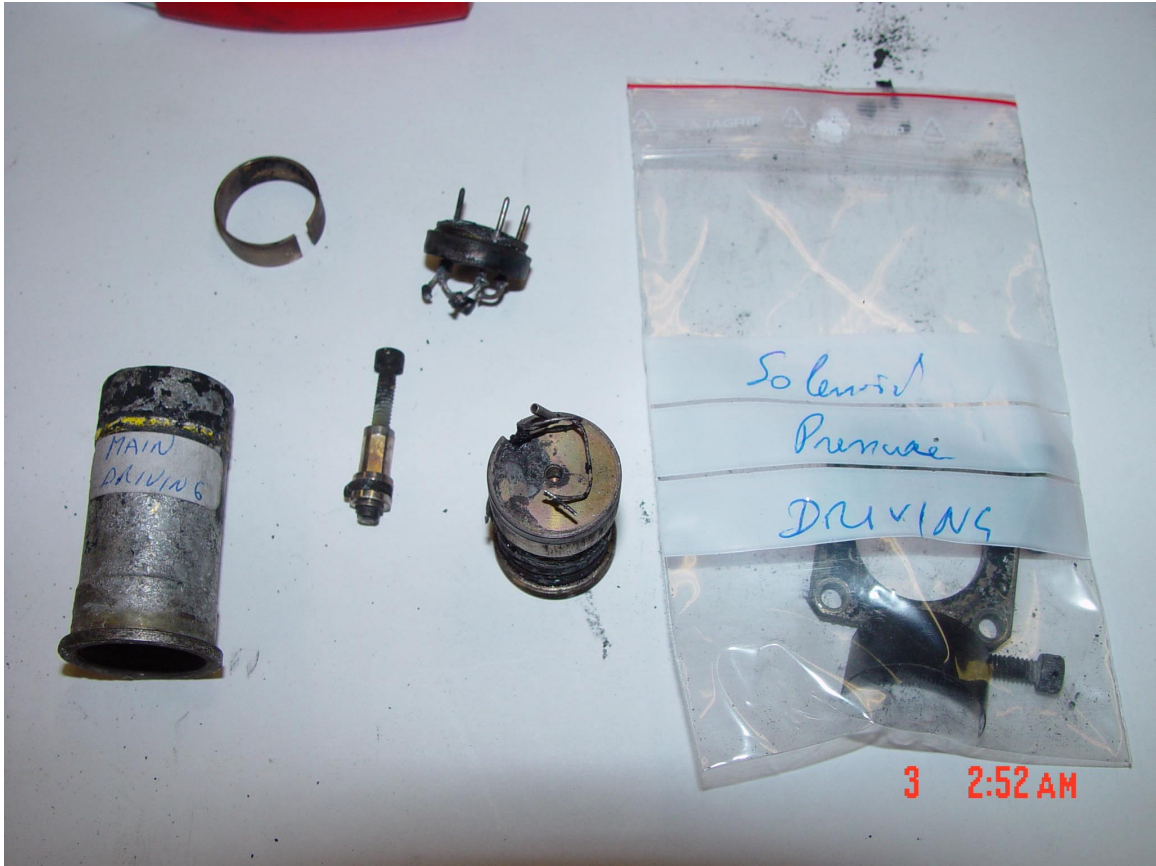
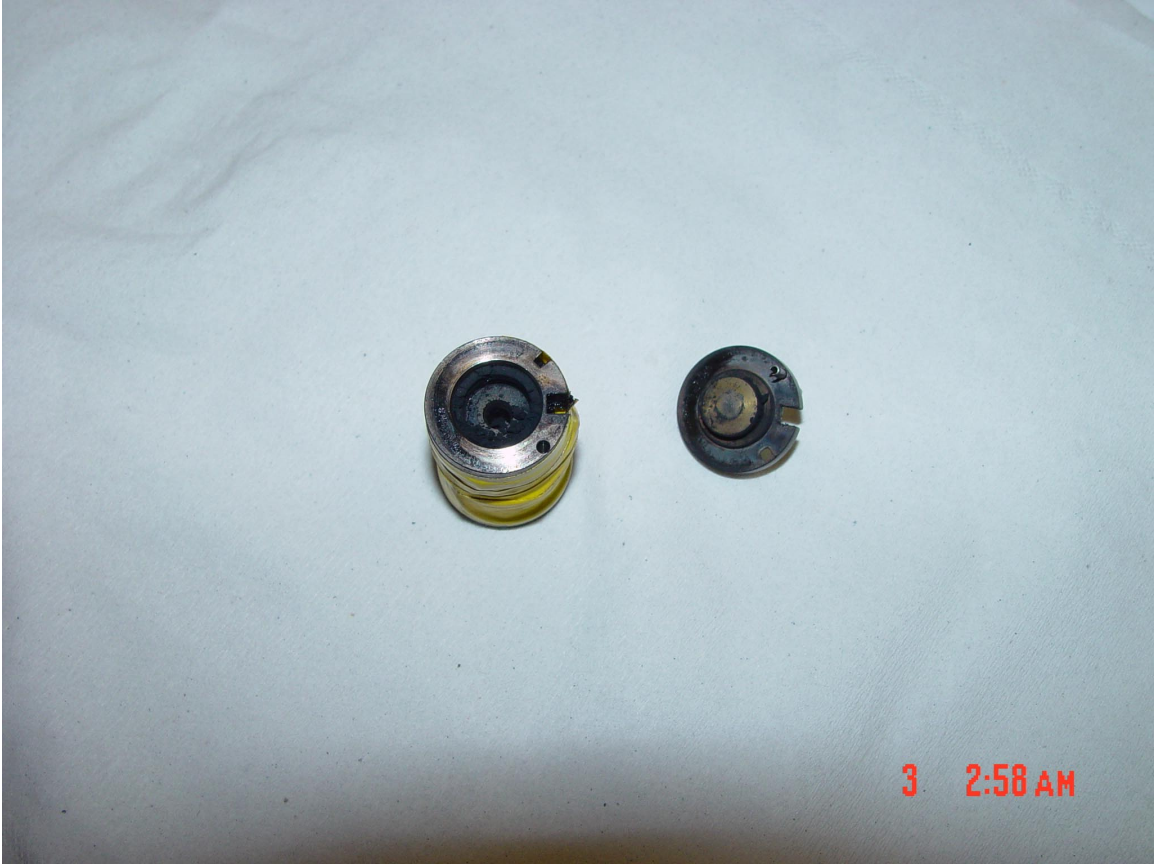
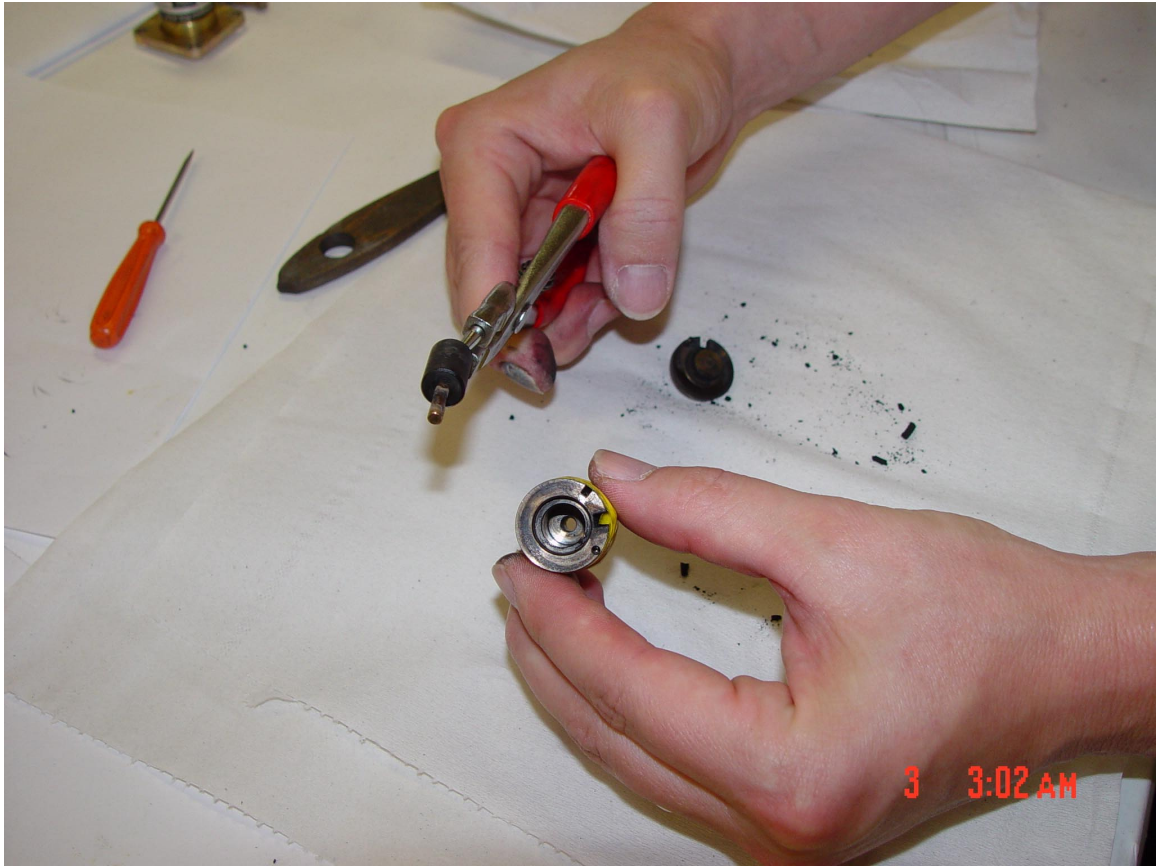
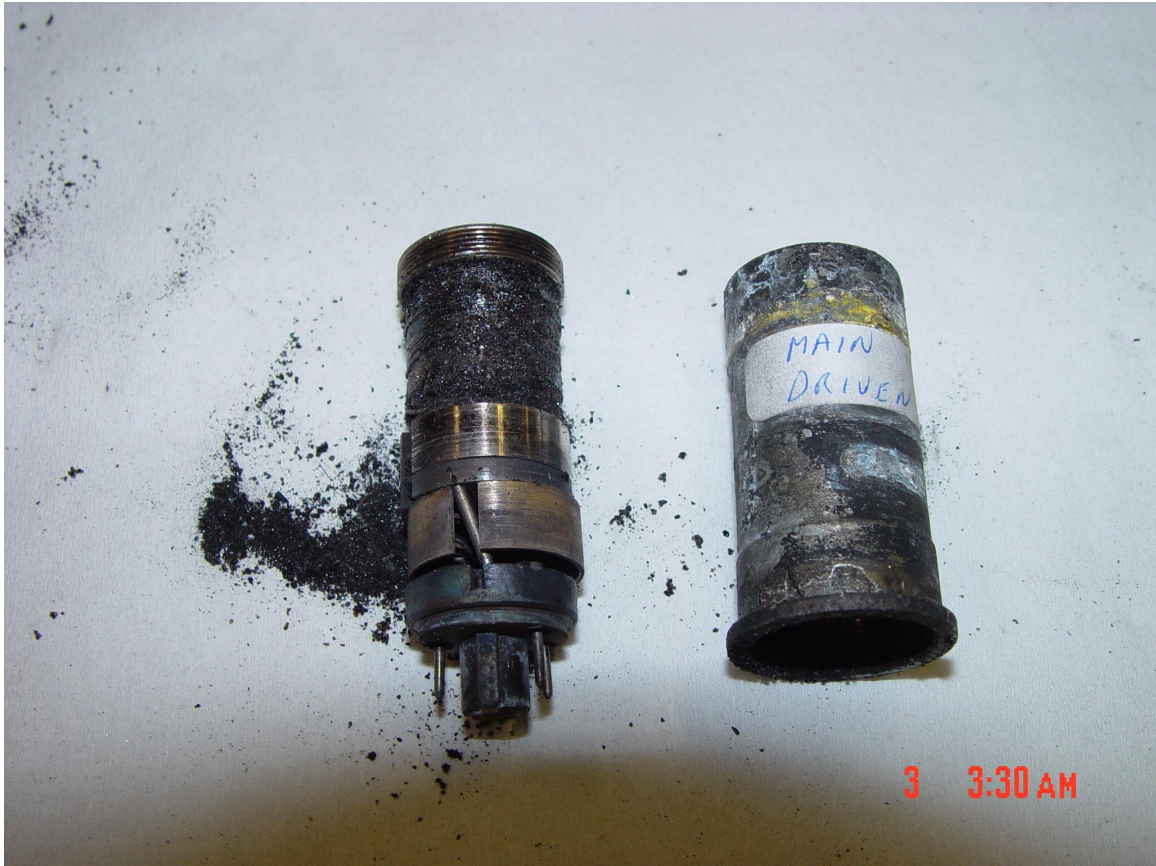
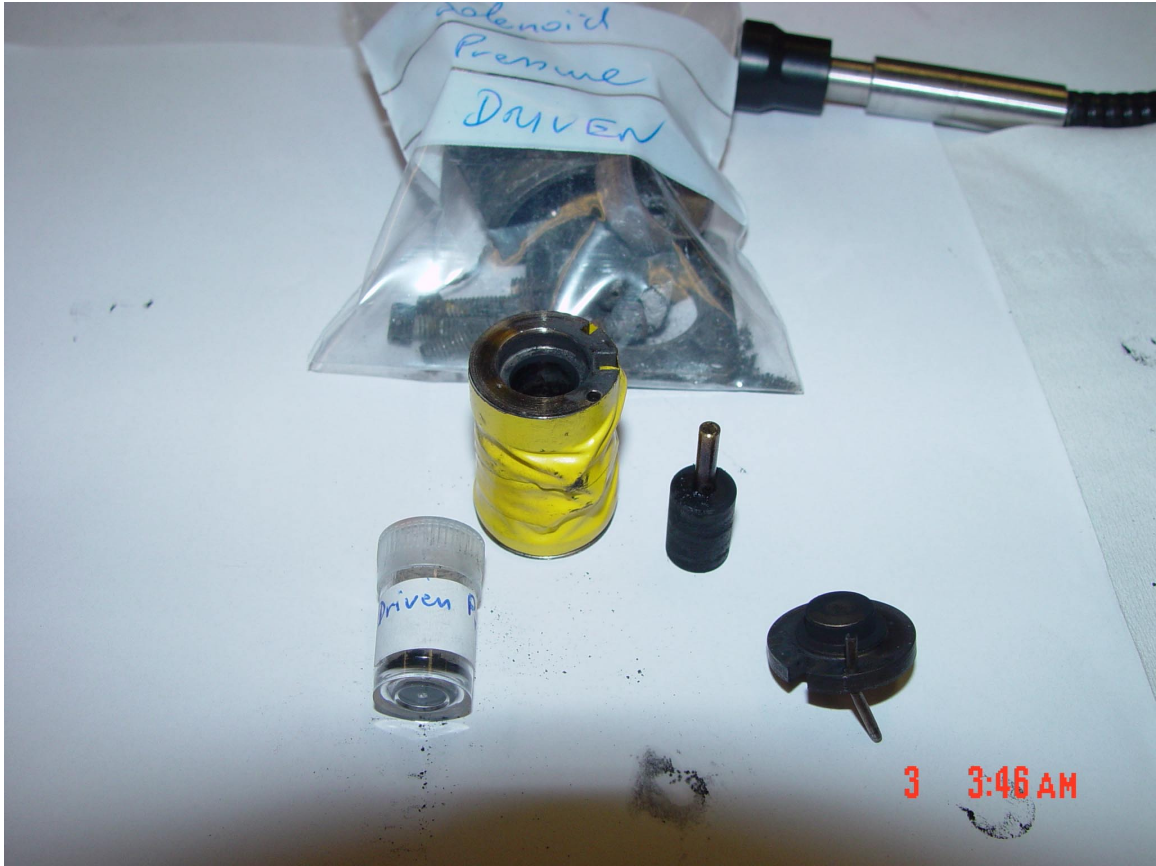
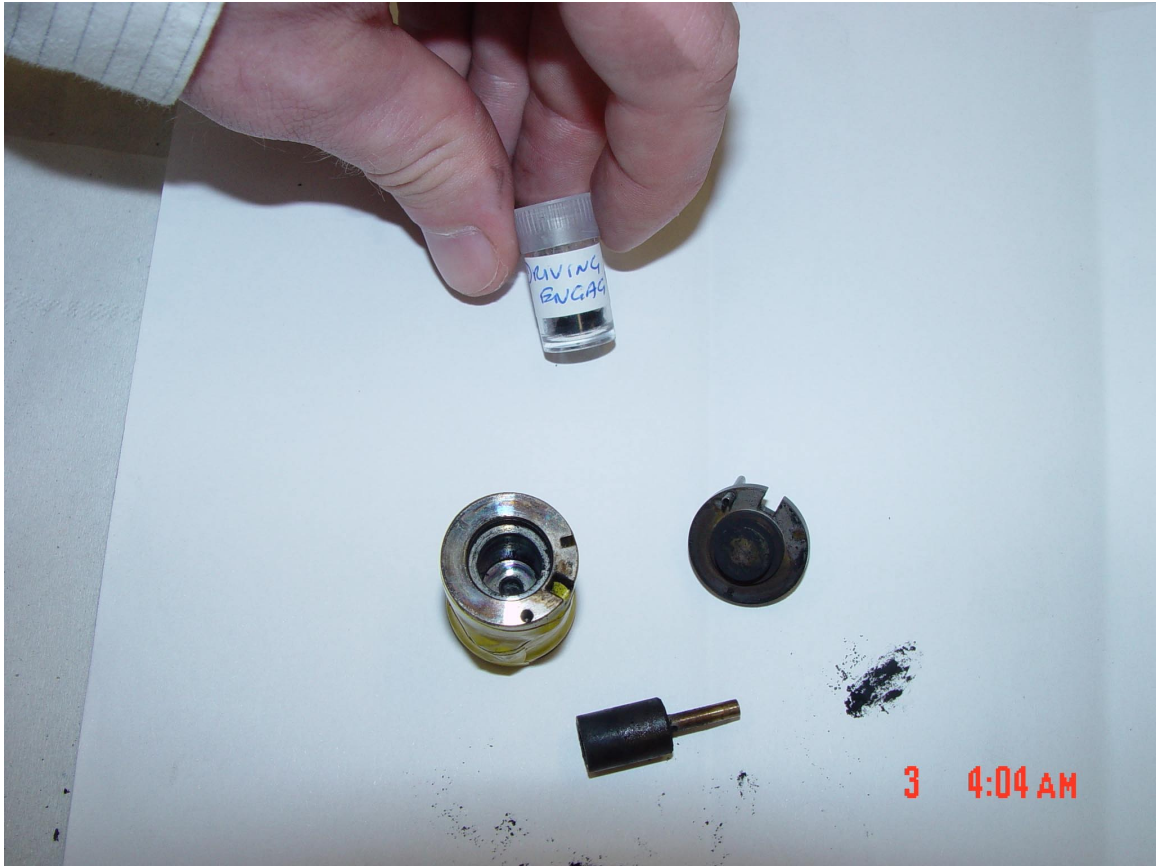
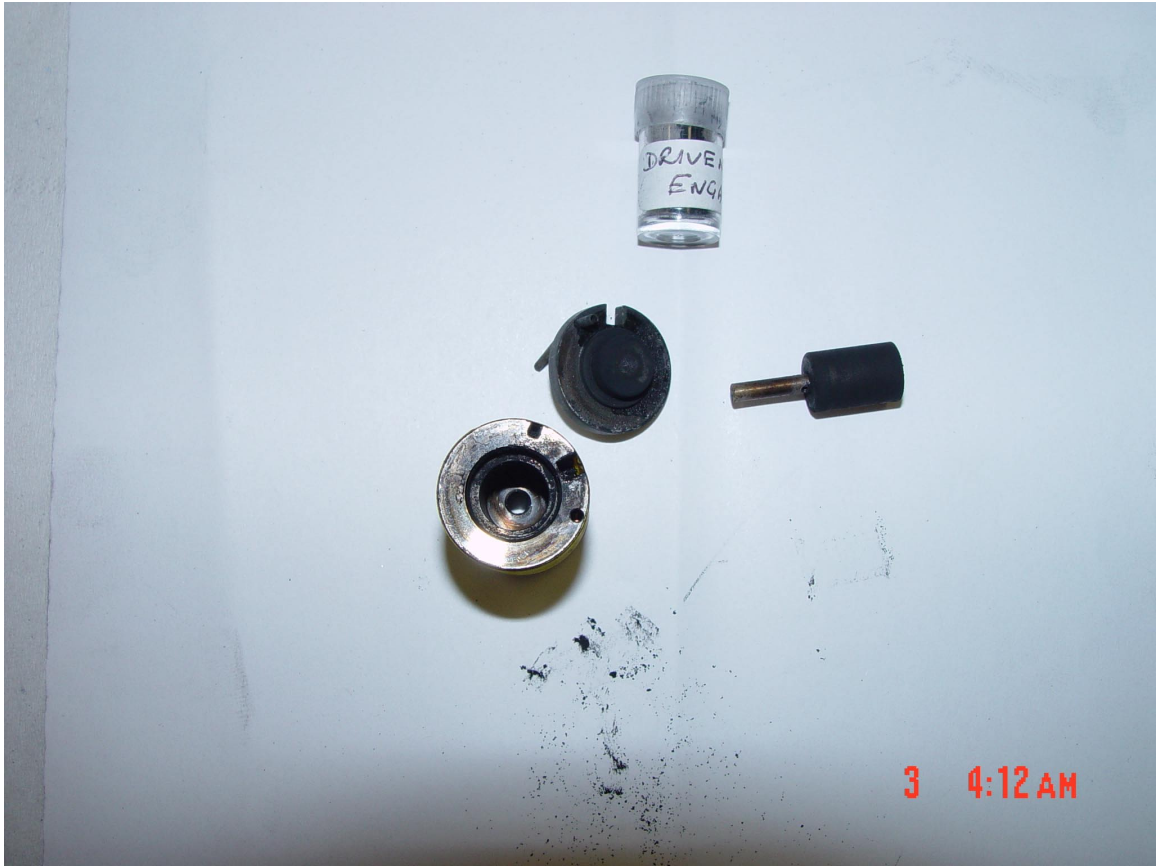
The solenoids were removed (IPL 1-240D), Appendix A, Figures 20 to 25. Upon disassembly, Appendix A, Figures 26 to 32, substantial heat damage was observed on all 4 solenoids as evidenced by the packings that had turned into powder. No foreign debris was found in the solenoids, especially in the bobbin and piston area. The powder was collected into containers.

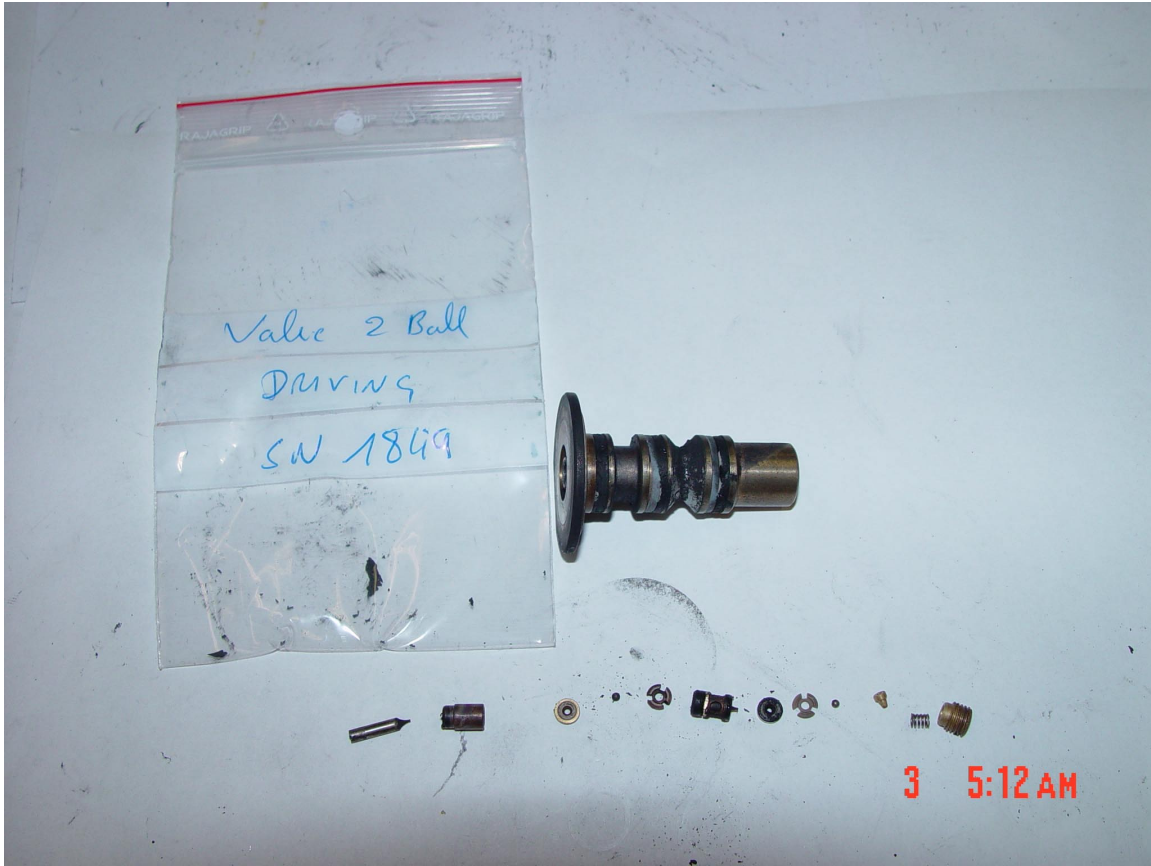
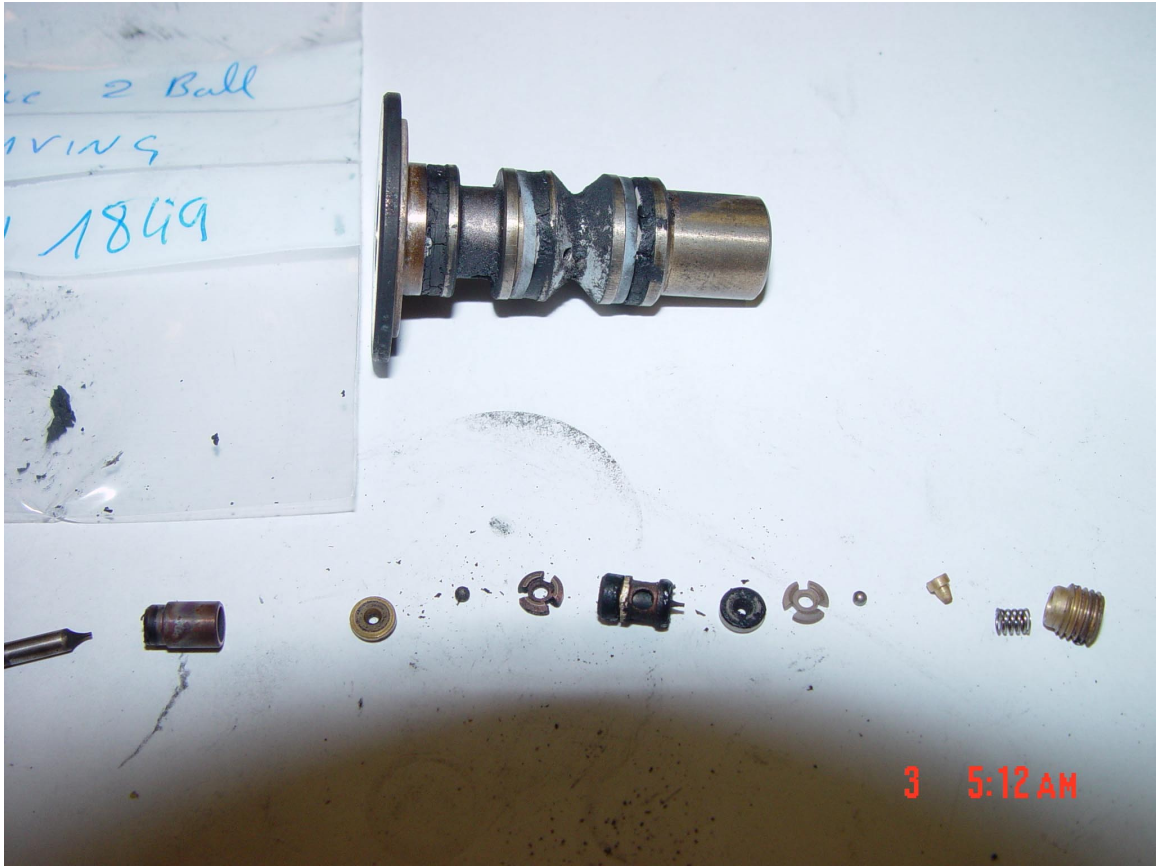
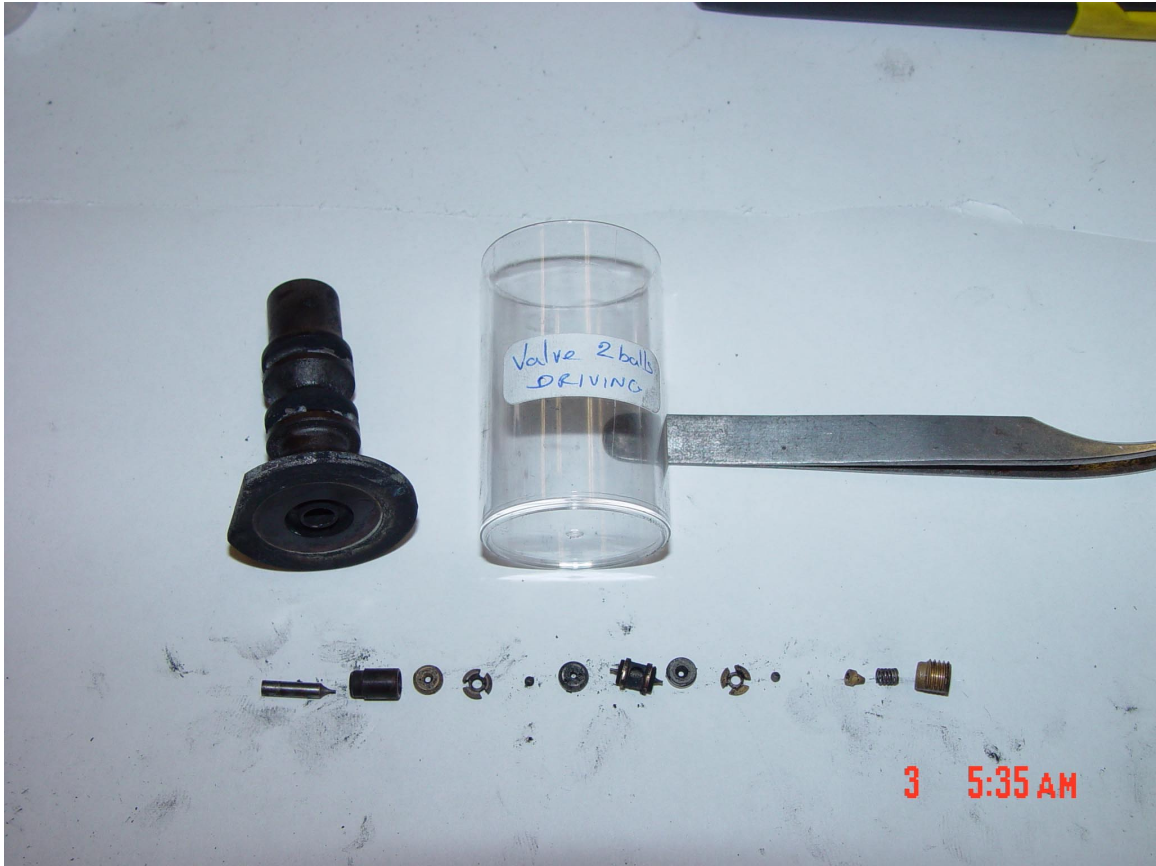
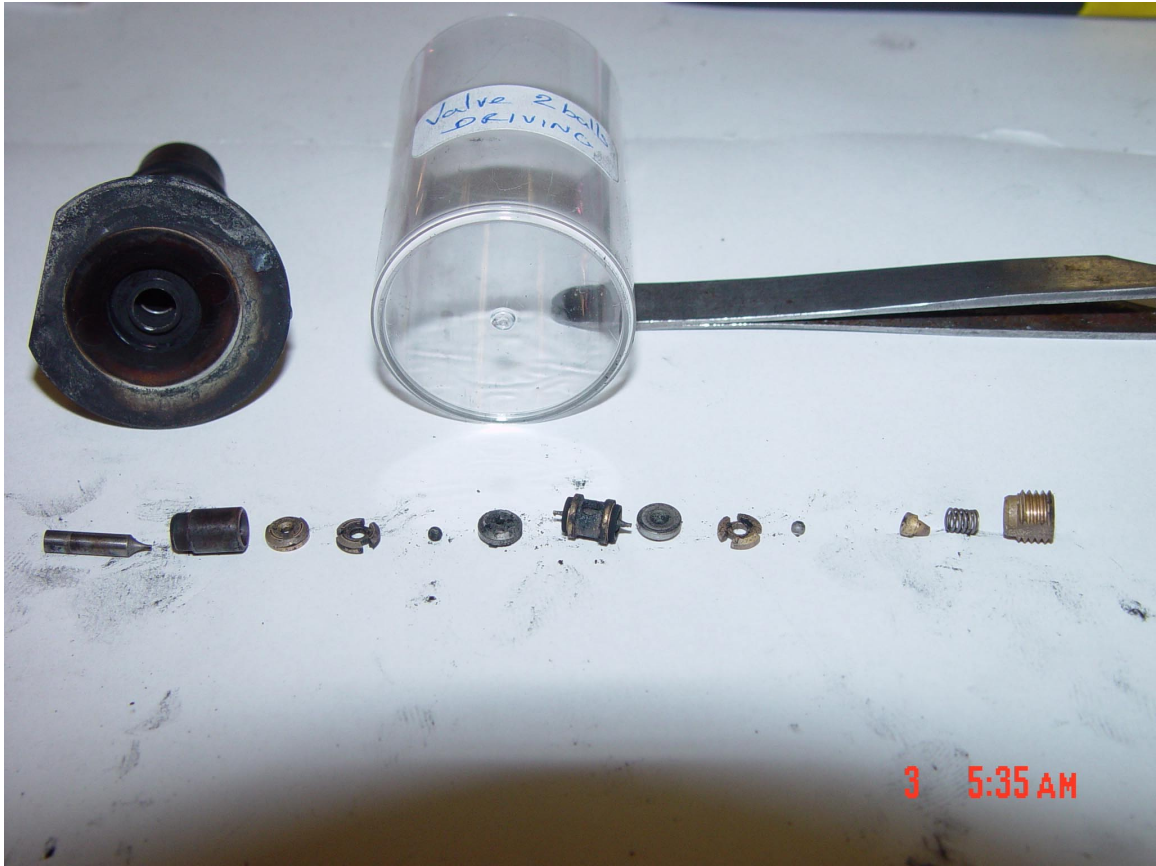
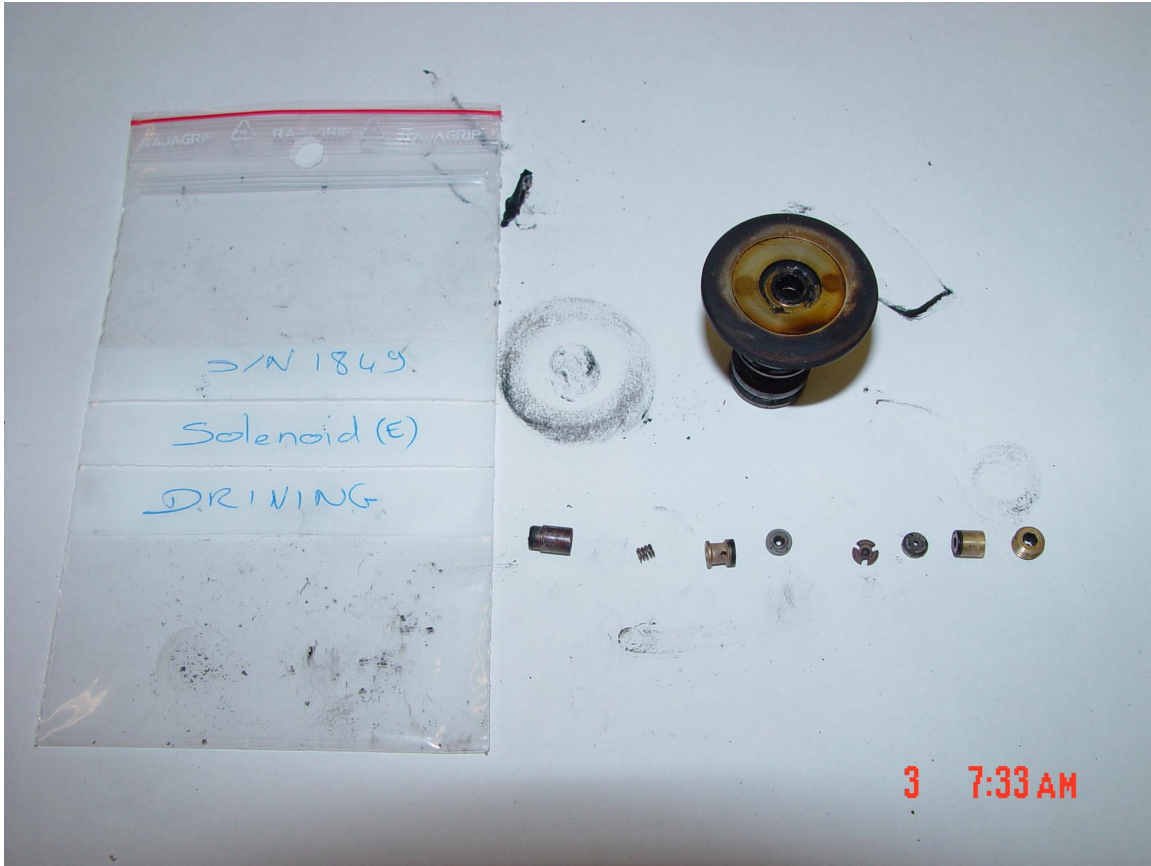
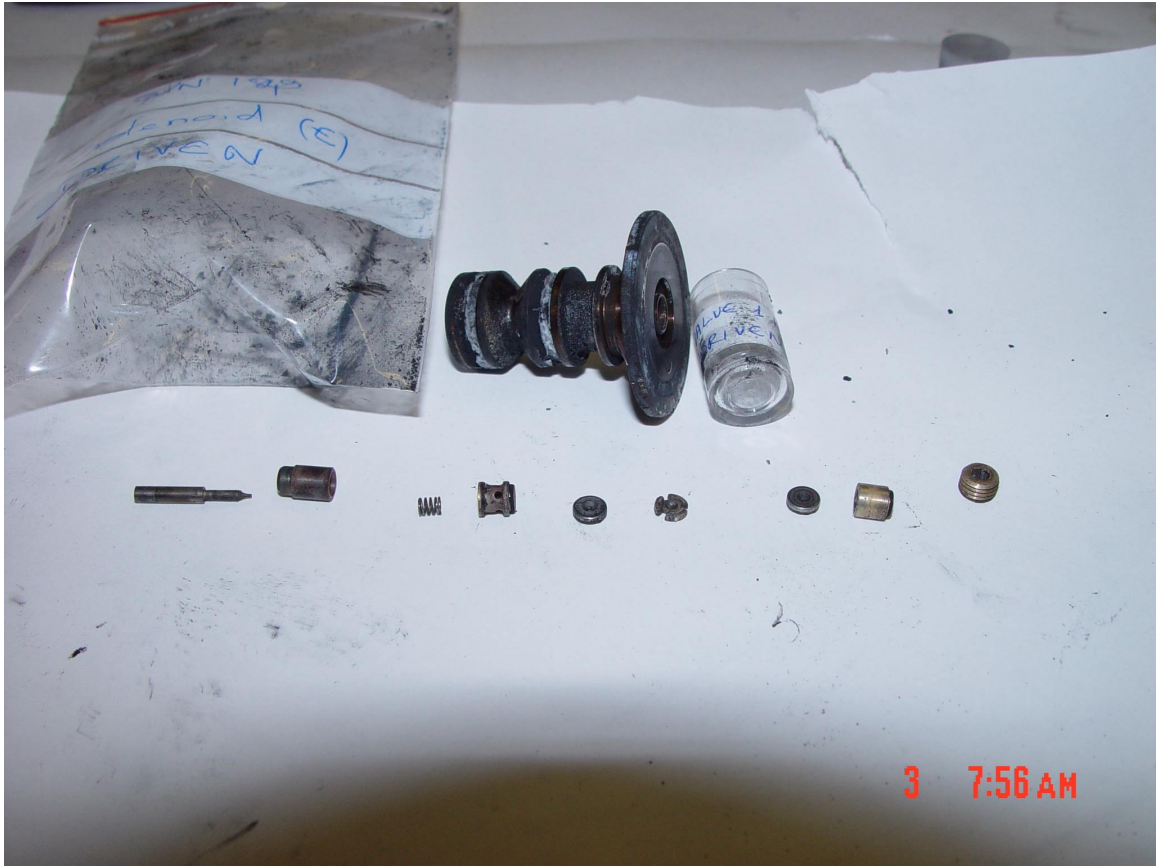
The solenoid valves (IPL 5-190A and 5-190B) were removed. The push rod protrusion was measured. The results are below. The valves were disassembled, Appendix A, Figures 33 to 38.

Driving: Protrusion 0.18 mm

Driven: Protrusion 0.12 mm

Specification for the ball stroke is 0.12 mm to 0.20 mm. Specification for the protrusion in the energized condition is 0.02 mm to 0.04 mm.

Driving: Protrusion 0.32 mm

Driven: Protrusion 0.00 mm

Upon disassembly of all of the 4 solenoid valves, the packings were observed to be heat damaged but not to the extent that they were powder. All small parts were collected into containers. Goodrich later performed a dimensional check of the solenoid parts. The results are provided in Figure 17 and Table 2.

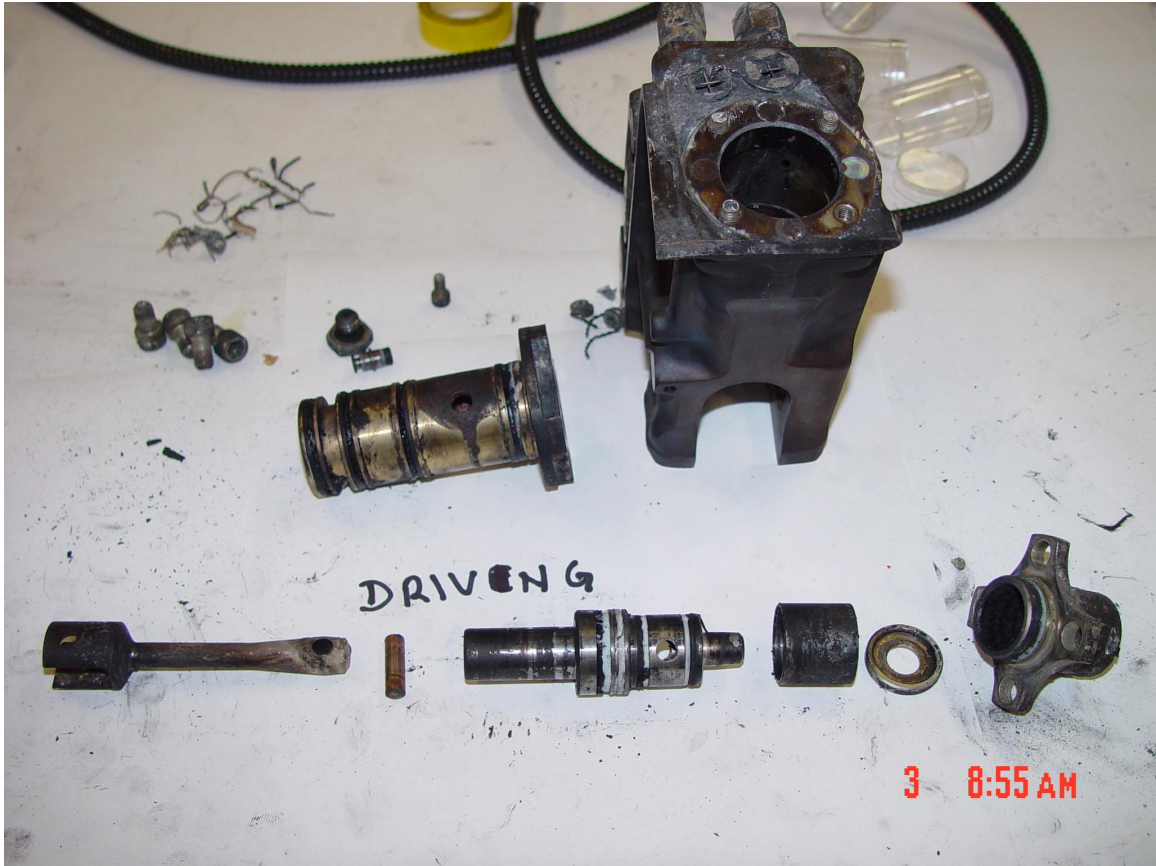
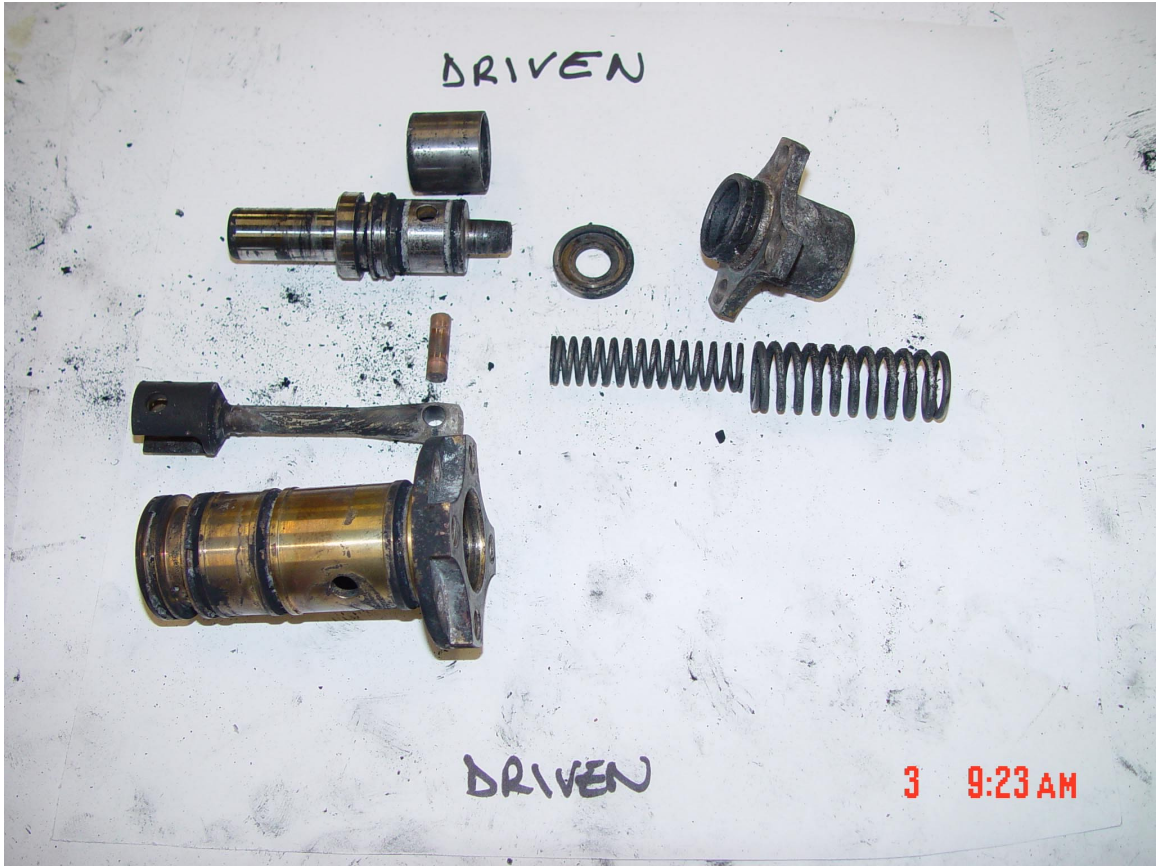
The engagement jacks were removed (IPL 6-010) and disassembled, the Driving, Appendix A, Figure 39 and Driven Appendix A, Figure 40. The springs (IPL 6-110 and 6-120) were tested (Appendix C, Figures 4 and 5 respectively). Spring constants were measured to be as per the specifications. The free heights were shorter than specification.

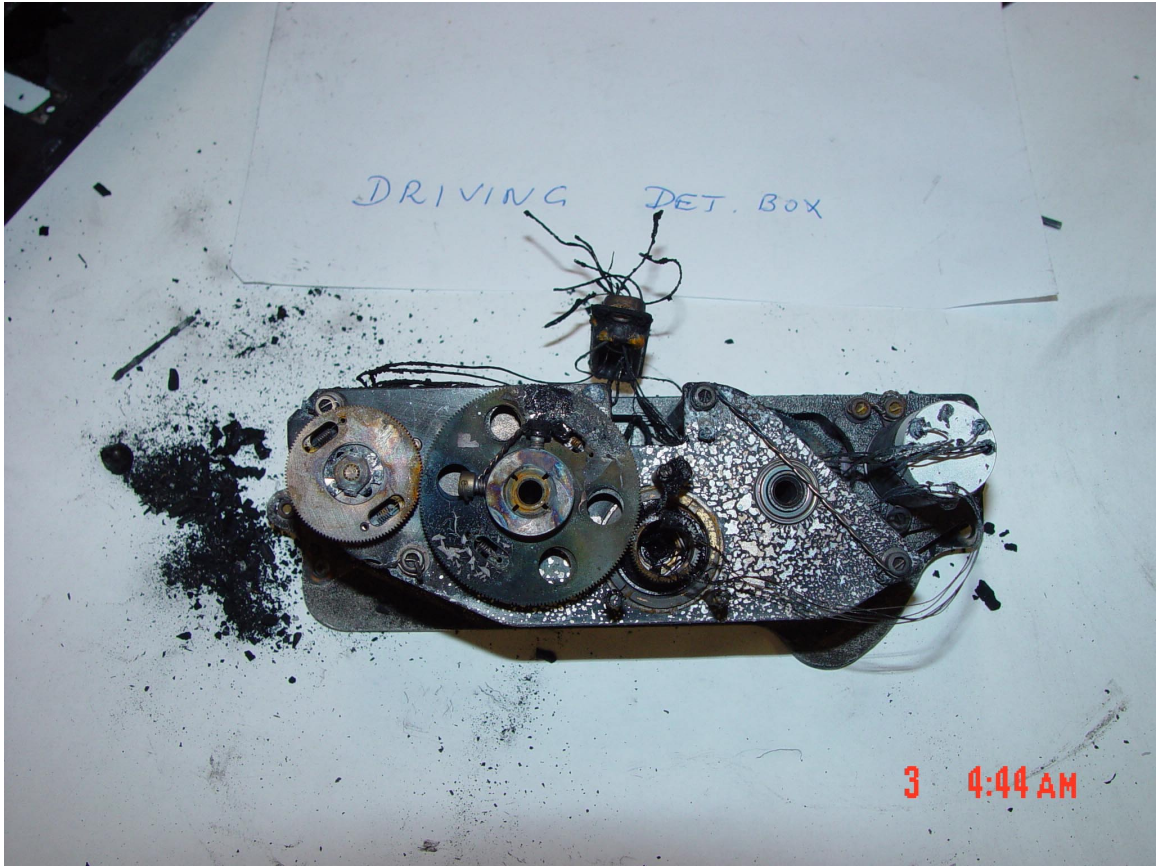
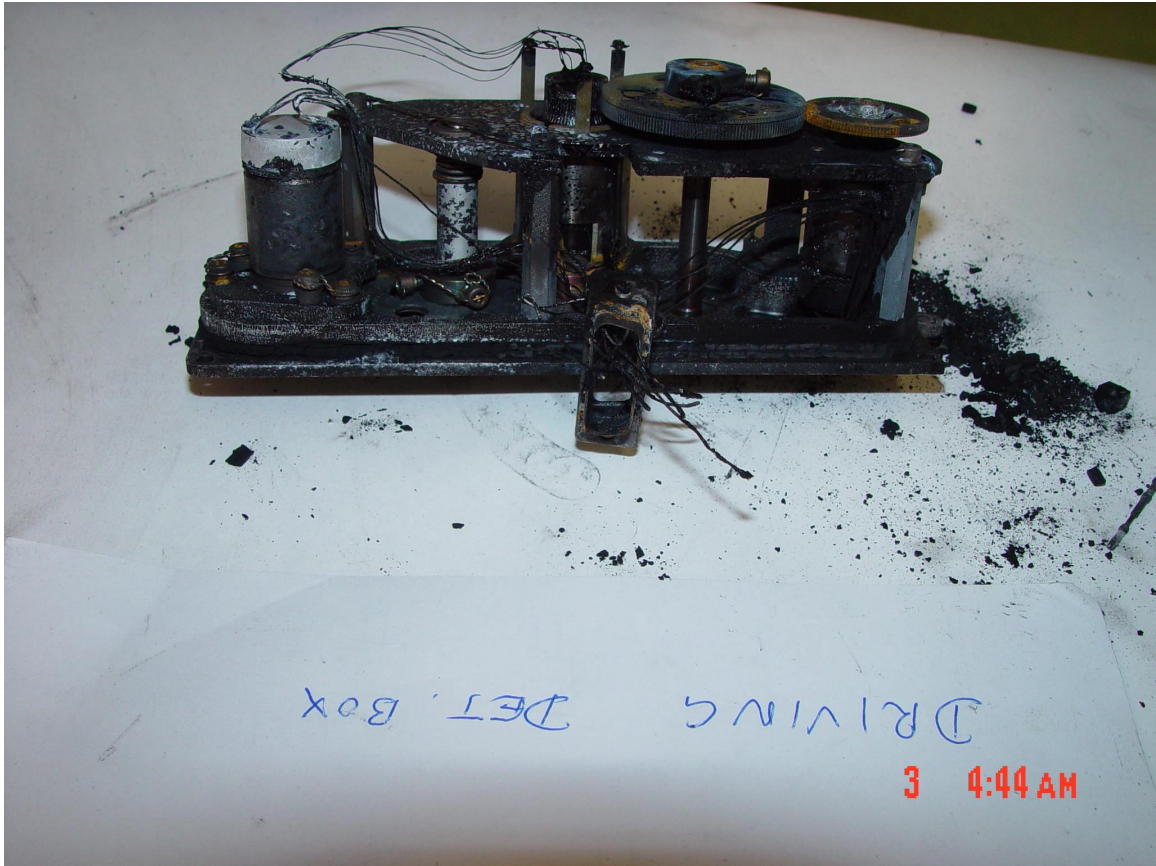
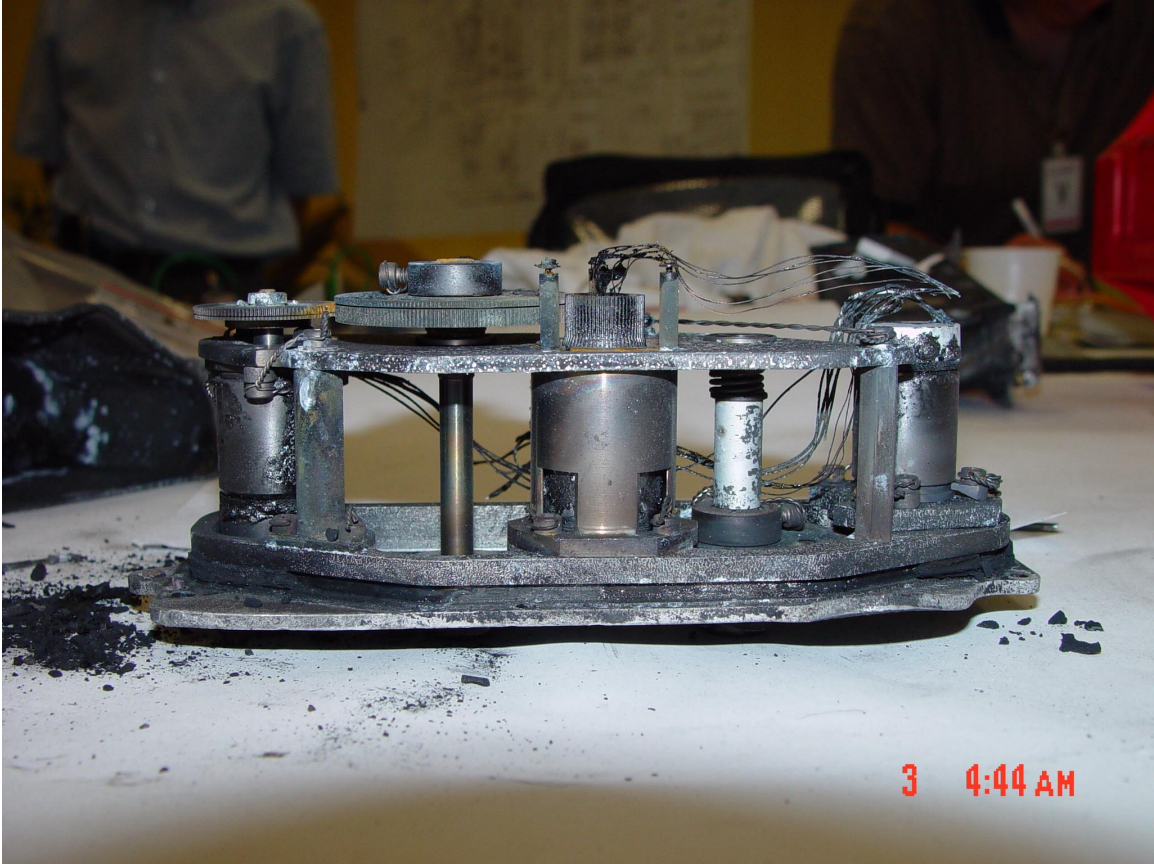
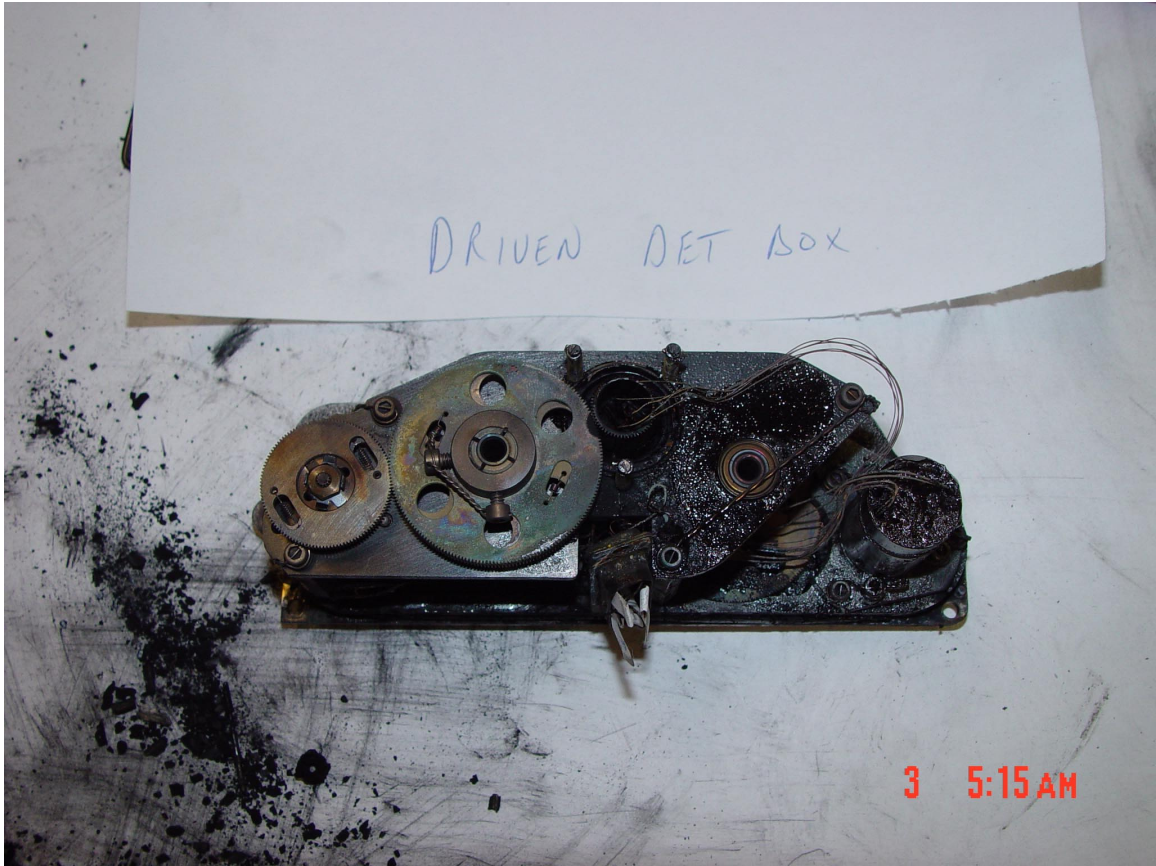
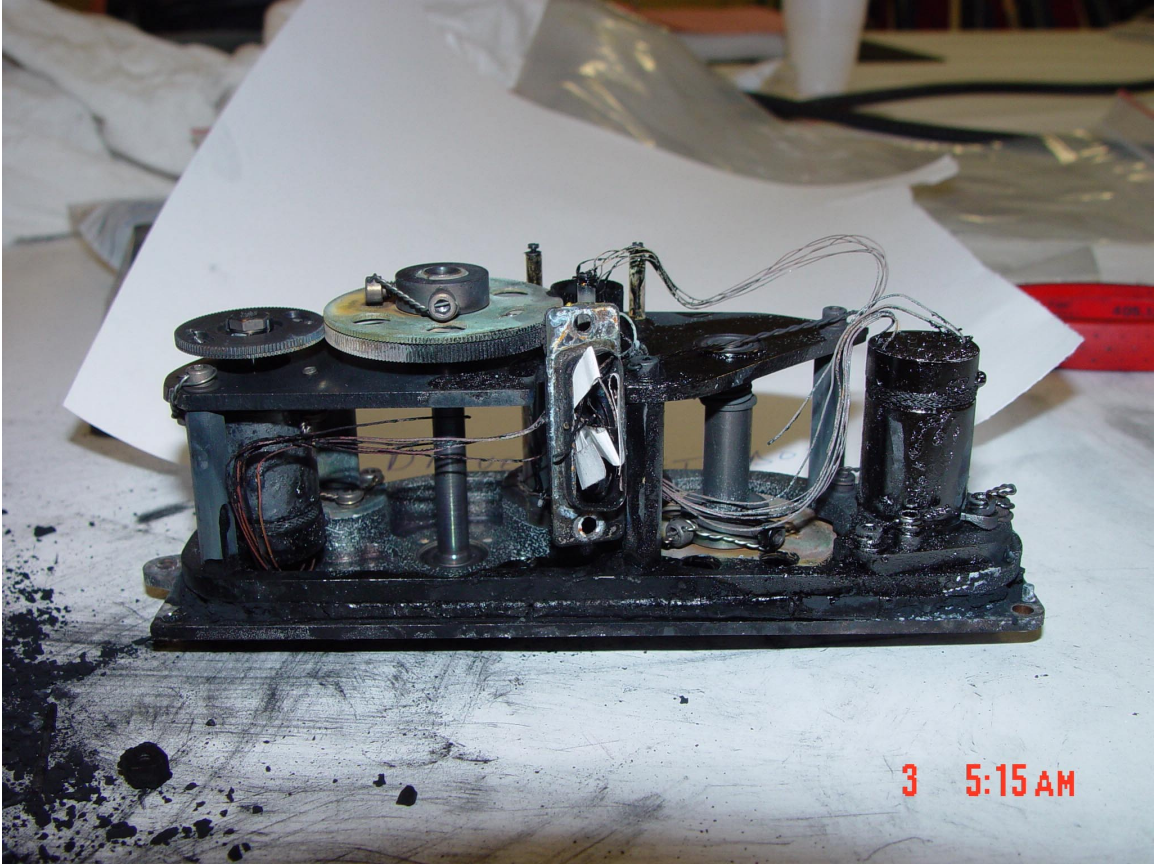
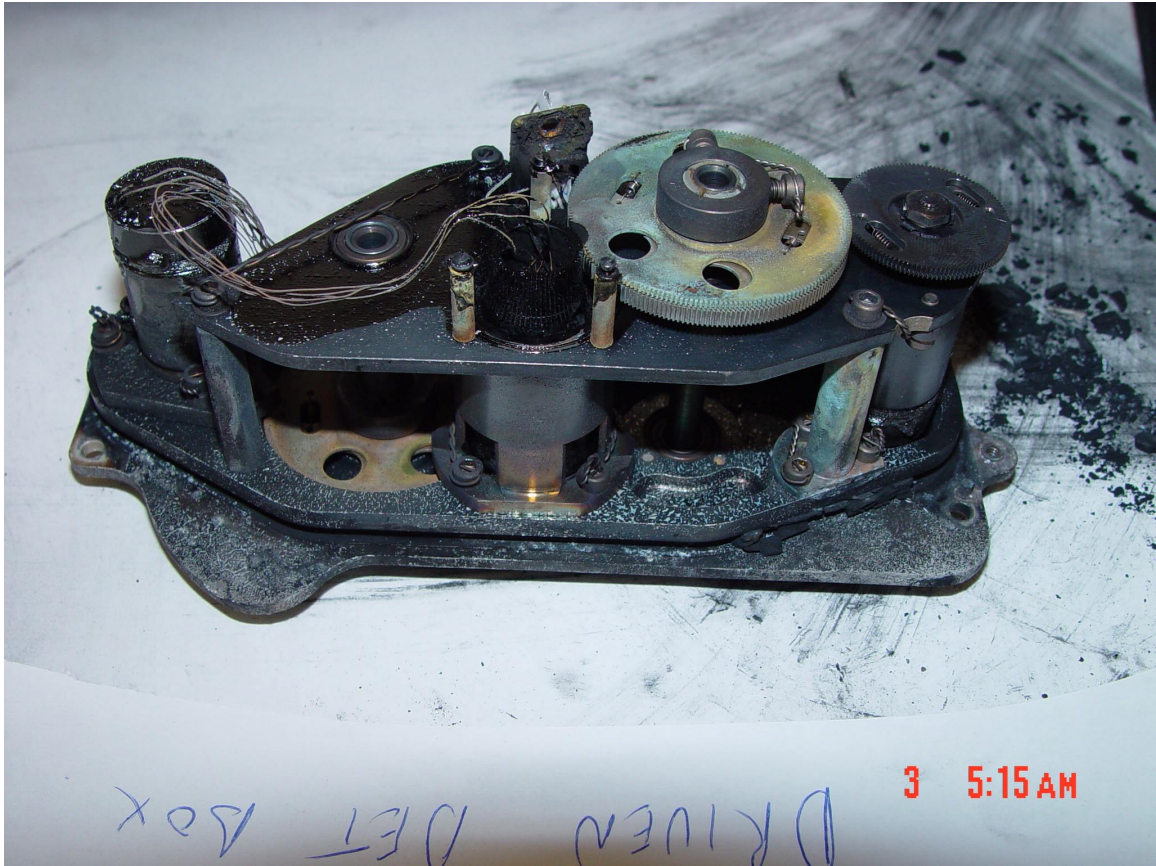
The covers of both detection boxes were removed, Appendix A, Figures 41 to 46. Severe heat damage was observed. The gearing was not free to move due to the damage.
