**NATIONAL TRANSPORTATION SAFETY BOARD
OFFICE OF AVIATION SAFETY
WASHINGTON, D.C. 20594**

**ADDENDUM NUMBER 5 TO THE SYSTEMS GROUP CHAIRMAN'S
FACTUAL REPORT OF INVESTIGATION- AUTOPILOT SERVOMOTOR
EXAMINATION**

DCA02MA001

Operator: American Airlines
Aircraft: A300-600R
Location: Belle Harbor, New York
Date: November 12, 2001
Time: 09:16 EDT

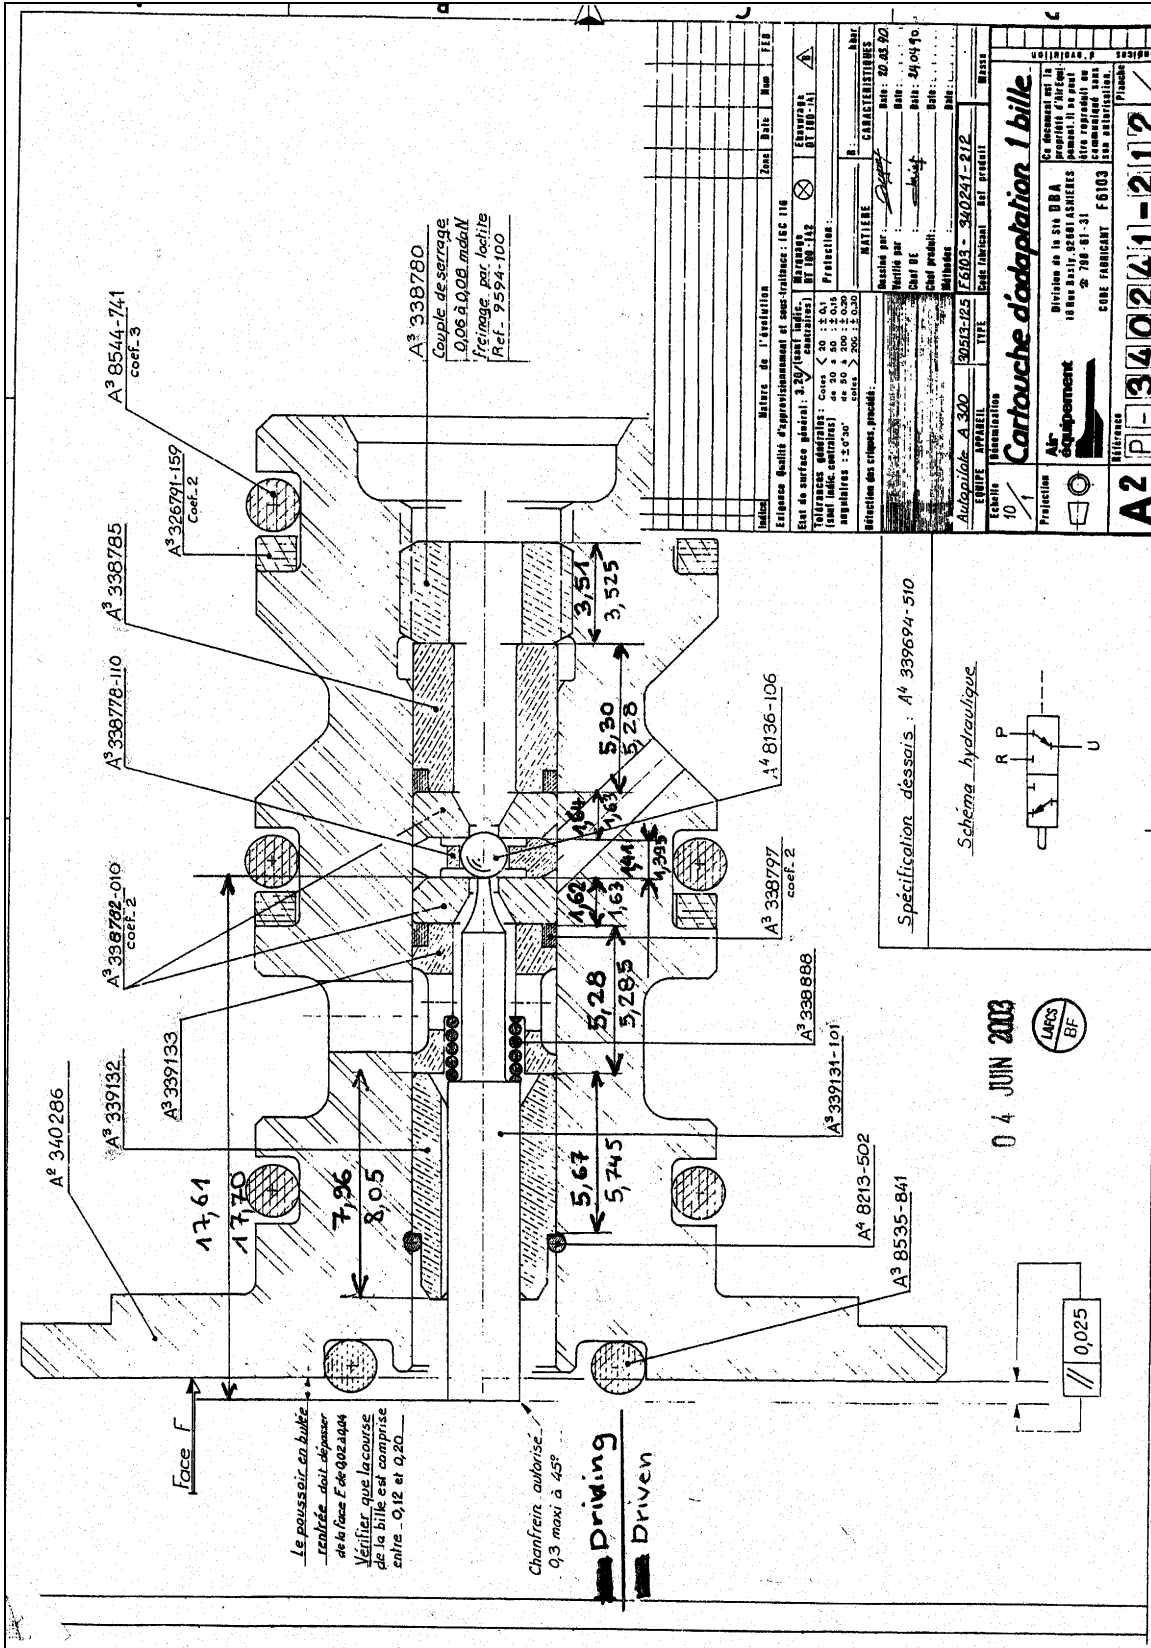
A dimensional check of the Engage solenoid valves was made, Appendix C, Figure 1. The transfer pistons (IPL 13-130A) is shorter than specified in the drawing. The Driving one was measured to be 17.61 mm, the Driven was 17.70 mm. The specified length is 18 +/- 0.1mm. However, the pistons are subsequently machined to achieve the dimension 0.02 to 0.04 mm protrusion with the piston in the fully retracted position per drawing 340241-212 (Appendix C, Figure 1).

Figure 1. Engage Solenoid Valve (1 Ball).

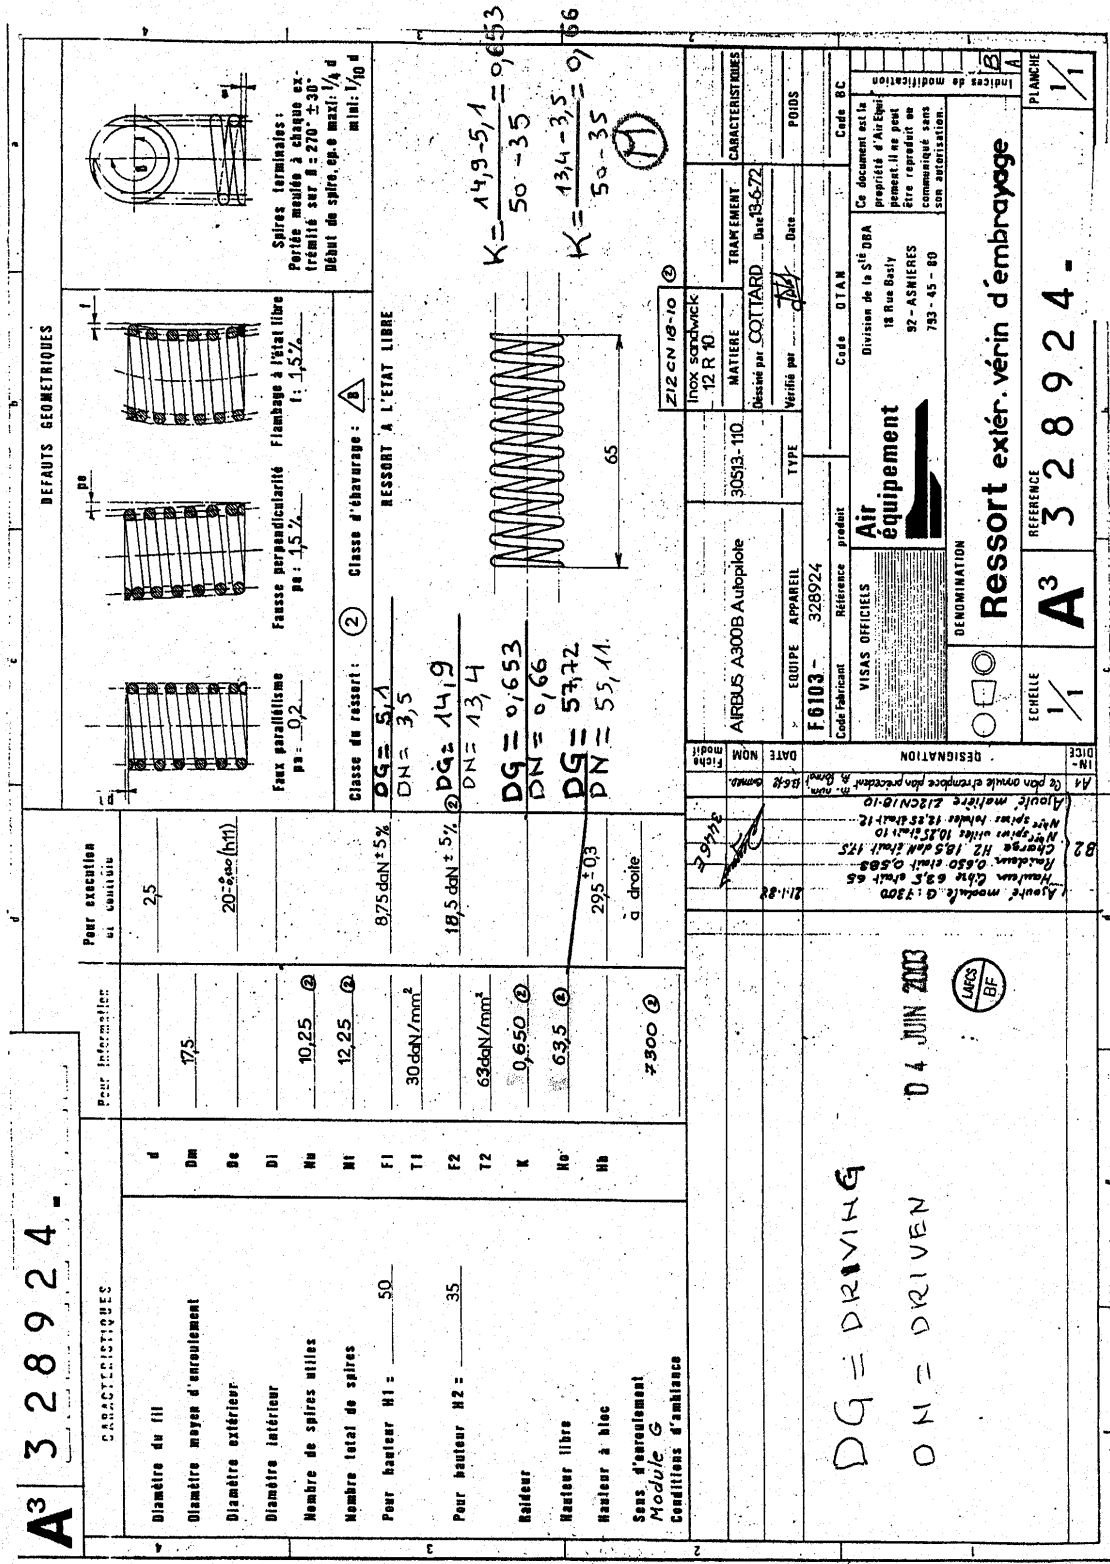
The engagement jacks were removed (IPL 6-010) and disassembled, the Driving, Appendix A, Figure 39 and Driven Appendix A, Figure 40. The springs (IPL 6-110 and 6-120) were tested (Appendix C, Figures 4 and 5 respectively). Spring constants were measured to be as per the specifications. The free heights were shorter than specification.

Figure 4. Dimensional Check of Engagement Spring.

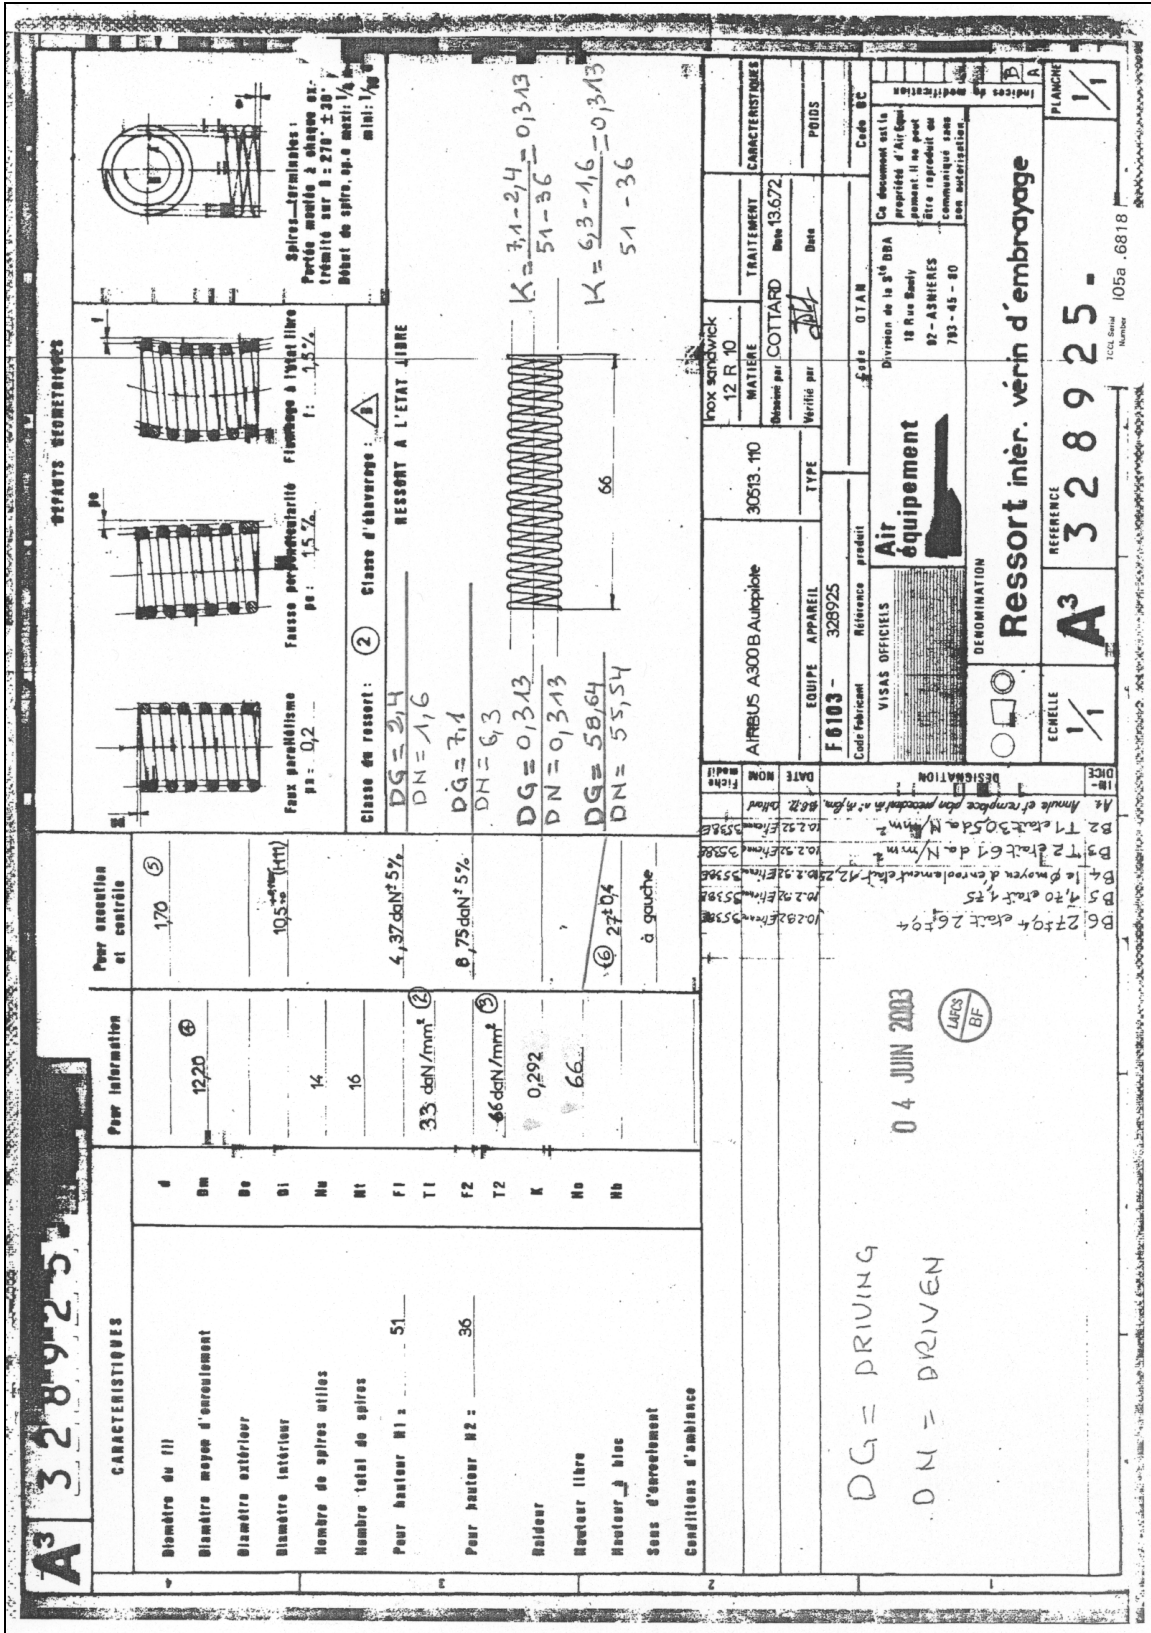
Figure 5. Dimensional Check of Engage Spring.
