**NATIONAL TRANSPORTATION SAFETY BOARD
OFFICE OF AVIATION SAFETY
WASHINGTON, D.C. 20594**

**ADDENDUM NUMBER 6 TO THE SYSTEMS GROUP CHAIRMAN'S
FACTUAL REPORT OF INVESTIGATION – YAW DAMPER EXAMINATION**

DCA02MA001

Operator: American Airlines
Aircraft: A300-600R
Location: Belle Harbor, New York
Date: November 12, 2001
Time: 09:16 EDT

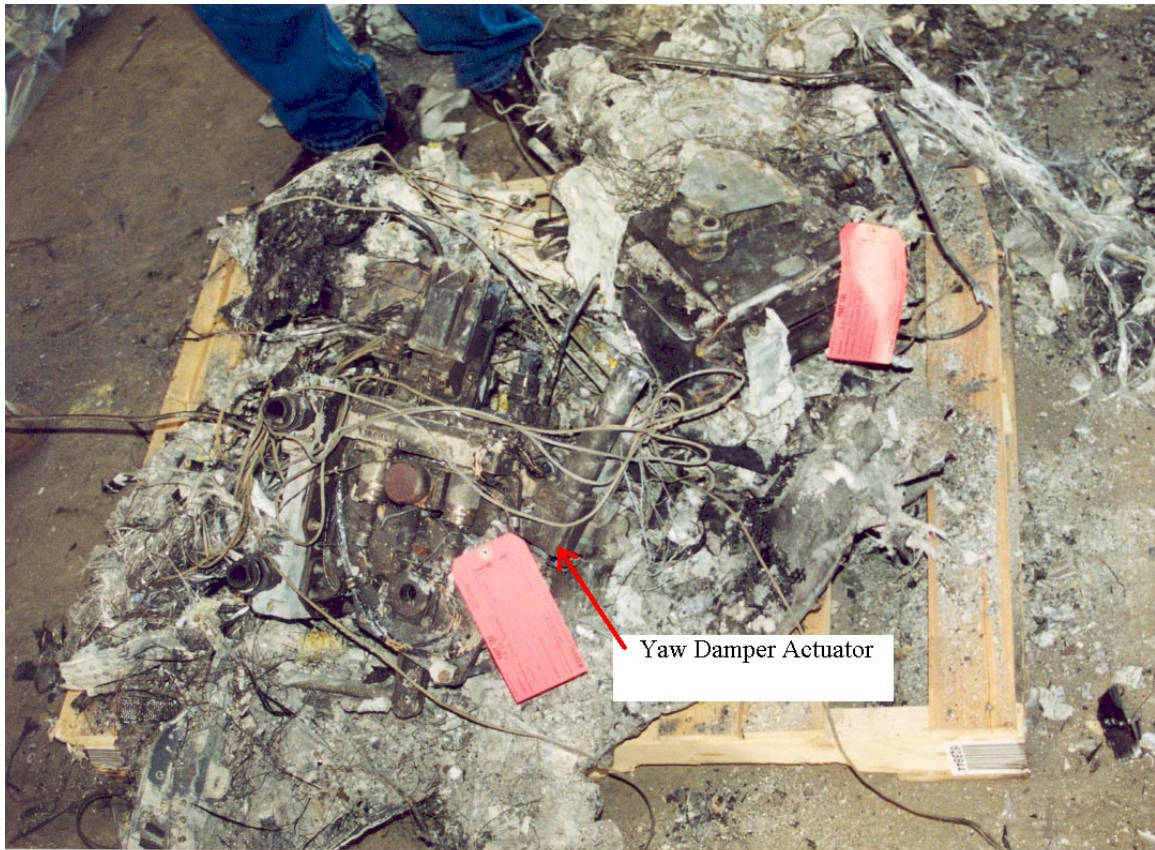
The yaw damper actuator was recovered from the accident site. It was attached to a large piece of re-solidified molten metal and debris (Figure 3). The wreckage was moved to NTSB Headquarters, Washington DC. The unit was cut away from the debris and shipped to France for further examination.

Figure 3. Yaw Damper Actuator as Recovered from the Wreckage.

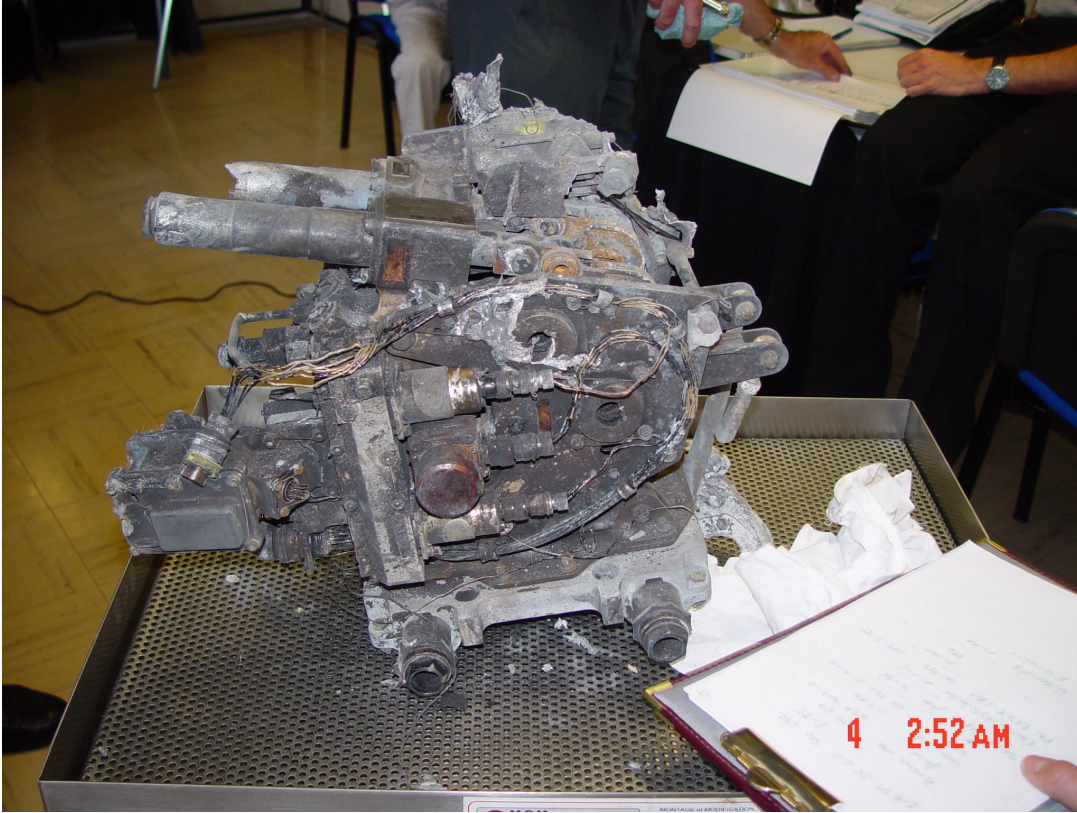
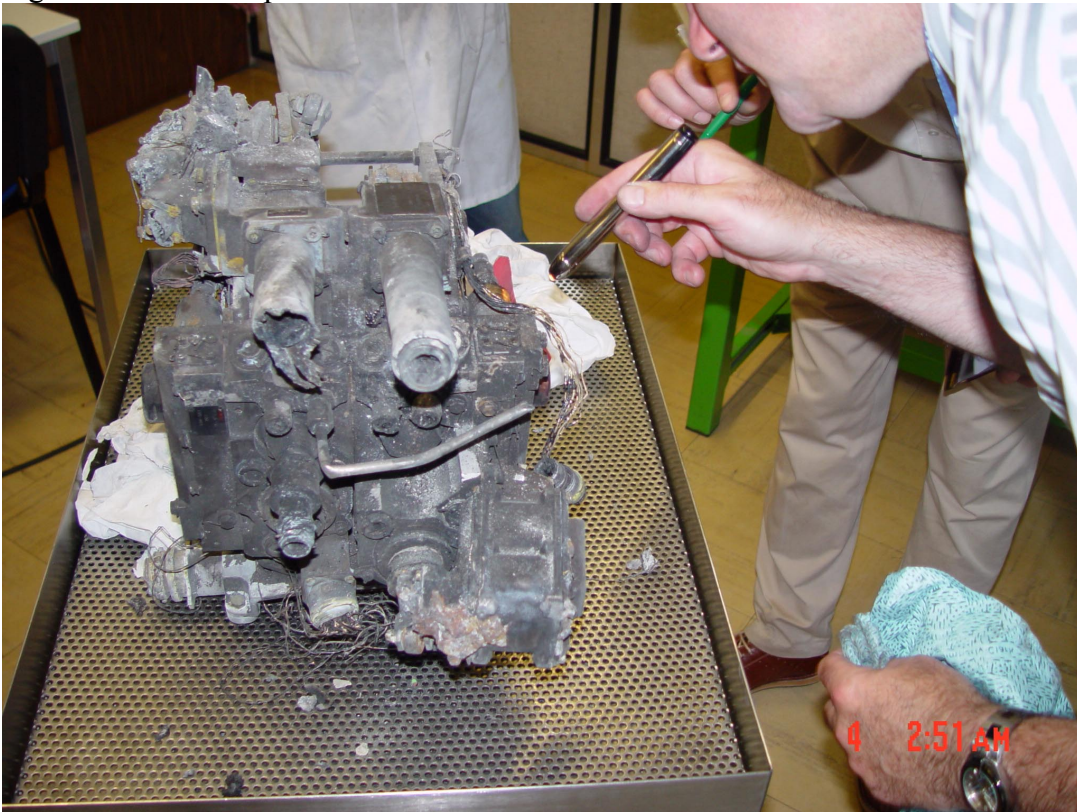
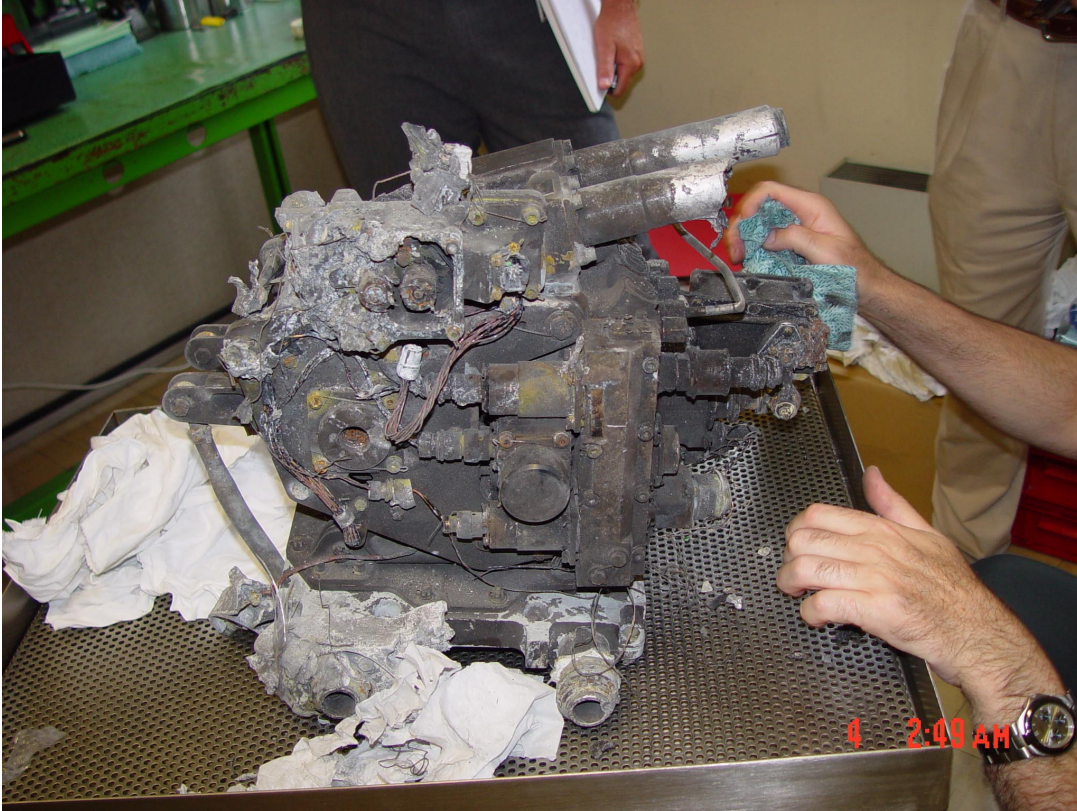
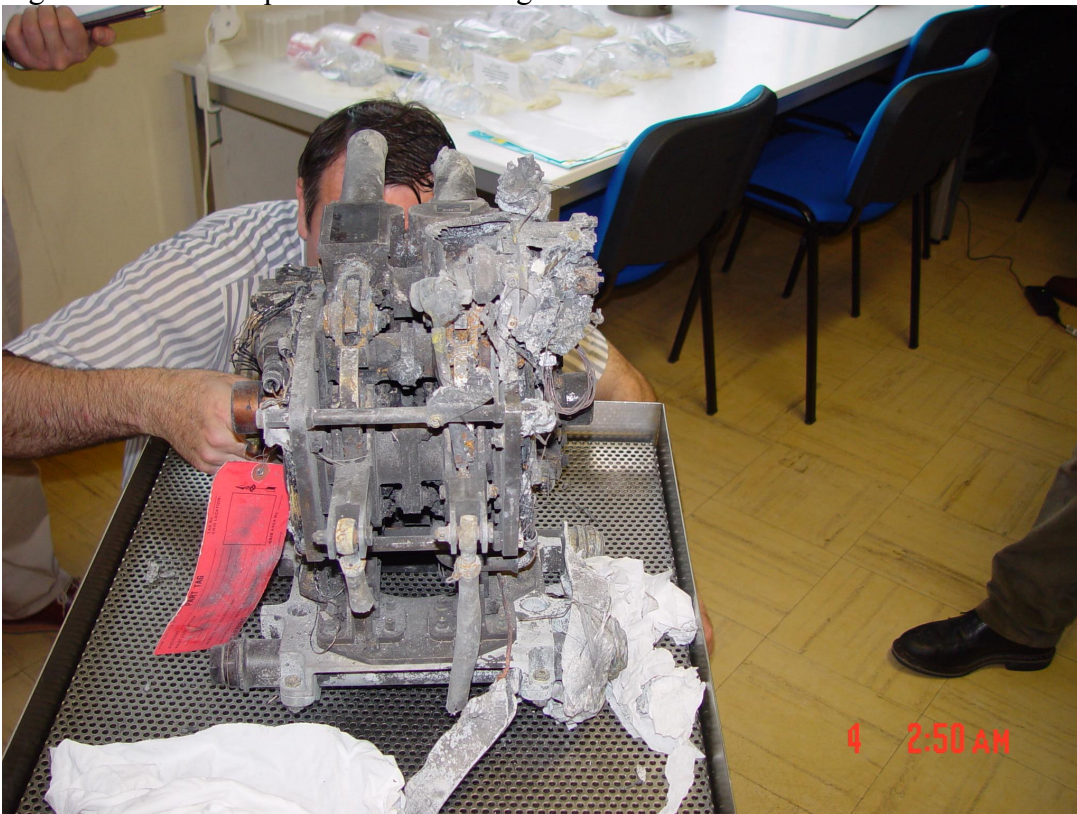
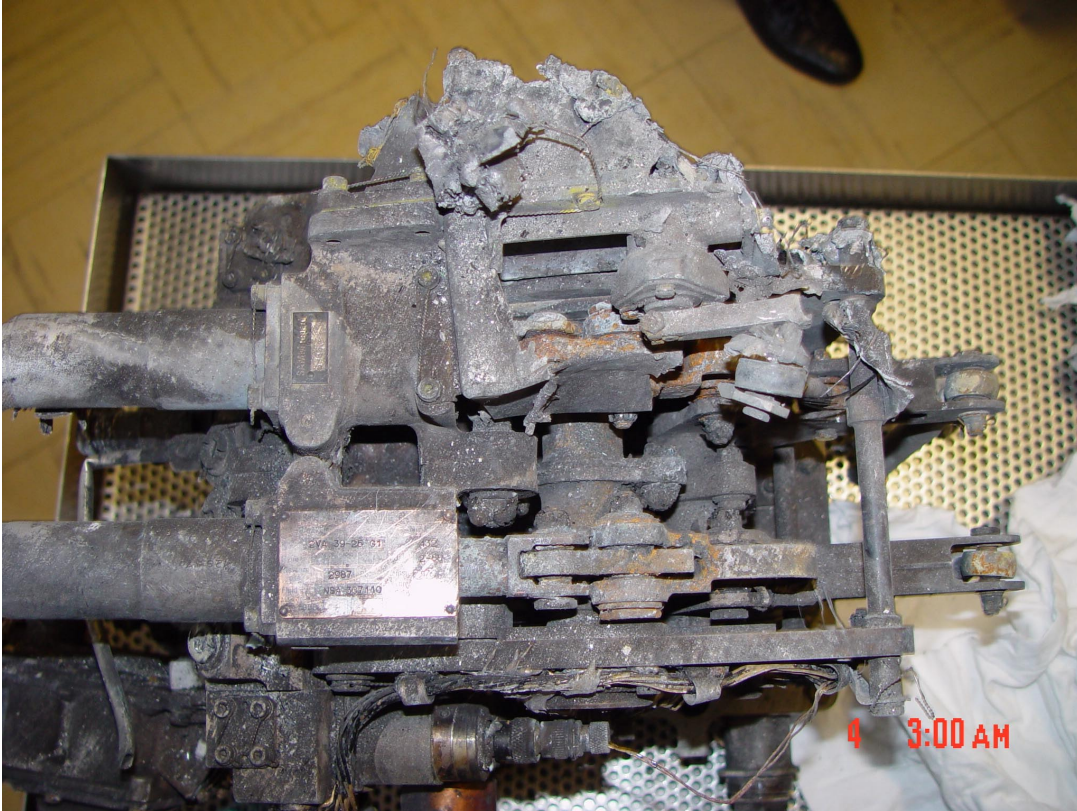
The Driving side synchro box input rod was fractured. This occurred while the unit was removed from molten metal parts which re-solidified on the component during the post accident fire. The synchro box linkage, which connected to the output arm was bent.

The Driven side synchro box attachment to the actuator was broken.

The locking forks were engaged, consistent with a locking to neutral when there is no hydraulic power.

The spring housings (IPL 5-020) were damaged. The Driven channel had two springs, the Driving side had only one spring (IPL 5-060).

The actuator output levers had a segment of the airplane control rods still connected.

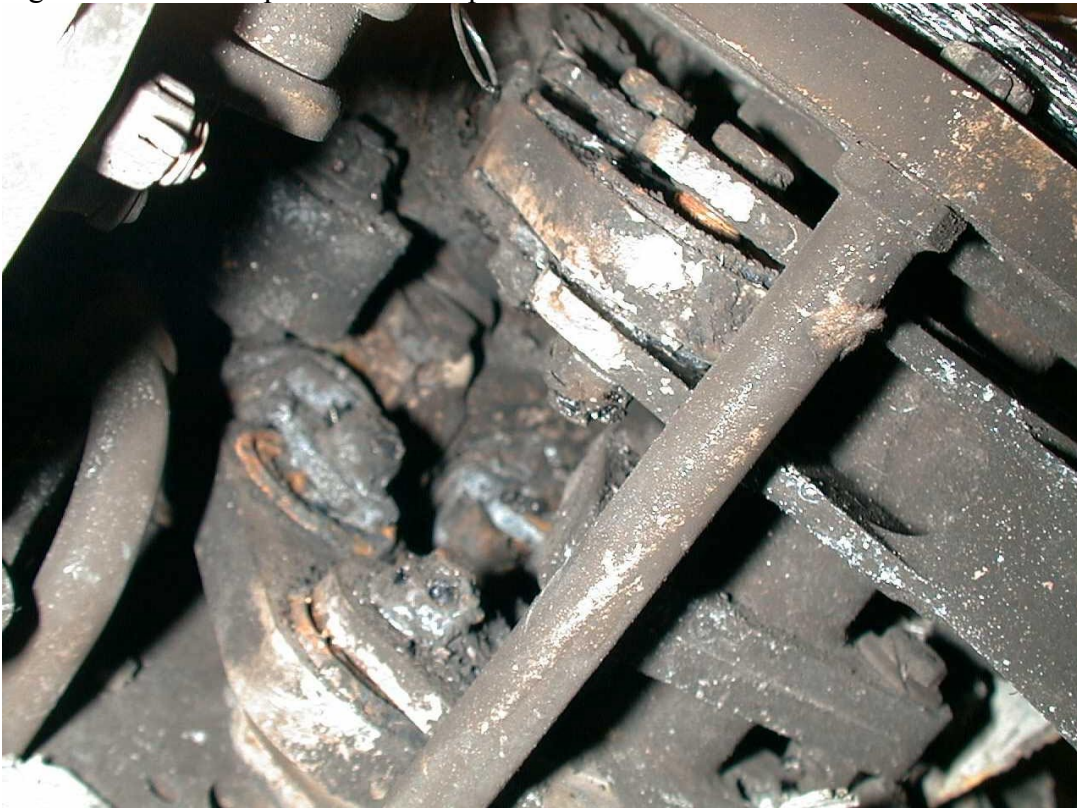
The linkage from the output levers (IPL 6-740), through the common output shaft (IPL6-620), and to the Driving cylinder (IPL 7-130, 7-150) and Driven cylinder (IPL 8-300, 8-380) was intact (Figure 9).

Figure 9. Yaw Damper Output Linkage.

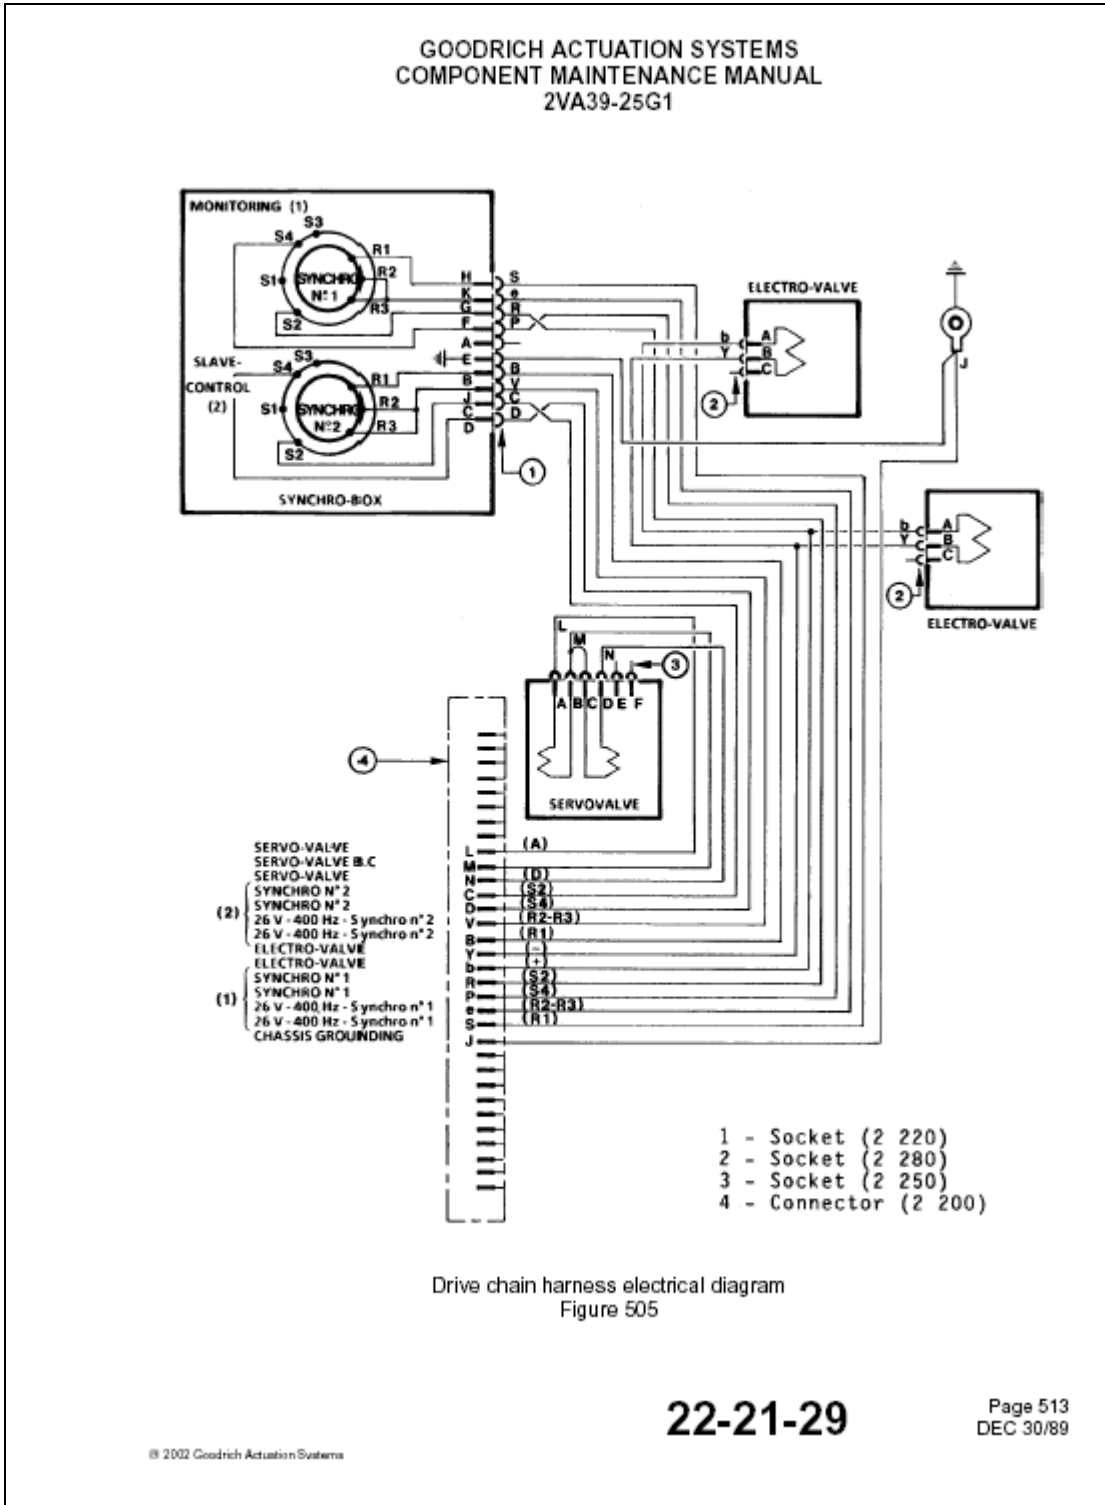
The connections as per CMM, Figure 505 (Figure 10) were confirmed except SV-C splice to SV-B (Splice melted).

The resistance at the solenoids pins A and B was measured to be 83.9 ohms at ED1 and 82.2 ohms at ED2.

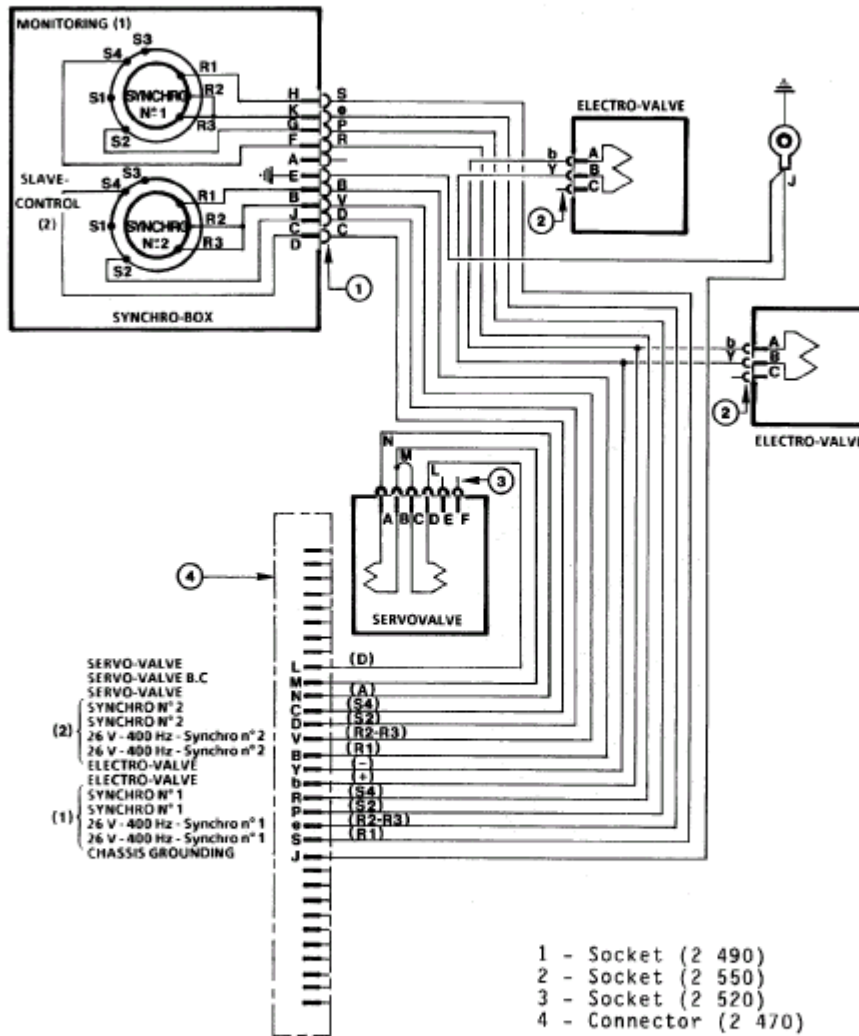
The connections as per CMM, Figure 506 (Figure 11) were confirmed except ED1-A to splice with ED2-A (Splice melted).

The resistance at the synchro resolvers and transmitters of the synchro box was measured to be 0.3 ohms pins G to F, 0.27 ohms pins C to D, 0.23 ohms pins H to K, and open

circuit between pins B and J. The synchro box cover was removed, but routing of the wires could not be confirmed visually.

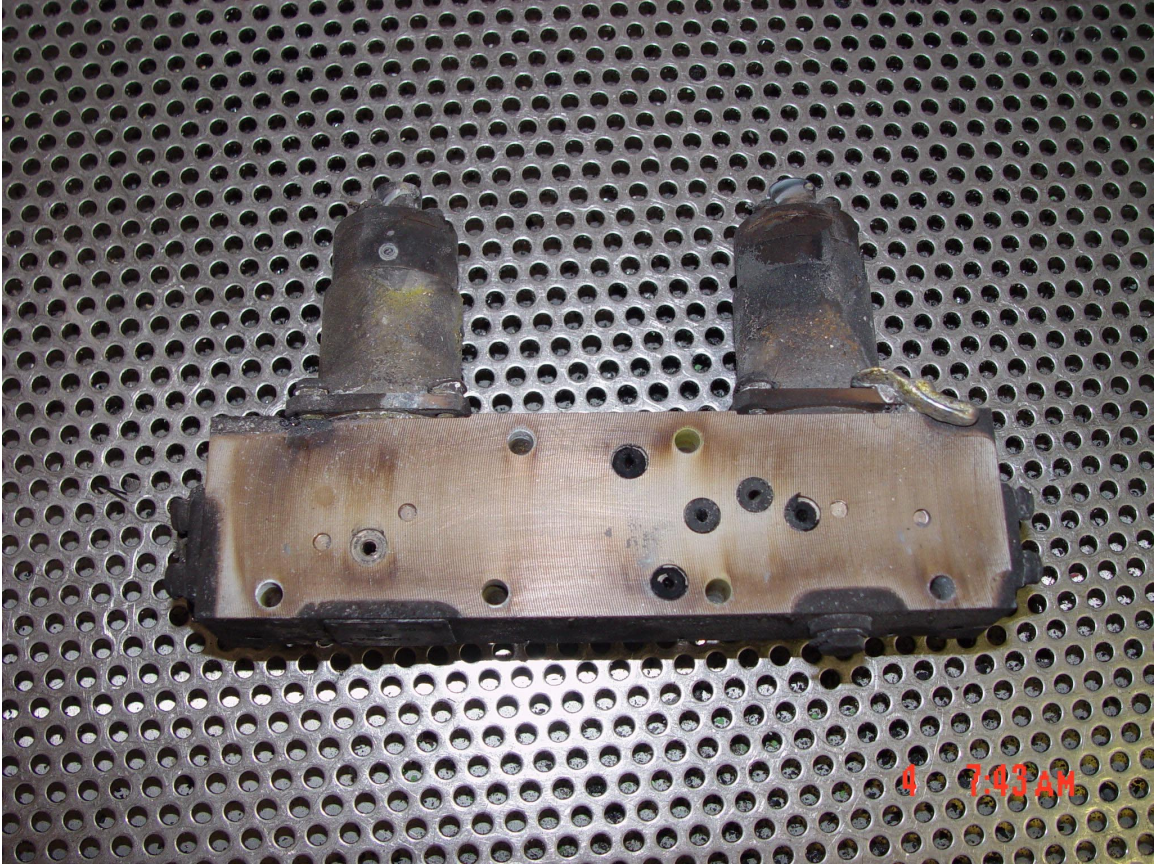
The Driving side electric distributor block was removed (IPL 1-80A), Appendix B, Figure 1 and Figure 2.

An external leakage was observed from cap (IPL 3-110).
Electrical consumption of the 2 solenoids was measured to be 300 mA each under 28V. Solenoids were energized. ED1 was confirmed to be operating by the observation that external leakage increased when it was energized. ED2 did not operate.

Figure 1. Electric Distributor Block and Solenoids – Driving Side.

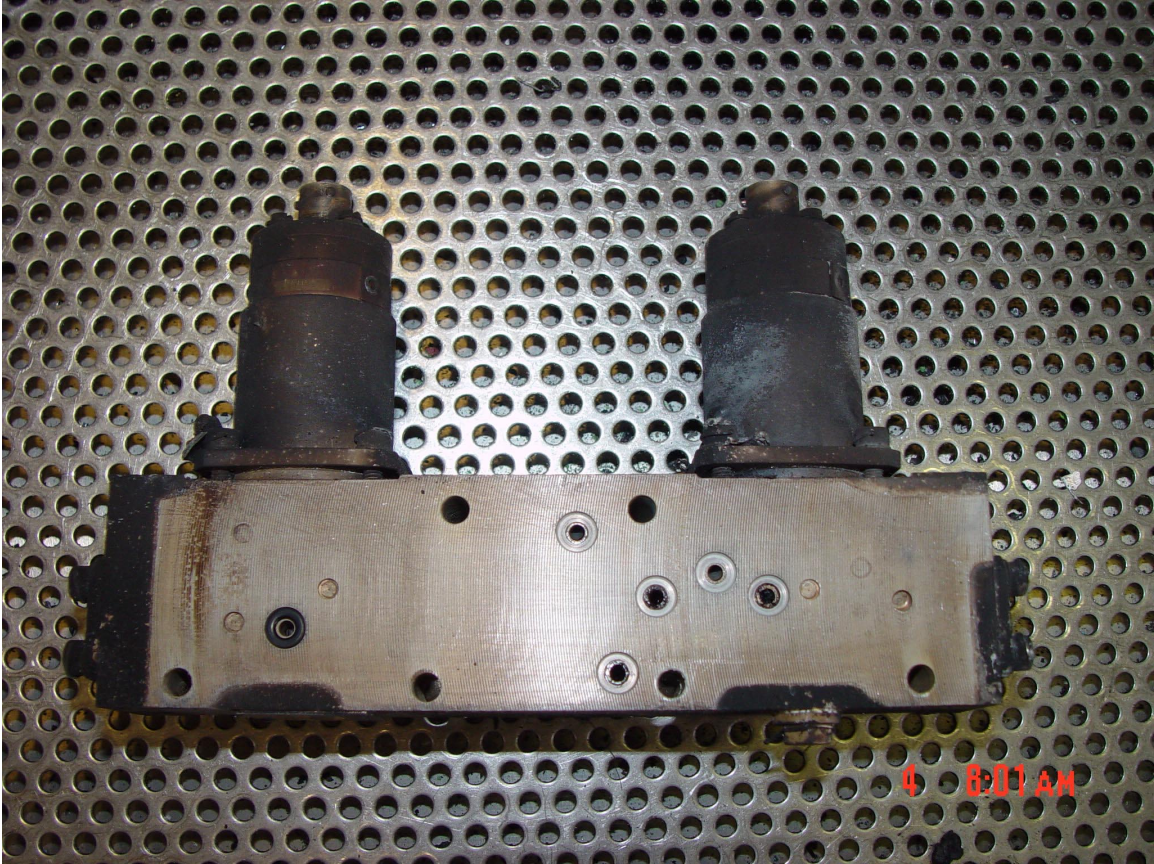
The Driven side distribution block was removed (IPL 1-80A), Appendix B, Figure 4 and Figure 5.

Electrical consumption of the 2 solenoids was measured to be 300 mA each under 28V. Solenoids were activated and their operation assessed by feeling the vibrations from the outside. ED1 did not operate. ED2 was confirmed to be operating.

Figure 4. Driven Side Electric Distribution Block

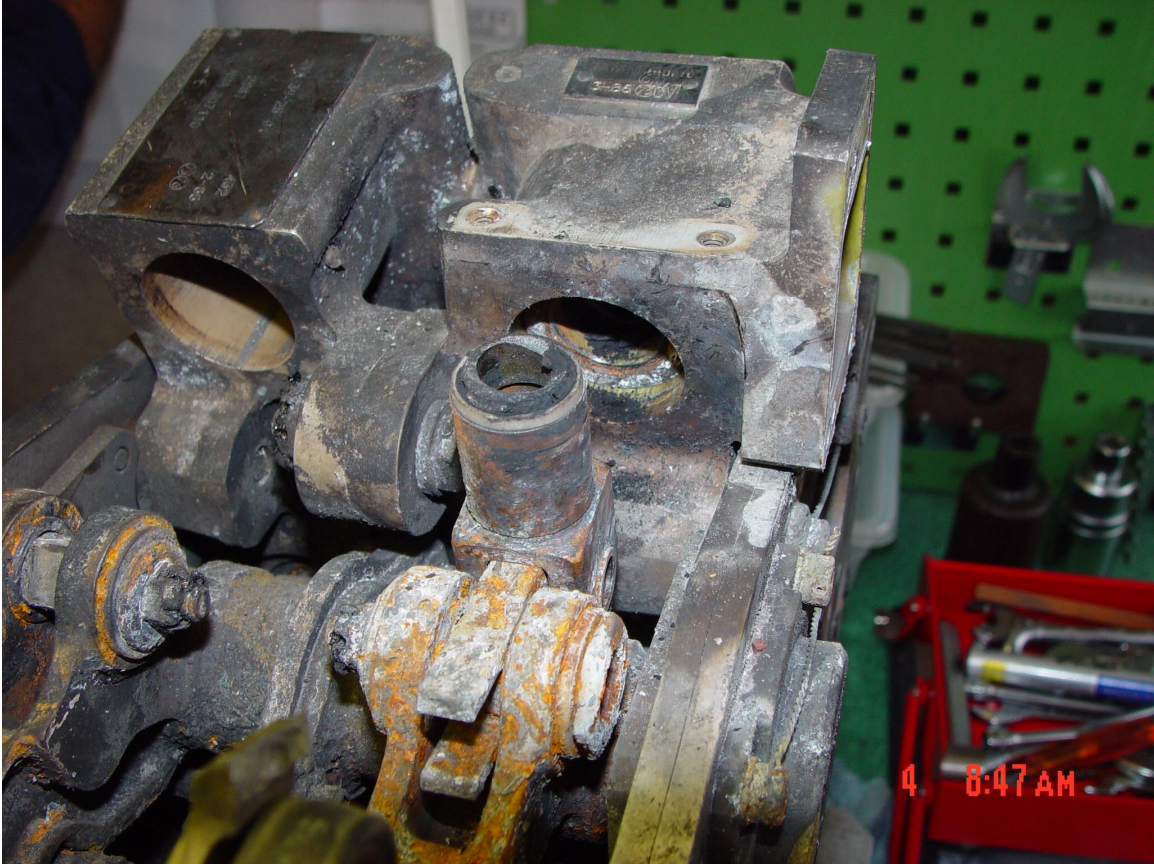
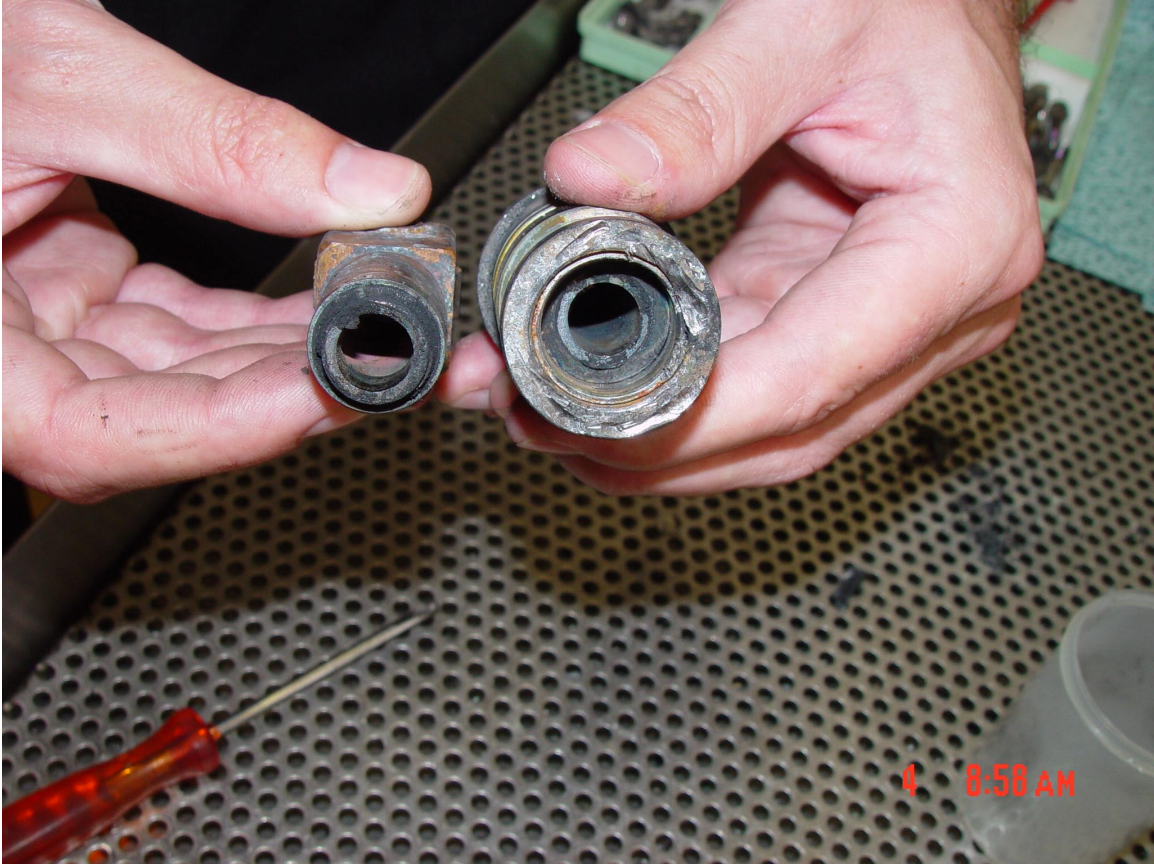
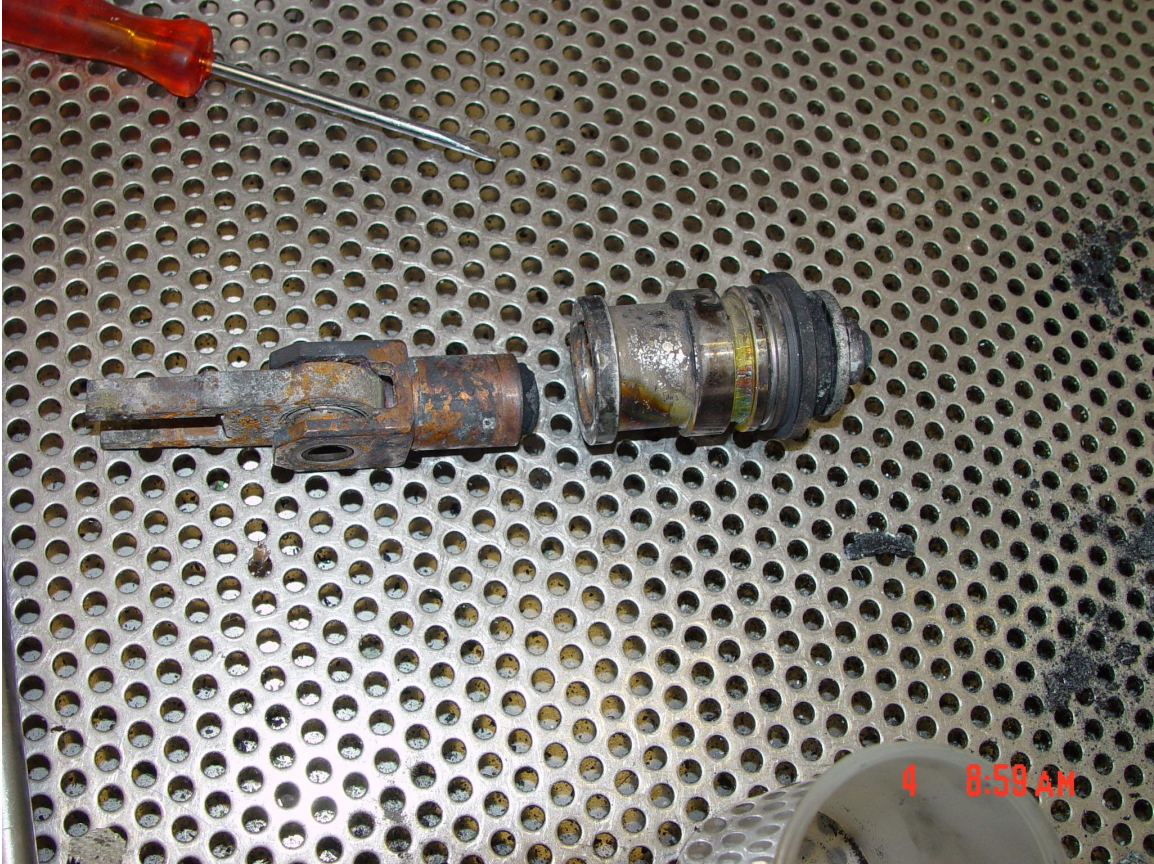
The Driving side lock linkage and piston were removed. During the removal the piston fractured (IPL 5-190), Appendix B, Figures 14 to 16.

Figure 14. Driving Side Locking Cam Linkage (fractured).

Figure 15. Driving Side Locking Cam Linkage Removed (fractured).

Figure 16. Driving Side Locking Cam Linkage (fractured).

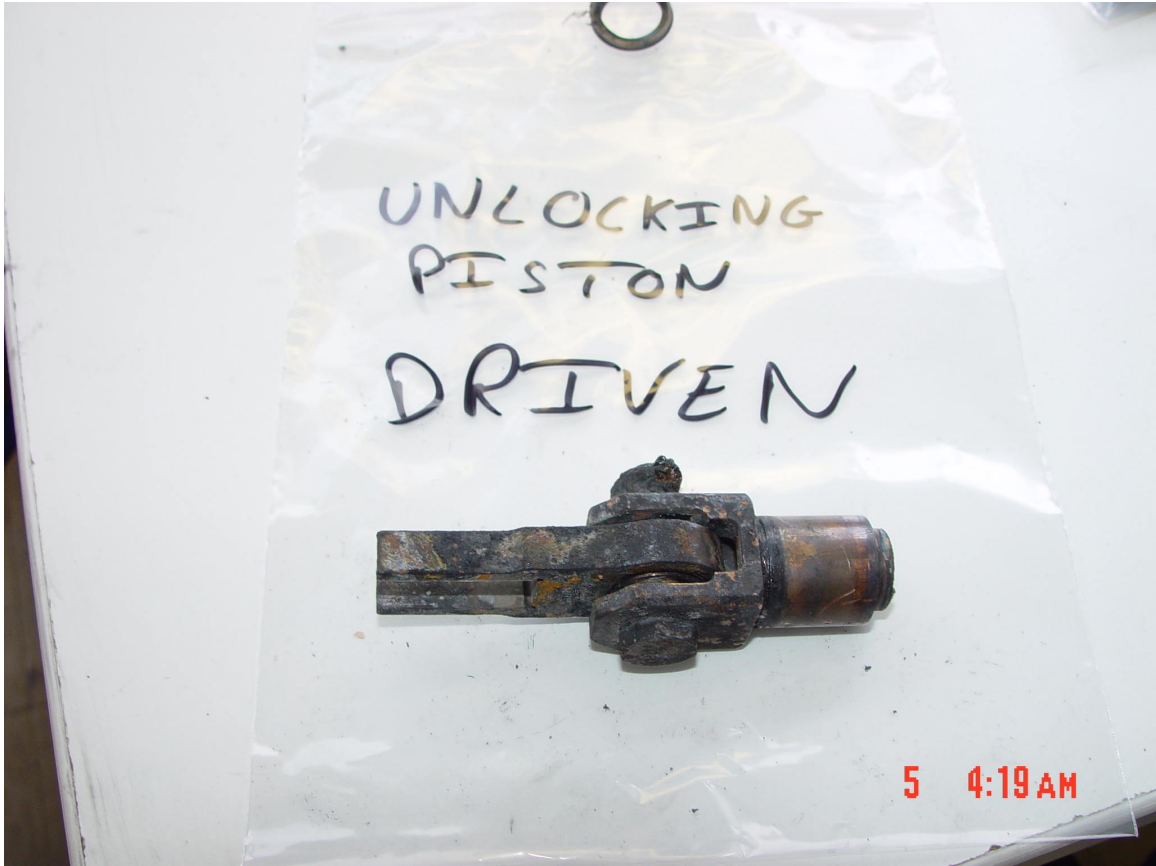
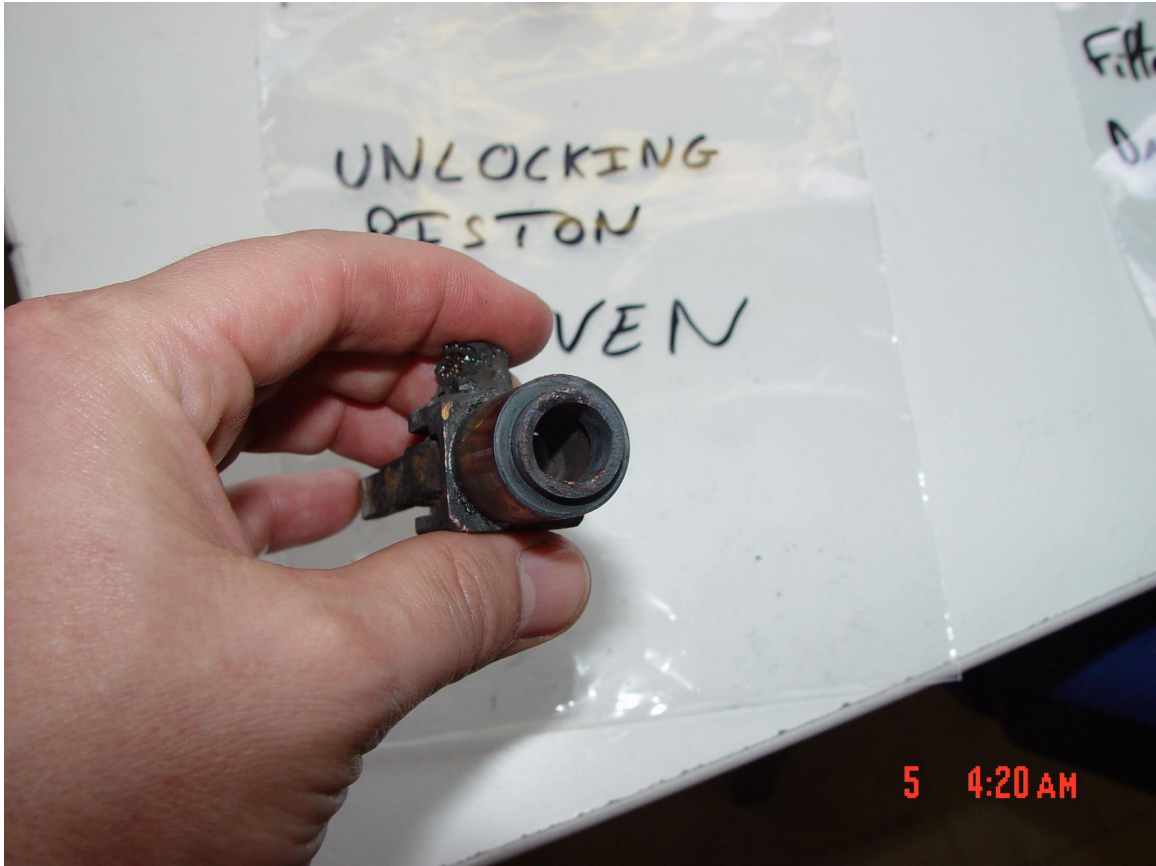
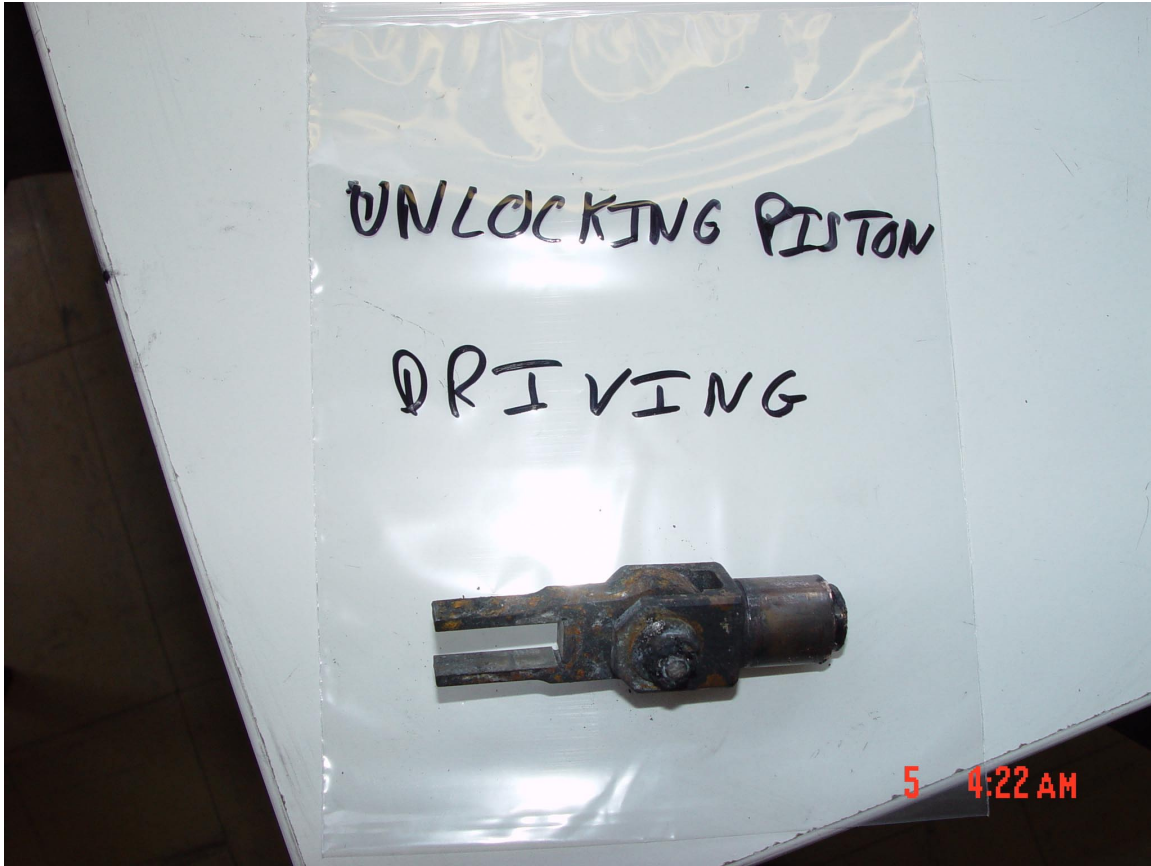
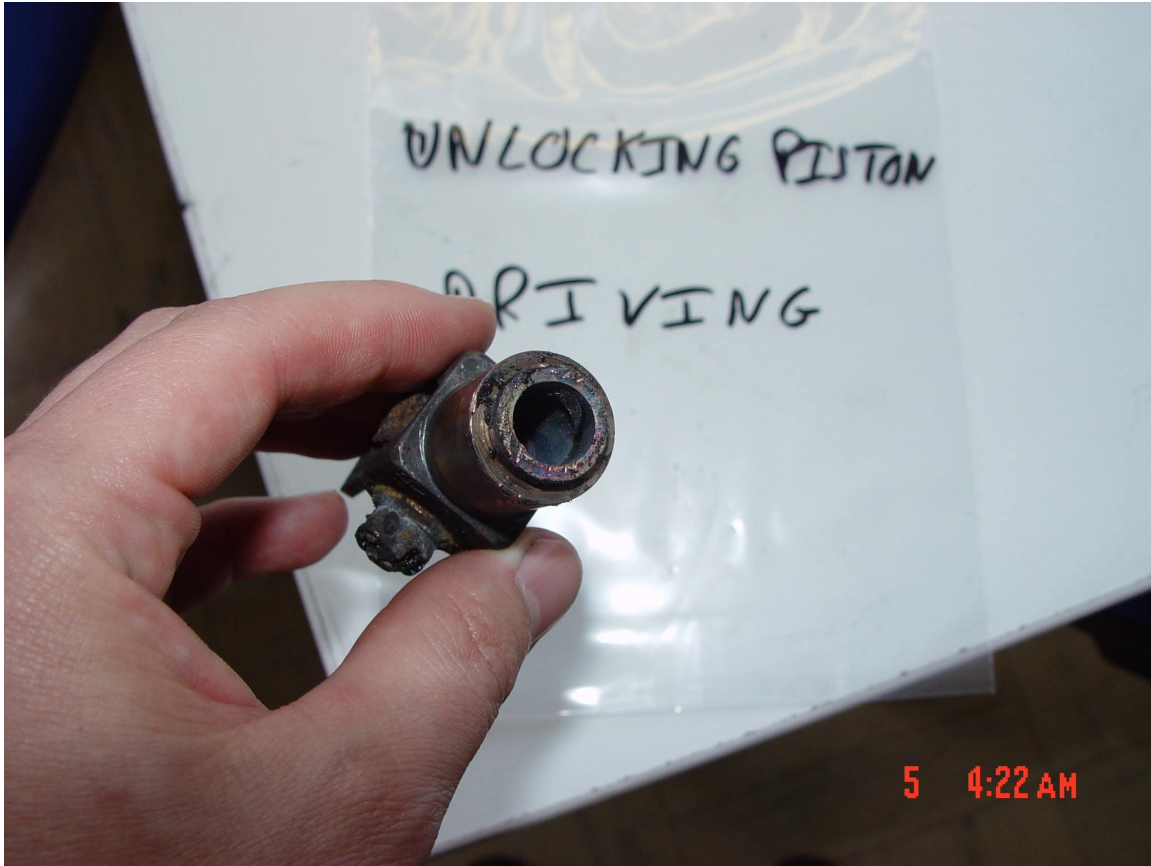
The fork portions of both unlocking pistons were removed (IPL 5-350). They were found to be fractured from the unlocking piston (IPL 5-400), Appendix B, Figures 23 to 26.

Figure 23. Driven Side Unlocking Piston and Fork (fractured).

Figure 24. Driven Side Unlocking Piston and Fork (fractured).

Figure 25. Driving Side Unlocking Piston and Fork (fractured).

Figure 26. Driving Side Unlocking Piston and Fork (fractured).

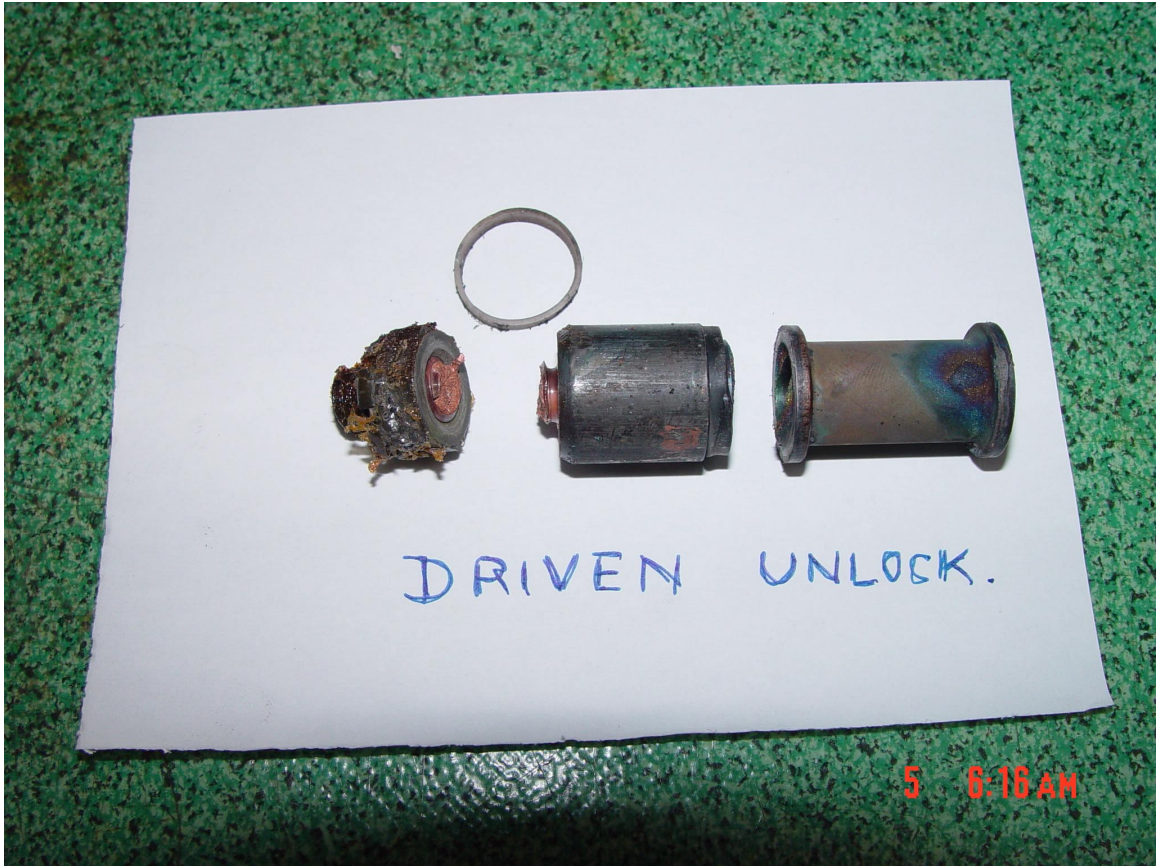
Attempts were made to remove the caps, which cover the unlocking pistons, but the parts were seized and could not be removed (IPL 5-260, 270). The Driven side cap was partially removed by destructive means. The piston segment was removed, Appendix B, Figure 27.

Figure 27. Driven Side Unlock Piston.
