ATTACHMENT 3

Mode 2 – Excessive Terrain Closure Rate Plots

DCA02MA054
FedEx Flight 1478
GPWS Mode 2A - Excessive Terrain Closure Rate (Not In Landing Configuration)

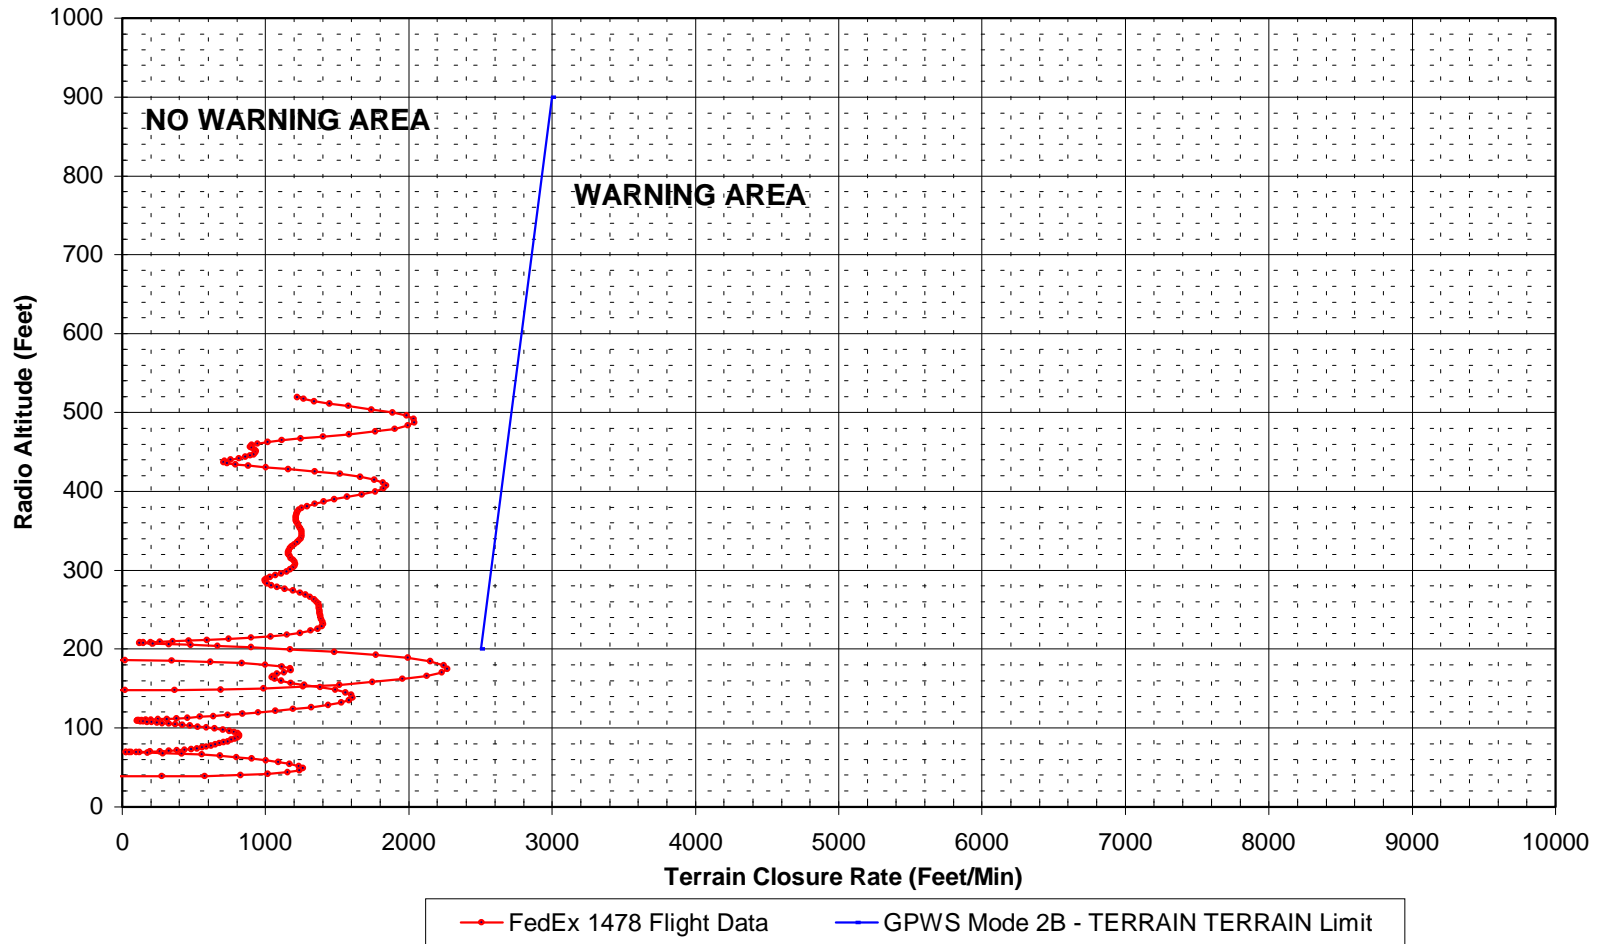
PLOT 3-2

DCA02MA054
FedEx 1478 Flight
GPWS Mode 2B - Excessive Terrain Clearance Rate (Landing Configuration)
