**NATIONAL TRANSPORTATION SAFETY BOARD
OFFICE OF AVIATION SAFETY
WASHINGTON, D.C. 20594**

**ADDENDUM NUMBER 1 TO THE SYSTEMS GROUP CHAIRMAN'S
FACTUAL REPORT OF INVESTIGATION CONCERNING THE ARTIFICIAL
FEEL AND TRIM SYSTEM**

DCA02MA001

Operator: American Airlines
Aircraft: A300-600R
Location: Belle Harbor, New York
Date: November 12, 2001
Time: 09:16 EDT

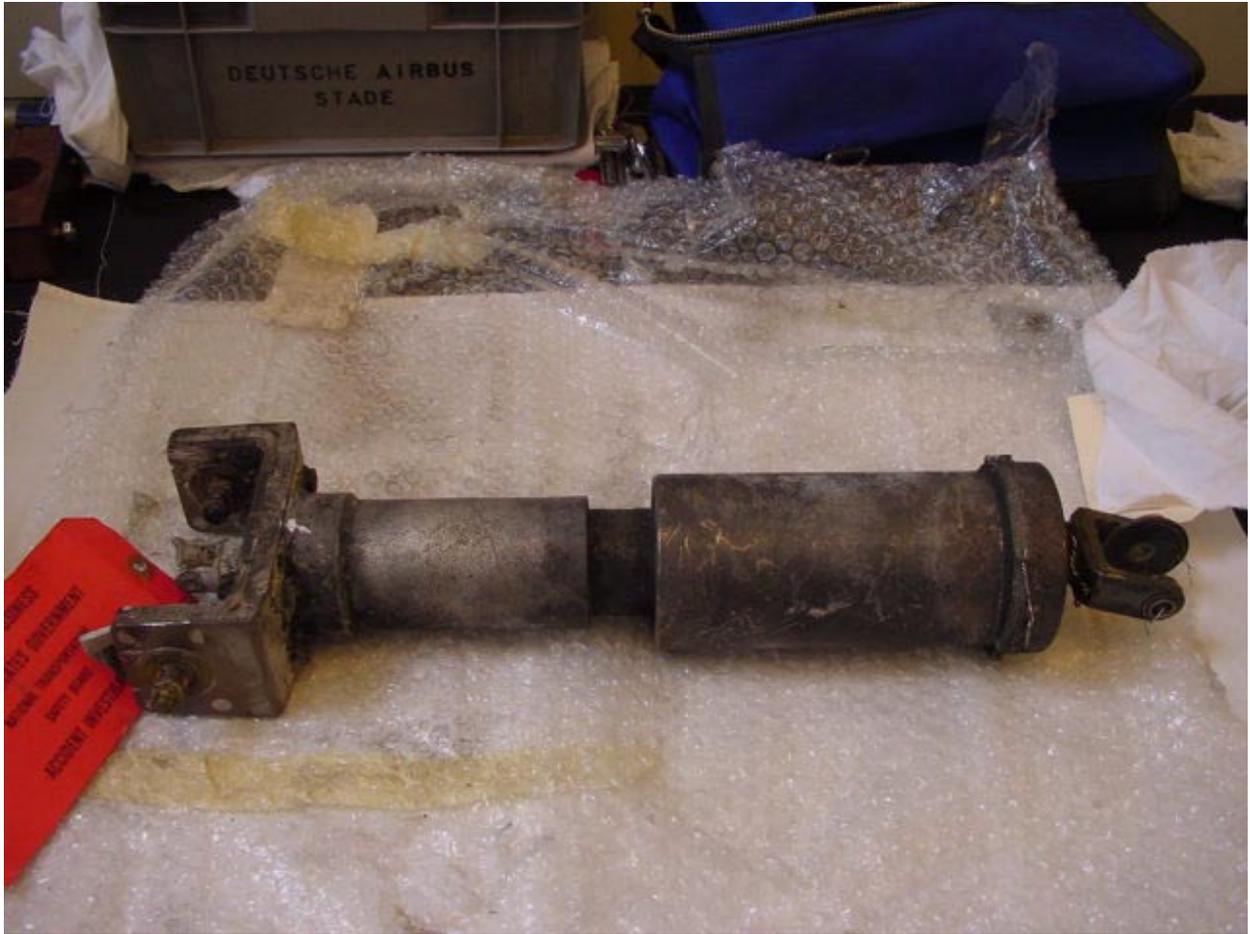
Figure 4. Accident airplane AFTU.

The part was found at the accident site, near other melted components of the rudder differential unit. The AFTU had separated from the lower attachment structure, with small pieces of the structure still attached to the lower fittings. The unit was also found separated from the rudder trim motor, with part of the universal joint still attached to the screwjack splines. The upper attachment point was still attached to the main bellcrank of the control linkage. All externally observable parts of the AFTU were intact (Figure 4). The part had black deposits over the surface. The paint was not present, and there was bare metal in places. A slight side to side freeplay was observed between the spring's housing and the screwjack housing. A slight axial freeplay was also observed. Two digital radiographs of the AFTU are shown in Figure 5. They did not reveal any major damage to the internal parts, except for possibly some deformation of inner sleeve, which retains the springs.

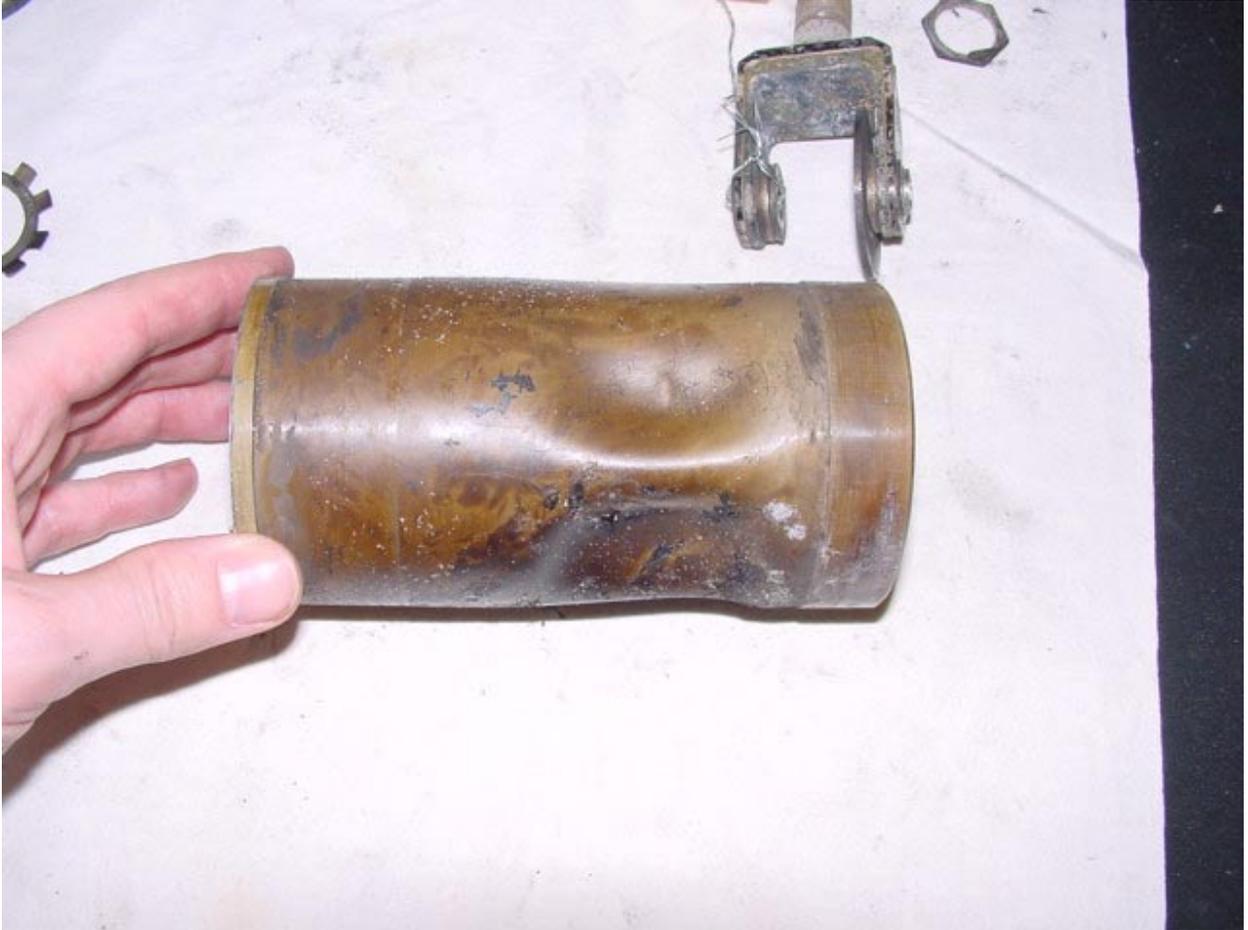
The inner sleeve, made of an aluminum alloy, was collapsed in on the item 190 outer spring. The sleeve was formed to the contour of the spring in some places (Figure 10). This restricted the compression of the outer spring and impeded any motion of the item 160 lower spring guide. The upper spring guide slip rings, made of Teflon, were partially melted. The inner spring was free to be removed from the assembly, but to remove the outer spring it was necessary to cut the inner sleeve.

Figure 10. Deformation of item 210 inner sleeve

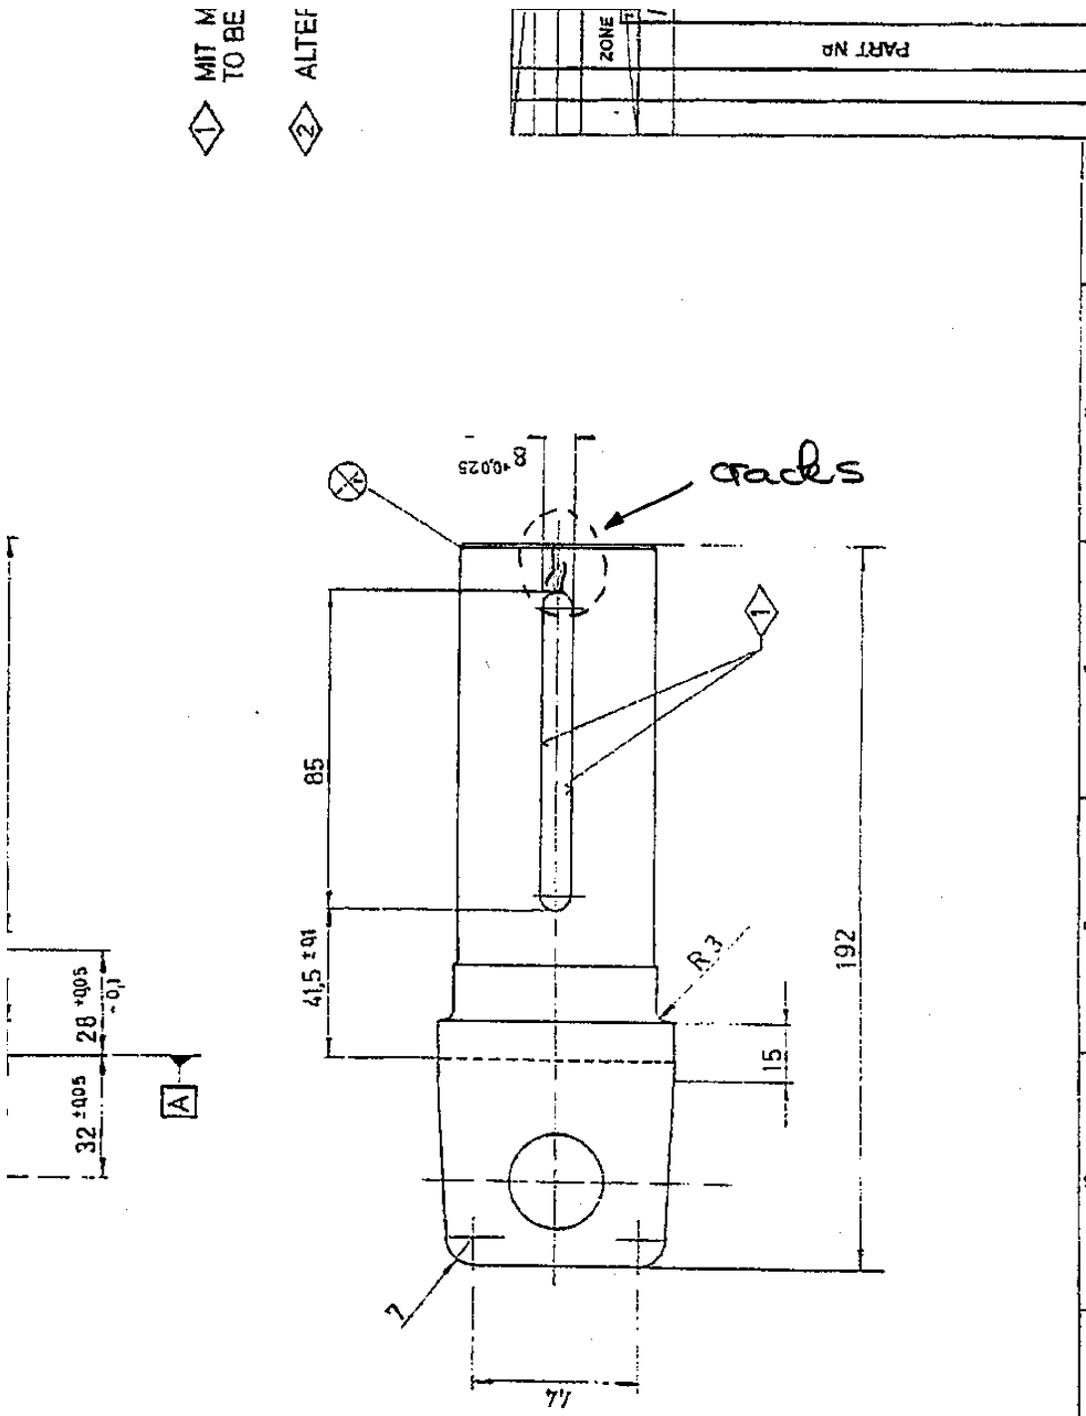
Considerable force was required to rotate and remove the item 10 outer casing from the item 100 fork end fitting. After removal the outer casing appeared to be slightly

ovalized. Two cracks were observed on the fork end fitting. The cracks are illustrated in Figure 11. The cracks appear to have deposits in them.

Figure 11. Cracks in Item 100 Fork End Fitting.
