NATIONAL TRANSPORTATION SAFETY BOARD
Office of Aviation Safety
Washington, DC

**ADDENDUM TO SYSTEMS GROUP CHAIRMAN'S
FACTUAL REPORT OF INVESTIGATION**

A. **ACCIDENT:** NTSB Case No. DCA00MA023

AIRCRAFT: McDonnell Douglas MD-83; N963AS

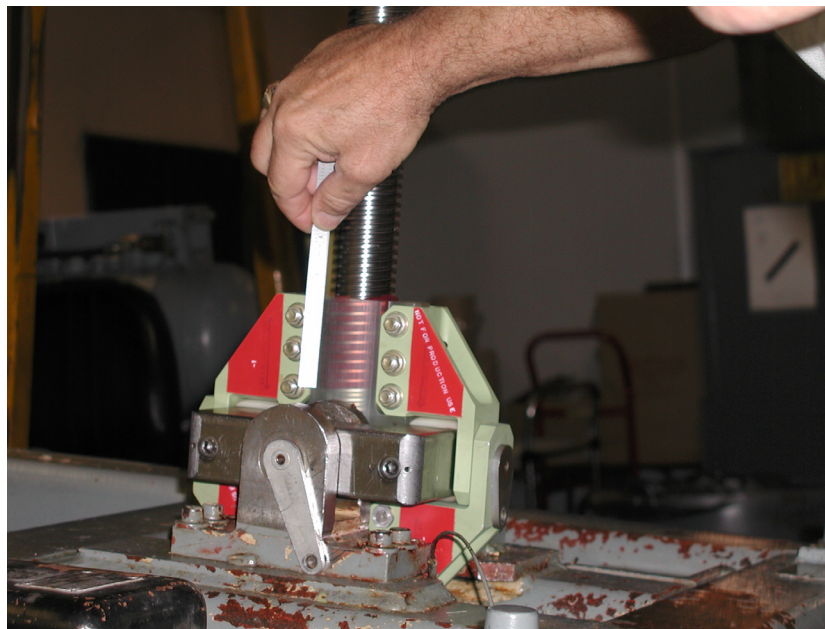
4. Mobile 28 grease after grease was applied into grease fitting until it was seen extruding out the top of the acme nut. Note that grease migrated through less than half the acme nut thread length.

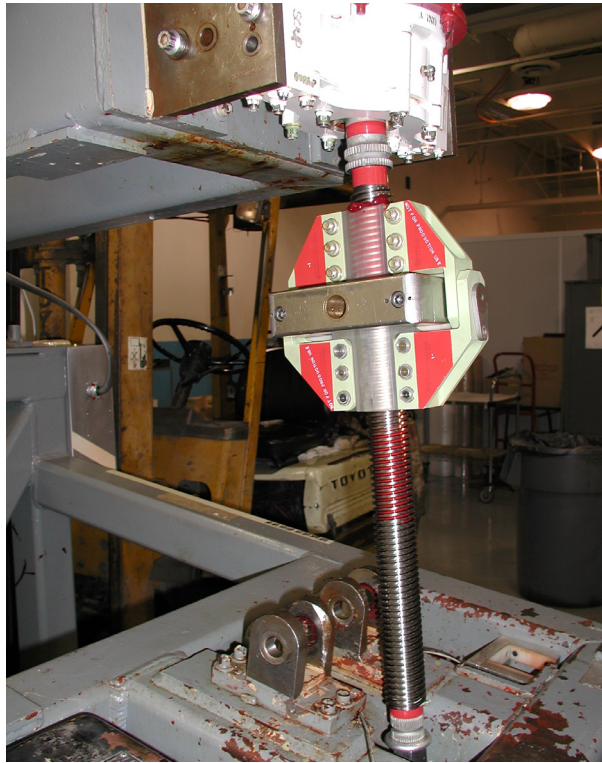
5. View of acme screw after it was cycled once up and down after grease was applied through fitting only. Note areas that are devoid of grease.

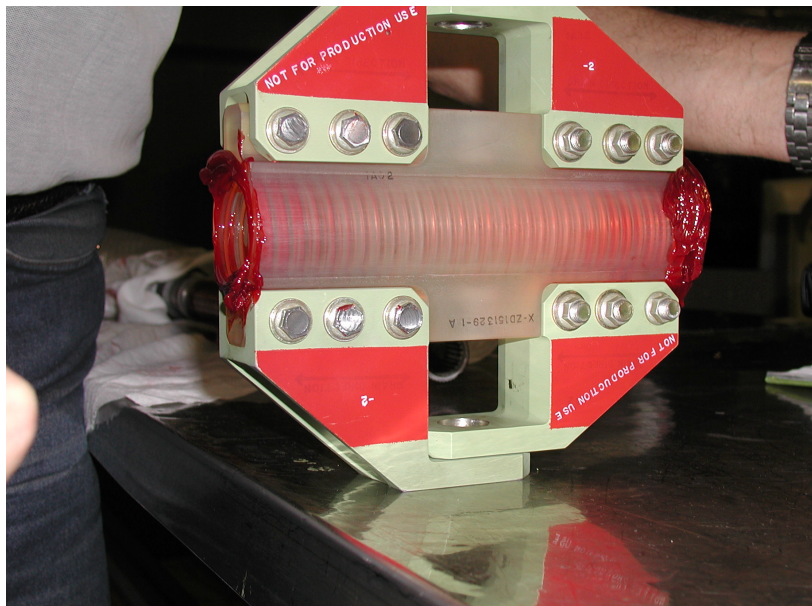
8. View of translucent acme nut after the “butter lube” of acme screw only. Note that entire length of acme nut thread bore shows the presence of grease.

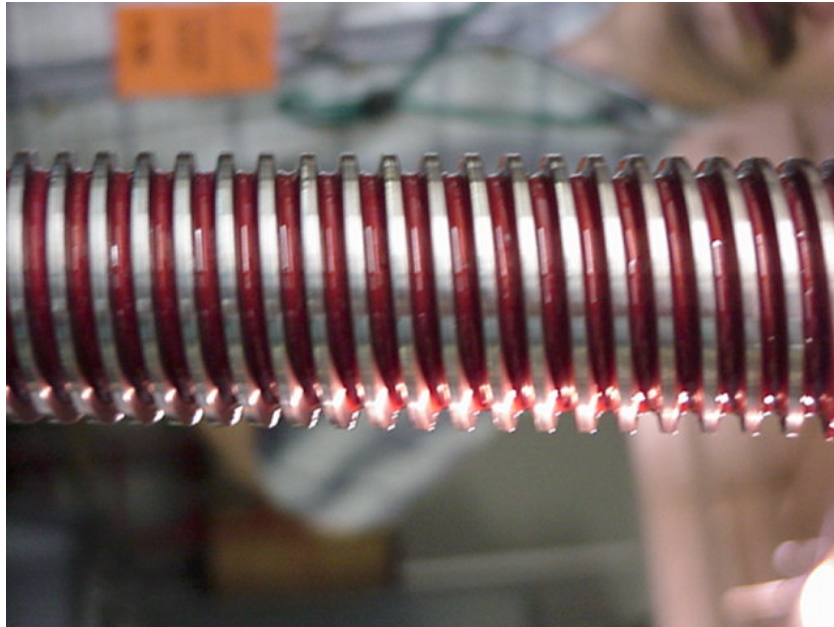
9. Close-up view of acme screw threads after a few cycles of the “butter lube” only. Note that all valleys of threads have grease in them.

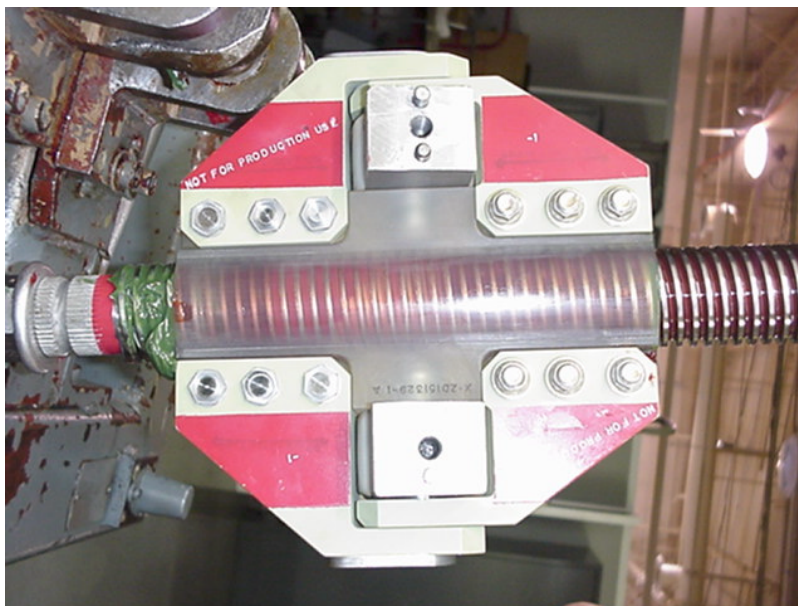
10. View of acme screw and translucent nut after Mobil 28 (red) grease was injected into the acme nut grease fitting, and Aeroshell 33 (green) was used to “butter lube” the acme screw.

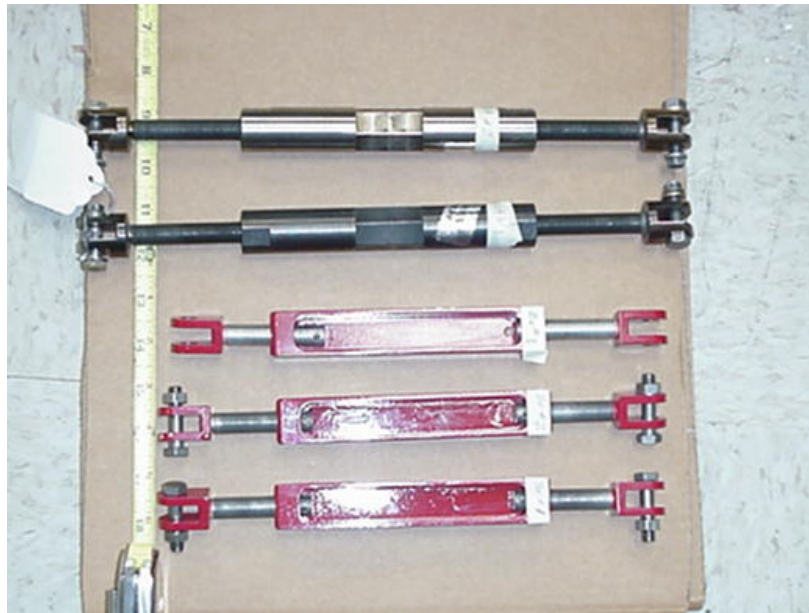
- The "nominal" end-play, with a "nominal" procedure (no variables introduced), was 0.016 inch.²⁷
- An Alaska fabricated tool (no. 0826) was damaged during the test. The damage appeared to be associated with the threads of the tool.²⁸ This was first evident when the measured end-play was less than the “nominal” end-play of 0.016-inch that was known to the Group. It was also evident by the zero endplay reading with 300 in-lbs of applied torque. This was the third known failure of an Alaska-fabricated restraining fixture tool since the accident.²⁹

12. View of the 2 Alaska Airlines fabricated restraining fixture tools (top) and the 3 Boeing restraining fixture tools used during the Huntington Beach Laboratory Force Output tests. Note the difference in length, shape, and configuration between the two types of tools.

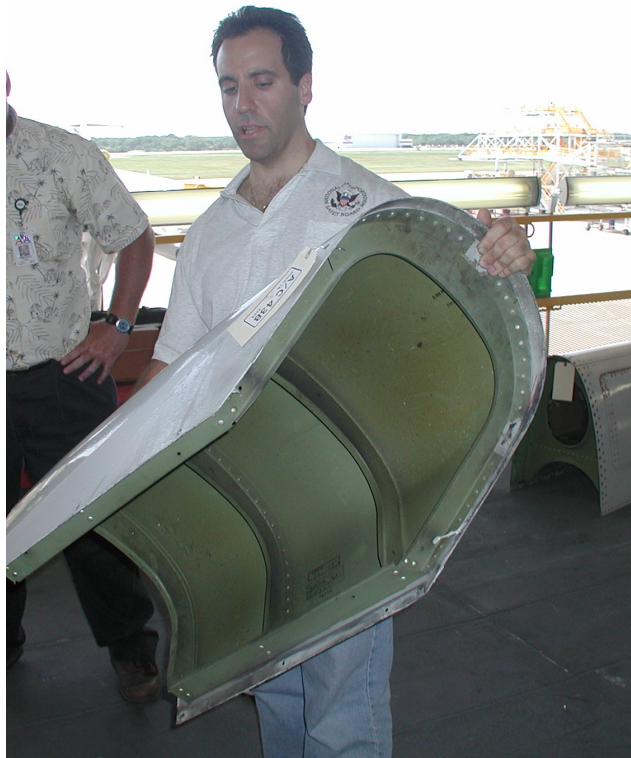
16. NTSB Systems Group Chairman holding an MD-80 “dog house” that fits on top of the vertical stabilizer. The dog house from the accident airplane was missing from the tail assembly and never recovered.

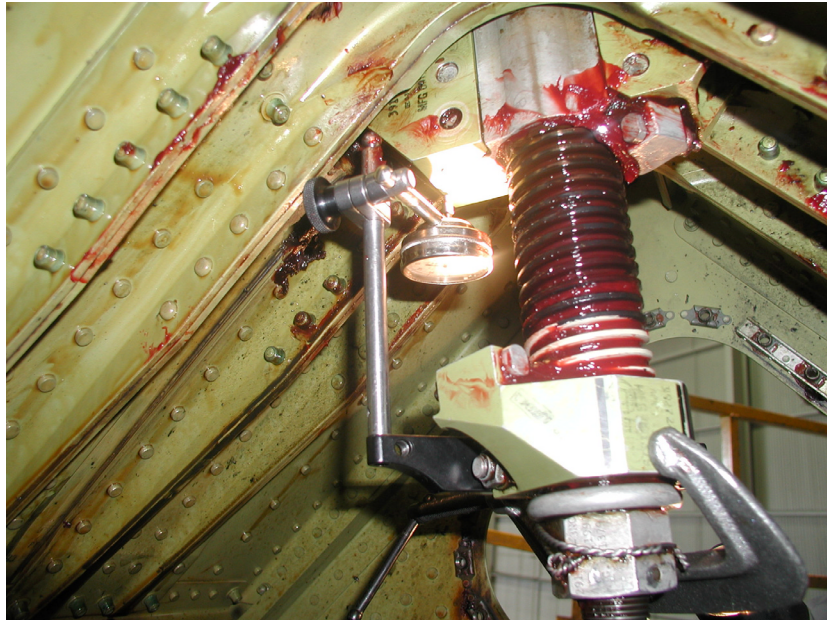
- Contact between the dial indicator clamp/brackets and aircraft structure.
 - Incorrect nulling and improper indicator number subtraction.
 - Rotation of the jackscrew can cause higher endplay readings, by about 0.003 to 0.004" (vertical plunger).

- Moving the indicator plunger further away from the jackscrew caused slightly higher endplay readings, by about 0.0005 to 0.001 inch.

- Placing the dial indicator plunger on the acme nut stop lug resulted in lower endplay readings by 0.003 inch when the jackscrew was unrestrained and rotated. When the jackscrew was restrained, no appreciable difference was noted.

17. Close-up view of a typical dial indicator set-up for endplay checks performed at Tulsa. Note close proximity of mounting hardware to structure, orientation of the dial indicator face, size of the access hole, and the attachment of the C-clamp to the lower stop.

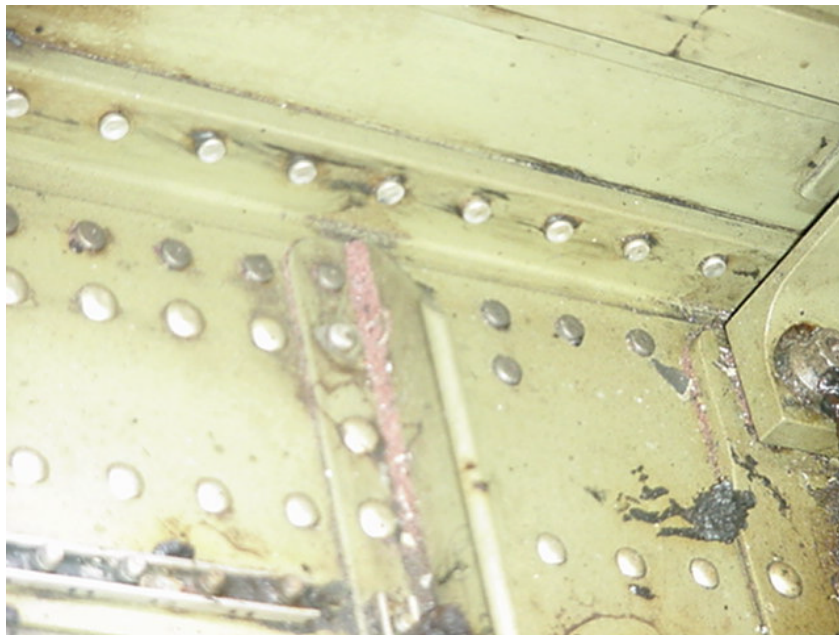
The assembly was sent to the NTSB Materials Laboratory for detailed examination by the Materials Group. NTSB Materials Laboratory Factual Report No. 01-082, dated September 24, 2001, was completed.⁴⁵ According to the report, evidence of pink-colored grit material was found inside the acme nut grease fitting.

18. View of interior of the vertical stabilizer of a Hawaiian Airlines DC-9. This view shows the area just beneath the jackscrew assembly. Note pink granular material.
