ANALYTICAL ENGINEERING REPORT

AIRPLANE 17

SUBJECT: Analysis of Contaminants on BACC45FT Connectors

**Honeywell 757 Fuel Tank Compensator
(Failure Analysis)**

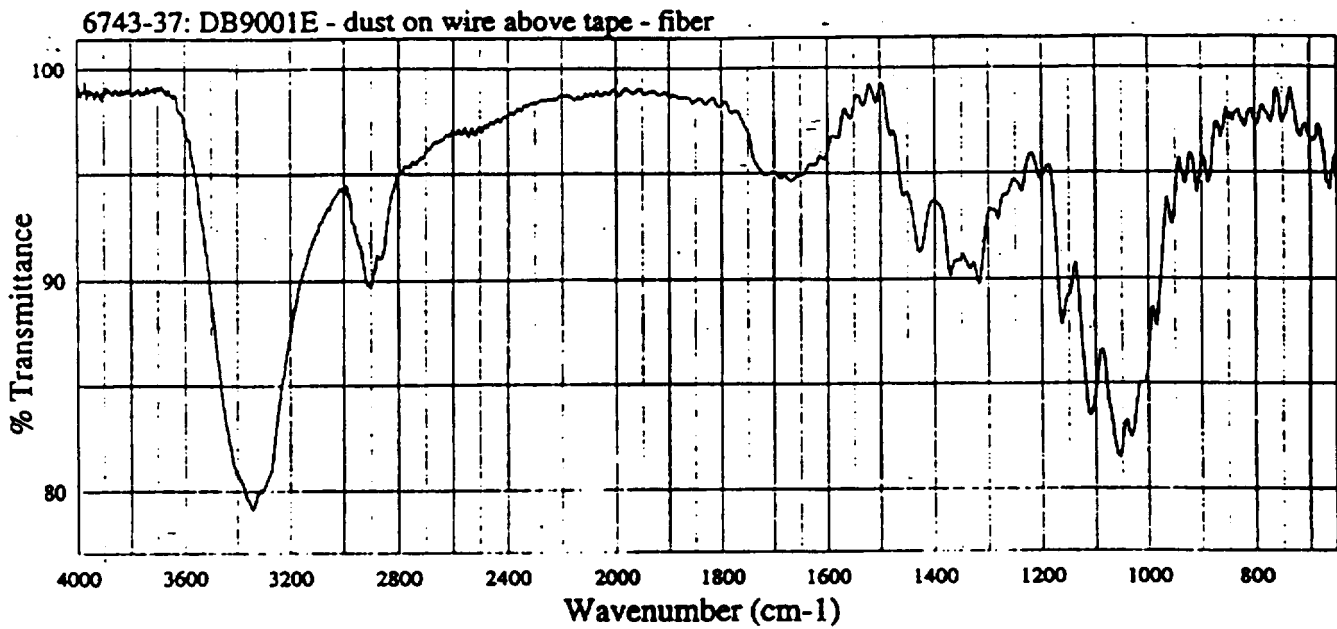
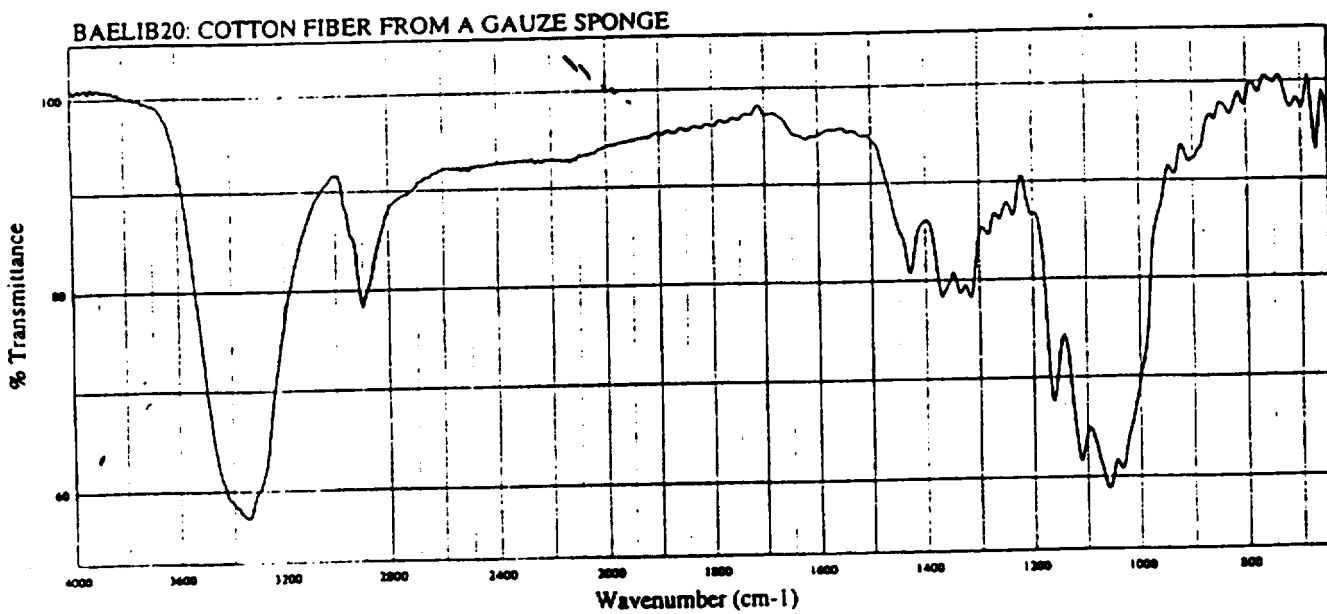
The contaminants on DB9001E connector, shown in Figure 2, were found to be consistent with environmental debris (i.e., dust and dirt). Specifically, the presence of cellulose fibers was identified by infrared spectroscopy (see Figure 12). Electron microprobe elemental analysis detected the presence

Figure 12. Infrared transmission spectra: (A) contaminant on DB9001E connector and (B) reference spectrum of cellulose, specifically a cotton fiber.

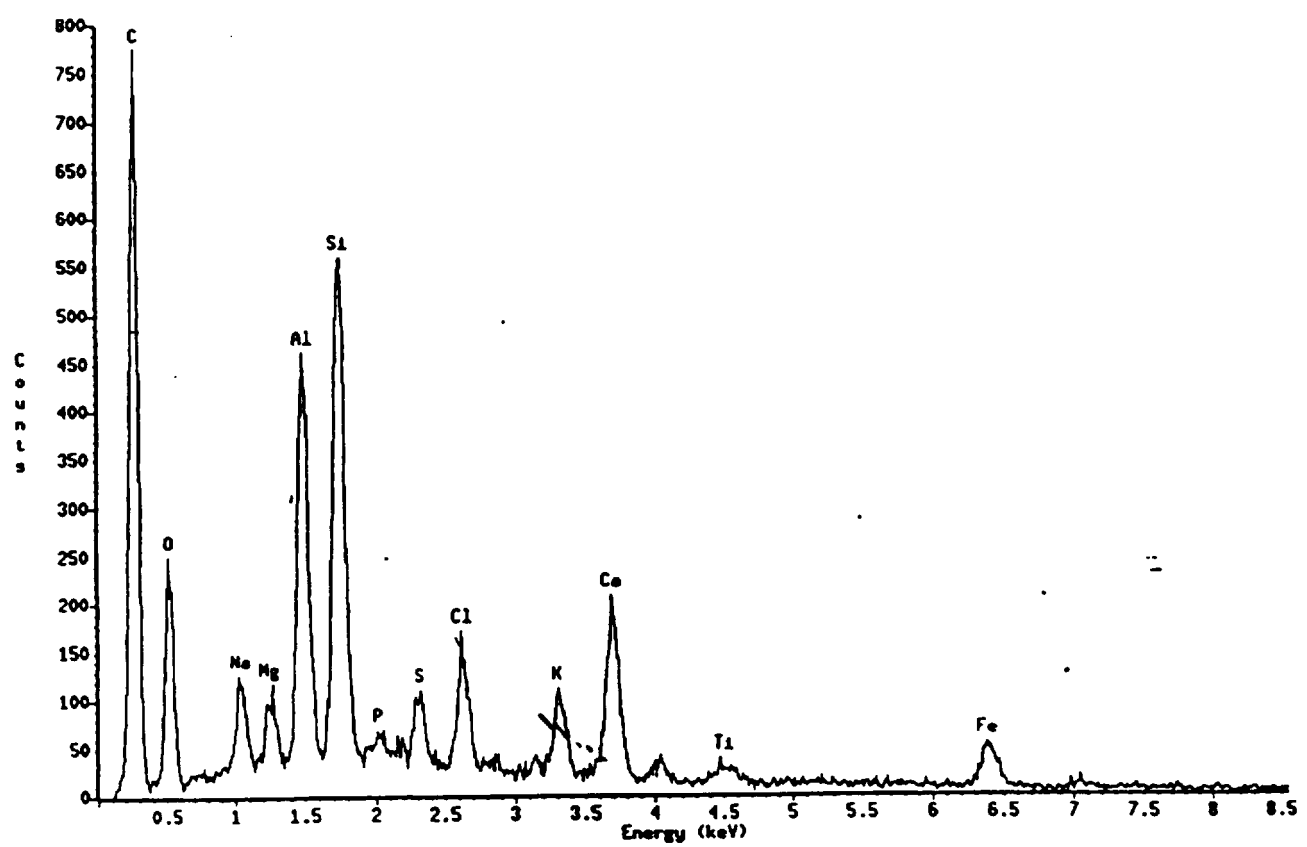
of the following elements: carbon, silicon, aluminum, oxygen, calcium, chlorine, sodium, magnesium, sulfur, potassium, phosphorus, iron and titanium (see Figure 13).

Figure 13. Electron microprobe elemental survey of contaminant on buildup tape beneath clamp on DB9001E connector.

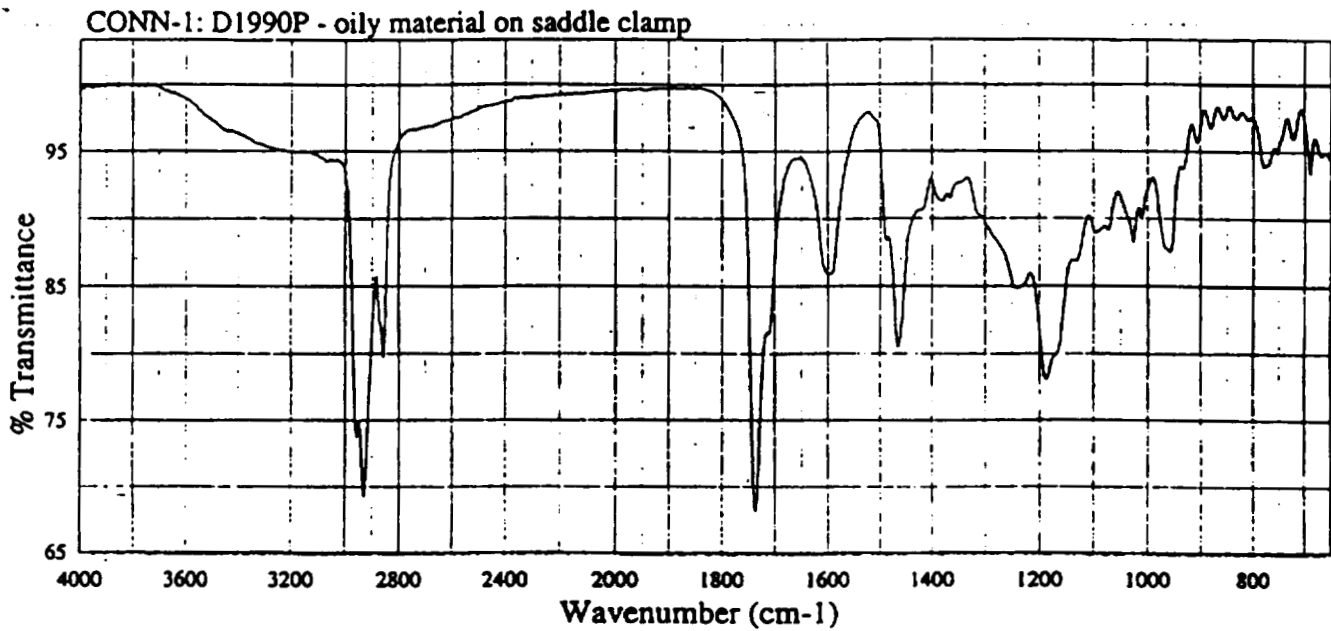
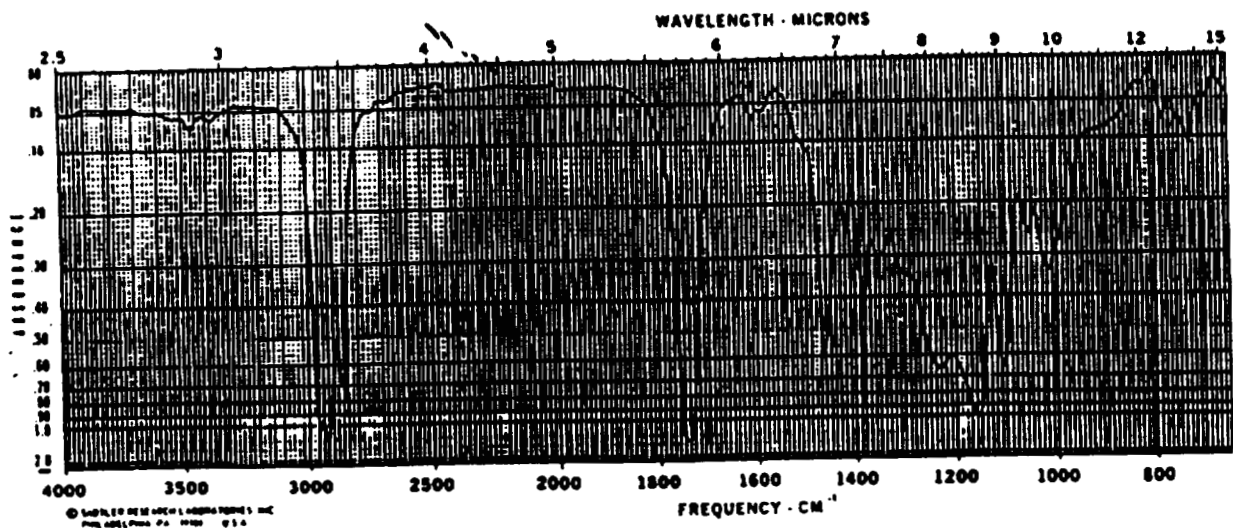
Oily contaminant on the saddle clamp of D1990 connector (see Figure 4) was separable into an MEK-soluble fraction and an MEK-insoluble fraction. The MEK-soluble fraction was identified as an ester oil, based on the infrared spectrum (refer to Figure 14 for the sample spectrum and a reference spectrum). The MEK-insoluble fraction was found to contain cellulosic debris, similar to that discussed above. Small crystals were found on the surface of the buildup tape. The infrared spectra of these crystals shows good spectral agreement to a reference spectrum of azelaic acid, as shown in Figure 15. In addition to the separate samples of ester oil and azelaic acid, mixtures of oil and acid were also observed (see spectrum of this type of mixture in Figure 16). The oil is identified by the presence of the ester carbonyl peak at 1740 wavenumbers and comparison to reference spectra of engine oils. The acid is identified by the presence of the acid carbonyl relaxation at 1700 wavenumbers. Electron microprobe analysis results were similar to those of the DB9001E connector.

Figure 14. Infrared transmittance spectra: (A) oily contaminant on saddle clamp of D1990P connector and (B) reference spectrum of an ester oil, specifically MIL-L-23699 (Sadtler Research Laboratories, Inc.).

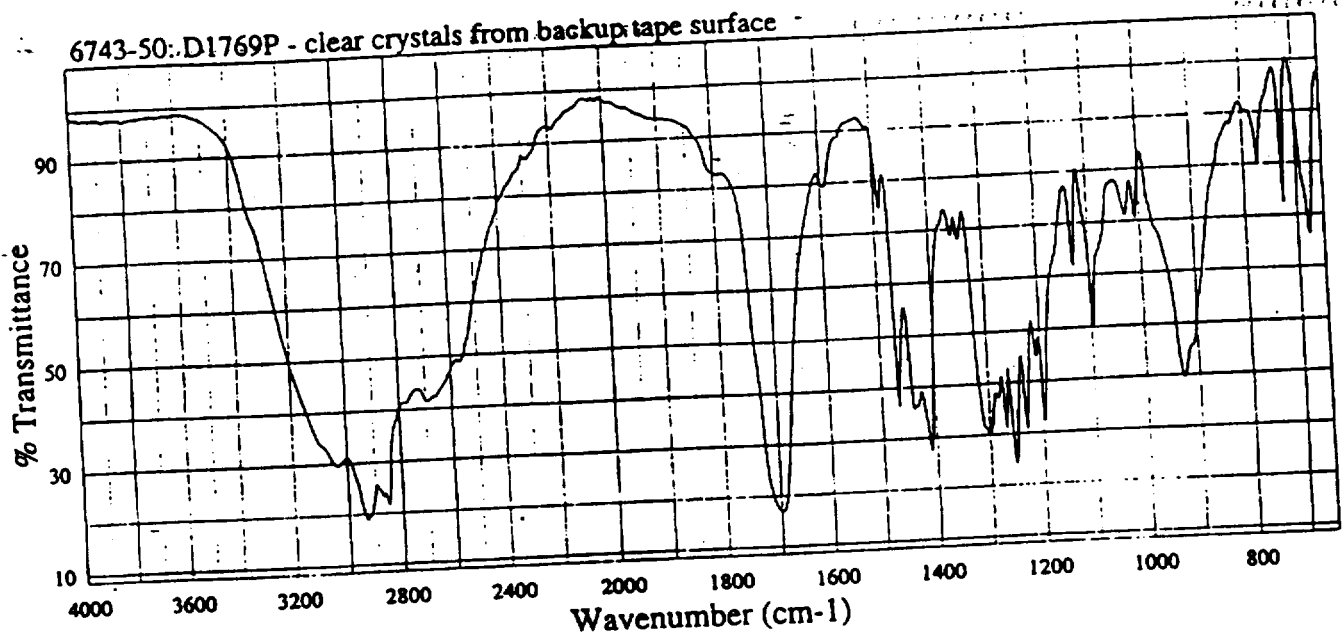
Engine turbine oils (such as MIL-L 23699 or MIL-L-7808) and ester greases are known to degrade to form azelaic acid and an alcohol. The alcohol generally evaporates leaving the azelaic acid behind to form crystals. A sample of the crystals from connector D1769P was dissolved in hot water to allow separation from any remaining oil, and then recrystallized upon cooling of the water. The water/crystal mixture was allowed to dry overnight and then the melting point of the crystals was measured using differential scanning calorimetry (DSC). Pure azelaic acid has a melting point of 106 °C (reference: Merck Index, Twelfth Edition. Merck & Co., Inc., 1996). The measured melting point of the crystals from the connector was 102 °C (see DSC scan in Figure 17. The similarity in the melting point of the sample compared to pure azelaic acid (102 °C compared to 106 °C) confirms the identity of the contaminant as azelaic acid. It is expected that the sample from the connector would have a slightly lowered melting point since it was not a pure sample.

Figure 15. Infrared transmittance spectra: (A) clear crystals from buildup tape surface and (B) reference spectrum of azelaic acid (Federation of Societies for Coatings Technology).

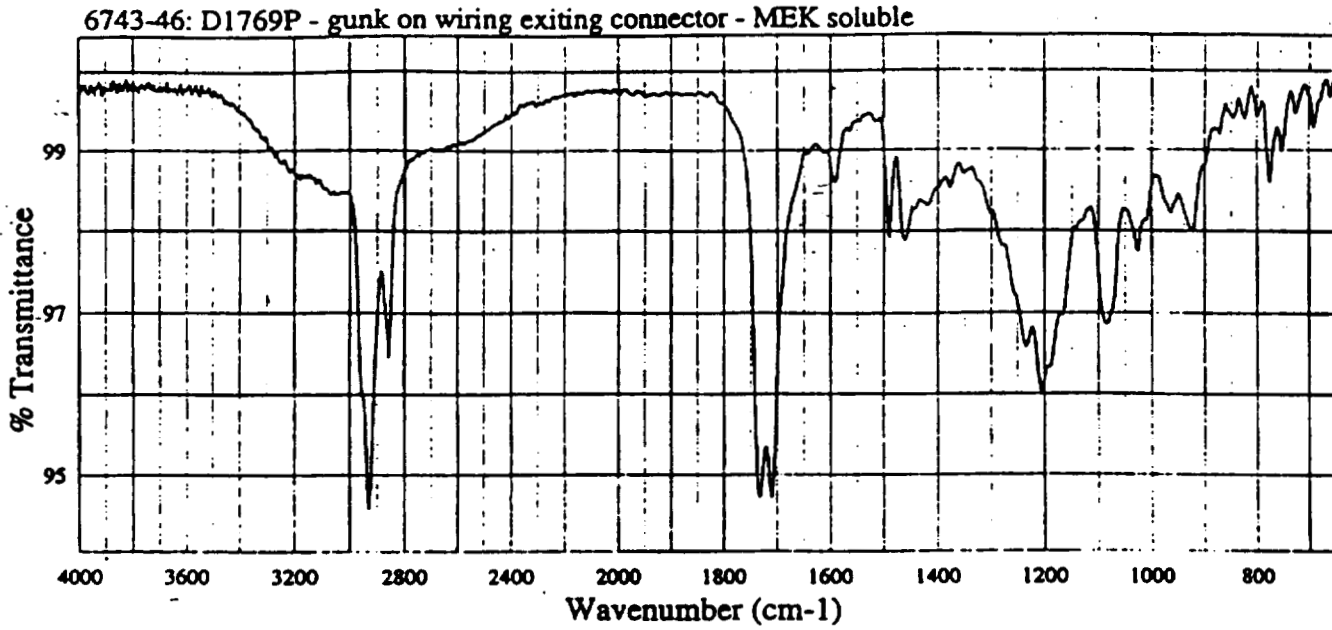
The D1769P connector was also found to have environmental debris (cellulosic debris and dust/dirt on the wires above the buildup tape, as shown in Figure 9). A mixture of ester oil and acid was identified on the wires exiting the connector. The contaminant on the buildup tape, shown in Figures 10 and 11, was identified as primarily azelaic acid. This connector had the largest quantity of contamination of the four connectors analyzed.

Figure 16. Infrared transmittance spectra of contaminant on wiring exiting a connector showing a mixture of ester oil and acid.

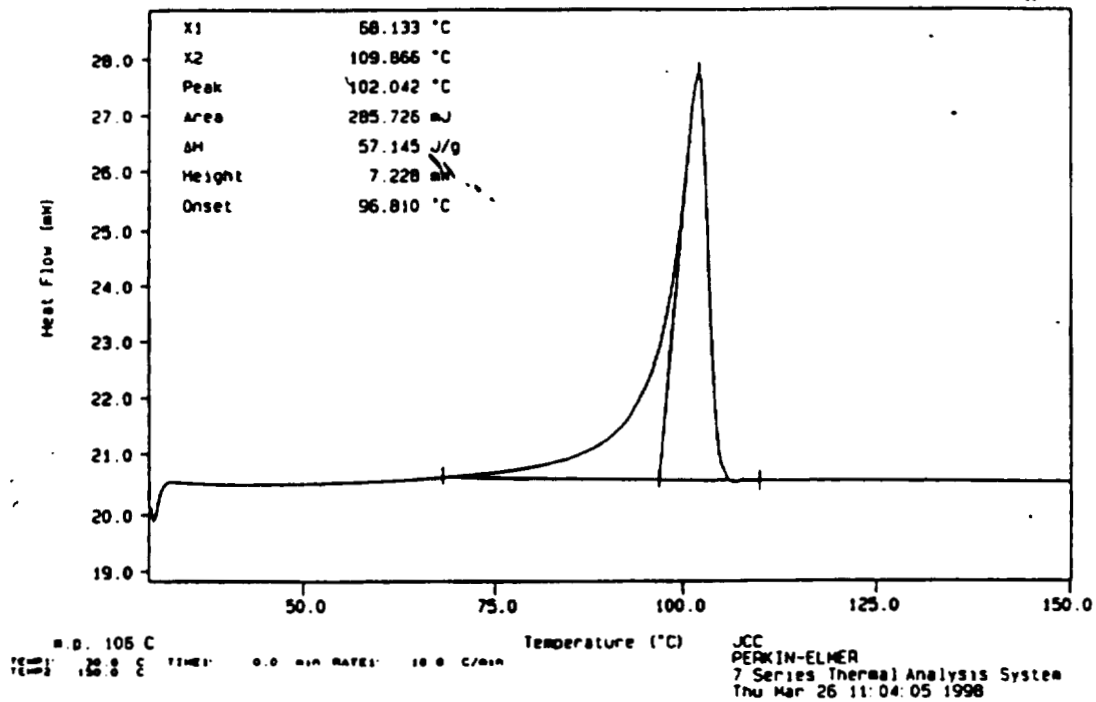
Figure 17. DSC scan of crystals from D1769P connector.

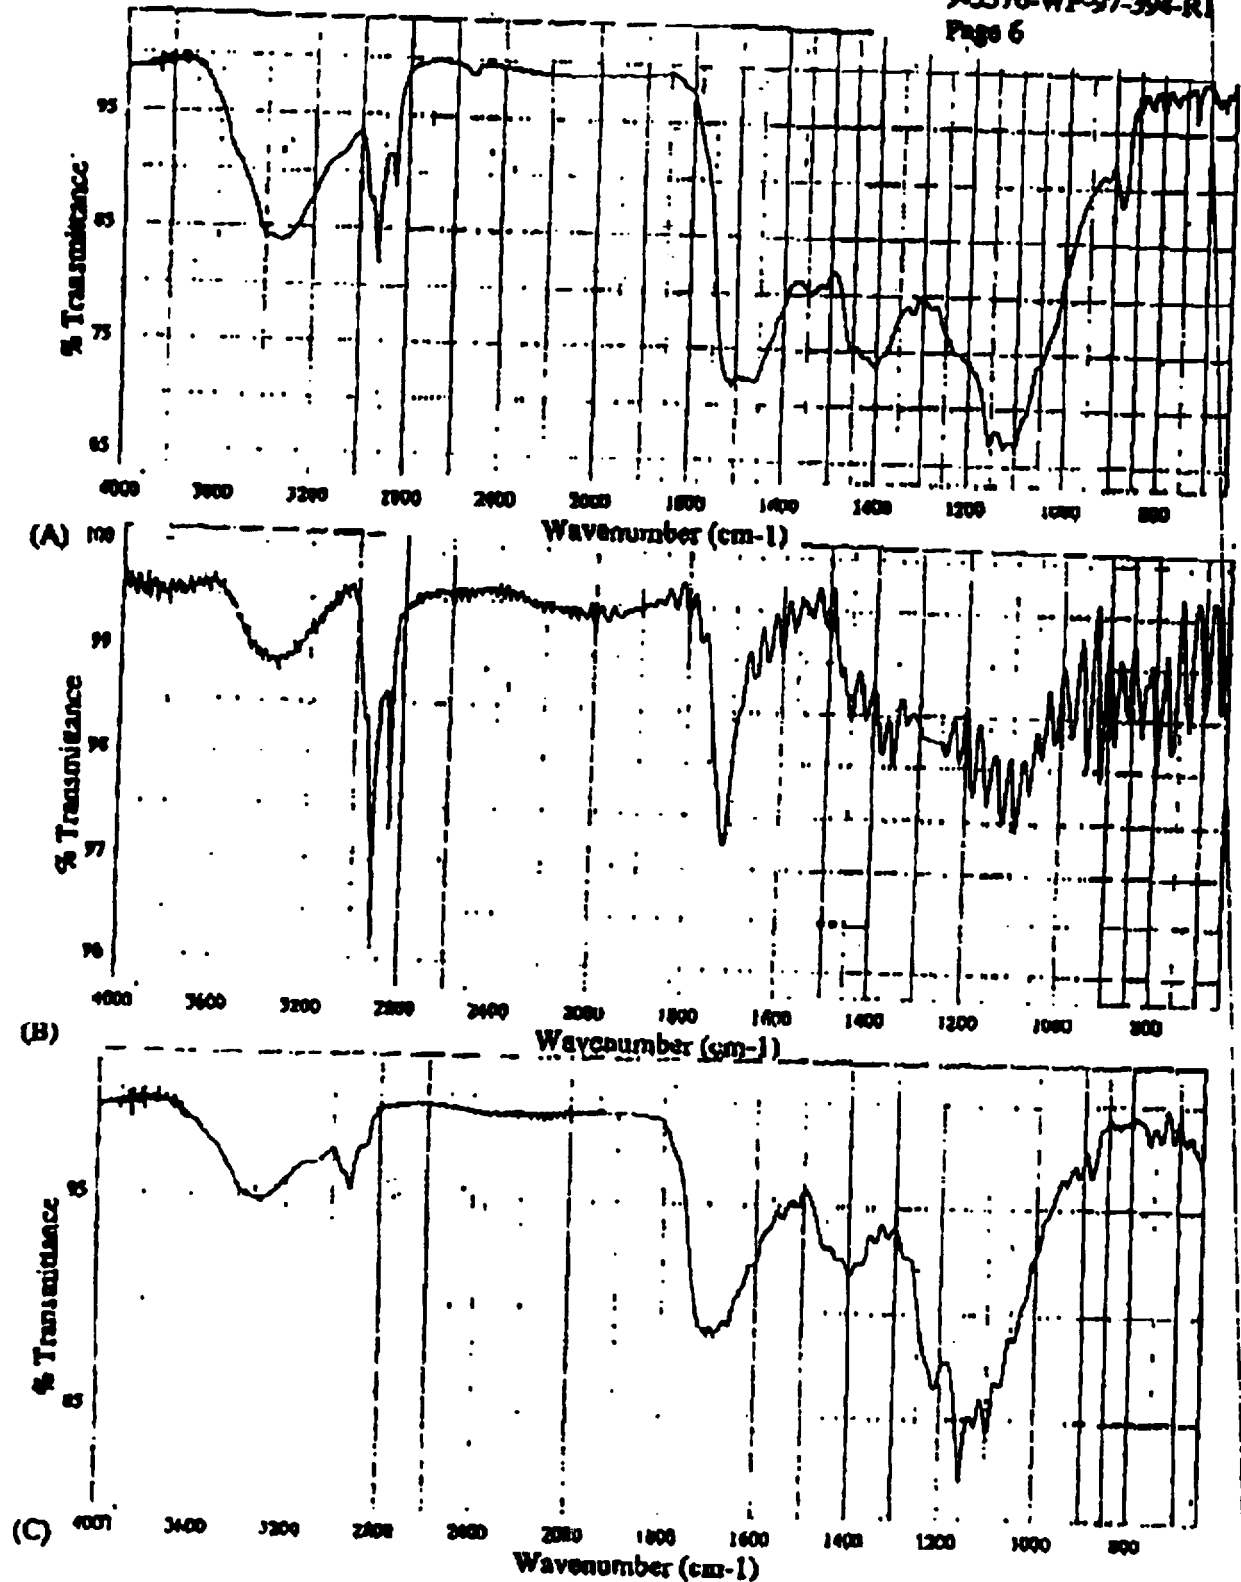
The dark deposit lifted from the surface of one of the wires was found to be separable into an MEK-soluble fraction and an MEK-insoluble fraction. Infrared transmittance spectra of these materials are shown in Figure 4. The peaks in the 3000 to 2800-wavenumber range are associated with -C-H stretching, suggesting the presence of an organic material, possibly lubricant or corrosion inhibiting

Figure 4. Infrared transmittance spectra: (A) dark deposit on wire above taps, (B) MEK-soluble fraction and (C) MEK-insoluble fraction.

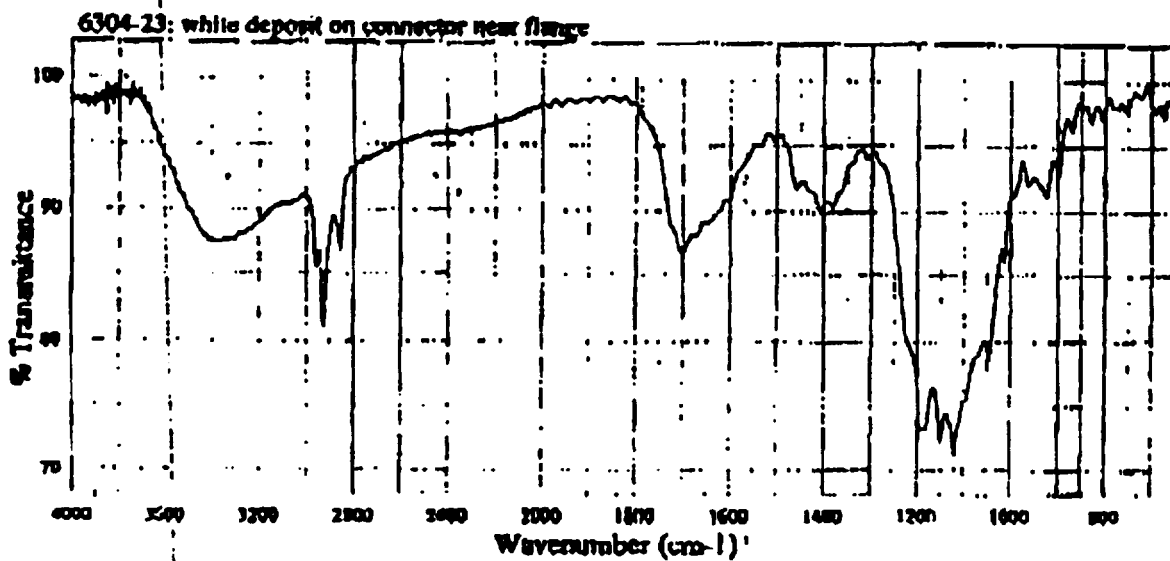
Figure 5. Infrared transmittance spectrum of light deposit on connector.

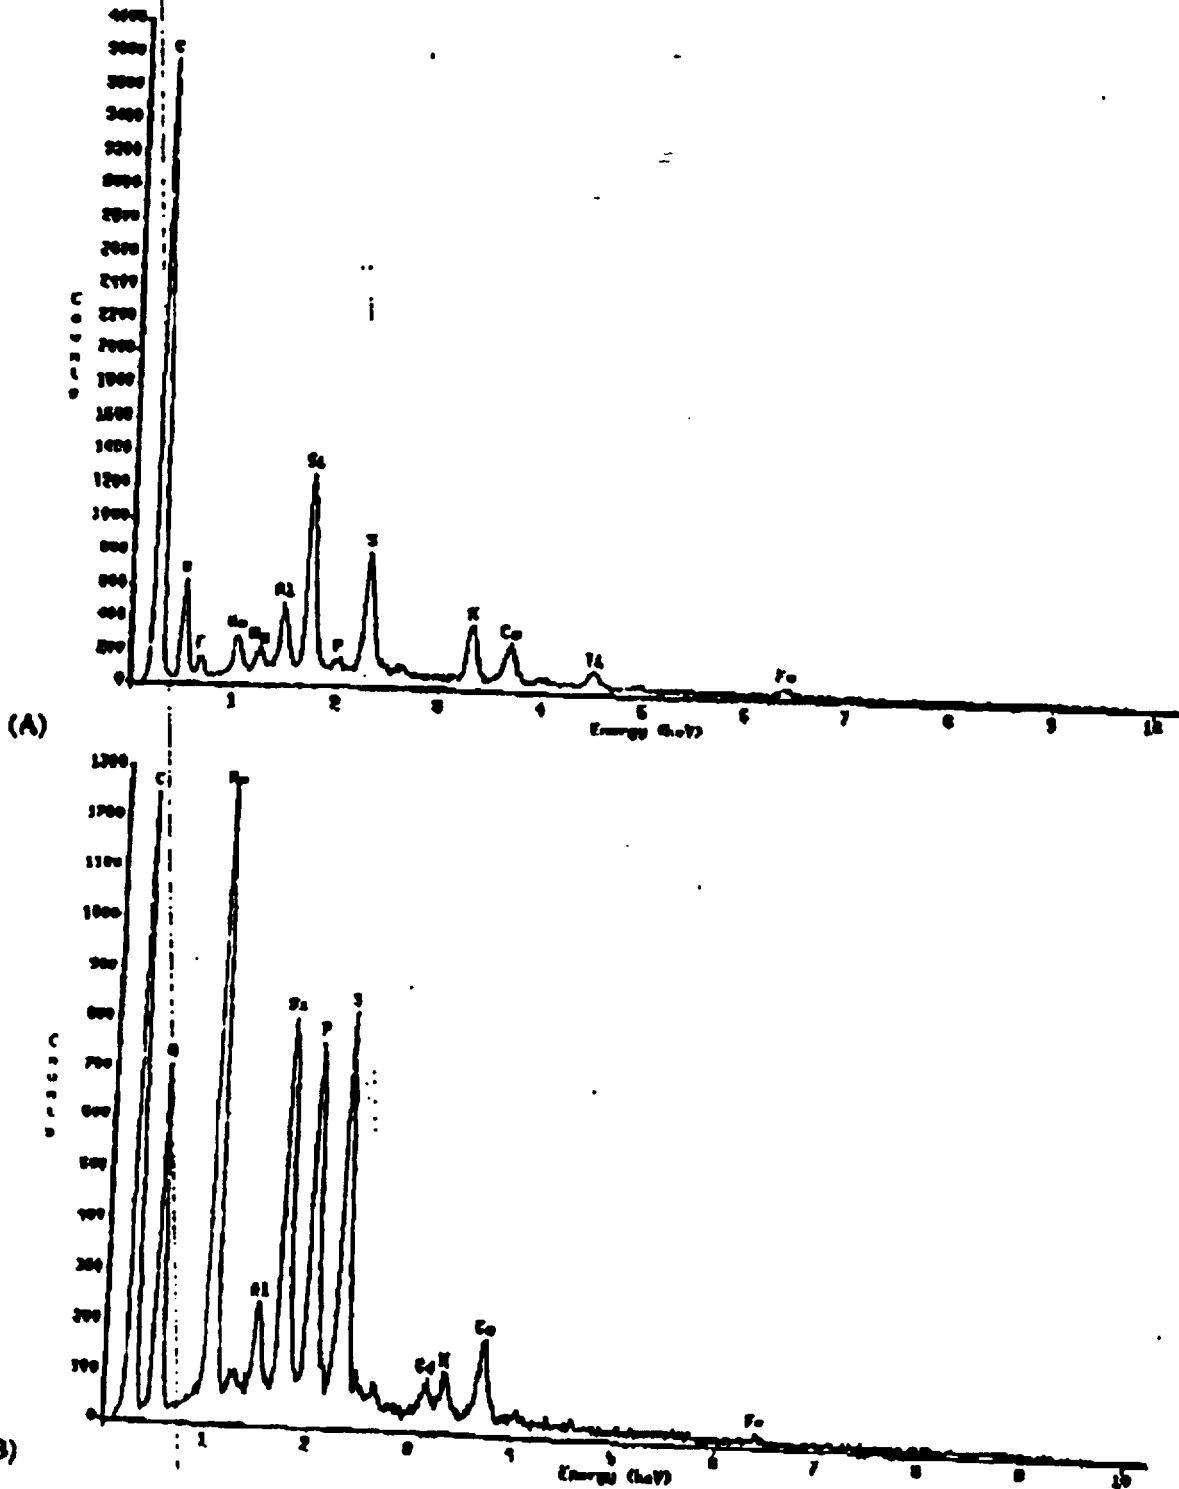
Representative electron microprobe elemental surveys of the deposits are shown in Figure 6. The following elements were detected in the dark deposit from the wires: carbon, silicon, sulfur, oxygen, potassium, with smaller quantities of calcium, aluminum, sodium, magnesium, titanium, manganese and iron. The light deposit on the connector was found to contain carbon, sodium, silicon, phosphorus, sulfur, oxygen and smaller quantities of aluminum, calcium, cadmium, potassium and iron.

Figure 6. Electron microprobe elemental surveys : (A) dark deposit on wire and (B) light deposit on connector.

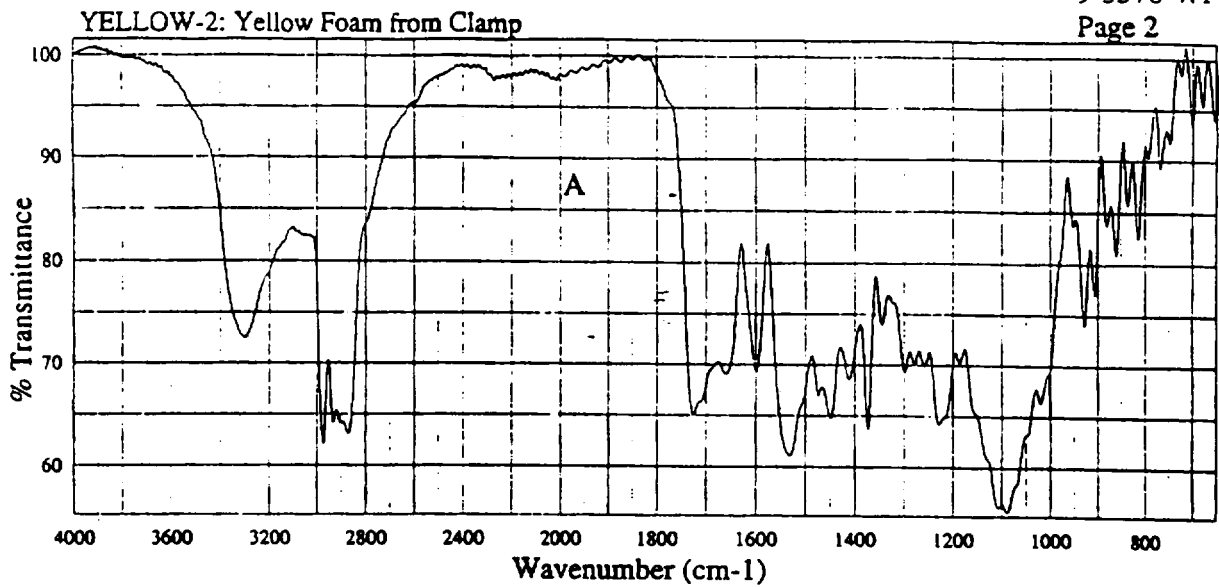
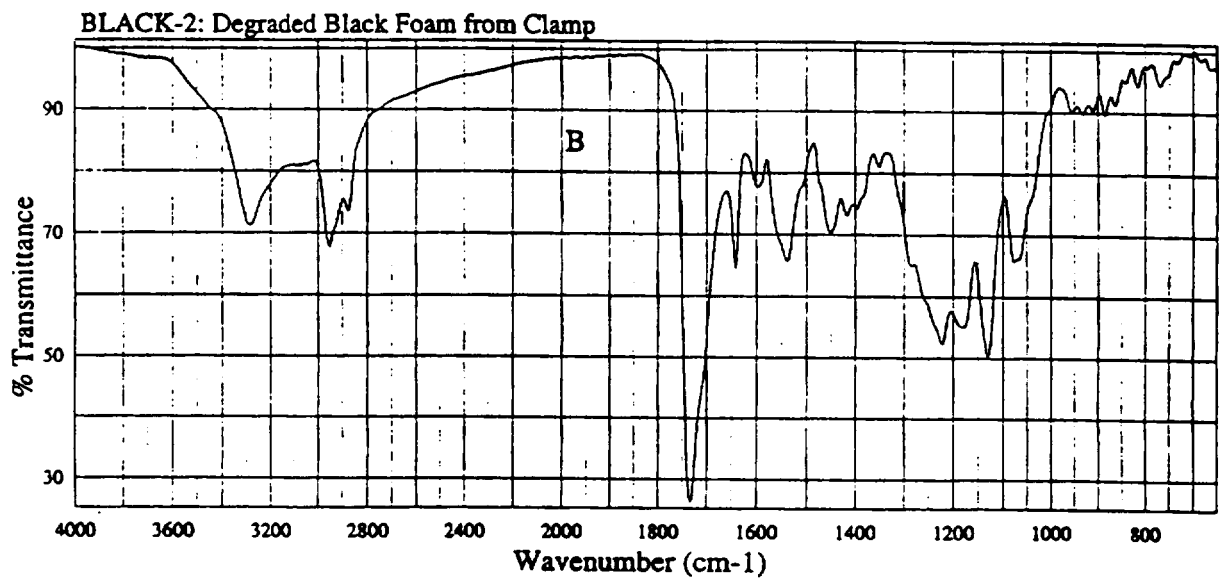
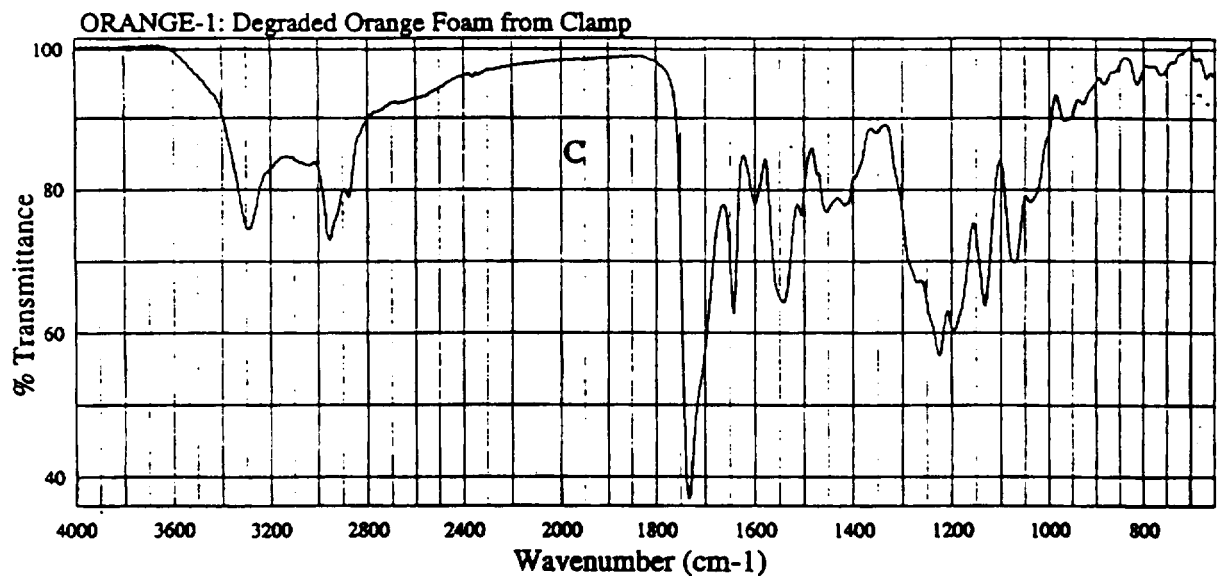
Figure 1. Infrared spectra of (A) the non-deteriorated yellow foam, (B) the degraded black pad and (C) the degraded orange pad. The absorption near 1540 wavenumbers in each of the three spectra is characteristic of polyurethane. The strong band near 1100 wavenumbers in (A), which is absent in (B) and (C), is due to the ether linkage in the yellow foam.
