NATIONAL TRANSPORTATION SAFETY BOARD
Office of Aviation Safety
Washington, D.C. 20594

SYSTEMS GROUP CHAIRMAN FACTUAL REPORT ADDENDUM
FOR AIRCRAFT WIRE INSPECTIONS AND HISTORICAL REPORTS

A. ACCIDENT: DCA96MA070

Airplane : Boeing 747-131, N93119
Operated as Trans World Airlines (TWA) Flight 800

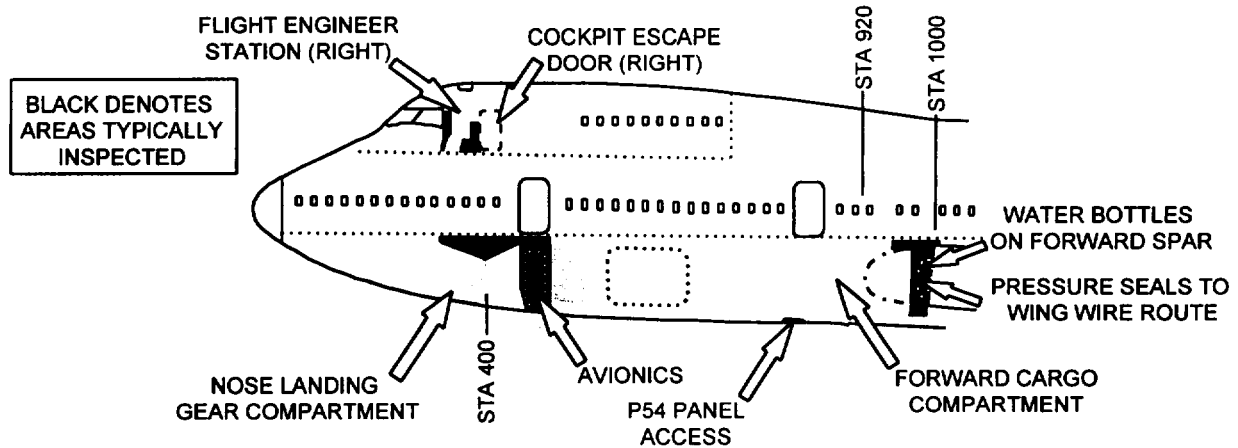
Illustration 1. Boeing 747 Inspected Areas⁶

The majority of airplanes inspected were B-747 models and the same general areas were inspected in each (when accessible). The black areas in the following graphic show the areas, which are located forward of the wing spar, in the Main Equipment Center⁵ (E/E), and behind the cockpit flight engineer station. The group inspected inside cockpit circuit breaker (C/B) panels when available. The group inspected the E/E located beneath the cockpits of other transport airplane models, as well as other areas. The list of airplanes that follows is sorted by age, with the newest airplanes first.
