APPENDIX J

Rudder Servo Control Hydraulic Fluid Sample Analysis

INVESTIGATION REPORT

37 – IP – 02
OT 4459**Subject of investigation :** AIRBUS A300-600 registered N 14053. Analysis of hydraulic fluid.**Références :** Request n° 06/2002 of 04/03/2002 by the BEA

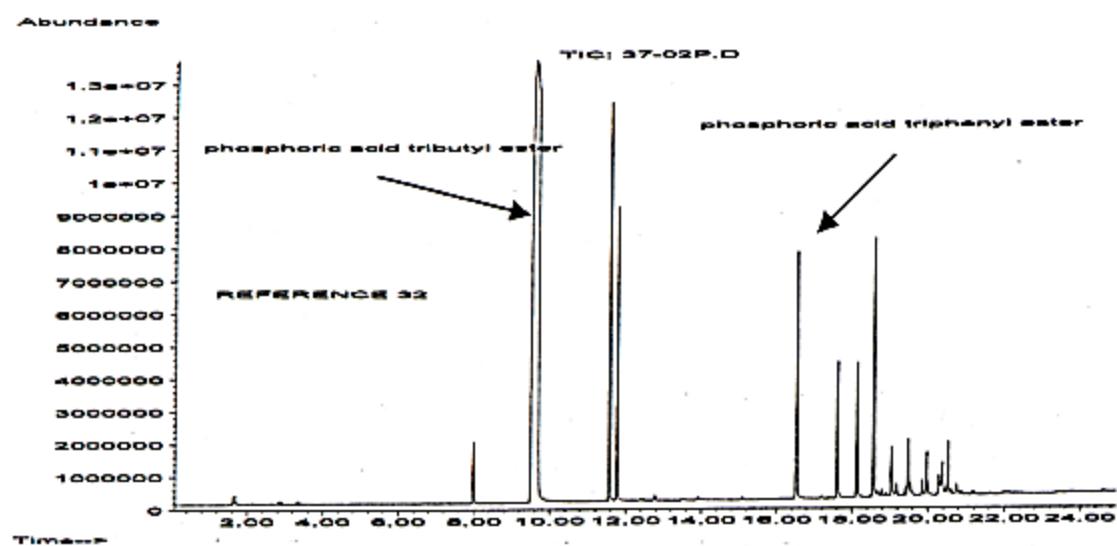
PLATE 6

The chromatograms of the samples of hydraulic fluid, from the servo-controls and the test bench, are shown in plates 6 to 10, the chromatogram of new fluid being illustrated in plate 6 for purposes of comparison.

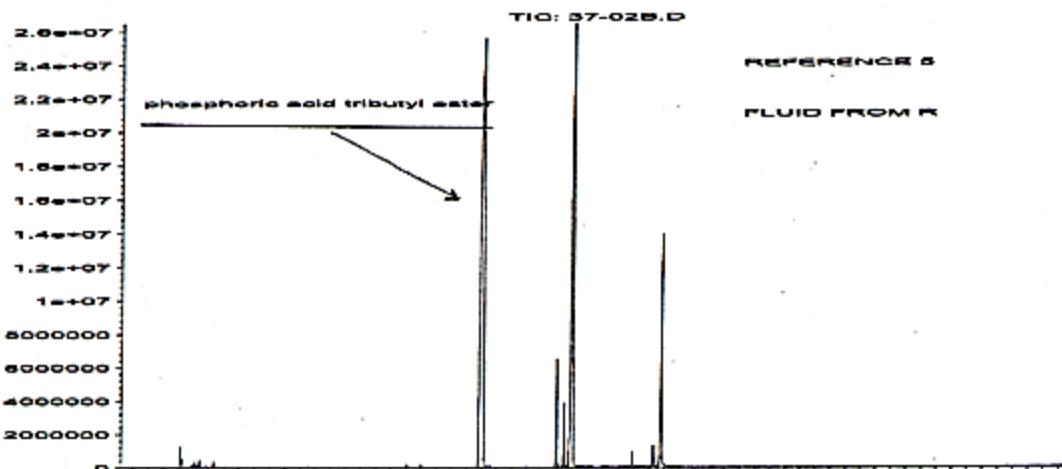
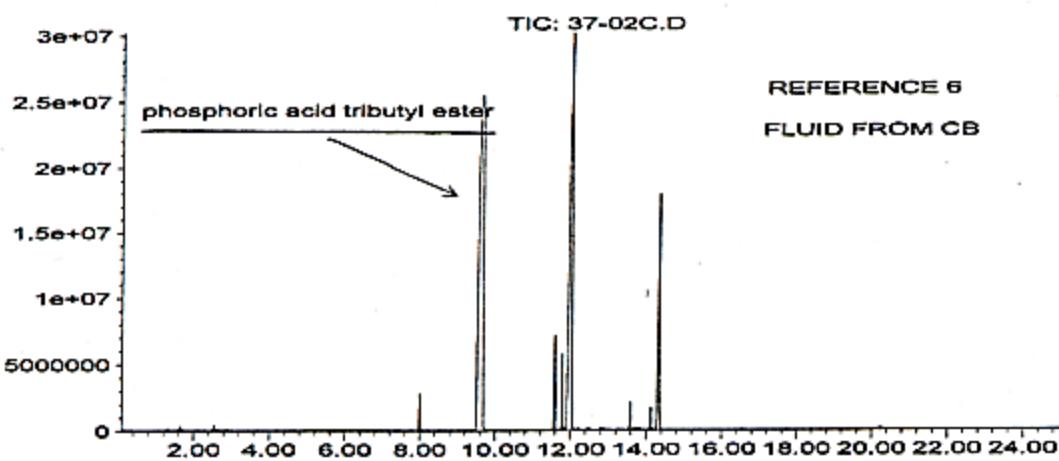
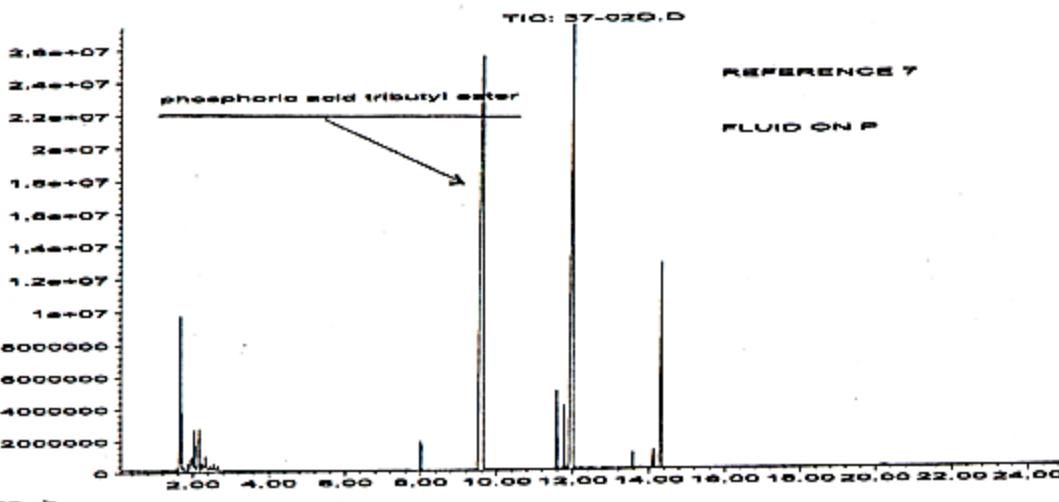
PLATE 7

The chromatograms of the samples referenced 5, 6, 7, 10, 12, 17, 19 and 26 taken from the servo-controls show the disappearance of certain plots, probably due to the fact that these fluids had been used and that the additives had fixed in the metallic parts of the system.

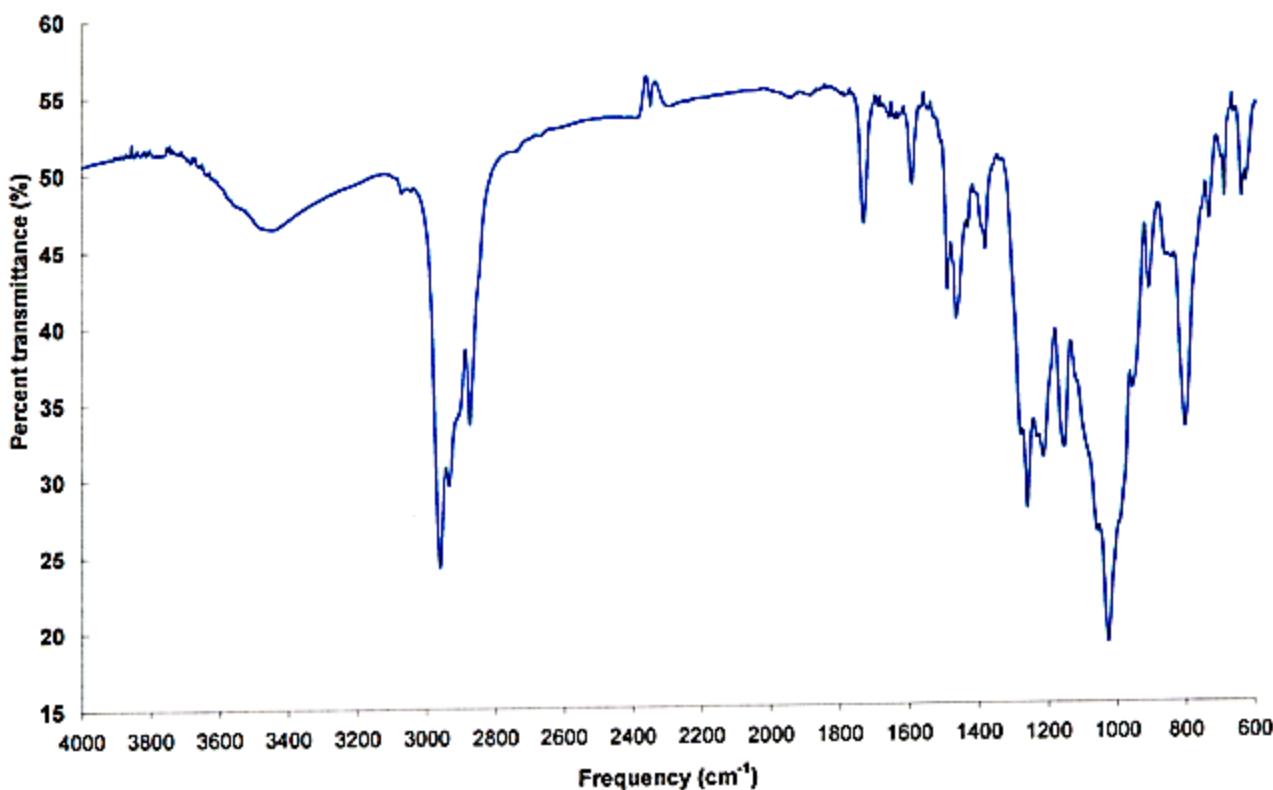
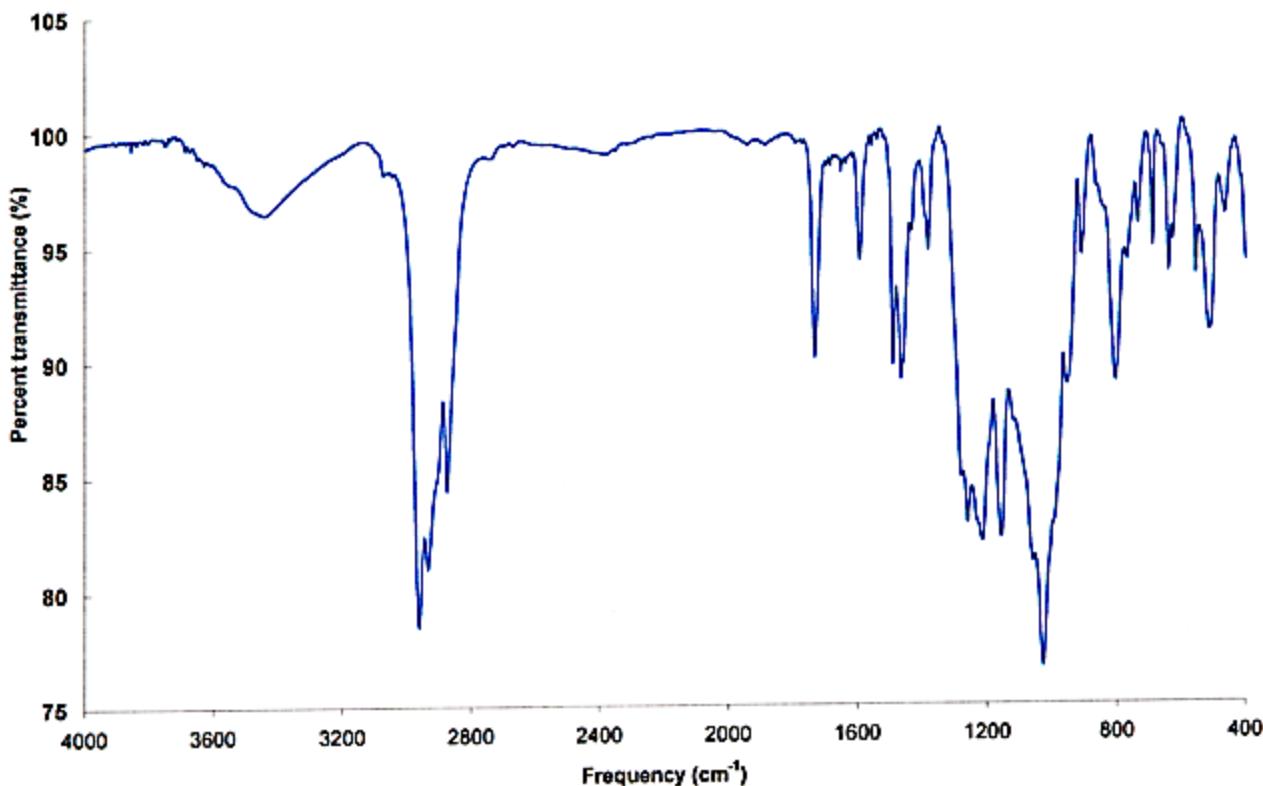
PLATE 12
Infrared Spectra

The results obtained by infra-red absorption spectrometry and by X ray fluorescence spectrometry are shown in the following table. The spectra are shown in plates 12, 13, 14 and 15.

Reference	IR ANALYSIS	X RAY ANALYSIS
1	teflon, silicone and traces of Hyjet IV	Cause of the low quantity of available products, not any element was detected
2	teflon, silicone and traces of Hyjet IV	main elements : silicon, aluminium, phosphorus. Trace of iron and silver
4	teflon, silicone and traces of Hyjet IV	Cause of the low quantity of available products, not any element was detected

According to the facts available to us, it appears that some Teflon, as well as traces of hyjet and silicon, can be found on the three samples.

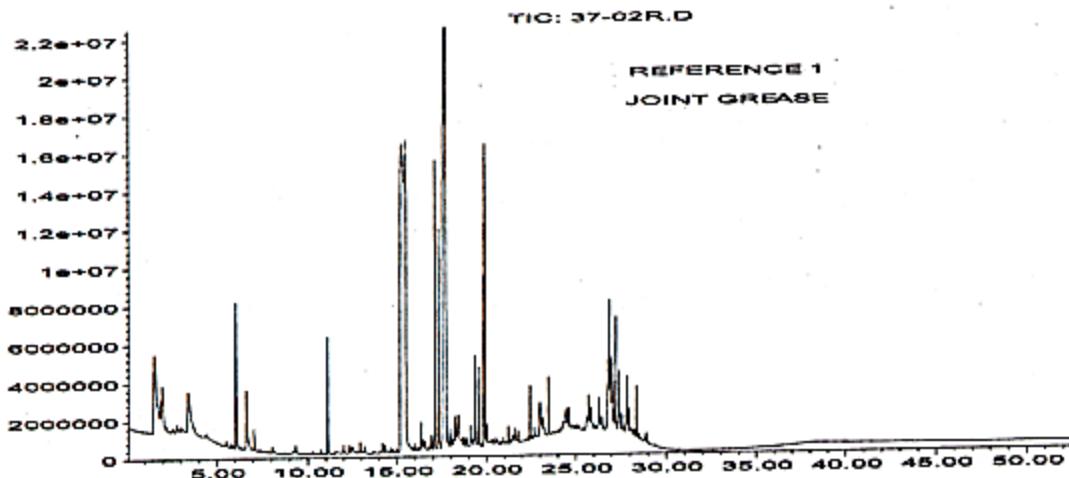
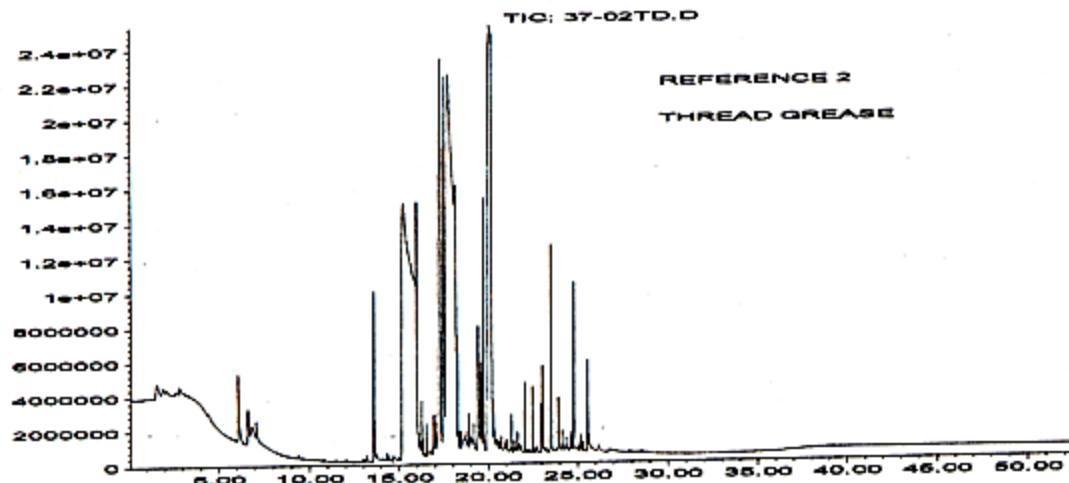
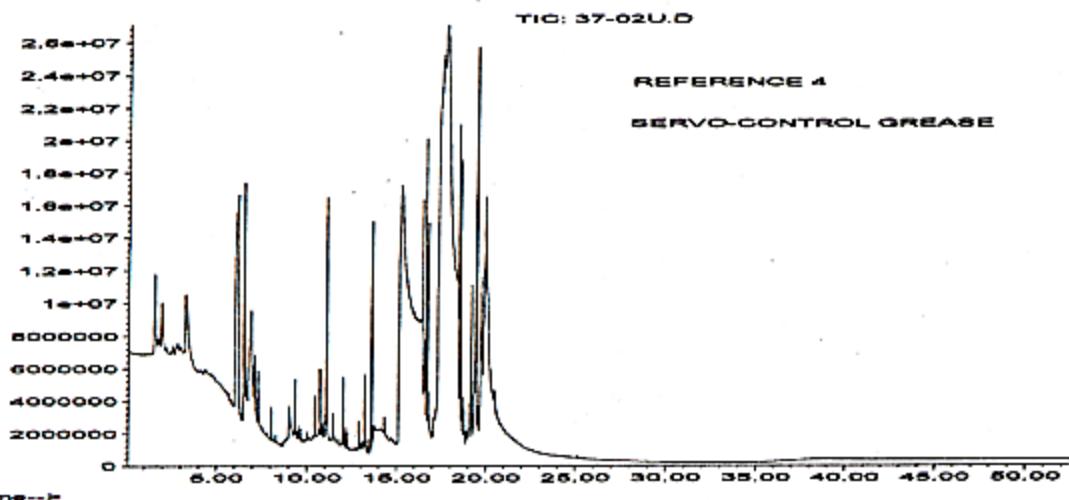
PLATE 16

Gas chromatography linked to mass spectrometry did not confirm the presence of Teflon. The resulting chromatograms are in plate 16.

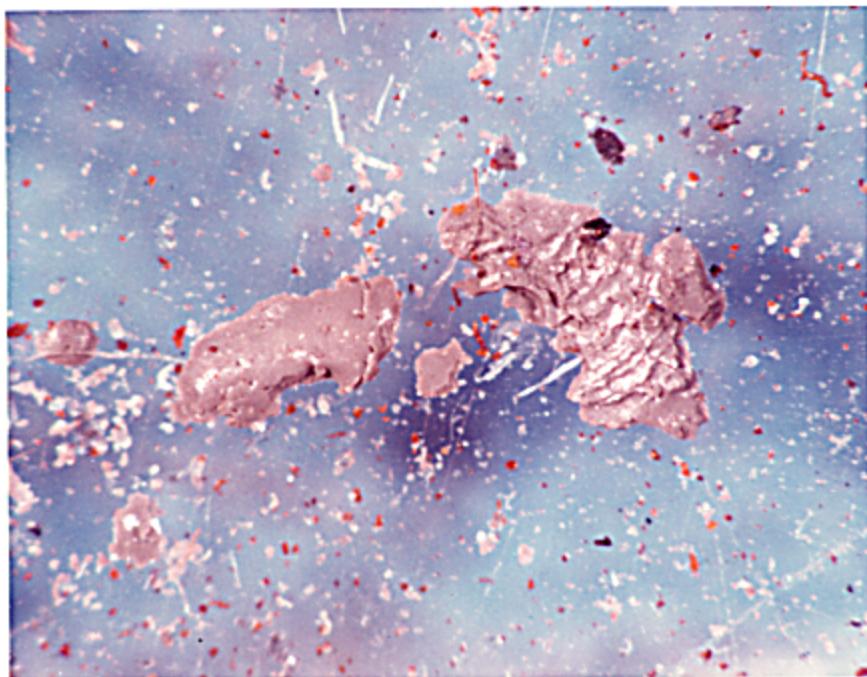
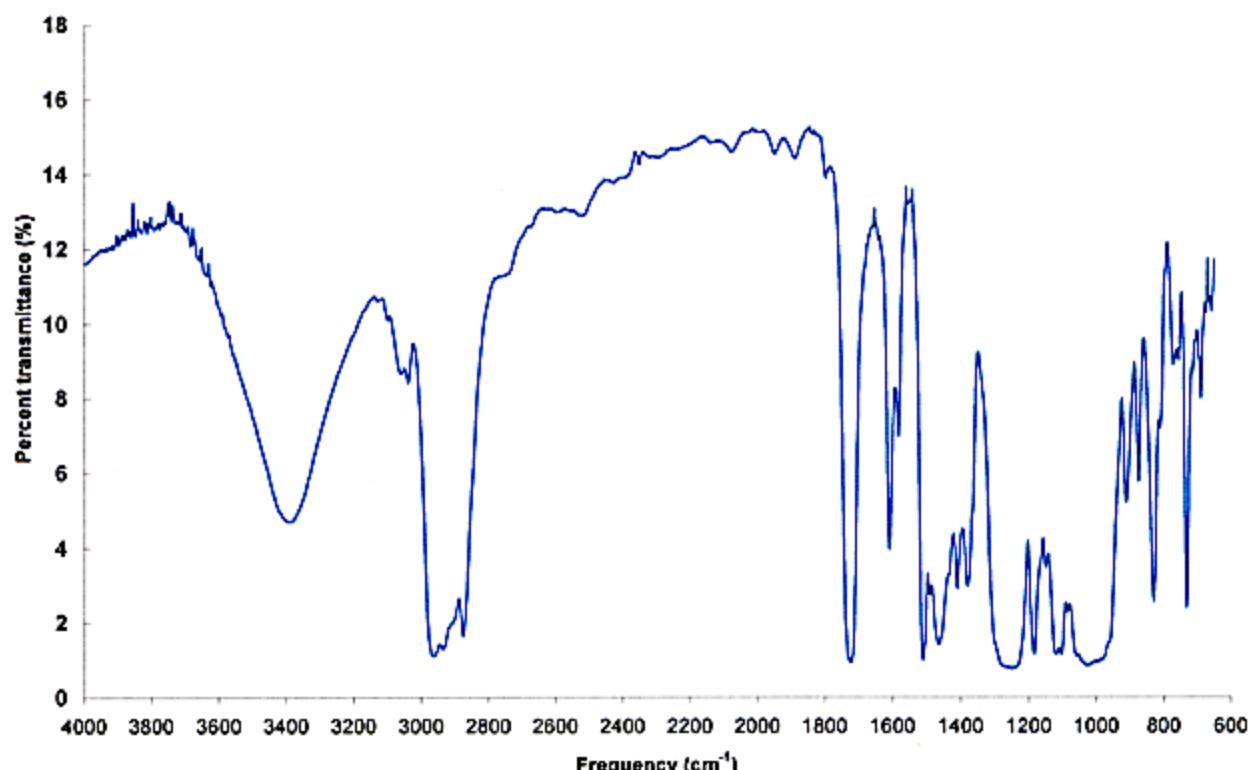
PLATE 17
Sediments recovered on the filter n° 30

The extracted product retrieved for reference 30 is shown in the photo in plate 17. The results are recorded in the following table.

Reference	IR ANALYSIS
29 et 31	Not any products were extracted by ultrasound
30	Epoxy resin bisphenol A

Only the extraction performed on the filter referenced 30 allowed a deposit to be recovered. In order to determine the origin of the recovered product, various parts of the filter were analysed. Analysis of the stick band of the filter revealed the presence of polyamide and trace of Hyjet. Analysis of the mastic revealed the presence of calcium carbonate CaCO_3 .

It was not possible to prove that the product detected was a part of the composition of the filter.

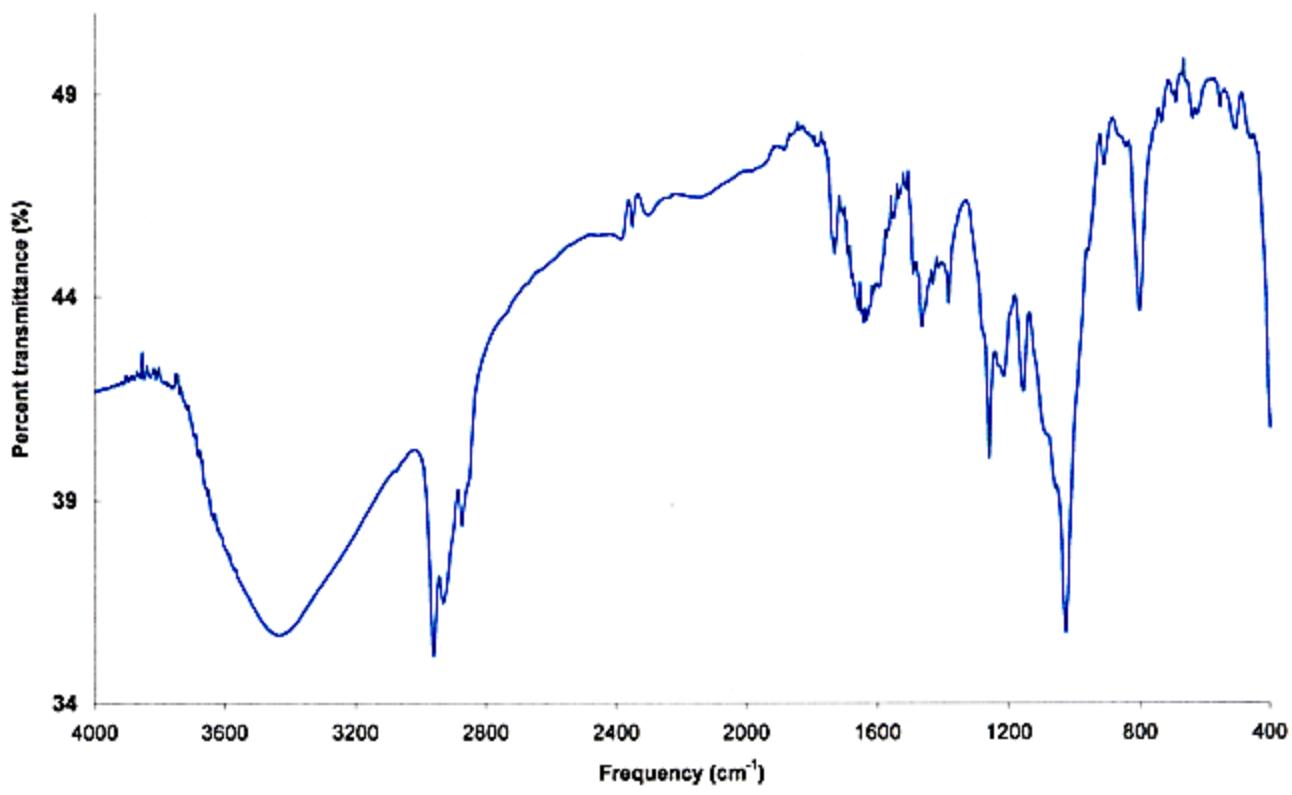
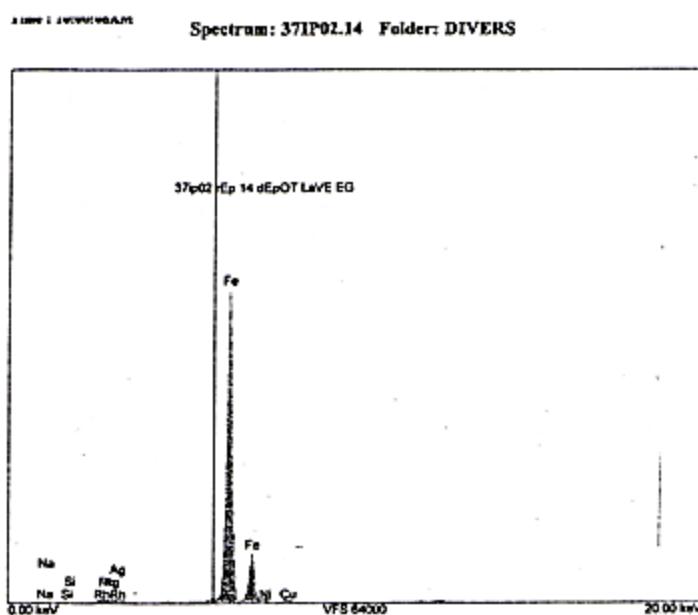
PLATE 18
Infrared and fluorescence X Spectrum item 14

The deposit referenced 14 appeared in the form of an oxidized and pasty deposit.

The deposit was first washed in petroleum ether then analysed by infra-red absorption spectrometry and by X ray fluorescence spectrometry. The spectra are shown in plate 18.

Analysis of the deposit after washing showed the presence of Teflon, carbonate and iron.

The washing liquid contained silicon and iron.

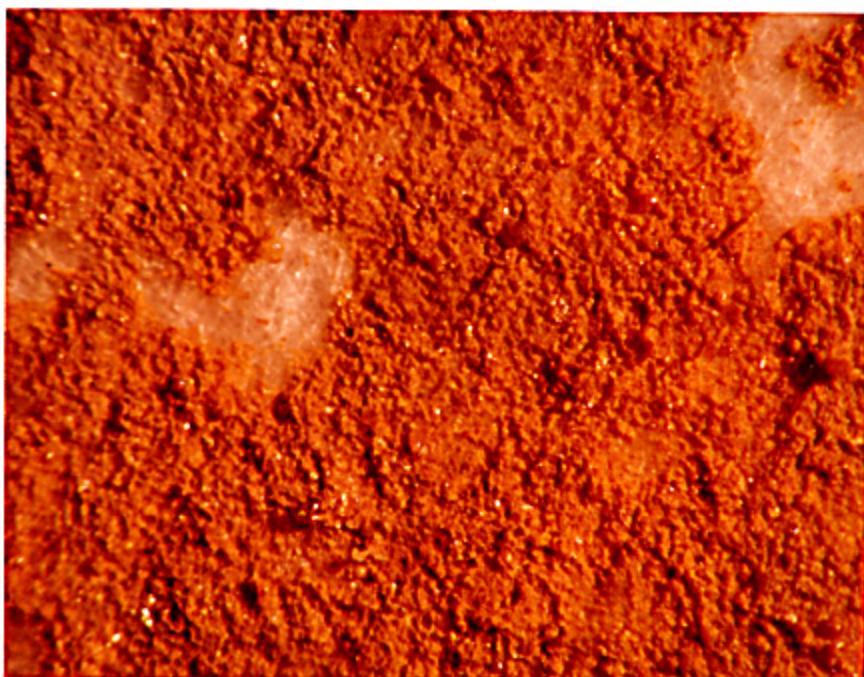
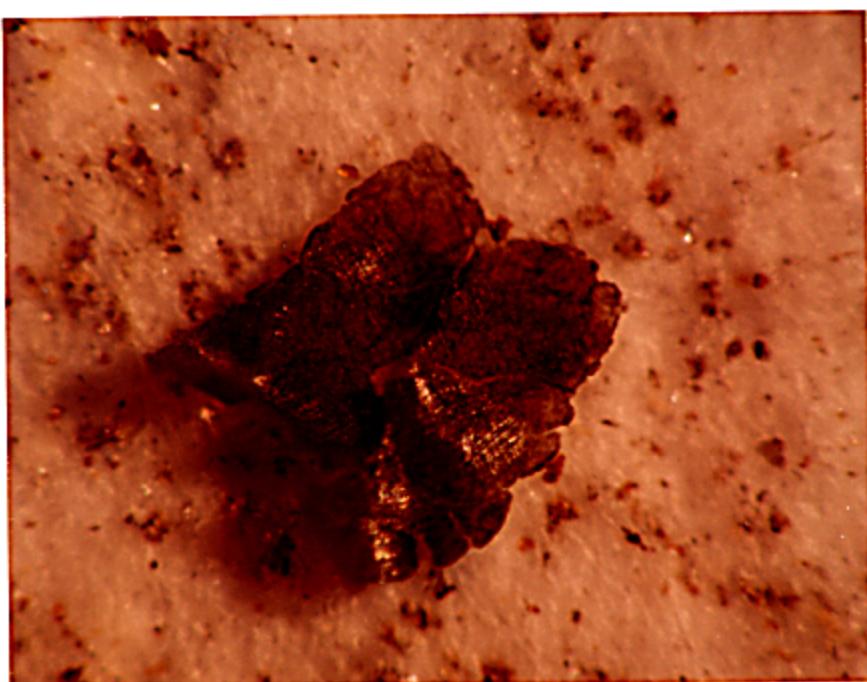
**PLATE 19
Sediments extracted from hydraulic fluids**

Photos of the 4 Millipore filters from which were extracted deposits characteristic of hydraulic fluids referenced 6, 8 and 25 are shown in plates 19 and 20.

Reference	IR analysis	X ray fluorescence analysis
6 « Fluid from CB »	no significant product	iron, chlorine, nickel, copper, phosphorus, aluminium, silicon, potassium, calcium, sulphur
8 « Fluid from return line »	no significant product	-
16 « Fluid from return line filter »	no significant product	iron, chlorine, nickel, copper, phosphorus, aluminium, silicon, potassium, calcium, sulphur
25 « Return line »	no significant product	-
26 « Fluid from CA »	no significant product	-

No unexpected products were brought to light.

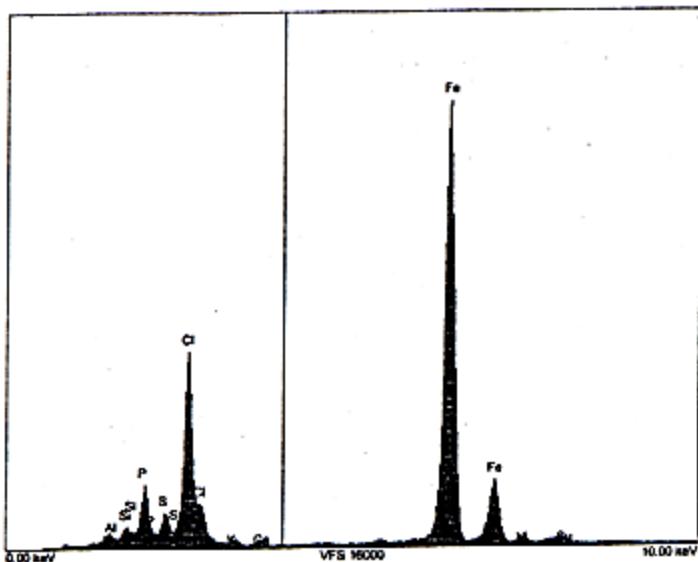
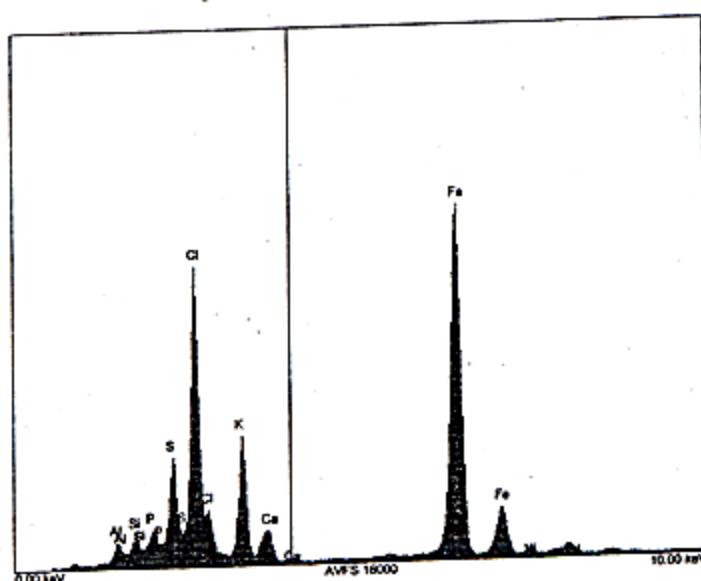
PLATE 21
Sediments extracted from hydraulic fluids

- potassium, chlorine and phosphate content were relatively higher on filter 16 than on filter 6,
- iron content appears higher on reference 6 than on reference 16.

These results appear to corroborate those obtained by rotated disc electrode optical emission spectrometry.
